# Pavement Condition Report

## Mahnomen County Airport (3N8)

**December 2016**

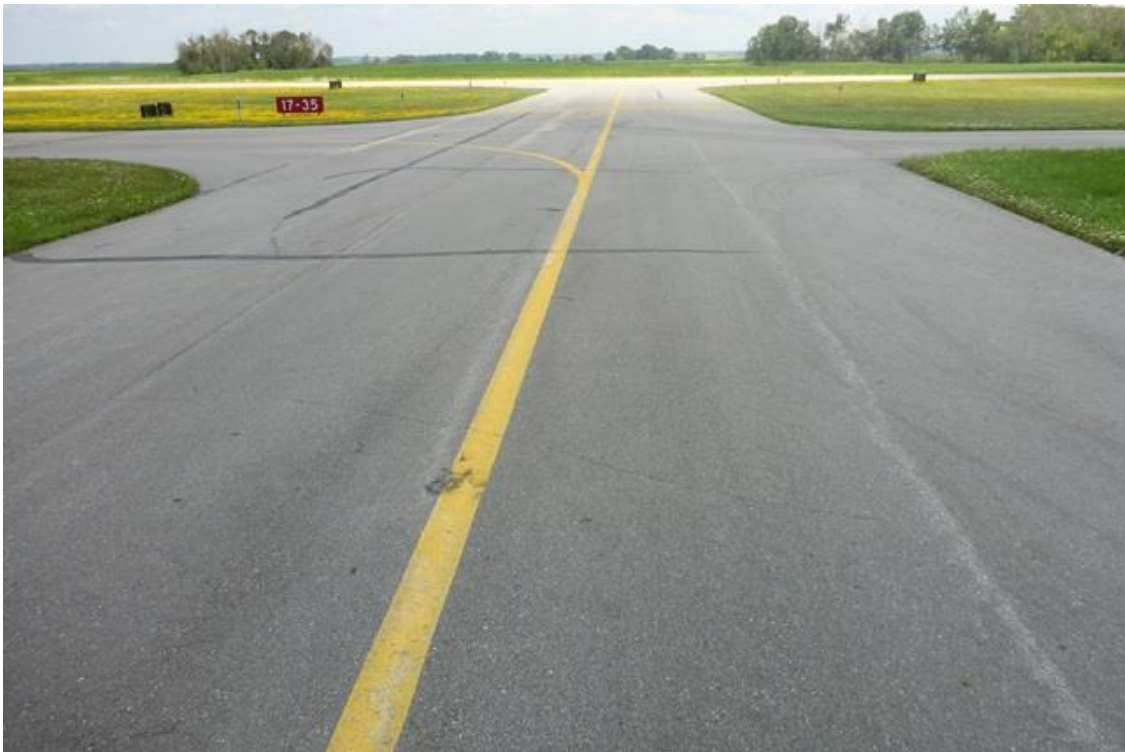
3N8 CTA 002 (PCI = 84)

Note: Overlay(2014) on CTA-002 exhibits reflective cracking leading to higher than normal deterioration of PCI.
