Pavement Condition Report

Hutchinson Municipal Airport (HCD)

December 2016

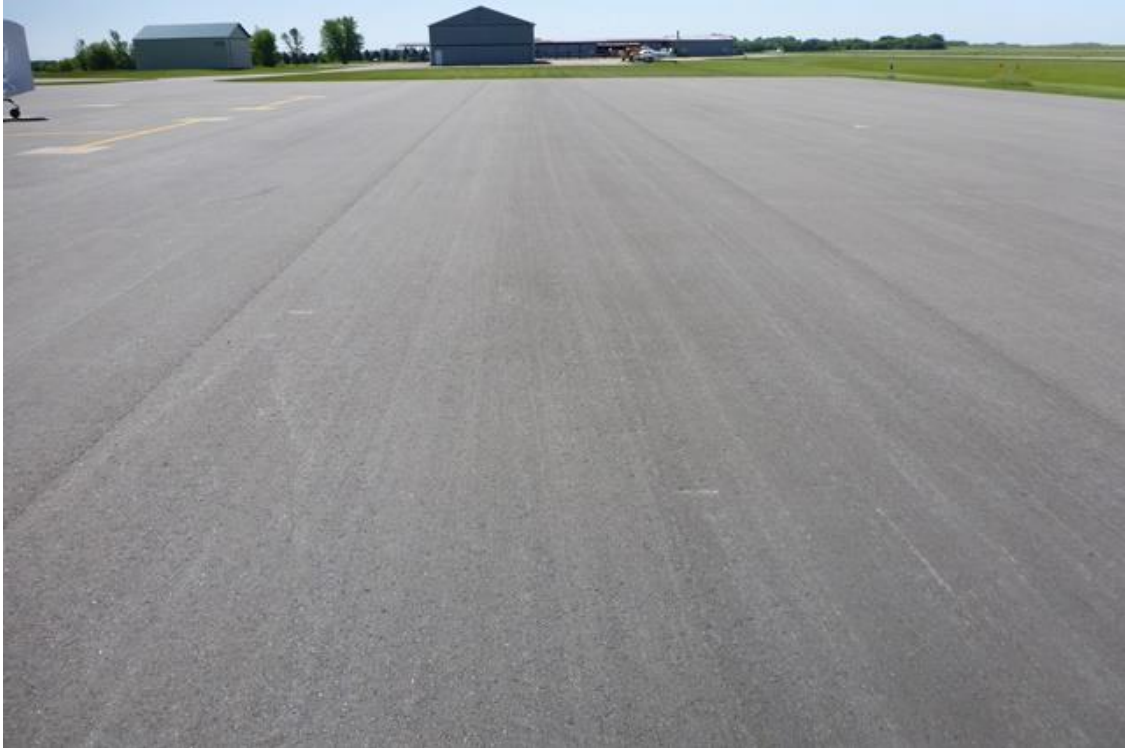
HCD APB 001 (PCI = 100)

Network:	HCD		Name:	HUTCHINSON			
Branch:	APB	Name:	APRON B (NORTH APRON)	Use:	APRON	Area:	143,475 SqFt
Section:	001	of 3	From:	100	To:	504	Last Const.: 10/1/2015
Surface:	AC	Family:	MN2013 Asphalt Aprons	Zone:	S	Category:	3
Area:	123,875 SqFt	Length:	480 Ft	Width:	265 Ft	Rank:	S
Slabs:	Slab Length:	Ft	Slab Width:	Ft	Joint Length:	Ft	
Shoulder:	Street Type:		Grade:	0	Lanes:	0	
Section Comments:							
Last Insp. Date:	5/26/2016	TotalSamples:	25	Surveyed:	4		
Conditions:	PCI: 100						
Inspection Comments:							
Sample Number:	100	Type:	R	Area:	5000.00 SqFt	PCI:	100
Sample Comments:							
<No Distress>							
Sample Number:	201	Type:	R	Area:	5000.00 SqFt	PCI:	100
Sample Comments:							
<No Distress>							
Sample Number:	302	Type:	R	Area:	5000.00 SqFt	PCI:	100
Sample Comments:							
<No Distress>							
Sample Number:	501	Type:	A	Area:	5000.00 SqFt	PCI:	100
Sample Comments:							
<No Distress>

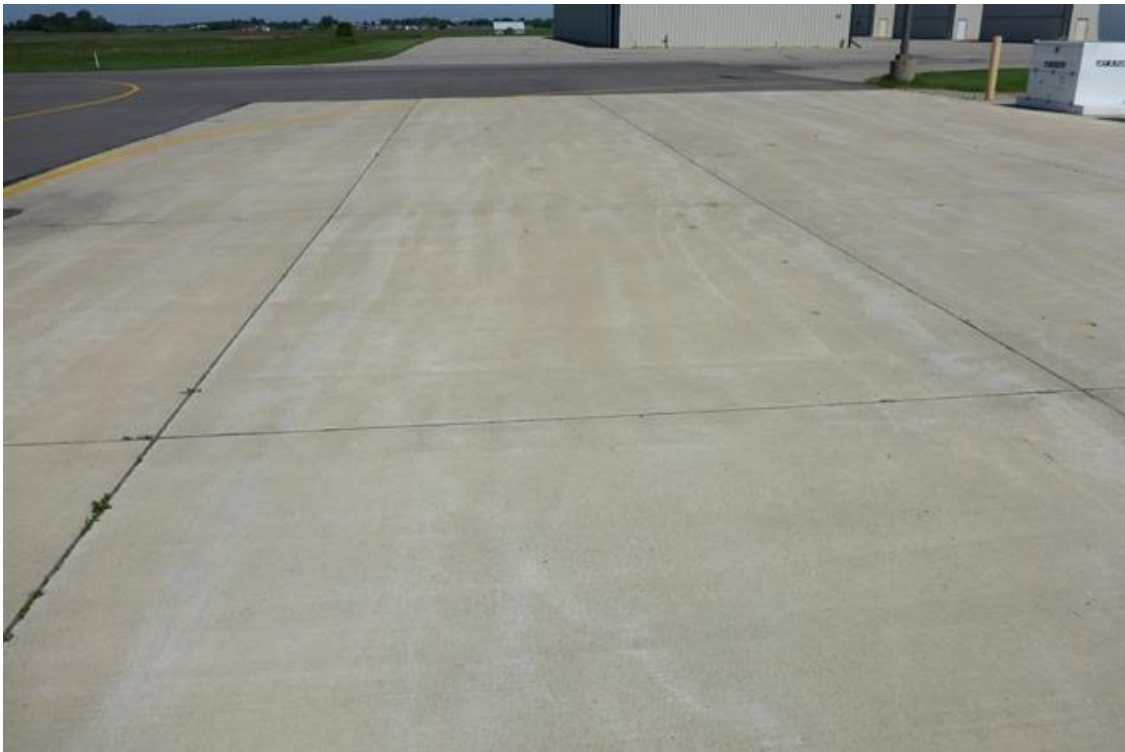
HCD APB 002 (PCI = 81)

Conditions: PCI: 81

74	JOINT SPALL	L	1.00	Slabs
65	JT SEAL DMG	M	20.00	Slabs
74	JOINT SPALL	M	2.00	Slabs
75	CORNER SPALL	H	1.00	Slabs

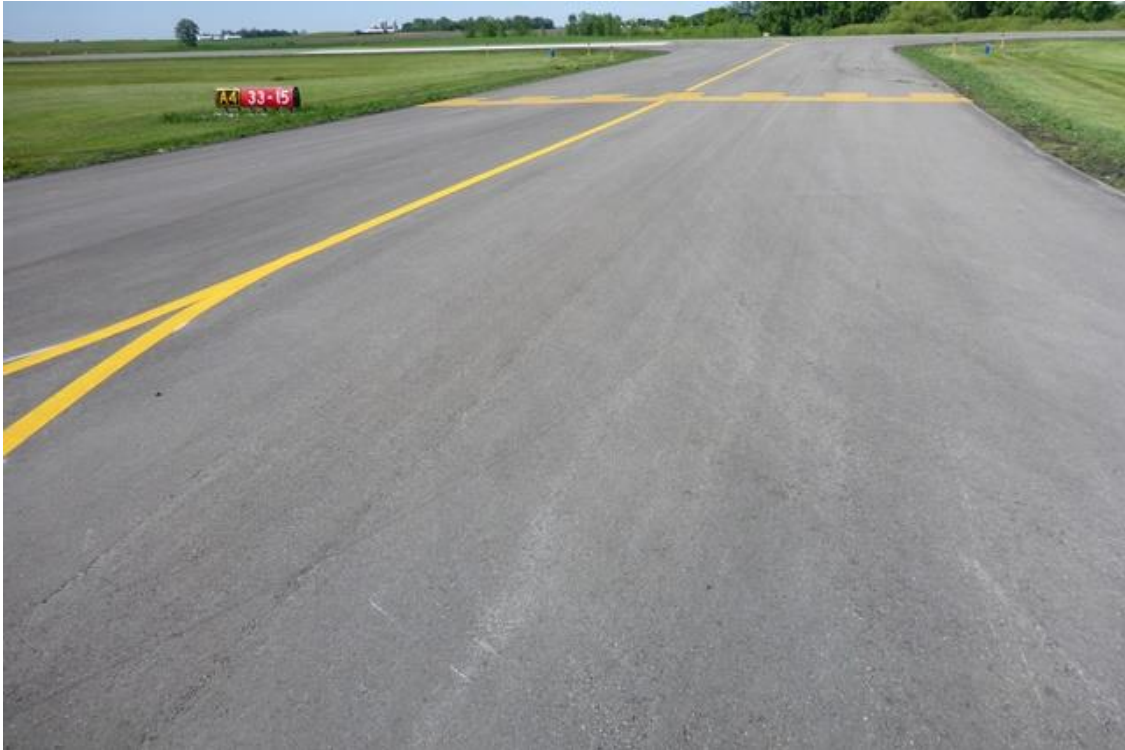
HCD CTA4 001 (PCI = 100)

Network:	HCD		Name:	HUTCHINSON					
Branch:	CTA4	Name:	CONNECTING TAXIWAY A4	Use:	TAXIWAY	Area:	10,950 SqFt		
Section:	001	of 1	From:	200	To:	201	Last Const.:	10/1/2015	
Surface:	AC	Family:	MN2013 Asphalt Taxiways	Zone:	S	Category:	3	Rank:	S
Area:	10,950 SqFt	Length:	240 Ft	Width:	40 Ft				
Slabs:		Slab Length:	Ft	Slab Width:	Ft	Joint Length:	Ft		
Shoulder:		Street Type:		Grade:	0	Lanes:	0		
Section Comments:	maint. (R&E?) CS								
Last Insp. Date:	5/26/2016	TotalSamples:	3	Surveyed:	2				
Conditions:	PCI: 100								
Inspection Comments:									
Sample Number:	200	Type:	A	Area:	4000.00 SqFt	PCI:	100		
Sample Comments:	<No Distress>								
Sample Number:	201	Type:	R	Area:	4000.00 SqFt	PCI:	100		
Sample Comments:	<No Distress>

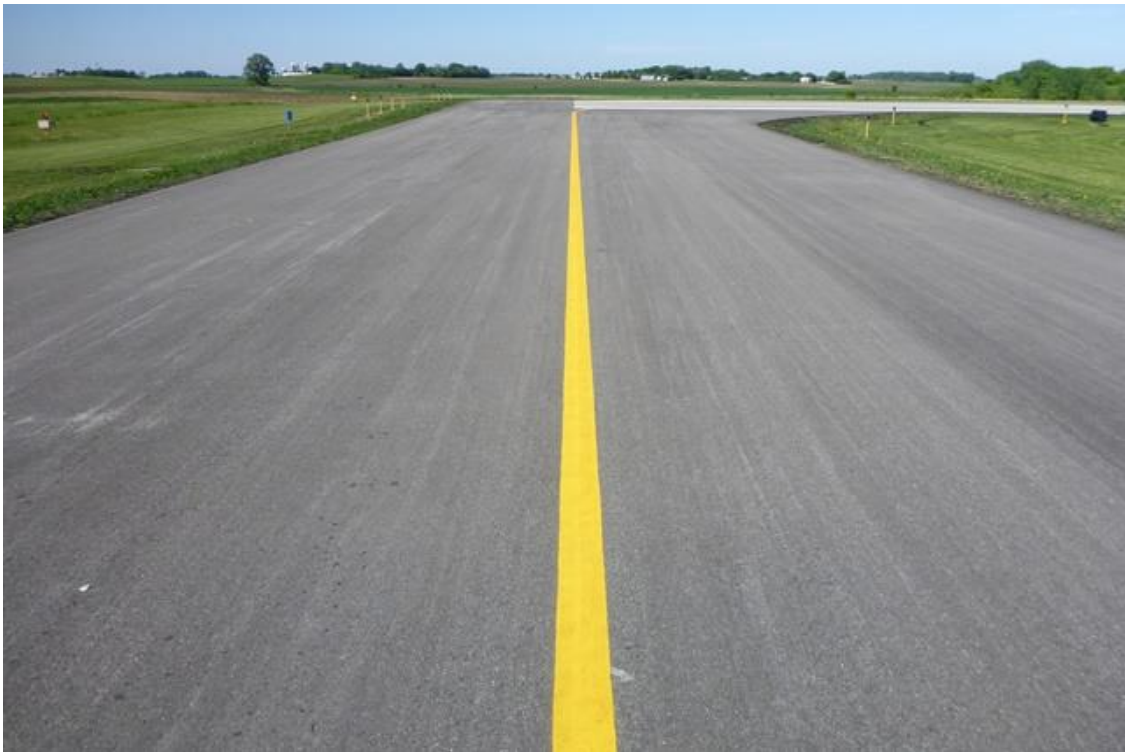
HCD PTA 001 (PCI = 100)

Network:	HCD	Name:	HUTCHINSON						
Branch:	PTA	Name:	PARALLEL TAXIWAY A	Use:	TAXIWAY	Area:	184,690 SqFt		
Section:	002	of 3	From:	101+82	To:	112+40	Last Const.:	10/1/2015	
Surface:	AC	Family:	MN2013 Asphalt Taxiways	Zone:	S	Category:	3	Rank:	P
Area:	46,800 SqFt	Length:	1,040 Ft	Width:	40 Ft				
Slabs:		Slab Length:	Ft	Slab Width:	Ft	Joint Length:	Ft		
Shoulder:		Street Type:		Grade:	0	Lanes:	0		
Section Comments:	maint. (R&E?) CS								
Last Insp. Date:	5/26/2016	TotalSamples:	10	Surveyed:	2				
Conditions:	PCI: 100								
Inspection Comments:									
Sample Number:	106	Type:	R	Area:	4000.00 SqFt	PCI:	100		
Sample Comments:	<No Distress>								
Sample Number:	111	Type:	R	Area:	4000.00 SqFt	PCI:	100		
Sample Comments:	<No Distress>

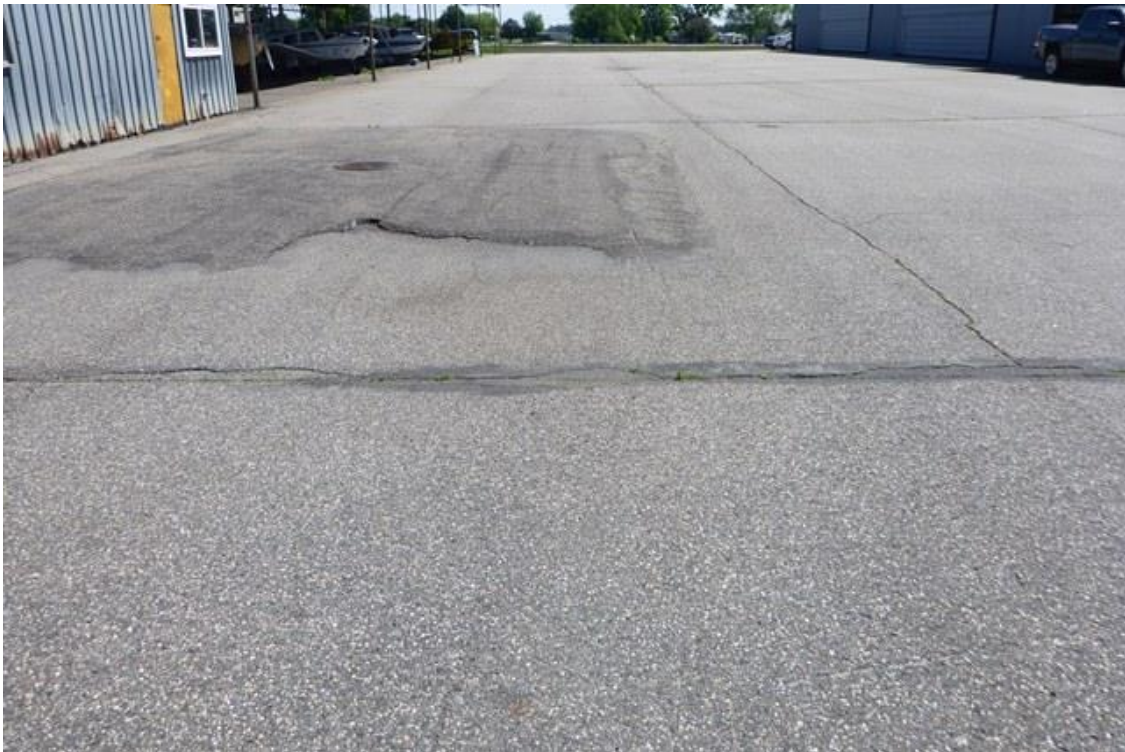
HCD TLA 001 (PCI = 61)

Conditions: PCI: 61

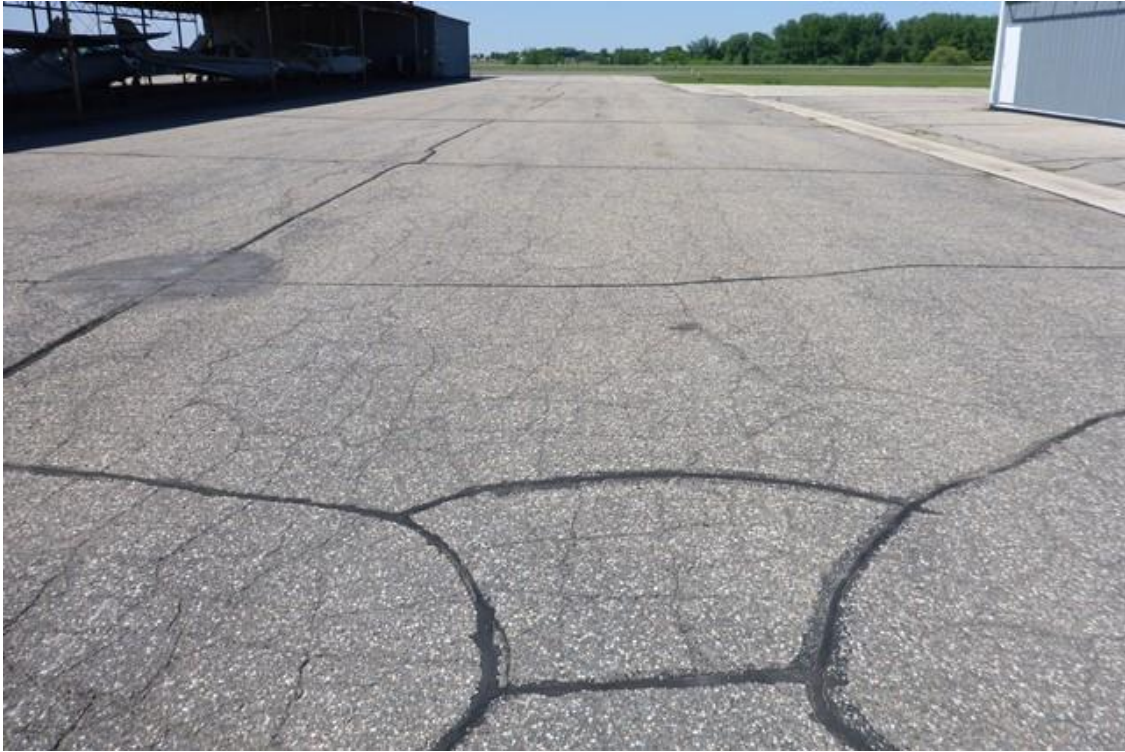
HCD TLA 003 (PCI = 30)

Conditions: PCI: 30

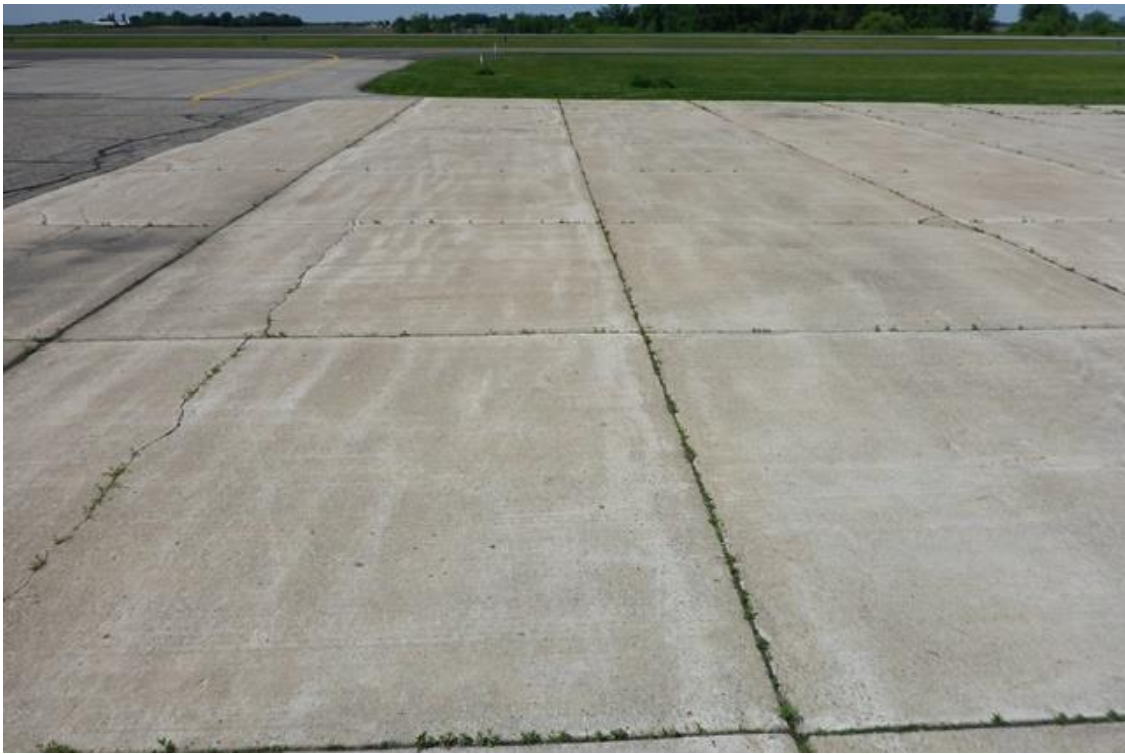
HCD TLA 004 (PCI = 26)

Conditions: PCI: 26

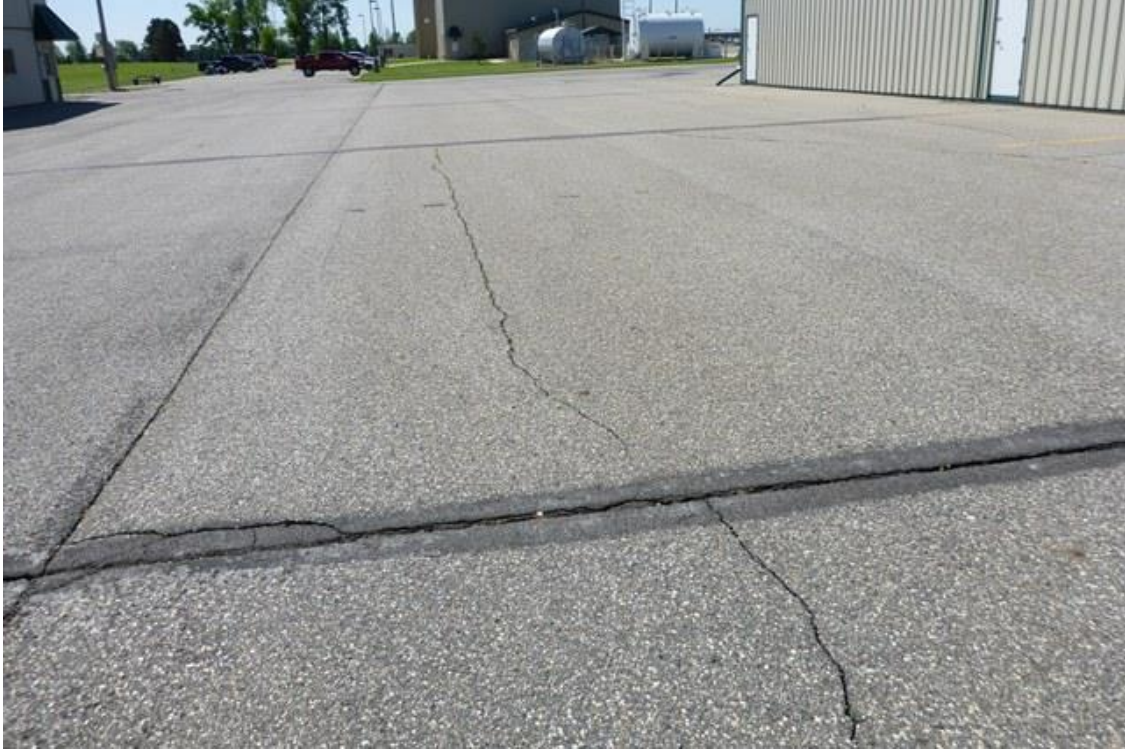
HCD TLB 001 (PCI = 64)

Network:	HCD	Name:	HUTCHINSON						
Branch:	TLB	Name:	TAXILANE B	Use:	TAXILANE	Area:	52,825 SqFt		
Section:	001	of 1	From:	100	To:	400	Last Const.: 9/30/2000		
Surface:	AC	Family:	MN2013 Asphalt Taxilanes	Zone:	S	Category:	3	Rank:	T
Area:	52,825 SqFt	Length:	350 Ft	Width:	180 Ft				
Slabs:		Slab Length:	Ft	Slab Width:	Ft	Joint Length:	Ft		
Shoulder:		Street Type:		Grade:	0	Lanes:	0		
Section Comments:									
Last Insp. Date:	5/26/2016	TotalSamples:	11	Surveyed:	3				
Conditions:	PCI: 64								
Inspection Comments:									
Sample Number:	102	Type:	R	Area:	7250.00 SqFt	PCI:	71		
Sample Comments:									
48	L & T CR	M	267.00	Ft					
48	L & T CR	L	54.00	Ft					
57	WEATHERING	M	650.00	SqFt					
Sample Number:	201	Type:	R	Area:	3700.00 SqFt	PCI:	58		
Sample Comments:									
48	L & T CR	M	212.00	Ft					
48	L & T CR	L	113.00	Ft					
57	WEATHERING	M	300.00	SqFt					
48	L & T CR	H	9.00	Ft					
Sample Number:	401	Type:	R	Area:	5000.00 SqFt	PCI:	57
