# Pavement Condition Report

## Brainerd Lakes Regional Airport (BRD)

**December 2017**

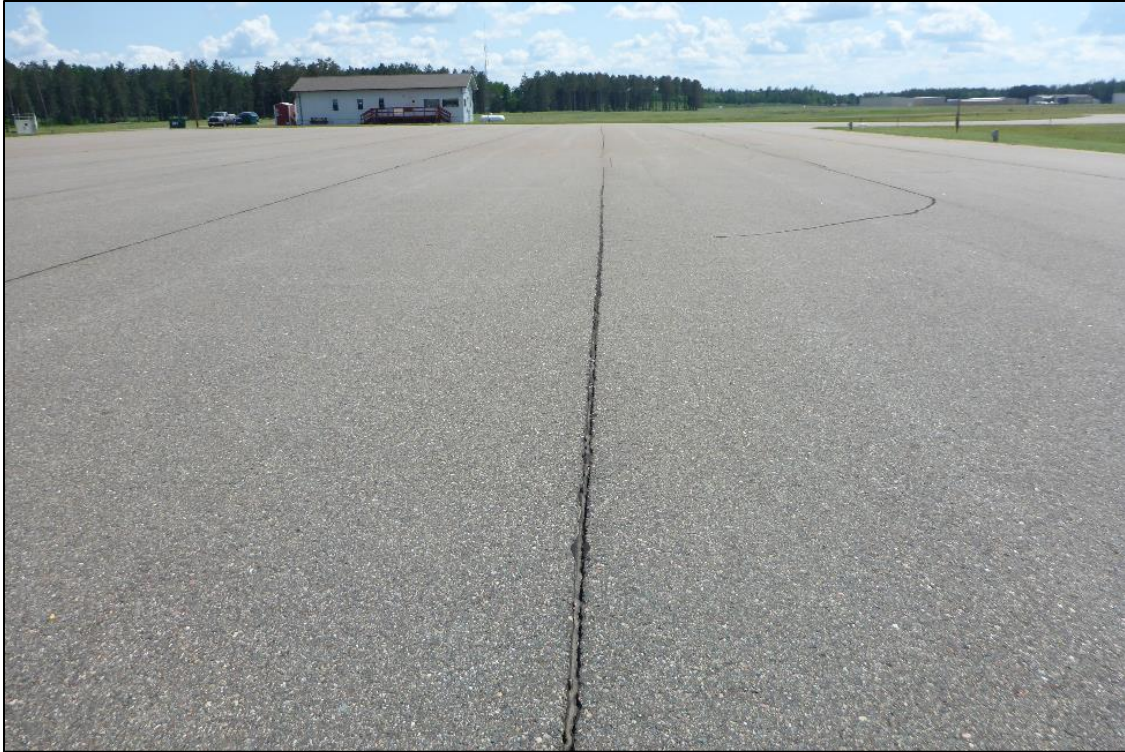
BRD ADNR 001 (PCI = 71)

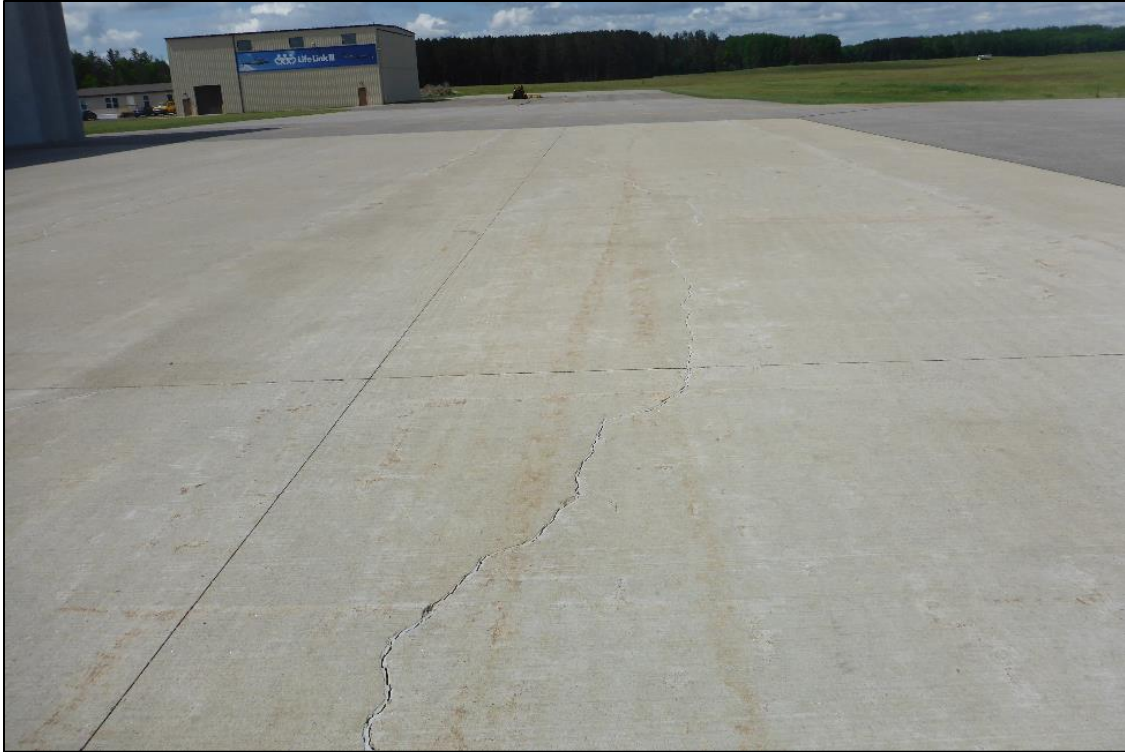
BRD APA 002 (PCI = 52)

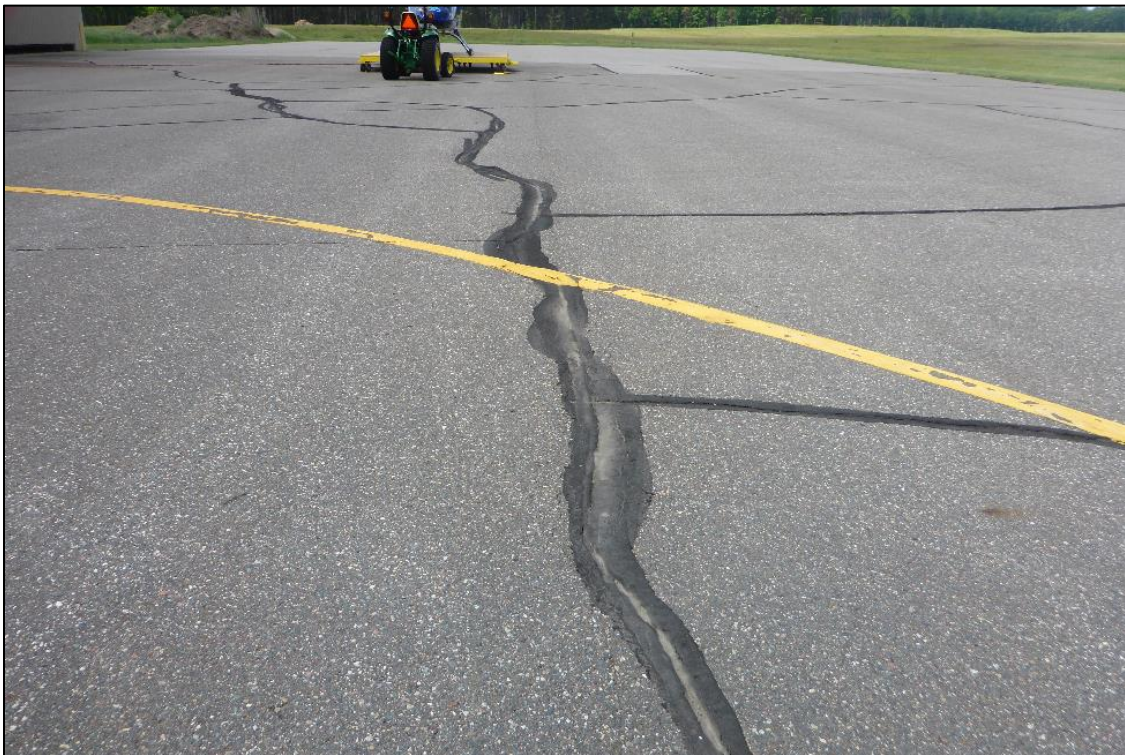
BRD APA 004 (PCI = 72)

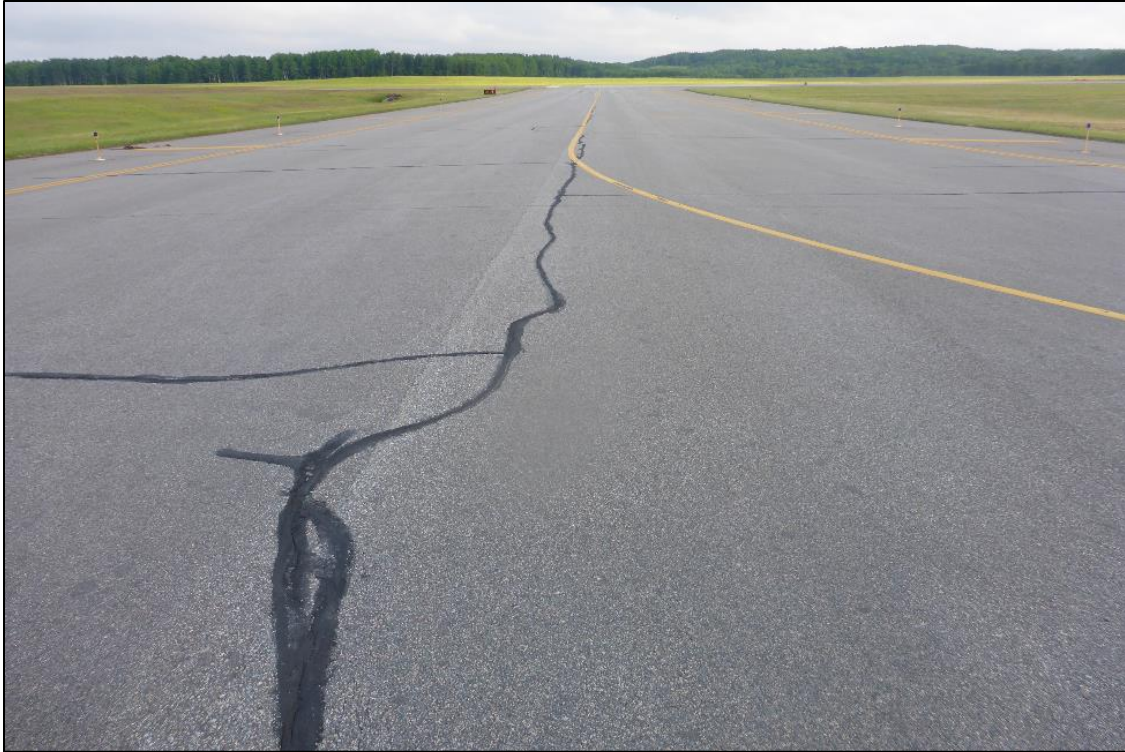
BRD CTA1 001 (PCI = 68)

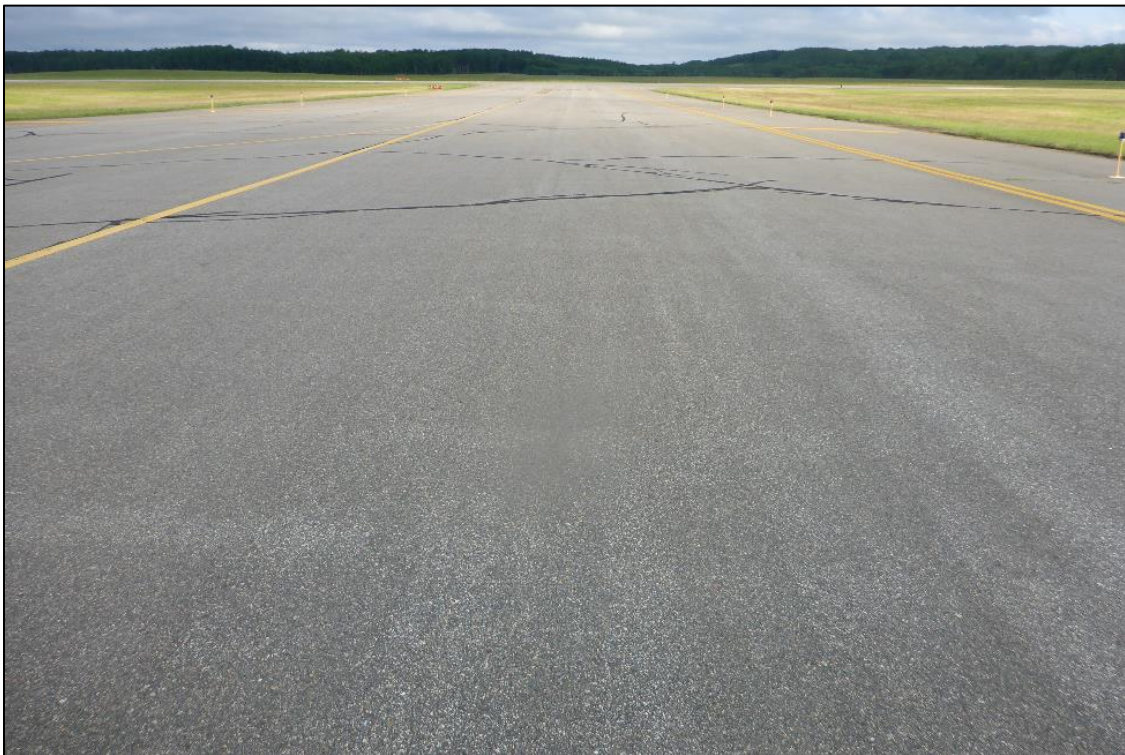
BRD CTA2 001 (PCI = 68)

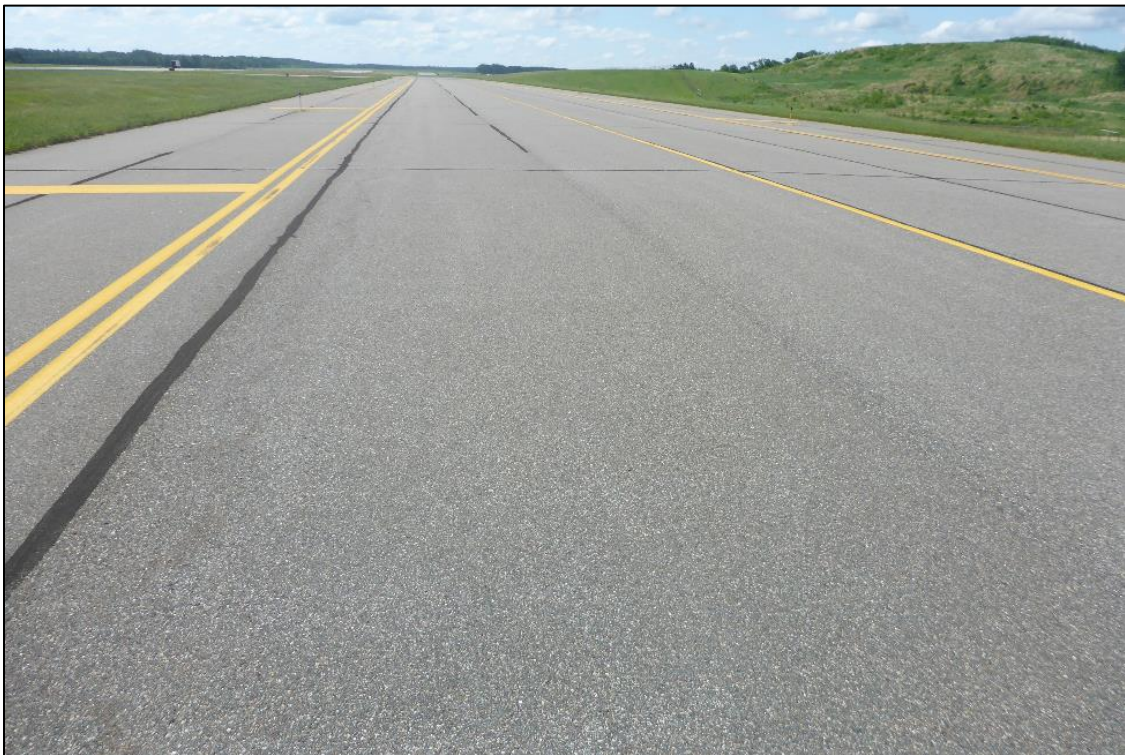
BRD PTC 003 (PCI = 64)

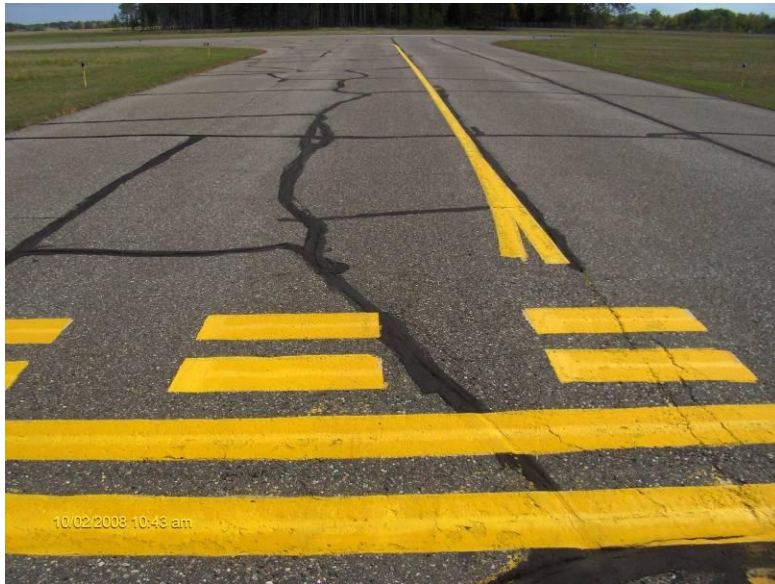
### *Example of Longitudinal and Transverse Cracking (L&T cracking)*

Longitudinal and transverse cracks are caused by pavement aging, by construction, and by subsurface movement. Aging occurs as pavement loses some of its components to the atmosphere and becomes more brittle. Consistent application of pavement sealcoats can help to prevent the occurrence of age related cracks. Cracks will also develop along poorly constructed paving lane joints. Ensuring that joints are made when both sides are still hot, and near the same temperature, is one of the best ways to mitigate this potential problem. Seasonal movement caused by changes in moisture content or temperature differences can also cause pavement cracks. Asphalt pavement placed over a PCC pavement or cement stabilized base course may evidence reflective cracking from the underlying material. Longitudinal and transverse cracks are not caused by wheel loads, although traffic may worsen their condition.

Low severity longitudinal and transverse cracks are less than  $\frac{1}{4}$  inch wide, or if sealed with suitable filler material in satisfactory condition can be any width, less than 3 inches, if they are not spalled. Maintenance usually is not indicated for low-severity cracking. Moderately spalled cracks and cracks wider than  $\frac{1}{4}$  inch which are not satisfactorily sealed are at medium severity. Medium-severity cracks should be sealed with a high-quality crack filling material. Severely spalled cracks and cracks wider than 3 inches are at high severity. High-severity L&T cracks normally require patching.

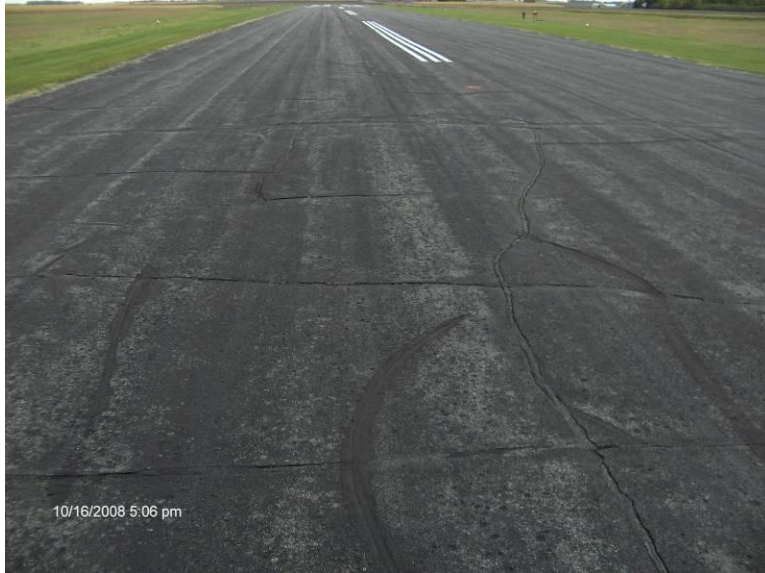
### ***Example of Block Cracking***

Block cracking is longitudinal and transverse cracking that has established a pattern of blocks ranging in size from 1ft x 1ft to 10ft x 10ft. This distress typically happens in older asphalt pavements and is an indication that the bituminous binder has lost most of its flexibility. The severity determination is basically determined by the crack width criteria defined for longitudinal and transverse cracking. Crack sealing typically is used to repair block cracking; however, the amount of required sealant can be extensive due to the high density of cracks.

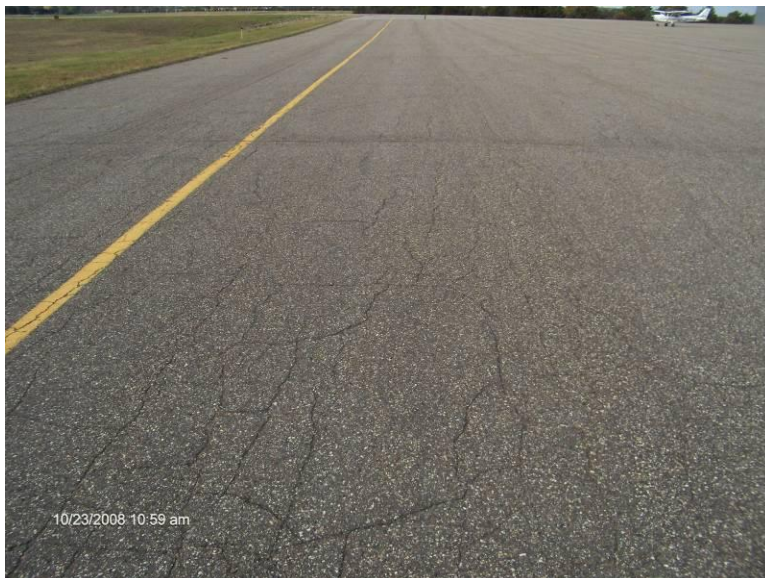
### ***Example of Alligator Cracking***

Alligator (or fatigue) cracks are a series of interconnected load-related cracks caused by fatigue of the asphalt surface. Alligator cracking is a significant structural distress and develops only in places subject to traffic loads. These cracks typically initiate at the bottom of the asphalt layer (where tensile strains

are highest) and propagate upward - so once a fatigue crack is visible, significant damage has already occurred.

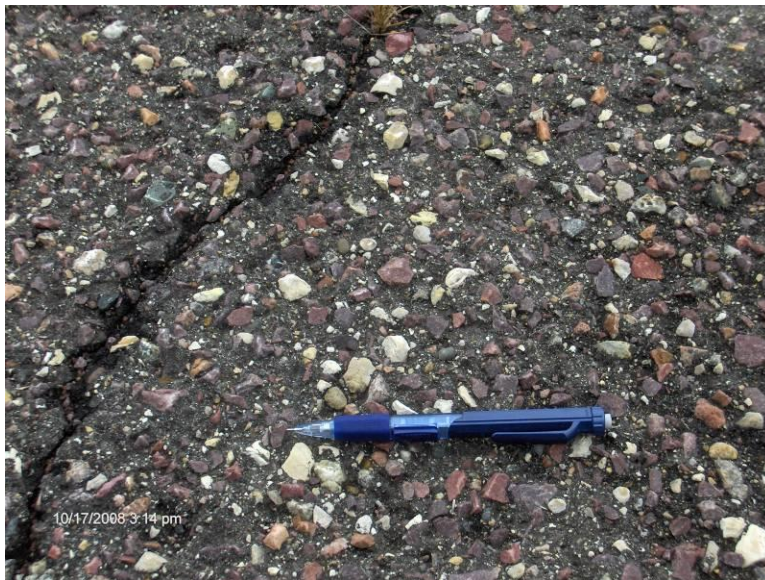
### *Example of Raveling/Weathering*

Raveling and weathering are the wearing away of the pavement surface. Raveling is the condition where the mid- to large size aggregates are becoming dislodged; weathering is when the fine aggregate wears away exposing the edges of the larger aggregate. These distresses are usually evident over large areas and may occur together (pictured above) or separately. Raveling and weathering may indicate that the asphalt binder has hardened significantly.

Raveling – At low severity, the number of missing coarse aggregates (> 3/8 inch) is between 5-20 missing/yd<sup>2</sup>, medium severity (pictured below where the missing coarse aggregates have been dotted with yellow paint) is 21-40 missing/yd<sup>2</sup>, and high severity is > 40 missing/yd<sup>2</sup>.

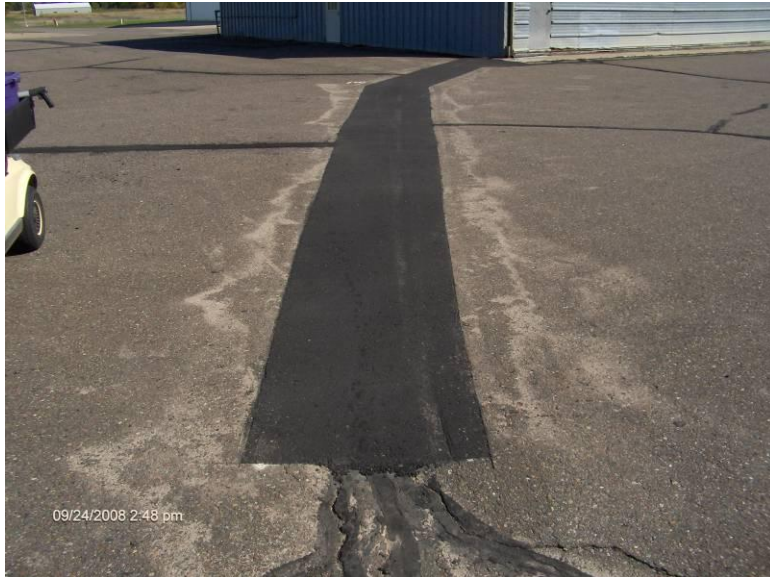
### Example of Patching

Patched areas are defined when a portion of the original pavement is replaced with a material intended as a semi-permanent repair. A patch is documented as a defect because it is considered a break in the integrity of the pavement structure. Patches are constructed for a variety of reasons including utility repairs, correcting grade issues, and addressing a defect in the original pavement. The severity level of patches is determined by the amount of distress (i.e. cracking, depression, weathering/raveling, etc.) occurring within the limits of the patched area.

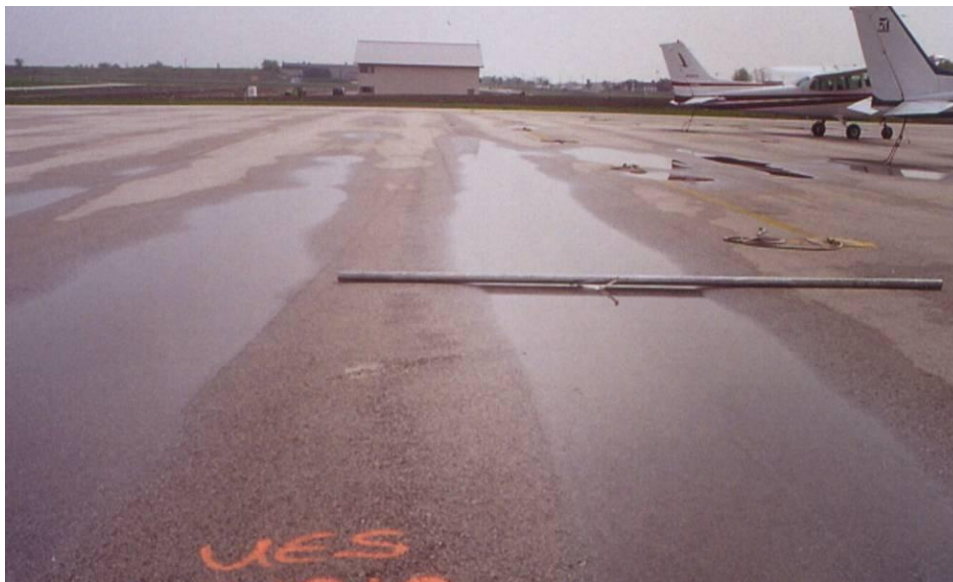
### Example of Rutting

Ruts are localized, load related, areas of pavement having elevations lower than the surrounding sections. Rutting is due to base and subgrade consolidation, caused by excessive wheel loads or poor compaction. Ruts indicate structural failure, and can cause hydroplaning. At low severity, ruts have an

average depth of ¼ to ½ inches. At medium severity, ruts have an average depth of ½ to 1 inch. High severity, ruts have an average depth greater than 1 inch. Full-depth patching is the appropriate repair for ruts.

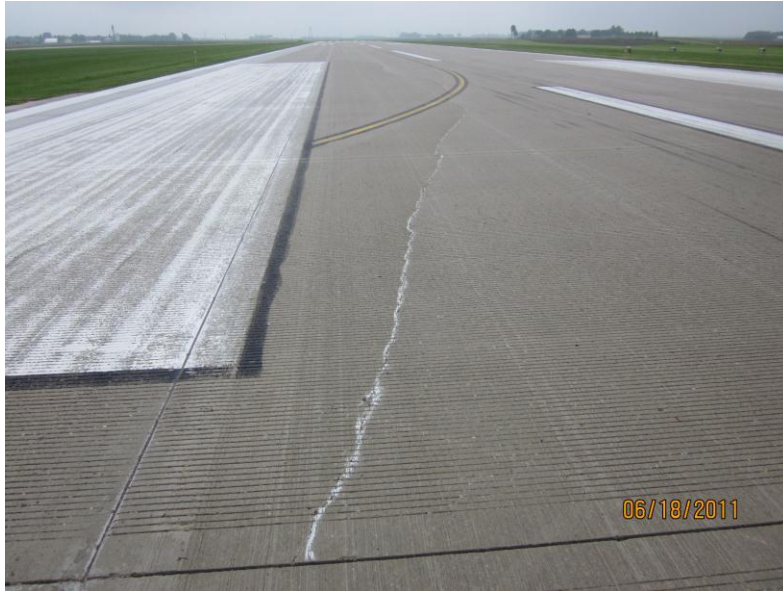
### *Example of Longitudinal, Transverse, and Diagonal Cracking*

LTD cracking is most often a result of externally applied loads and/or constrained temperature deformations. External loads cause LTD cracking through flexure. Temperature changes on restrained slabs will result in stresses due to friction or curling. When any of these stresses exceed the strength of the slab, cracking will occur. LTD cracking is recorded at low, medium, or high severity, depending on the width of crack opening and degree of deterioration. At low severity, the crack is less than 1/8th inch wide with little spalling and no corrective action is indicated. At medium severity, LTD cracks can be up to 1 inch wide with moderate spalling, and should be repaired and sealed using procedures similar to joint sealing. At high severity, cracks exceed 1 inch in width and may be severely spalled. High-severity LTD cracking is evidence of serious load failure of the slab, and correction may require patching or slab replacement. If the distress occurs in several adjacent slabs at medium or high severity, major rehabilitation of that pavement area is indicated.

When a slab is divided by LTD cracks into four or more pieces, the slab is said to be "divided" or "shattered." Shattered slab is a separate distress category and is indicative of significant structural failure as the slab loses its ability to distribute loads to subgrade and further slab deterioration can be expected. Shattered slabs are rated in three severities, with slab replacement recommended for medium and high severities.

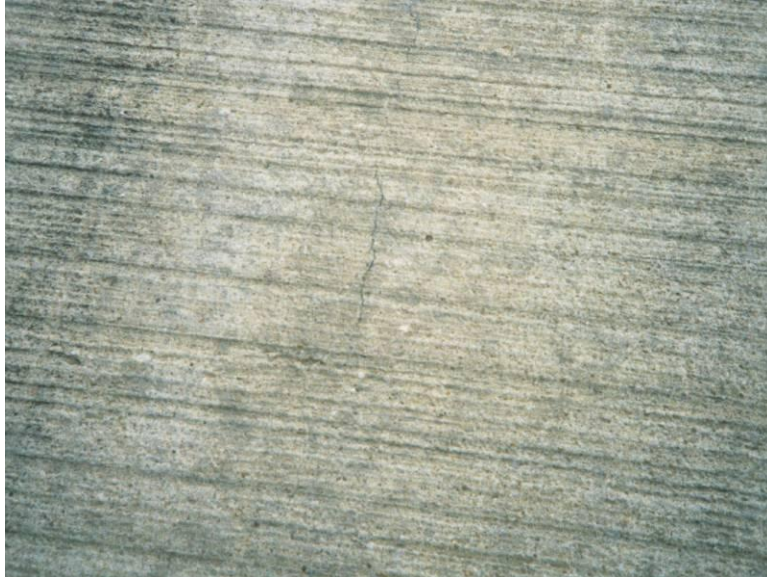
### *Example of Shrinkage Cracking*

Shrinkage cracks are small, nonworking (no spalling along edge) cracks that are visible at the surface but do not penetrate through the full depth of concrete. Shrinkage cracks most commonly occur shortly after construction due to concrete shrinkage during the curing process. Shrinkage cracks are usually so small that they are not visible until staining or material loss at crack edges begins to take place. Shrinkage cracks do not represent a structural weakness, and no corrective action is prescribed.

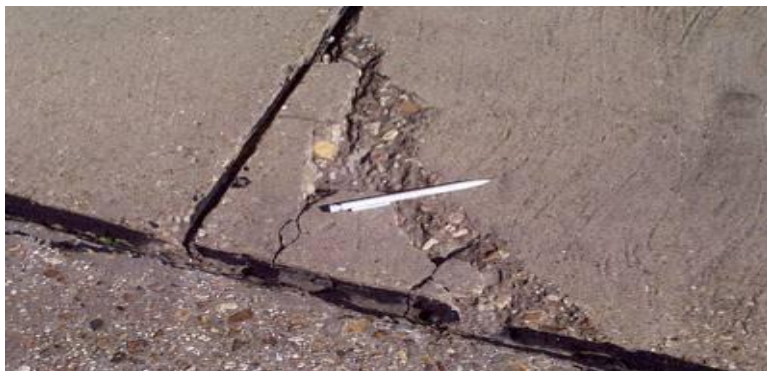
### *Example of Joint and Corner Spalling*

Spalls at slab joints and corners are caused by excessive internal stress in the pavement. Spalls occur when these stresses exceed the shear strength of the concrete. Spalling usually results from thermal expansion during warm or hot weather. As slabs expand, they push against one another at joints. If the joints are filled with incompressibles, such as sand, or if adjacent slabs offset slightly, stresses can become severe, causing spalls. Spalling can be reduced significantly by conscientious maintenance of joint sealant.

Spall repair requires patching. The extent and severity of spalling on a pavement surface suggests appropriate action. For example, at low severity, spalled concrete remains securely in place in the slab. A low-severity spall should be monitored closely for further deterioration and should be patched when

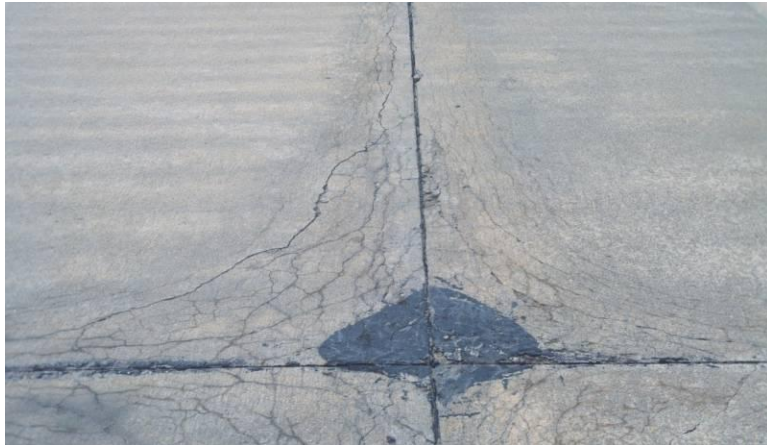
#### ***Example of Durability Cracking***

Durability cracking (D-cracking) is caused by environmental factors, the most common of which is freezing/thawing. It usually appears as a pattern of hairline cracks running parallel to a joint or crack, or in a corner, where water tends to collect. This type of cracking eventually leads to disintegration of the pavement, creating FOD potential. At low severity, D-cracking is evident, but no disintegration has occurred. As the distress advances to medium severity, the distress pattern is evident over a significant area of the slab, and some disintegration and FOD potential exists. High severity durability cracking is evidenced by extensive cracking with loose and missing pieces and significant FOD potential.

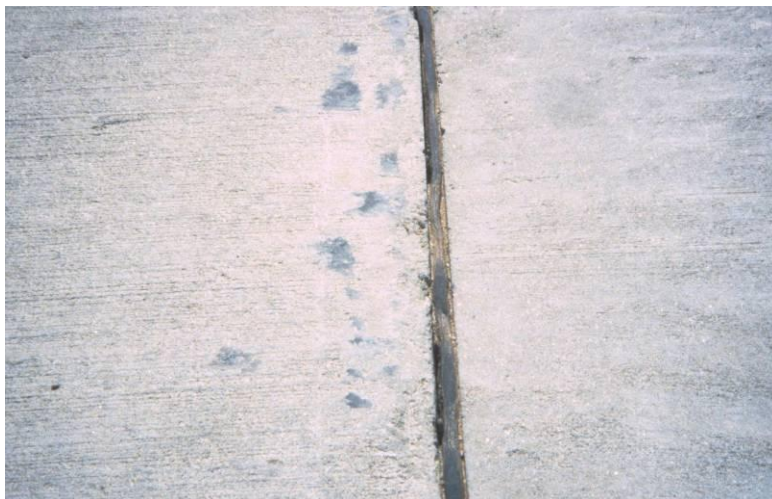
#### ***Example of Joint Seal Damage***

Joint seal damage is recorded at three severities: low, medium, and high. When joint sealant is in perfect condition (no damage), it is not a distress. At low severity, at least 10 percent of the sealant is debonded but still in contact with the joint edges (i.e., joint sealant is in serviceable condition but should

be monitored for evidence of more serious failure). Medium-severity joint seal damage is recorded when at least 10 percent of the sealant has visible gaps smaller than 1/8th inch and is an indicator that replacement should be programmed as soon as is practicable. In the meantime, aggressive inspection and sustaining maintenance is recommended to minimize subsurface damage from moisture penetration. At high severity, visible gaps exceed 1/8th inch and the amount and degree of joint seal damage is such that repair is no longer feasible. The only appropriate corrective action is sealant replacement.

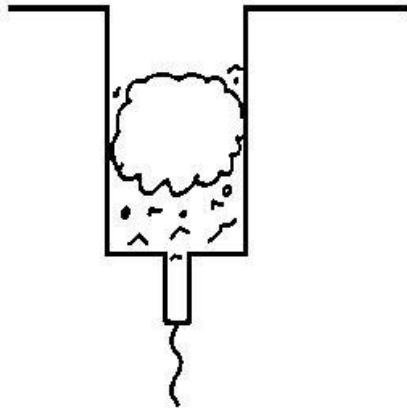
Typical joint with deficient sealant and a collection of debris & incompressibles.
