Pavement Condition Report

Benson Municipal Airport (BBB)

December 2018

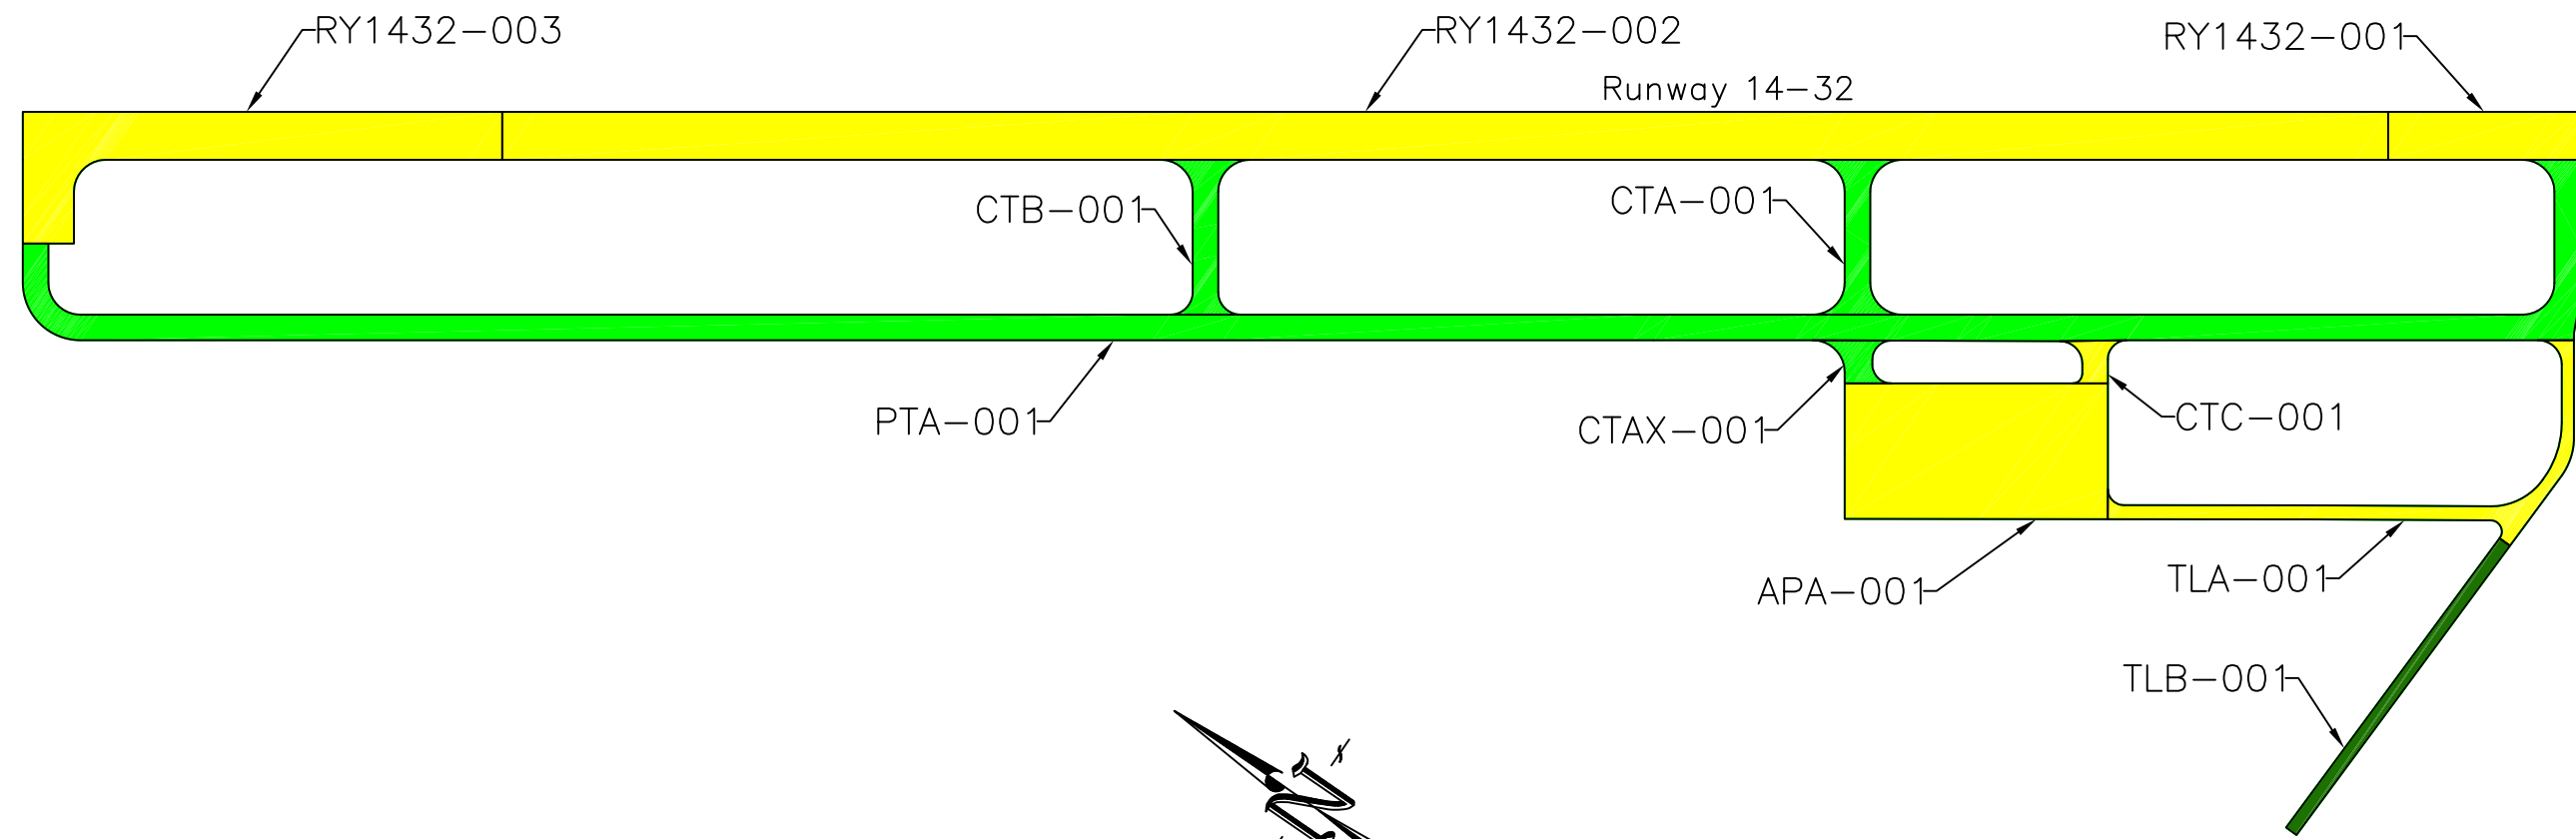
Figure 4. 2018 Pavement Condition Index Rating at Benson Municipal Airport (BBB).

Figures 5 and 6 present the overall PCI for BBB by area distribution and pavement use, respectively. Table 3 presents the PCI summary for each section at BBB, including the drop in PCI per year. Generally, pavement sections will deteriorate between 1 and 3 PCI points per year. Sections deteriorating at higher rates may need maintenance above the normal application rates and should be closely monitored in case major repairs become necessary earlier than expected.

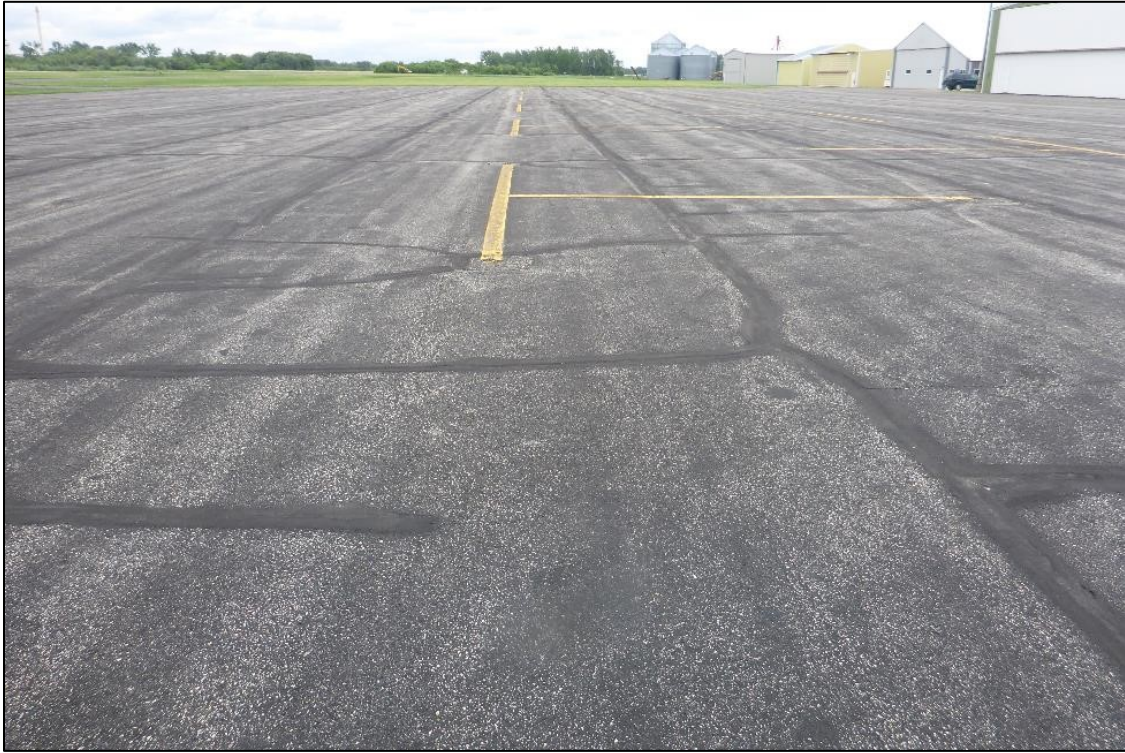
BBB APA 001 (PCI = 65)

Network: BBB						Name: BENSON
Branch: APA	Name: APRON A	Use: APRON	Area: 88,000 SqFt			
Section: 001	of 1	From: 100	To: 403	Last Const.: 9/30/2006		
Surface: AAC	Family: MN2018 Asphalt Aprons	Zone: W	Category: 2	Rank: S		
Area: 88,000 SqFt	Length: 400 Ft	Width: 220 Ft				
Slabs:	Slab Length: Ft	Slab Width: Ft	Joint Length: Ft			
Shoulder:	Street Type:	Grade: 0	Lanes: 0			
Last Insp. Date: 6/2/2018	Total Samples: 18	Surveyed: 4				
Conditions: PCI: 65						
Sample Number: 100	Type: R	Area: 5000.00 SqFt	PCI: 65			
48 L & T CR	M	38.00 Ft				
48 L & T CR	L	801.00 Ft				
Sample Number: 201	Type: R	Area: 5000.00 SqFt	PCI: 61			
48 L & T CR	M	4.00 Ft				
48 L & T CR	L	790.00 Ft				
52 RAVELING	H	2.00 SqFt				
Sample Number: 302	Type: R	Area: 5000.00 SqFt	PCI: 66			
48 L & T CR	M	12.00 Ft				
48 L & T CR	L	784.00 Ft				
Sample Number: 403	Type: R	Area: 5000.00 SqFt	PCI: 67			
48 L & T CR	L	720.00 Ft				
48 L & T CR	M	18.00 Ft

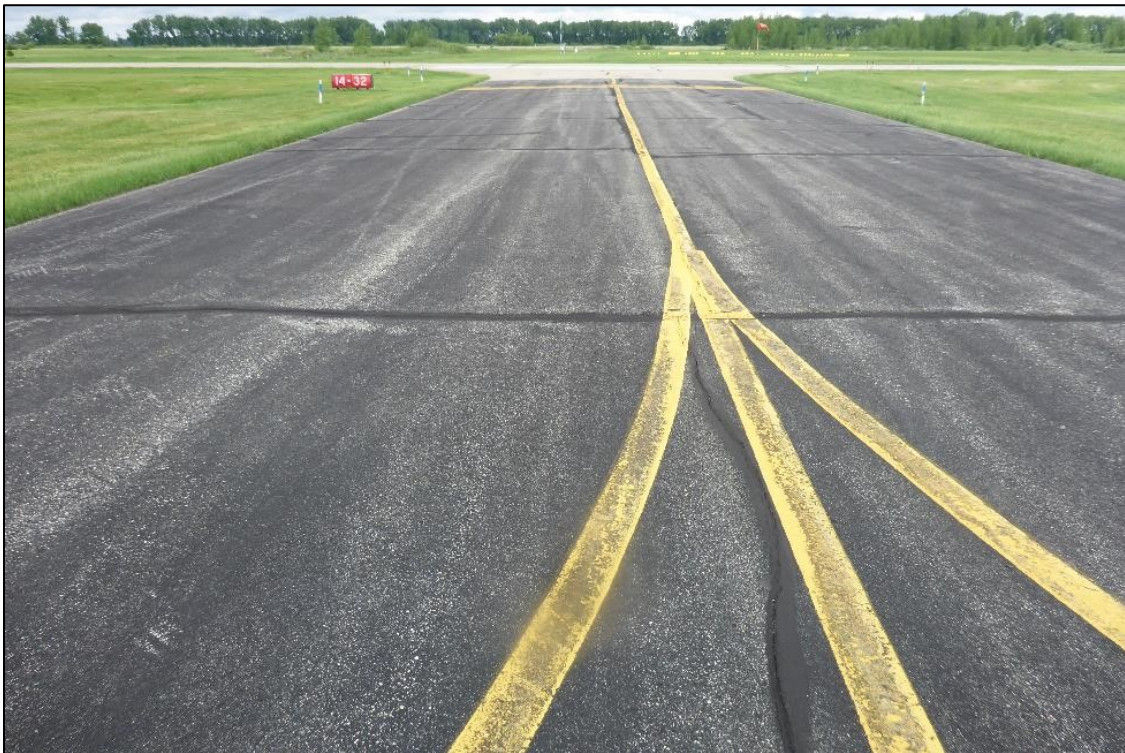
BBB CTA 001 (PCI = 72)

Network:	BBB	Name:	BENSON						
Branch:	CTA	Name:	CONNECTING TAXIWAY A	Use:	TAXIWAY	Area:	11,850 SqFt		
Section:	001	of	1	From:	100	To:	102	Last Const.:	9/30/2006
Surface:	AAC	Family:	MN2018 Asphalt Runway- Taxiways	Zone:	W	Category:	2	Rank:	P
Area:	11,850 SqFt	Length:	230 Ft	Width:	40 Ft				
Slabs:		Slab Length:	Ft	Slab Width:	Ft	Joint Length:	Ft		
Shoulder:		Street Type:		Grade:	0	Lanes:	0		
Last Insp. Date:	6/2/2018	TotalSamples:	3	Surveyed:	1				
Conditions:	PCI: 72								
Sample Number:	101	Type:	R	Area:	4000.00 SqFt	PCI:	72		
48	L & T CR		L	403.00	Ft				
48	L & T CR		M	23.00	Ft				
48	L & T CR		H	4.00	Ft

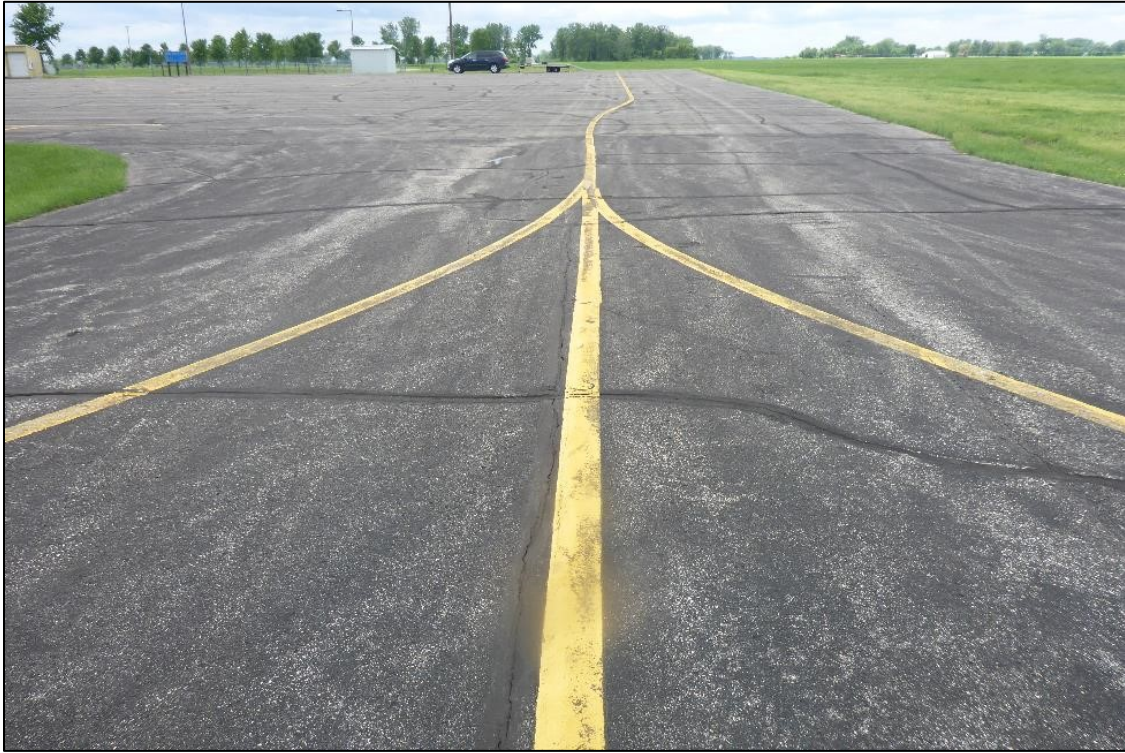
BBB CTAX 001 (PCI = 72)

Network:	BBB	Name:	BENSON						
Branch:	CTAX	Name:	CONN. TAXIWAY A EXT.	Use:	TAXIWAY	Area:	3,800 SqFt		
Section:	001	of	1	From:	201	To:	201	Last Const.:	9/30/2006
Surface:	AAC	Family:	MN2018 Asphalt Runway- Taxiways	Zone:	W	Category:	2	Rank:	P
Area:	3,800 SqFt	Length:	68 Ft	Width:	40 Ft				
Slabs:		Slab Length:	Ft	Slab Width:	Ft	Joint Length:	Ft		
Shoulder:		Street Type:		Grade:	0	Lanes:	0		
Last Insp. Date:	6/2/2018	TotalSamples:	1	Surveyed:	1				
Conditions:	PCI: 72								
Sample Number:	201	Type:	R	Area:	3490.00 SqFt	PCI:	72		
48	L & T CR	L		495.00 Ft

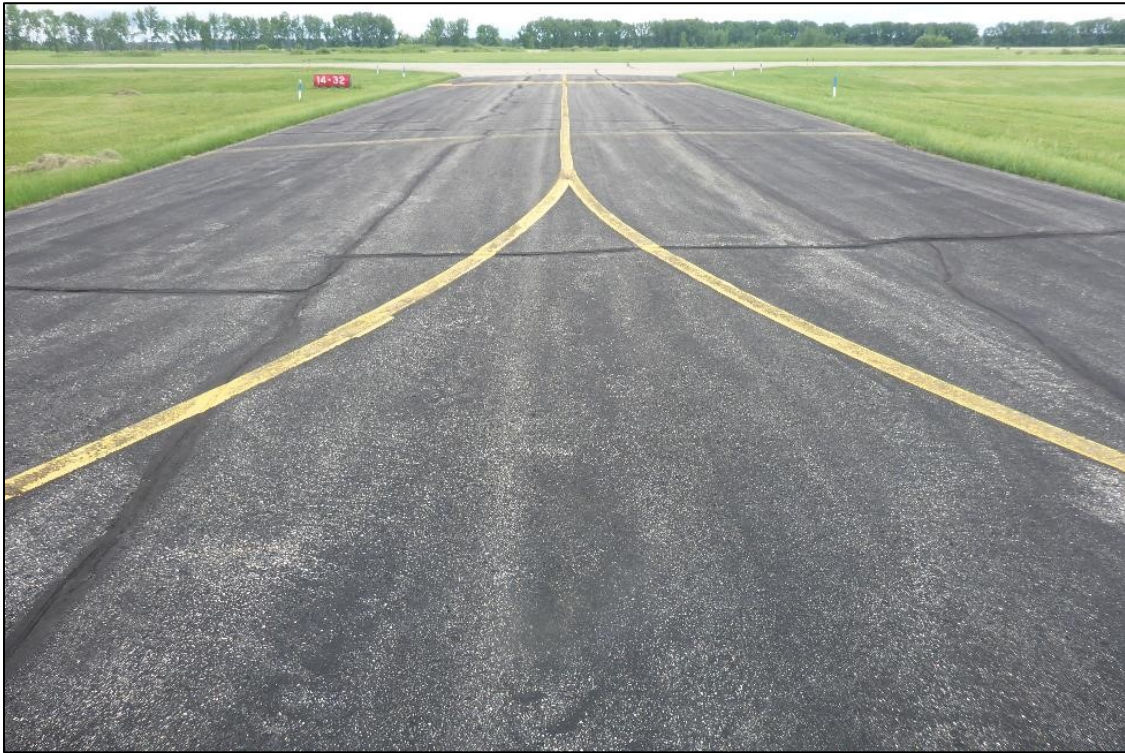
BBB CTB 001 (PCI = 72)

Network:	BBB	Name:	BENSON						
Branch:	CTB	Name:	CONNECTING TAXIWAY B	Use:	TAXIWAY	Area:	11,300 SqFt		
Section:	001	of 1	From:	100	To:	102	Last Const.:	9/30/2006	
Surface:	AAC	Family:	MN2018 Asphalt Runway- Taxiways	Zone:	W	Category:	2	Rank:	S
Area:	11,300 SqFt	Length:	230 Ft	Width:	40 Ft				
Slabs:	Slab Length:	Ft	Slab Width:	Ft	Joint Length:	Ft			
Shoulder:	Street Type:	Grade:	0	Lanes:	0				
Last Insp. Date:	6/2/2018	TotalSamples:	3	Surveyed:	1				
Conditions:	PCI: 72								
Sample Number:	100	Type:	R	Area:	4675.00 SqFt	PCI:	72		
50	PATCHING	L		108.00	SqFt				
48	L & T CR	L		198.00	Ft				
48	L & T CR	M		47.00	Ft				
48	L & T CR	H		4.00	Ft

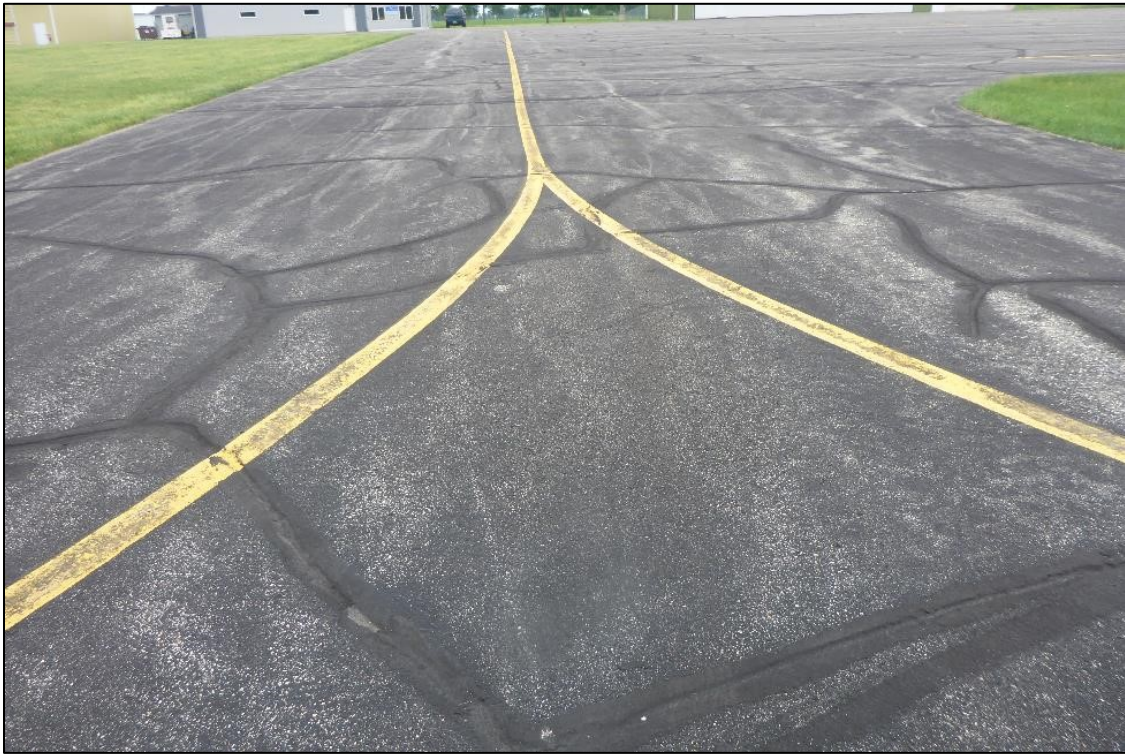
BBB CTC 001 (PCI = 70)

Network:	BBB	Name:	BENSON						
Branch:	CTC	Name:	CONNECTING TAXIWAY C	Use:	TAXIWAY	Area:	3,120 SqFt		
Section:	001	of 1	From:	301	To:	301	Last Const.:	9/30/2006	
Surface:	AAC	Family:	MN2018 Asphalt Runway- Taxiways	Zone:	W	Category:	2	Rank:	S
Area:	3,120 SqFt	Length:	68 Ft	Width:	40 Ft				
Slabs:	Slab Length:	Ft	Slab Width:	Ft	Joint Length:	Ft			
Shoulder:	Street Type:	Grade:	0	Lanes:	0				
Last Insp. Date:	6/2/2018	TotalSamples:	1	Surveyed:	1				
Conditions:	PCI: 70								
Sample Number:	301	Type:	R	Area:	3120.00 SqFt	PCI:	70		
48	L & T CR	L	500.00	Ft

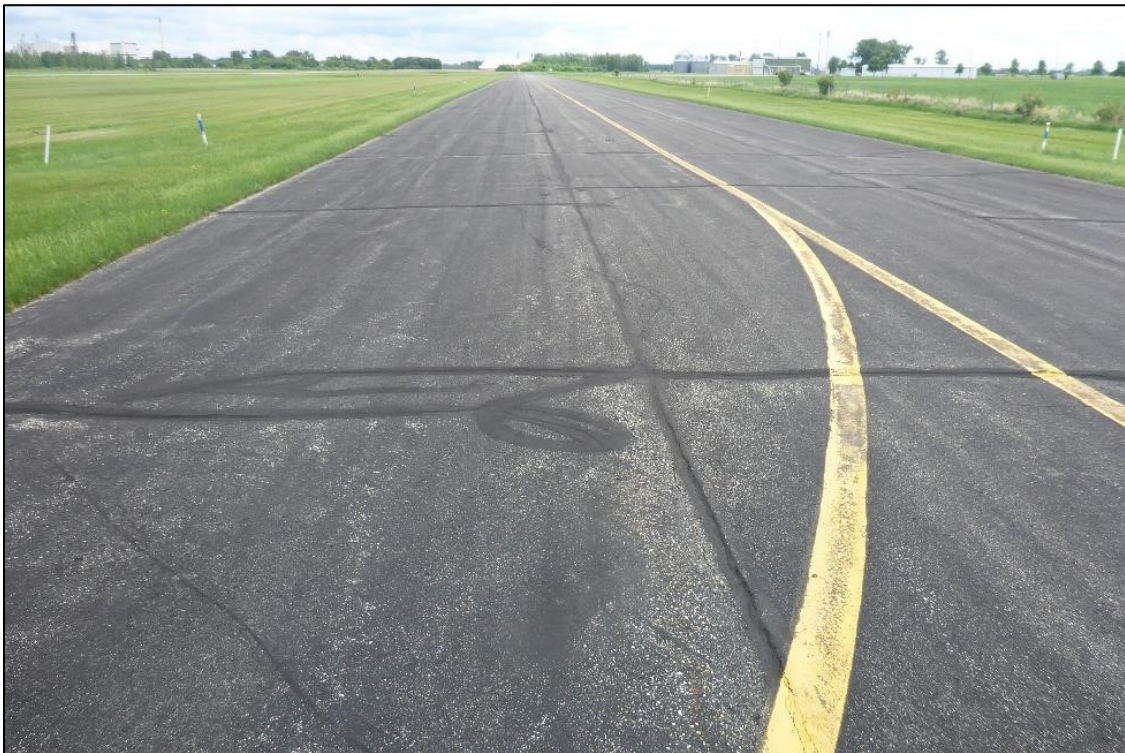
BBB PTA 001 (PCI = 72)

Network:	BBB	Name:	BENSON						
Branch:	PTA	Name:	PARALLEL TAXIWAY A	Use:	TAXIWAY	Area:	174,000 SqFt		
Section:	001	of 1	From:	100	To:	142	Last Const.:	9/30/2006	
Surface:	AAC	Family:	MN2018 Asphalt Runway- Taxiways	Zone:	W	Category:	2	Rank:	P
Area:	174,000 SqFt	Length:	4,300 Ft	Width:	40 Ft				
Slabs:	Slab Length:	Ft	Slab Width:	Ft	Joint Length:	Ft			
Shoulder:	Street Type:	Grade:	0	Lanes:	0				
Last Insp. Date:	6/2/2018	TotalSamples:	43	Surveyed:	6				
Conditions:	PCI: 72								
Sample Number:	103	Type:	R	Area:	4000.00 SqFt	PCI:	72		
48	L & T CR		L	380.00	Ft				
48	L & T CR		M	111.00	Ft				
Sample Number:	111	Type:	R	Area:	4000.00 SqFt	PCI:	75		
48	L & T CR		M	124.00	Ft				
48	L & T CR		L	322.00	Ft				
Sample Number:	119	Type:	R	Area:	4000.00 SqFt	PCI:	70		
48	L & T CR		L	405.00	Ft				
48	L & T CR		M	153.00	Ft				
Sample Number:	120	Type:	A	Area:	4000.00 SqFt	PCI:	69		
48	L & T CR		L	304.00	Ft				
45	DEPRESSION		H	4.00	SqFt

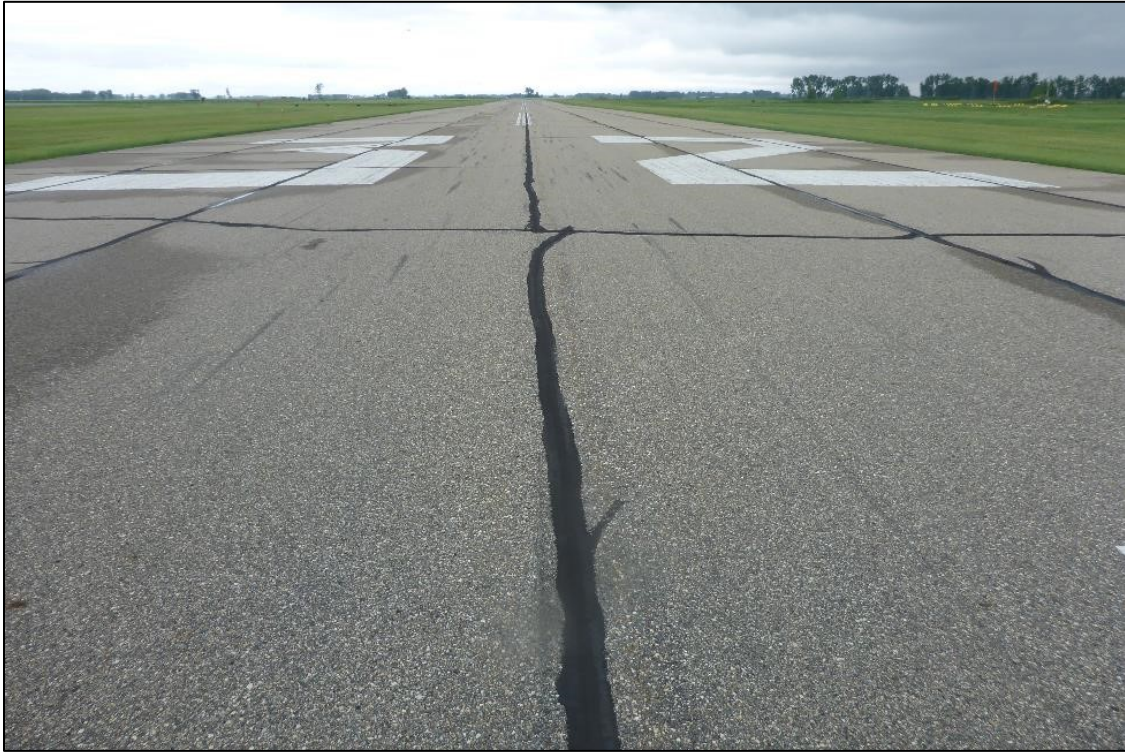
BBB RY1432 001 (PCI = 64)

Network:	BBB	Name:	BENSON						
Branch:	RY1432	Name:	RUNWAY 14-32	Use:	RUNWAY	Area:	311,000 SqFt		
Section:	001	of 3	From:	100	To:	105	Last Const.:	9/30/2006	
Surface:	AAC	Family:	MN2018 Asphalt Runway- Taxiways	Zone:	W	Category:	2	Rank:	P
Area:	22,500 SqFt	Length:	300 Ft	Width:	75 Ft				
Slabs:	Slab Length:	Ft	Slab Width:	Ft	Joint Length:	Ft			
Shoulder:	Street Type:	Grade:	0	Lanes:	0				
Last Insp. Date:	6/2/2018	TotalSamples:	6	Surveyed:	2				
Conditions:	PCI: 64								
Sample Number:	101	Type:	R	Area:	3750.00 SqFt	PCI:	58		
57	WEATHERING	L		2800.00 SqFt					
48	L & T CR	M		74.00 Ft					
48	L & T CR	H		9.00 Ft					
48	L & T CR	L		262.00 Ft					
57	WEATHERING	M		200.00 SqFt					
41	ALLIGATOR CR	L		16.00 SqFt					
Sample Number:	104	Type:	R	Area:	3750.00 SqFt	PCI:	70		
48	L & T CR	L		283.00 Ft					
48	L & T CR	M		25.00 Ft					
57	WEATHERING	L		3000.00 SqFt

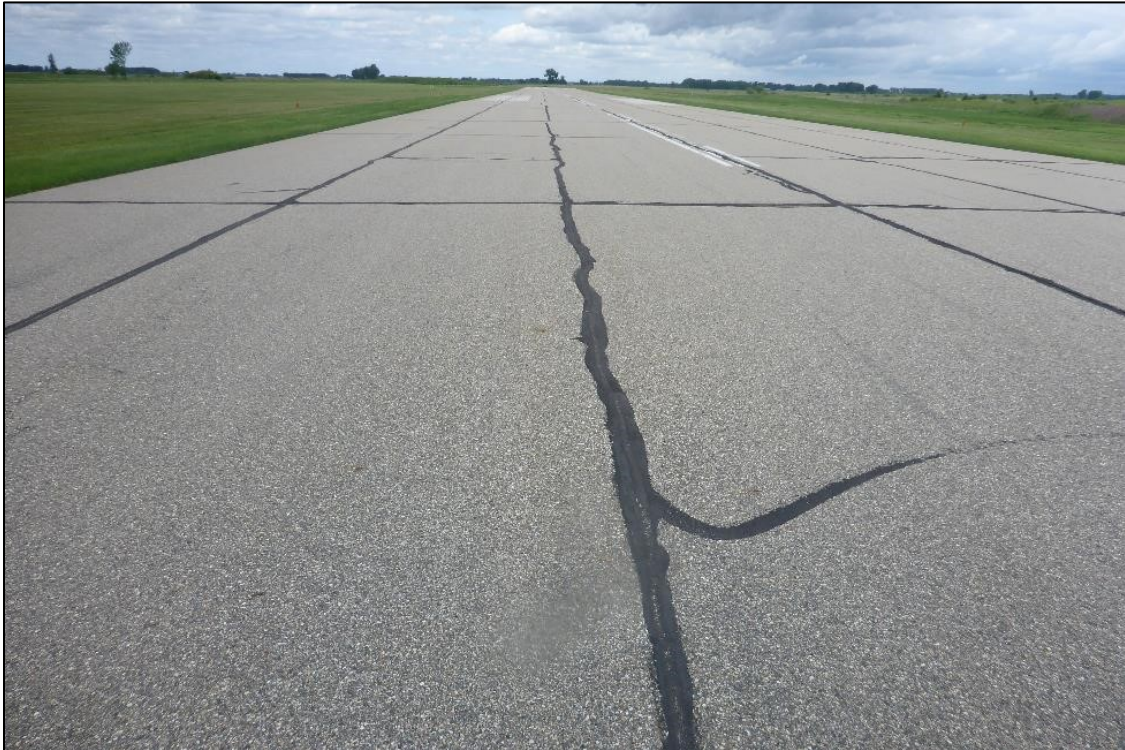
BBB RY1432 002 (PCI = 63)

Network:	BBB	Name:	BENSON						
Branch:	RY1432	Name:	RUNWAY 14-32	Use:	RUNWAY	Area:	311,000 SqFt		
Section:	002	of 3	From:	106	To:	164	Last Const.:	9/30/2006	
Surface:	AAC	Family:	MN2018 Asphalt Runway- Taxiways	Zone:	W	Category:	2	Rank:	P
Area:	221,250 SqFt	Length:	2,950 Ft	Width:	75 Ft				
Slabs:	Slab Length:	Ft	Slab Width:	Ft	Joint Length:	Ft			
Shoulder:	Street Type:	Grade:	0	Lanes:	0				
Last Insp. Date:	6/2/2018	TotalSamples:	59	Surveyed:	6				
Conditions:	PCI: 63								
Sample Number:	113	Type:	R	Area:	3750.00 SqFt	PCI:	56		
45	DEPRESSION	M		8.00	SqFt				
45	DEPRESSION	L		13.00	SqFt				
48	L & T CR	L		351.00	Ft				
57	WEATHERING	L		3400.00	SqFt				
48	L & T CR	M		54.00	Ft				
57	WEATHERING	M		350.00	SqFt				
Sample Number:	122	Type:	R	Area:	3750.00 SqFt	PCI:	65		
48	L & T CR	M		45.00	Ft				
57	WEATHERING	M		200.00	SqFt				
48	L & T CR	L		308.00	Ft				
57	WEATHERING	L		1800.00	SqFt				
48	L & T CR	H		3.00	Ft

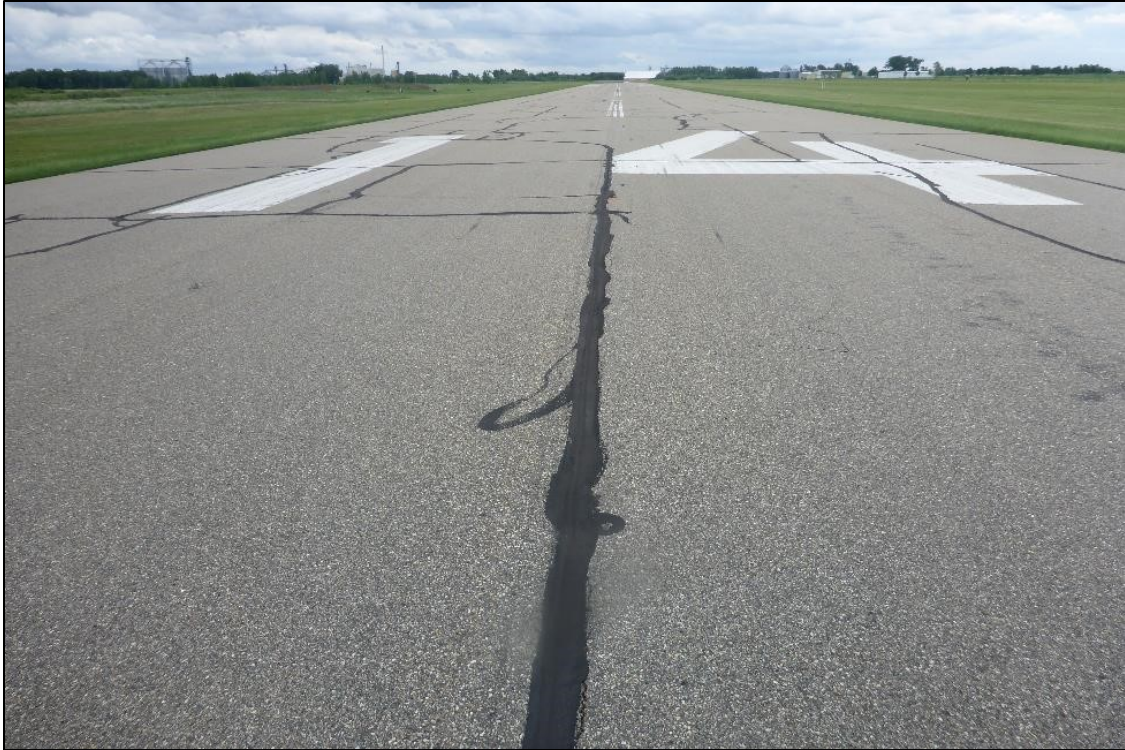
BBB RY1432 003 (PCI = 62)

Network:	BBB	Name:	BENSON						
Branch:	RY1432	Name:	RUNWAY 14-32	Use:	RUNWAY	Area:	311,000 SqFt		
Section:	003	of 3	From:	165	To:	179	Last Const.:	9/30/2006	
Surface:	AAC	Family:	MN2018 Asphalt Runway- Taxiways	Zone:	W	Category:	2	Rank:	P
Area:	67,250 SqFt	Length:	750 Ft	Width:	75 Ft				
Slabs:	Slab Length:	Ft	Slab Width:	Ft	Joint Length:	Ft			
Shoulder:	Street Type:	Grade:	0	Lanes:	0				
Last Insp. Date:	6/2/2018	TotalSamples:	17	Surveyed:	3				
Conditions:	PCI: 62								
Sample Number:	166	Type:	R	Area:	3750.00 SqFt	PCI:	61		
48	L & T CR	H	8.00	Ft					
57	WEATHERING	L	3500.00	SqFt					
57	WEATHERING	M	250.00	SqFt					
48	L & T CR	M	55.00	Ft					
48	L & T CR	L	290.00	Ft					
Sample Number:	171	Type:	R	Area:	3750.00 SqFt	PCI:	63		
48	L & T CR	L	229.00	Ft					
48	L & T CR	H	35.00	Ft					
57	WEATHERING	M	100.00	SqFt					
48	L & T CR	M	47.00	Ft					
57	WEATHERING	L	3650.00	SqFt					
Sample Number:	176	Type:	R	Area:	3750.00 SqFt	PCI:	61

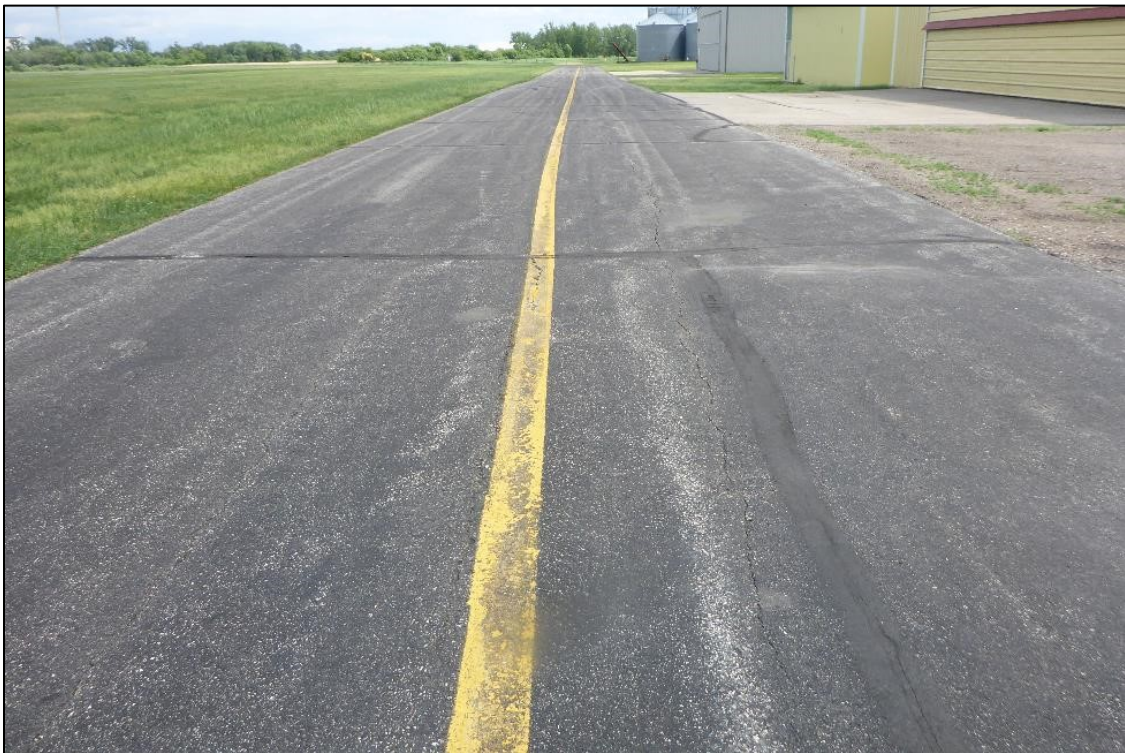
BBB TLA 001 (PCI = 70)

Network:	BBB	Name:	BENSON						
Branch:	TLA	Name:	Taxilane A	Use:	TAXILANE	Area:	22,100 SqFt		
Section:	001	of 1	From:	100	To:	104	Last Const.:	9/30/2006	
Surface:	AC	Family:	MN2018 Asphalt Taxilanes	Zone:	W	Category:	2	Rank:	T
Area:	22,100 SqFt	Length:	520 Ft	Width:	22 Ft				
Slabs:	Slab Length:	Ft	Slab Width:	Ft	Joint Length:	Ft			
Shoulder:	Street Type:	Grade:	0	Lanes:	0				
Last Insp. Date:	6/2/2018	TotalSamples:	5	Surveyed:	2				
Conditions:	PCI: 70								
Sample Number:	100	Type:	R	Area:	4400.00 SqFt	PCI:	73		
48	L & T CR	M	52.00	Ft					
48	L & T CR	L	389.00	Ft					
Sample Number:	103	Type:	R	Area:	4000.00 SqFt	PCI:	67		
48	L & T CR	L	582.00	Ft					
48	L & T CR	M	13.00	Ft
