Pavement Condition Report

Winona Municipal Airport (ONA)

December 2018

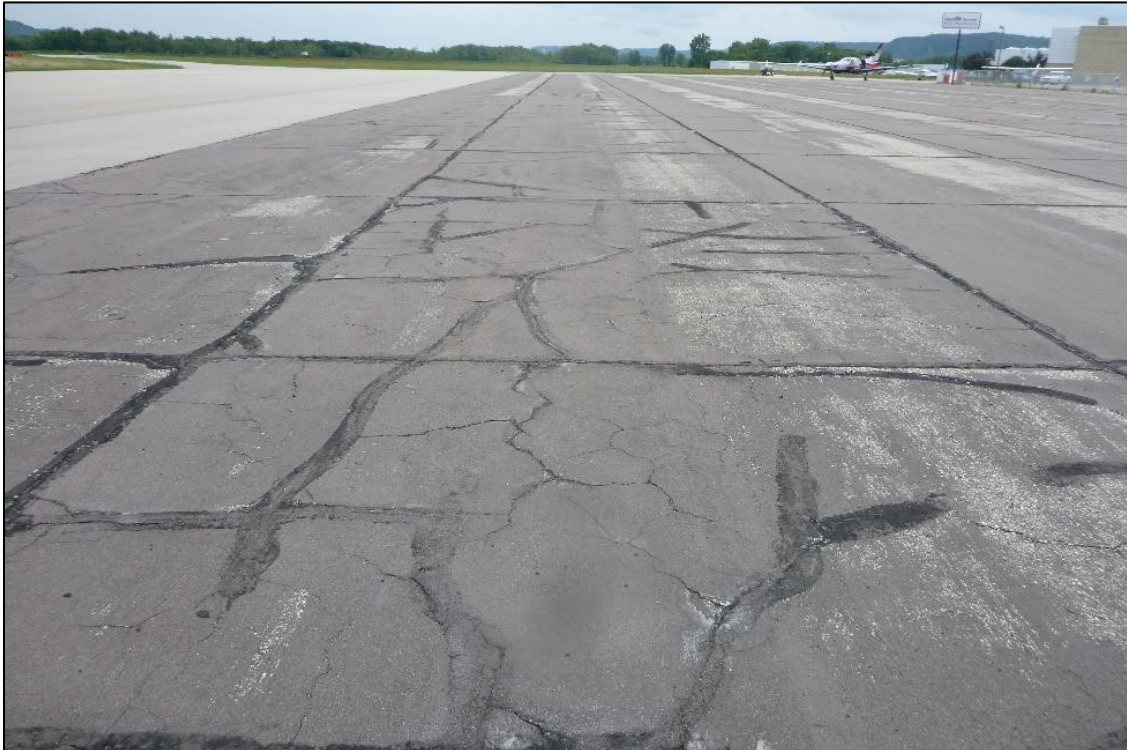
ONA APA 002 (PCI = 59)

Network:	ONA	Name:	WINONA						
Branch:	APA	Name:	APRON A	Use:	APRON	Area:	208,320 SqFt		
Section:	002	of 2	From:	95	To:	305	Last Const.:	9/30/1992	
Surface:	APC	Family:	MN2018 Asphalt Aprons	Zone:	S	Category:	2	Rank:	S
Area:	55,000 SqFt		Length:	400 Ft	Width:	125 Ft			
Slabs:	Slab Length:	Ft	Slab Width:	Ft		Joint Length:	Ft		
Shoulder:	Street Type:		Grade:	0	Lanes:	0			
Last Insp. Date:	6/8/2018		TotalSamples:	12	Surveyed:	3			
Conditions:	PCI:	59							
Sample Number:	204	Type:	R	Area:	5000.00 SqFt		PCI:	60	
57	WEATHERING	L		600.00	SqFt				
43	BLOCK CR	L		2400.00	SqFt				
48	L & T CR	L		126.00	Ft				
47	JT REF. CR	L		700.00	Ft				
Sample Number:	303	Type:	R	Area:	5000.00 SqFt		PCI:	59	
47	JT REF. CR	L		700.00	Ft				
43	BLOCK CR	L		2600.00	SqFt				
57	WEATHERING	L		600.00	SqFt				
48	L & T CR	L		254.00	Ft				
Sample Number:	305	Type:	R	Area:	5000.00 SqFt		PCI:	59	
47	JT REF. CR	L		700.00	Ft				
43	BLOCK CR	L		2400.00	SqFt

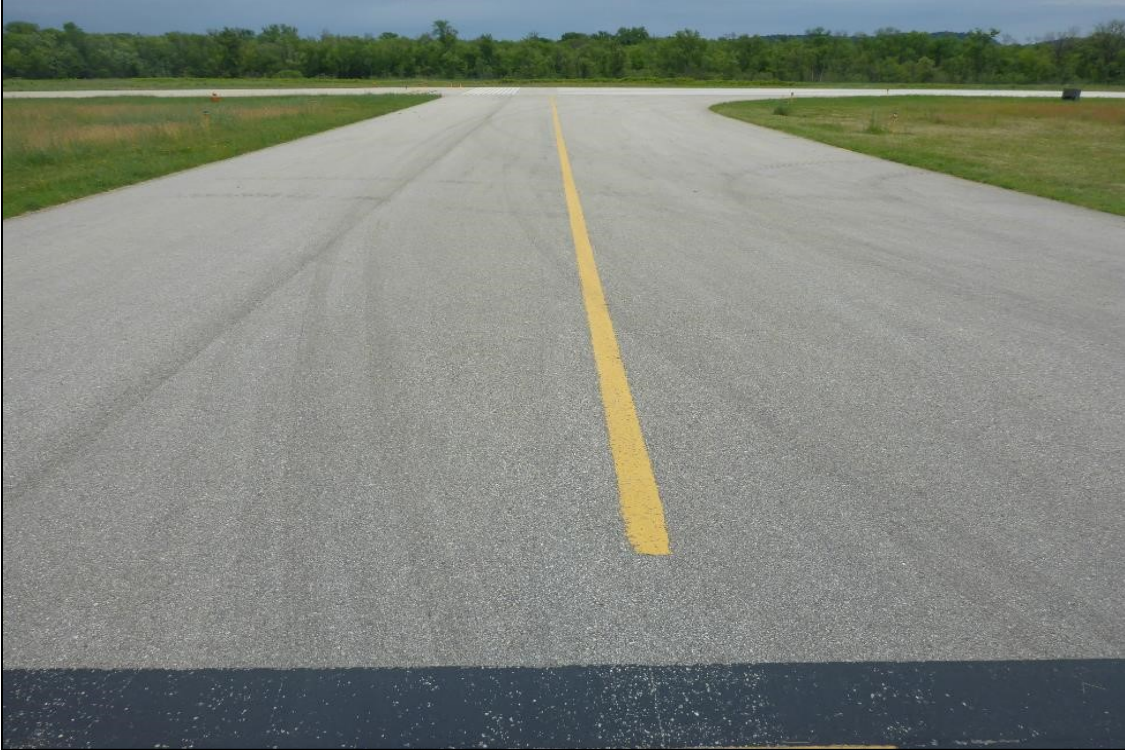
ONA CTA1 001 (PCI = 100)

Network:	ONA	Name:	WINONA						
Branch:	CTA1	Name:	CONNECTING TAXIWAY A1	Use:	TAXIWAY	Area:	14,150 SqFt		
Section:	001	of	1	From:	100	To:	101	Last Const.:	5/1/2015
Surface:	AC	Family:	MN2018 Asphalt Runway- Taxiways		Zone:	Category:	Rank:	P	
Area:	14,150 SqFt	Length:	210 Ft	Width:	50 Ft				
Slabs:	Slab Length:	Ft	Slab Width:	Ft	Joint Length:	Ft			
Shoulder:	Street Type:	Grade:	0	Lanes:	0				
Last Insp. Date:	6/8/2018	TotalSamples:	3	Surveyed:	1				
Conditions:	PCI: 100								
Sample Number:	101	Type:	R	Area:	5000.00 SqFt	PCI:	100

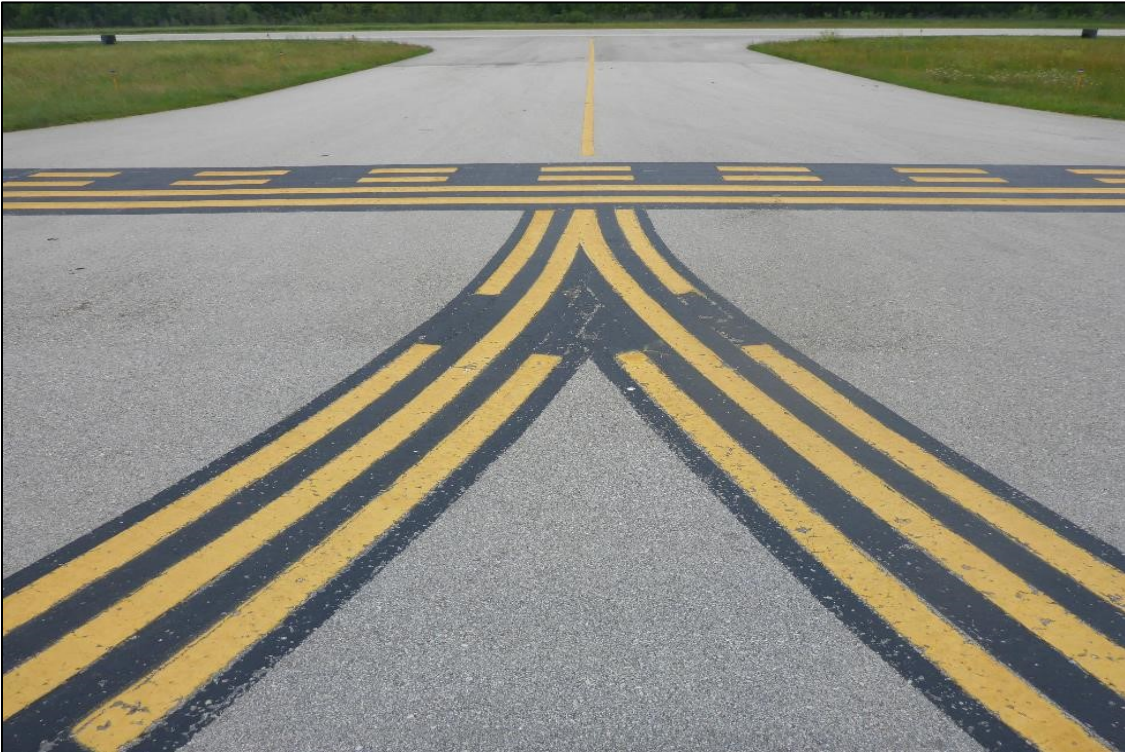
ONA CTA2 001 (PCI = 100)

Network:	ONA	Name:	WINONA						
Branch:	CTA2	Name:	CONNECTING TAXIWAY A2	Use:	TAXIWAY	Area:	18,600 SqFt		
Section:	001	of 2	From:	100	To:	101	Last Const.:	9/30/2014	
Surface:	AC	Family:	MN2018 Asphalt Runway- Taxiways	Zone:	S	Category:	2	Rank:	S
Area:	10,450 SqFt	Length:	130 Ft	Width:	50 Ft				
Slabs:		Slab Length:	Ft	Slab Width:	Ft	Joint Length:	Ft		
Shoulder:		Street Type:		Grade:	0	Lanes:	0		
Last Insp. Date:	6/8/2018	TotalSamples:	2	Surveyed:	1				
Conditions:	PCI: 100								
Sample Number:	101	Type:	R	Area:	5000.00 SqFt	PCI:	100

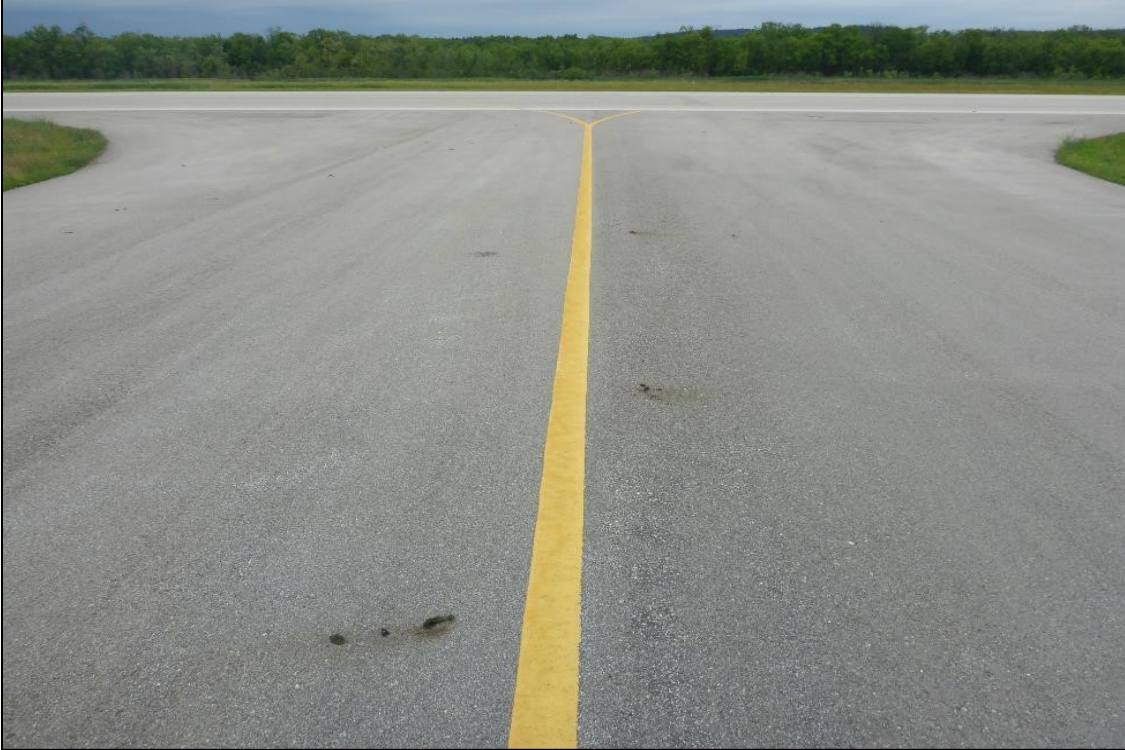
ONA CTA2 002 (PCI = 94)

Network:	ONA	Name:	WINONA				
Branch:	CTA2	Name:	CONNECTING TAXIWAY A2	Use:	TAXIWAY	Area:	18,600 SqFt
Section:	002	of 2	From:	100	To:	100	Last Const.: 5/1/2015
Surface:	AC	Family:	MN2018 Asphalt Runway- Taxiways	Zone:		Category:	Rank: P
Area:	8,150 SqFt	Length:	75 Ft	Width:	50 Ft		
Slabs:		Slab Length:	Ft	Slab Width:	Ft	Joint Length:	Ft
Shoulder:		Street Type:		Grade:	0	Lanes:	0
Last Insp. Date:	6/8/2018	TotalSamples:	1	Surveyed:	1		
Conditions:	PCI: 94						
Sample Number:	100	Type:	R	Area:	5000.00 SqFt	PCI:	94
48	L & T CR		L		65.00 Ft

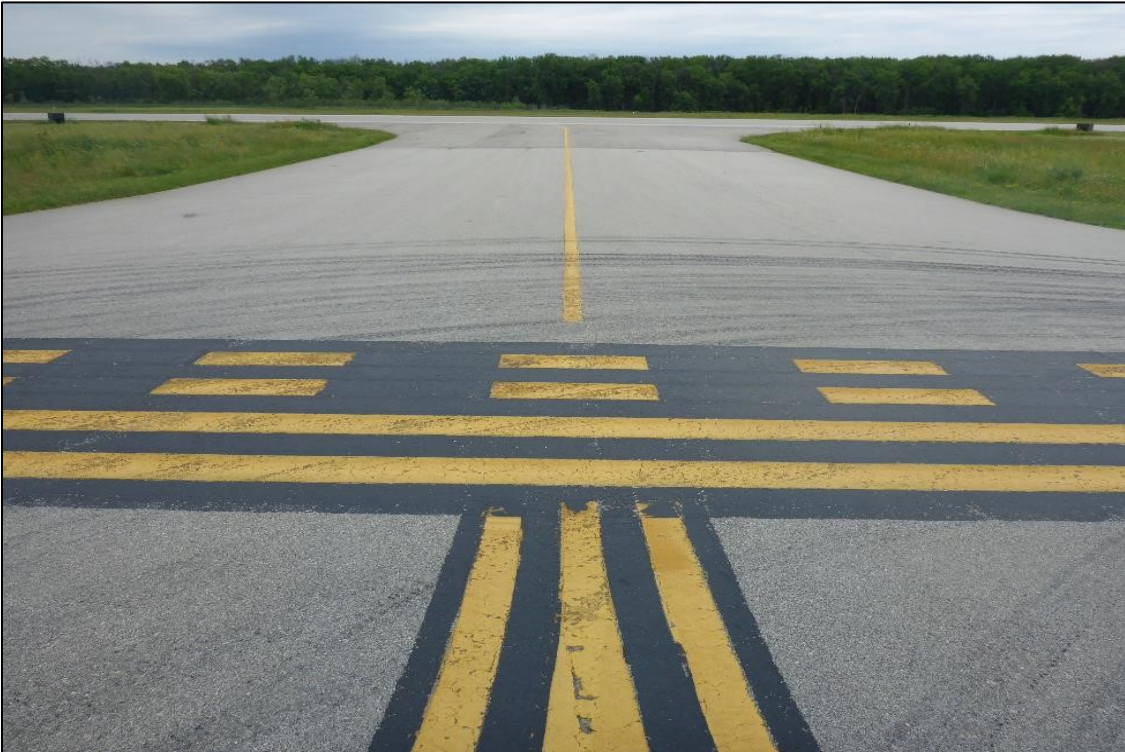
ONA CTA3 001 (PCI = 100)

Network:	ONA	Name:	WINONA						
Branch:	CTA3	Name:	CONNECTING TAXIWAY A3	Use:	TAXIWAY	Area:	12,100 SqFt		
Section:	001	of 2	From:	100	To:	101	Last Const.: 9/30/2014		
Surface:	AC	Family:	MN2018 Asphalt Runway- Taxiways	Zone:	S	Category:	2	Rank:	S
Area:	6,450 SqFt	Length:	132 Ft	Width:	45 Ft				
Slabs:	Slab Length:	Ft	Slab Width:	Ft	Joint Length:	Ft			
Shoulder:	Street Type:		Grade:	0	Lanes:	0			
Last Insp. Date:	6/8/2018	TotalSamples:	2	Surveyed:	1				
Conditions:	PCI: 100								
Sample Number:	101	Type:	R	Area:	5000.00 SqFt	PCI:	100

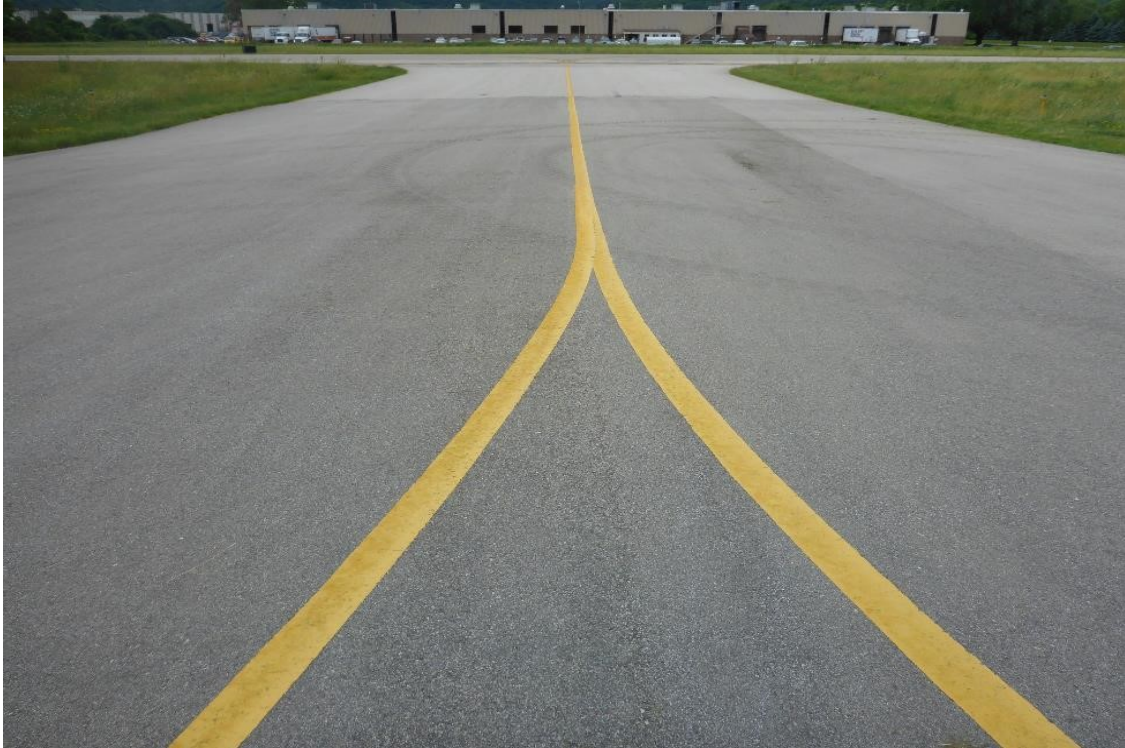
ONA CTA3 002 (PCI = 94)

Network:	ONA	Name:	WINONA				
Branch:	CTA3	Name:	CONNECTING TAXIWAY A3	Use:	TAXIWAY	Area:	12,100 SqFt
Section:	002	of 2	From:	100	To:	100	Last Const.: 5/1/2015
Surface:	AC	Family:	MN2018 Asphalt Runway- Taxiways	Zone:		Category:	Rank: P
Area:	5,650 SqFt	Length:	75 Ft	Width:	50 Ft		
Slabs:		Slab Length:	Ft	Slab Width:	Ft	Joint Length:	Ft
Shoulder:		Street Type:		Grade:	0	Lanes:	0
Last Insp. Date:	6/8/2018	TotalSamples:	1	Surveyed:	1		
Conditions:	PCI: 94						
Sample Number:	100	Type:	R	Area:	4380.00 SqFt	PCI:	94
48	L & T CR		L		65.00 Ft

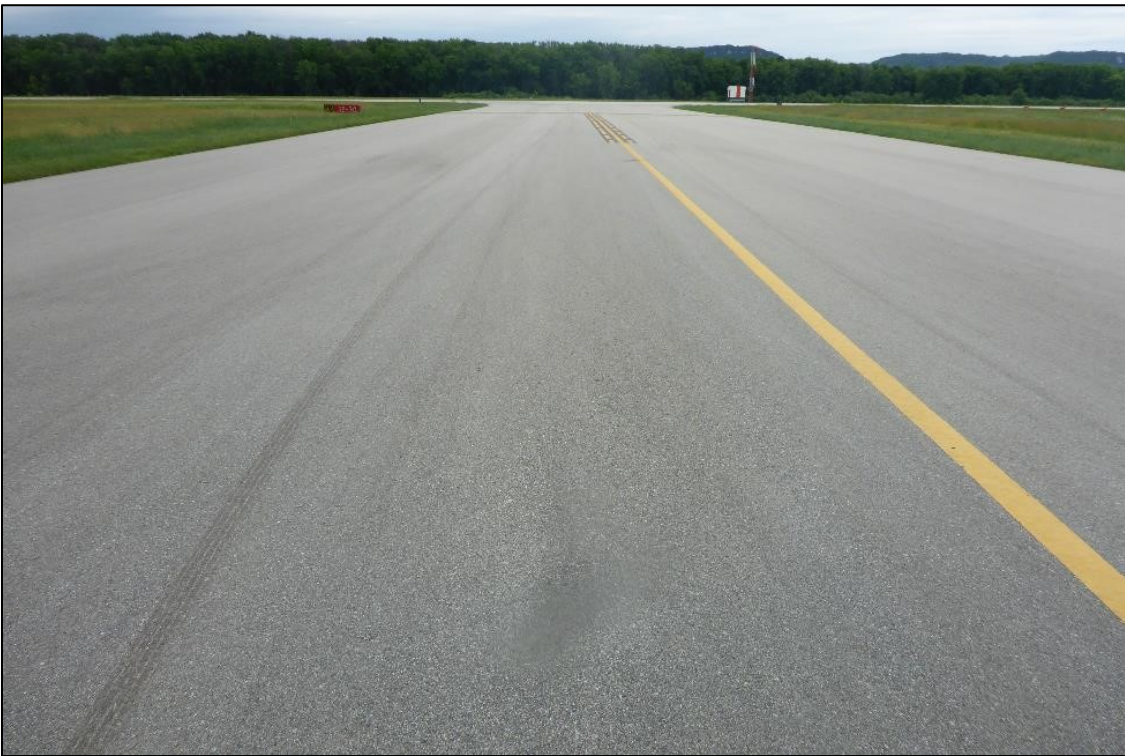
ONA CTA4 001 (PCI = 97)

Network:	ONA	Name:	WINONA						
Branch:	CTA4	Name:	CONNECTING TAXIWAY A4	Use:	TAXIWAY	Area:	43,500 SqFt		
Section:	001	of 1	From:	200	To:	204	Last Const.:	12/7/2015	
Surface:	AC	Family:	MN2018 Asphalt Runway- Taxiways	Zone:	S	Category:	2	Rank:	S
Area:	43,500 SqFt	Length:	525 Ft	Width:	50 Ft				
Slabs:		Slab Length:	Ft	Slab Width:	Ft	Joint Length:	Ft		
Shoulder:		Street Type:		Grade:	0	Lanes:	0		
Last Insp. Date:	6/8/2018	TotalSamples:	5	Surveyed:	3				
Conditions:	PCI: 97								
Sample Number:	200	Type:	R	Area:	3850.00 SqFt	PCI:	90		
48	L & T CR	L		114.00 Ft					
Sample Number:	202	Type:	R	Area:	3850.00 SqFt	PCI:	100		
<No Distress>									
Sample Number:	206	Type:	R	Area:	3850.00 SqFt	PCI:	100		
<No Distress>

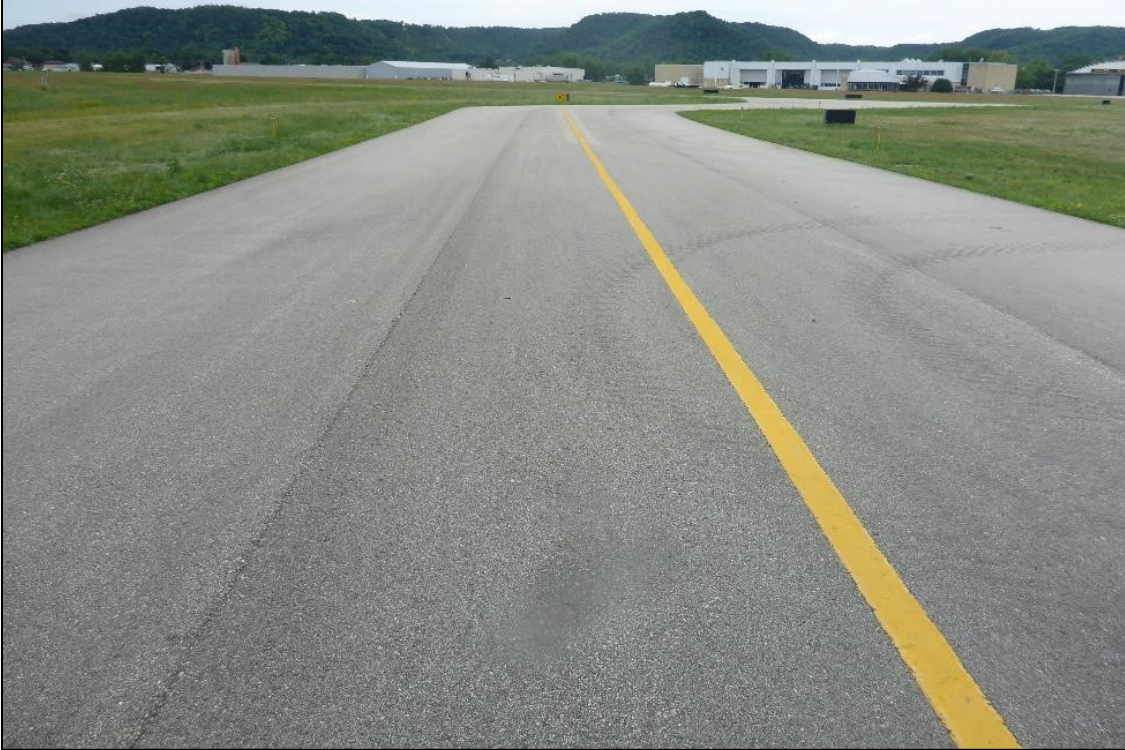
ONA CTB 001 (PCI = 100)

Network:	ONA	Name:	WINONA						
Branch:	CTB	Name:	CONNECTING TAXIWAY B	Use:	TAXIWAY	Area:	54,770 SqFt		
Section:	001	of 1	From:	100	To:	110	Last Const.:	5/1/2015	
Surface:	AC	Family:	MN2018 Asphalt Runway- Taxiways	Zone:	S	Category:	2	Rank:	P
Area:	54,770 SqFt	Length:	1,000 Ft	Width:	50 Ft				
Slabs:		Slab Length:	Ft	Slab Width:	Ft	Joint Length:	Ft		
Shoulder:		Street Type:		Grade:	0	Lanes:	0		
Last Insp. Date:	6/8/2018	TotalSamples:	13	Surveyed:	3				
Conditions:	PCI: 100								
Sample Number:	101	Type:	R	Area:	4000.00 SqFt	PCI:	100		
<No Distress>									
Sample Number:	105	Type:	R	Area:	4000.00 SqFt	PCI:	100		
<No Distress>									
Sample Number:	108	Type:	R	Area:	4000.00 SqFt	PCI:	100		
<No Distress>

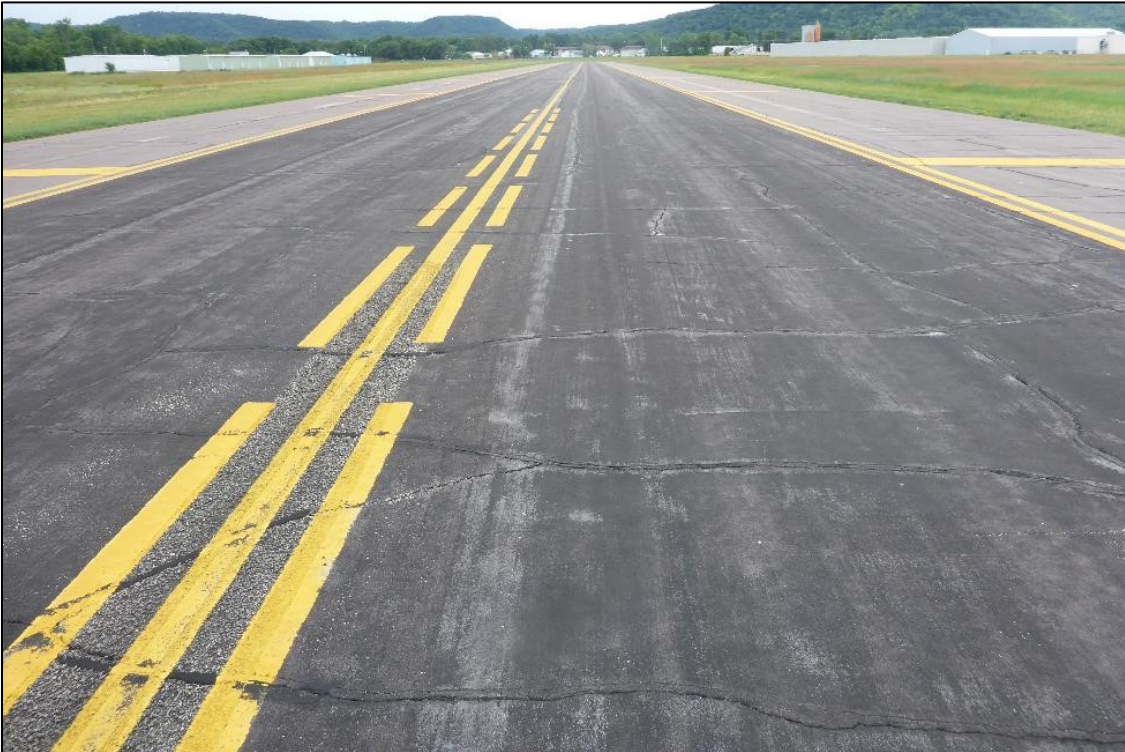
ONA CTC 001 (PCI = 65)

⁶Increase in PCI in CTC-001 due change in section definition (was RY1735-001 last insp.) and boundaries, with lower PCI values outside of new inspected area.
