Pavement Condition Report

Todd Field Airport - Long Prairie (14Y)

December 2019

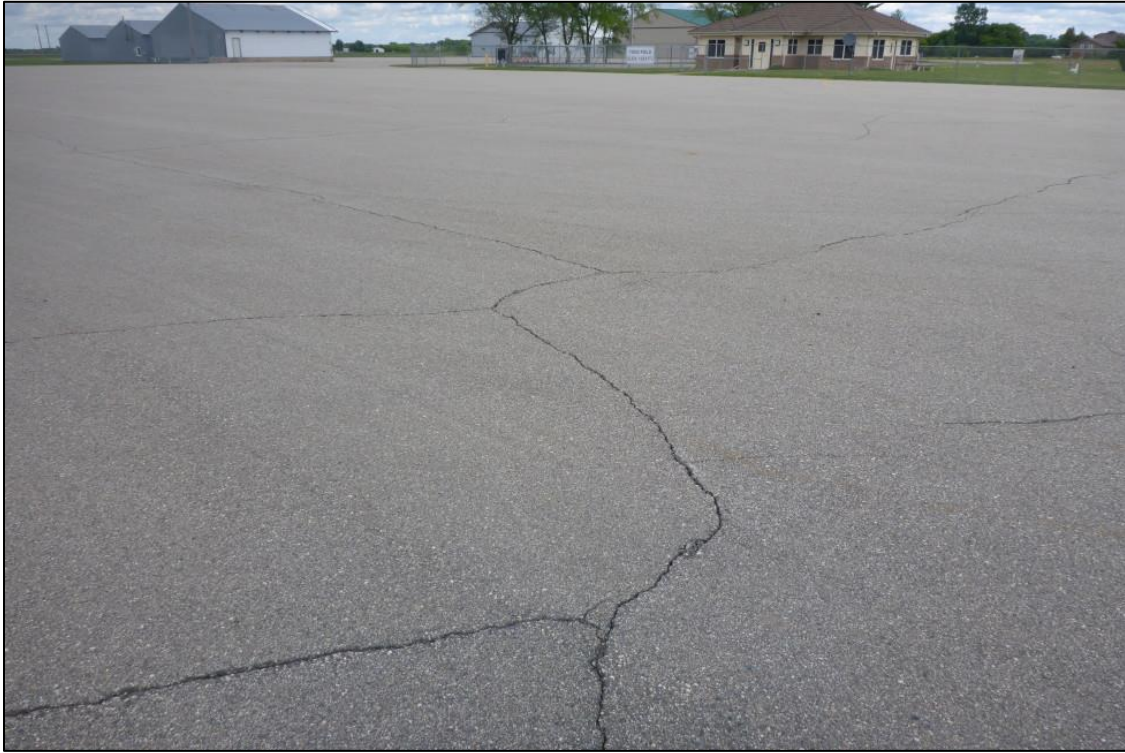
14Y APA 001 (PCI = 73)

| Branch | Section | Treatment | Quantity | Unit | Cost |
|---|---|---|---|---|---|
| APA | 001 | Crack Sealing - AC | 353 | Ft | \$455 |

| Branch | Section | Distress Type | Severity | Treatment | Estimated Quantity | Unit | Cost |
|---|---|---|---|---|---|---|---|
| APA | 001 | L & T CR | M | Crack Sealing - AC | 353 | Ft | \$455 |

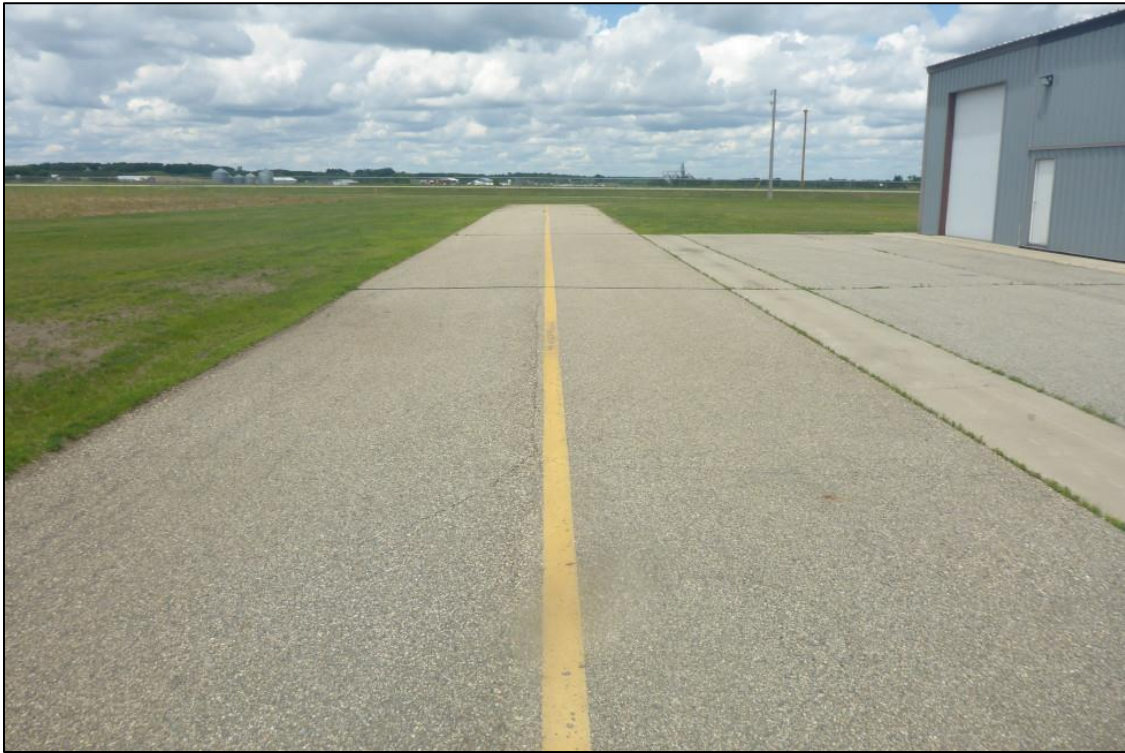
14Y TLA 001 (PCI = 79)

| Branch | Section | Treatment | Quantity | Unit | Cost |
|---|---|---|---|---|---|
| TLA | 001 | Crack Sealing - AC | 134 | Ft | \$172 |

| Branch | Section | Distress Type | Severity | Treatment | Estimated Quantity | Unit | Cost |
|---|---|---|---|---|---|---|---|
| TLA | 001 | L & T CR | M | Crack Sealing - AC | 134 | Ft | \$172 |
