# Pavement Condition Report

## Aitkin Airport (AIT)

**December 2019**

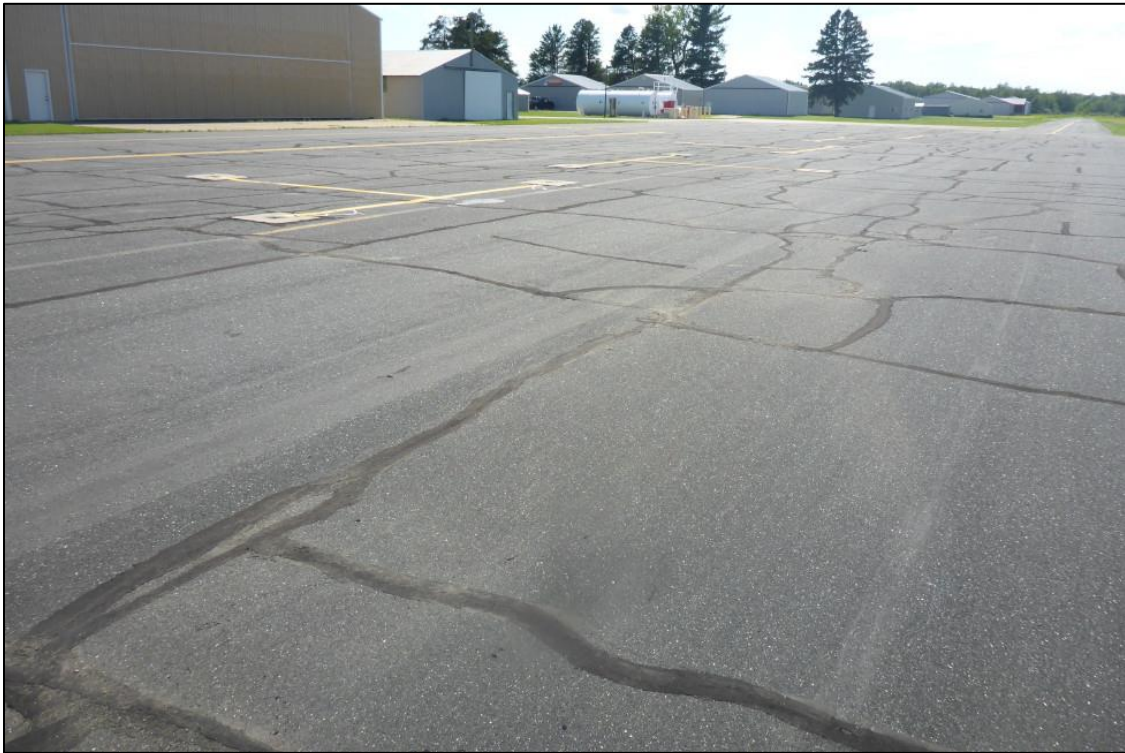
AIT APA 001 (PCI = 59)

**Conditions:** PCI: 59

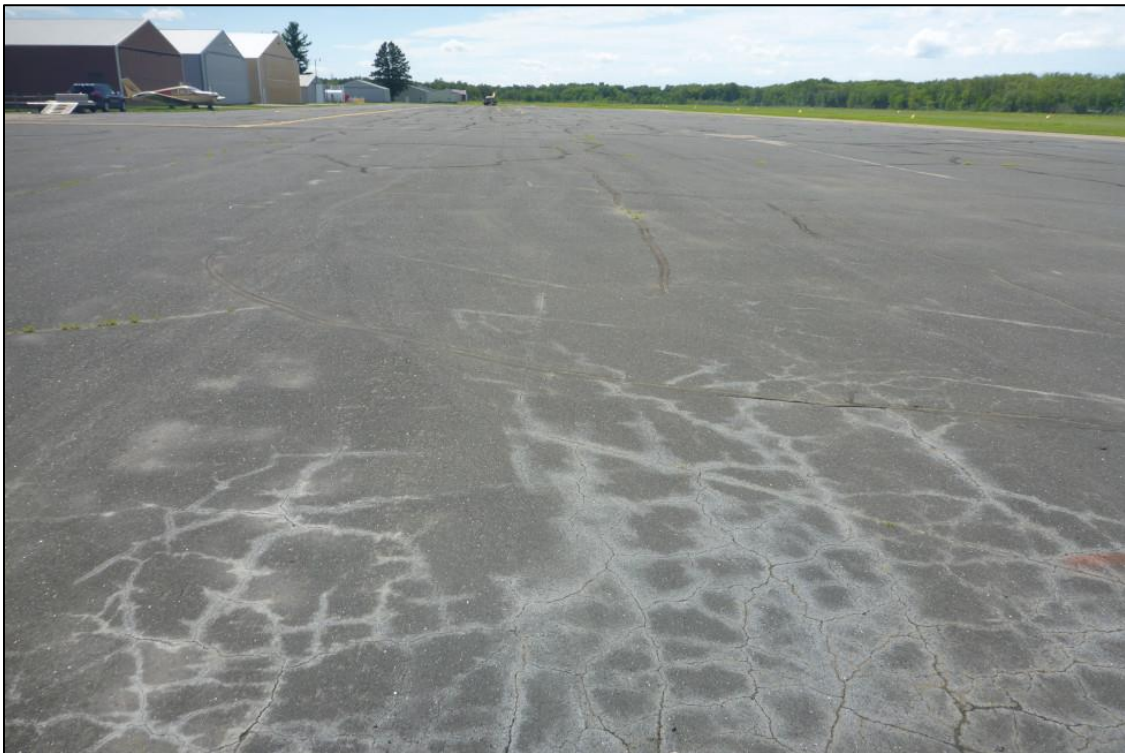
AIT APA 002 (PCI = 45)

**Conditions:** PCI: 45

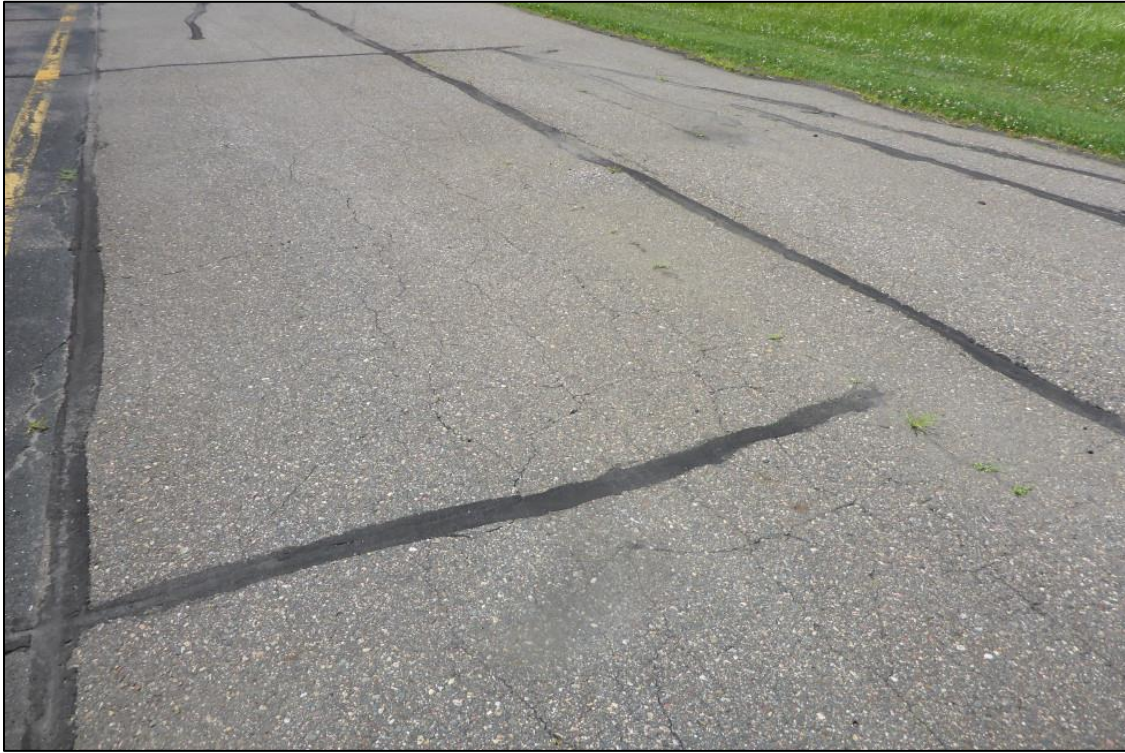
AIT APA 003 (PCI = 32)

**Conditions:** PCI: 32

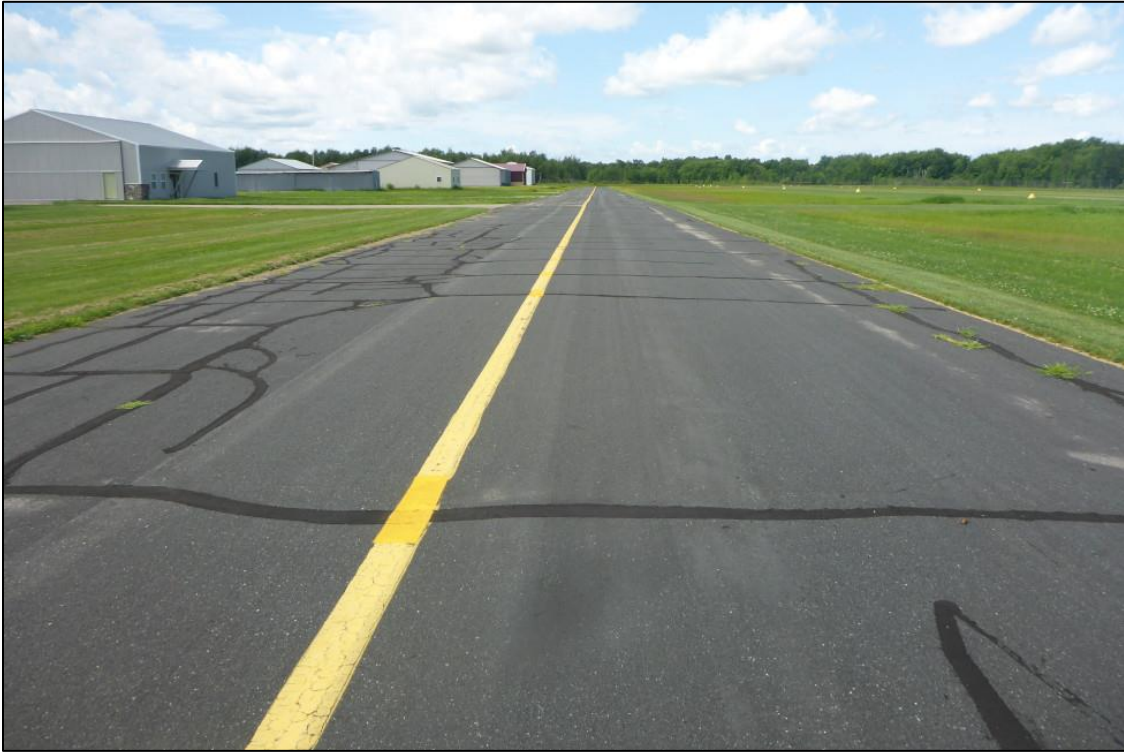
AIT CTB 001 (PCI = 61)

**Conditions:** PCI: 61

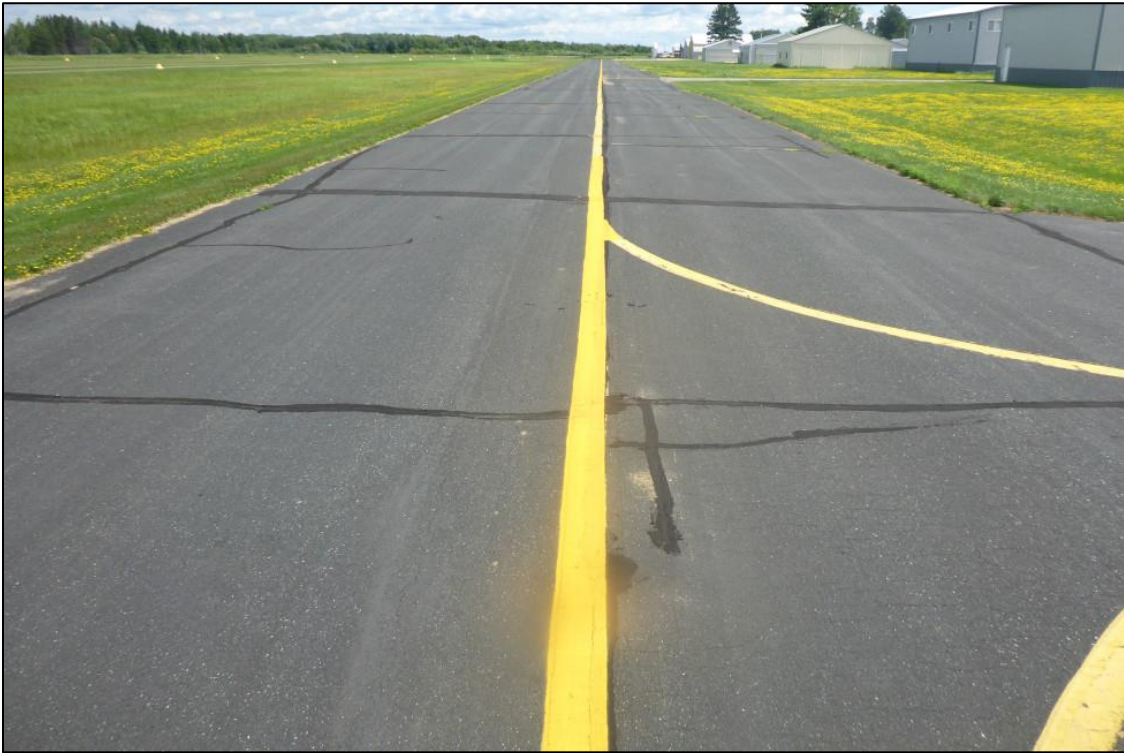
AIT CTB 002 (PCI = 72)

**Conditions:** PCI: 72

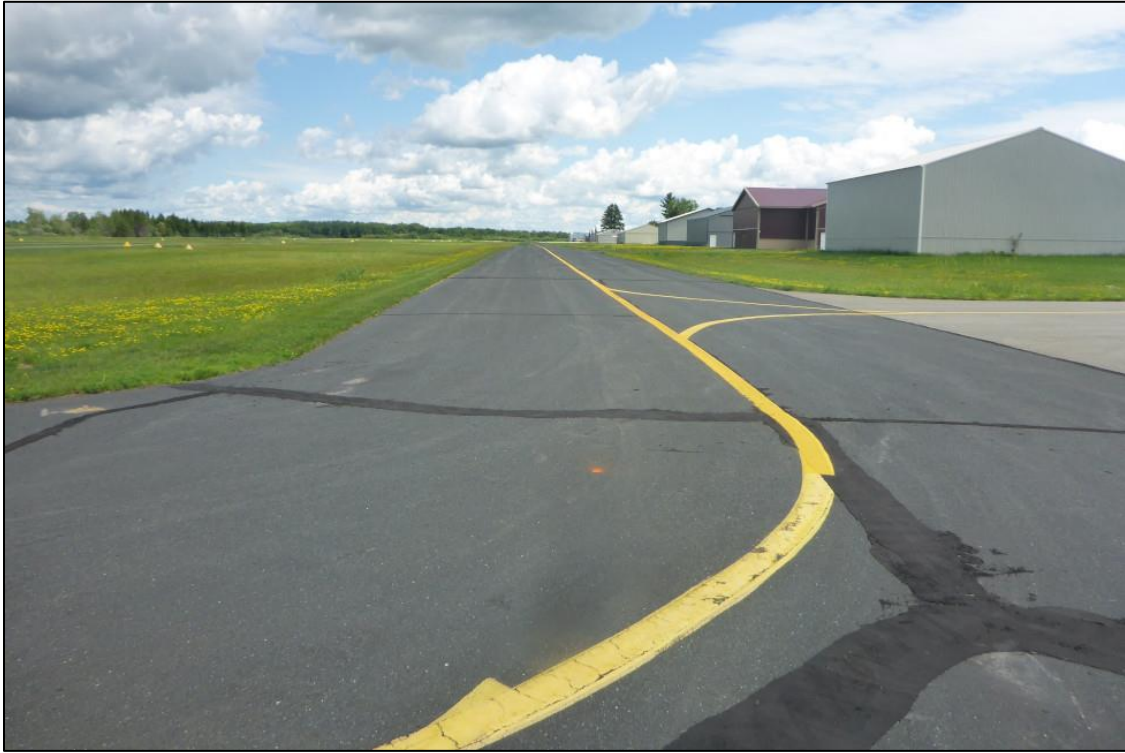
AIT CTB 003 (PCI = 79)

<sup>8</sup>Increase in PCI due to quality maintenance being completed since last inspection showing losses of high and medium cracking.

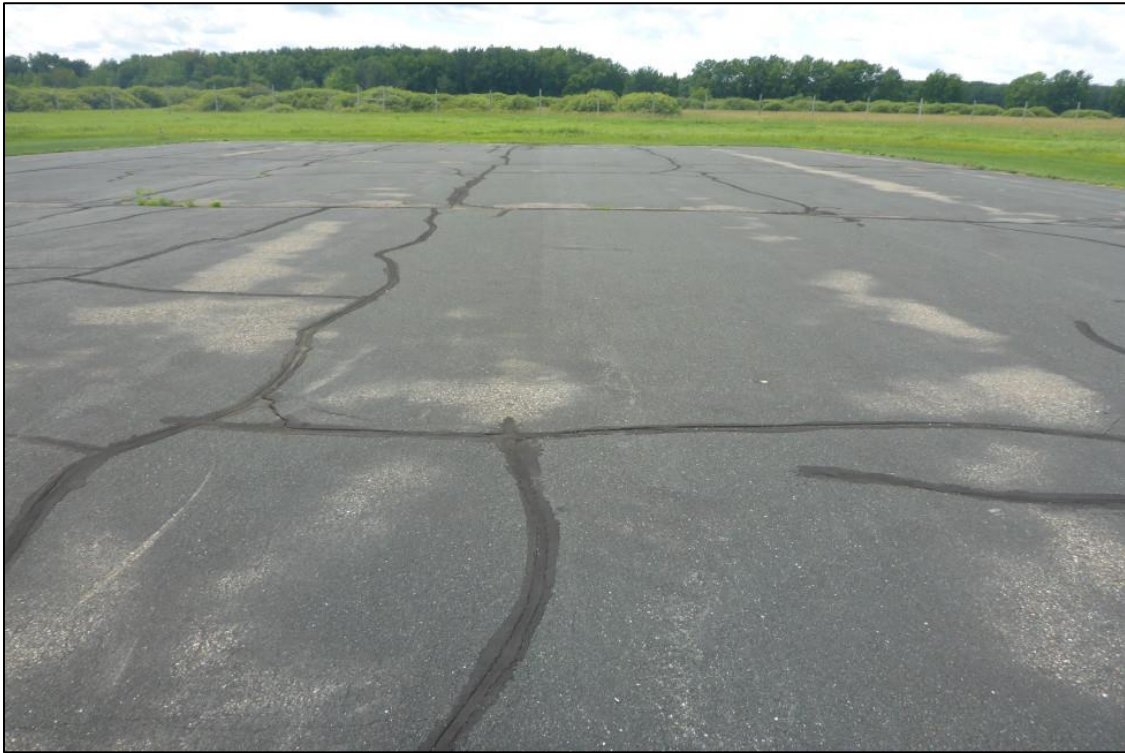
AIT RTA 001 (PCI = 42)

**Conditions:** PCI: 42
