Pavement Condition Report

Chandler Field Airport – Alexandria (AXN)

December 2019

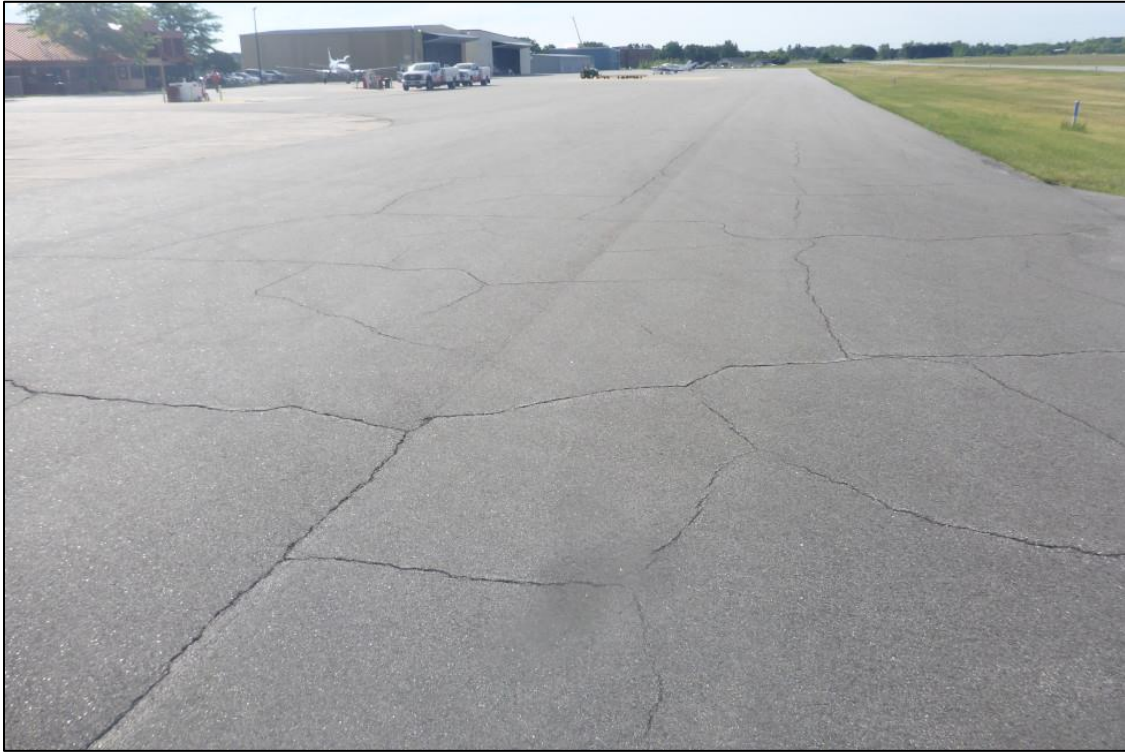
AXN APA 001 (PCI = 68)

⁹Higher than expected deterioration rate due to reflective cracking through the asphalt overlay.

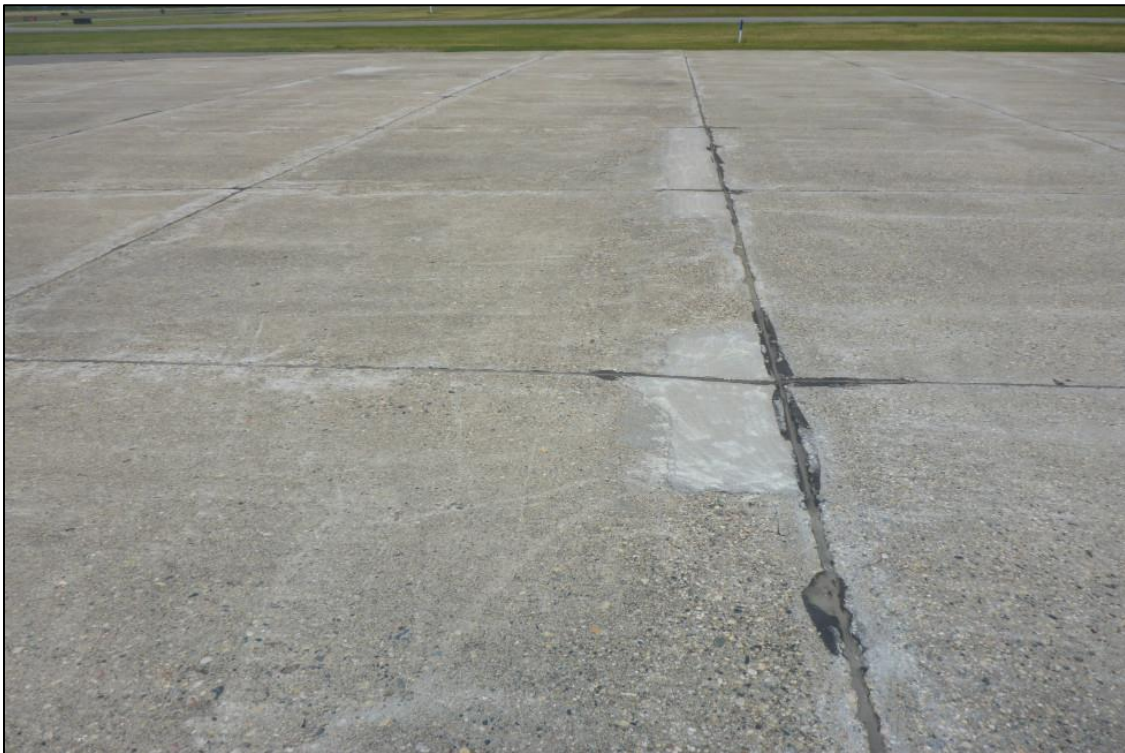
AXN APA 002 (PCI = 69)

⁷Increase in PCI due to joint seal replacement and patching that took place after the 2016 inspection.

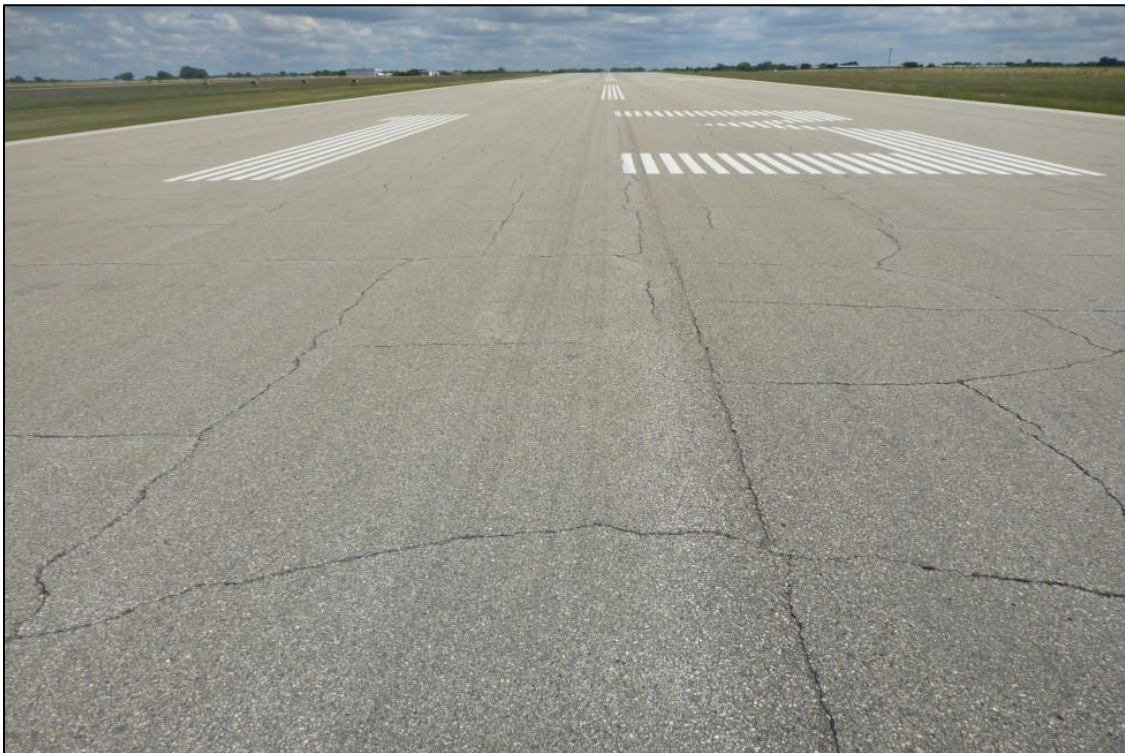
AXN RY1331 001 (PCI = 59)

⁸Higher than expected deterioration rate of 5.9 PCI/year due to the development of low Block cracking and low L&T cracking in significant quantities.
