Pavement Condition Report

Staples Municipal Airport (SAZ)

December 2019

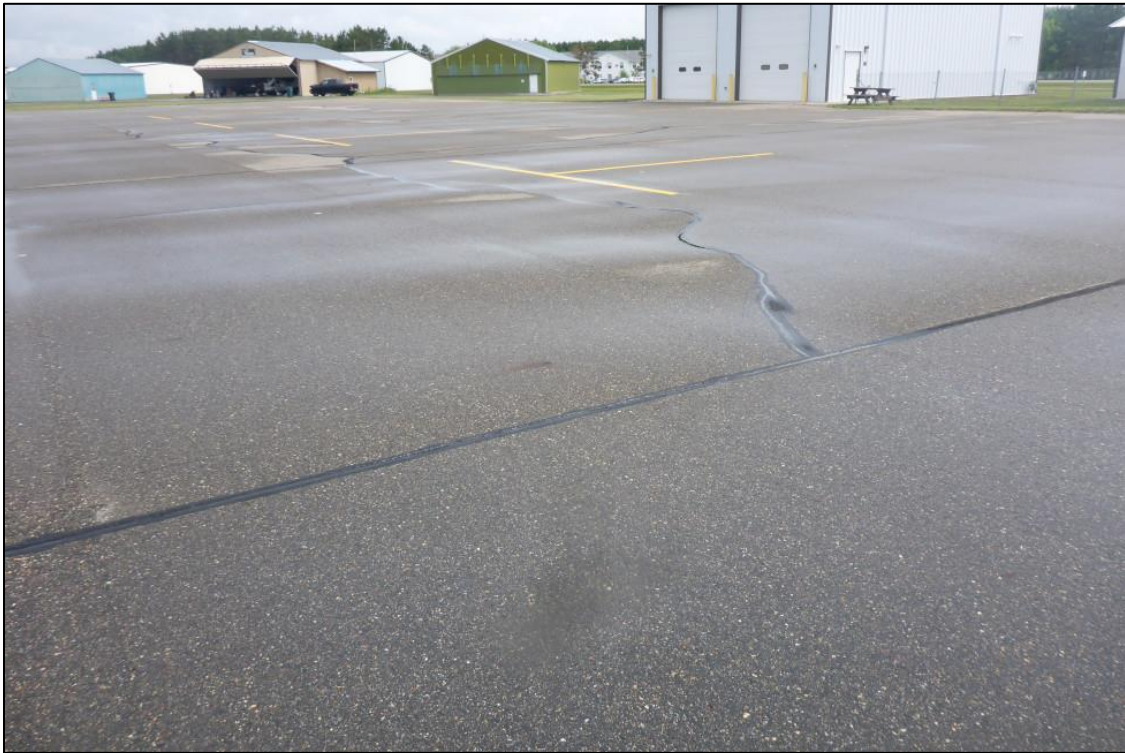
SAZ APA 001 (PCI = 78)

Conditions: PCI: 78

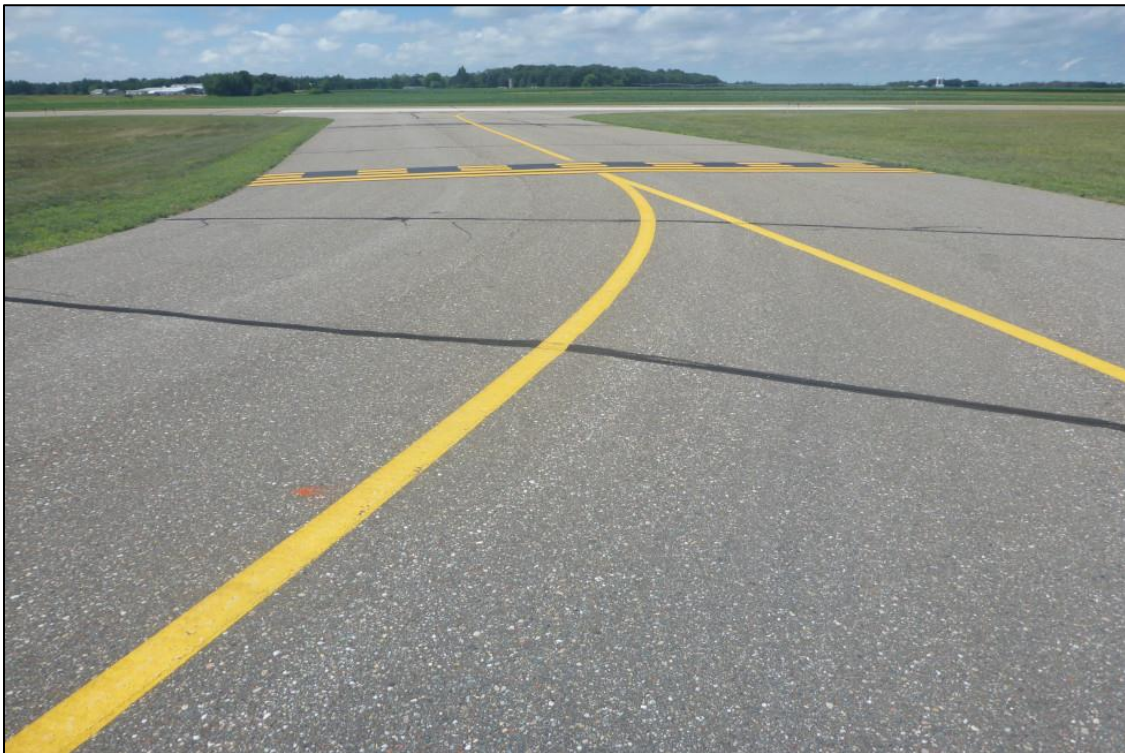
SAZ CTA 001 (PCI = 87)

Network:	SAZ	Name:	STAPLES						
Branch:	CTA	Name:	CONNECTING TAXIWAY A	Use:	TAXIWAY	Area:	44,377 SqFt		
Section:	001	of 3	From:	100	To:	102+81	Last Const.:	9/1/2006	
Surface:	AAC	Family:	MN2018 Asphalt Runway- Taxiways	Zone:	W	Category:	3	Rank:	P
Area:	11,752 SqFt	Length:	281 Ft	Width:	40 Ft				
Slabs:		Slab Length:	Ft	Slab Width:	Ft	Joint Length:	Ft		
Shoulder:		Street Type:		Grade:	0	Lanes:	0		
Section Comments:									
Last Insp. Date:	7/16/2019	TotalSamples:	3	Surveyed:	1				
Conditions:	PCI: 87								
Inspection Comments:									
Sample Number:	101	Type:	R	Area:	4000.00 SqFt	PCI:	87		
Sample Comments:	pic 527 528								
48	L & T CR	L	152.00	Ft					
57	WEATHERING	L	250.00	SqFt

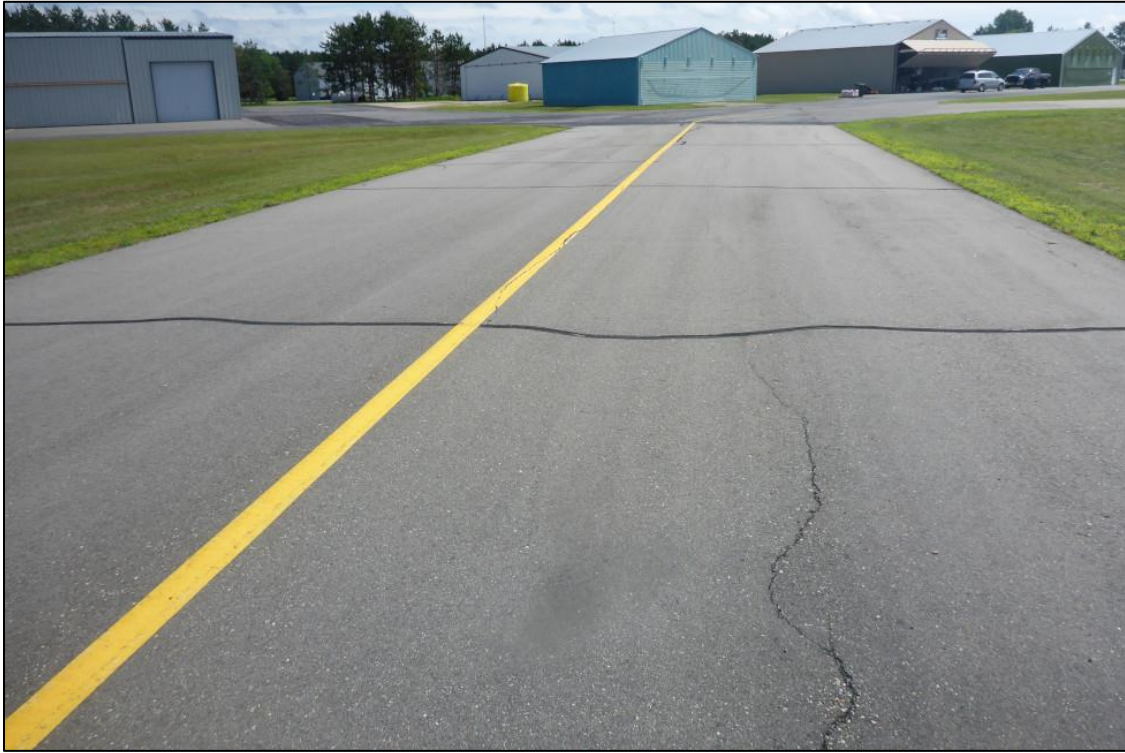
SAZ CTA 002 (PCI = 80)

Network:	SAZ	Name:	STAPLES						
Branch:	CTA	Name:	CONNECTING TAXIWAY A	Use:	TAXIWAY	Area:	44,377 SqFt		
Section:	002	of 3	From:	102+81	To:	111	Last Const.:	9/15/2017	
Surface:	AC	Family:	MN2018 Asphalt Runway- Taxiways	Zone:	W	Category:	3	Rank:	P
Area:	27,625 SqFt	Length:	800 Ft	Width:	40 Ft				
Slabs:		Slab Length:	Ft	Slab Width:	Ft	Joint Length:	Ft		
Shoulder:		Street Type:		Grade:	0	Lanes:	0		
Section Comments:									
Last Insp. Date:	7/16/2019	TotalSamples:	9	Surveyed:	3				
Conditions:	PCI: 80								
Inspection Comments:									
Sample Number:	103	Type:	R	Area:	3500.00 SqFt	PCI:	81		
Sample Comments:									
48	L & T CR	L	244.00	Ft					
Sample Number:	106	Type:	R	Area:	3500.00 SqFt	PCI:	79		
Sample Comments:									
48	L & T CR	L	297.00	Ft					
Sample Number:	108	Type:	R	Area:	3500.00 SqFt	PCI:	79		
Sample Comments: p072									
48	L & T CR	L	292.00	Ft

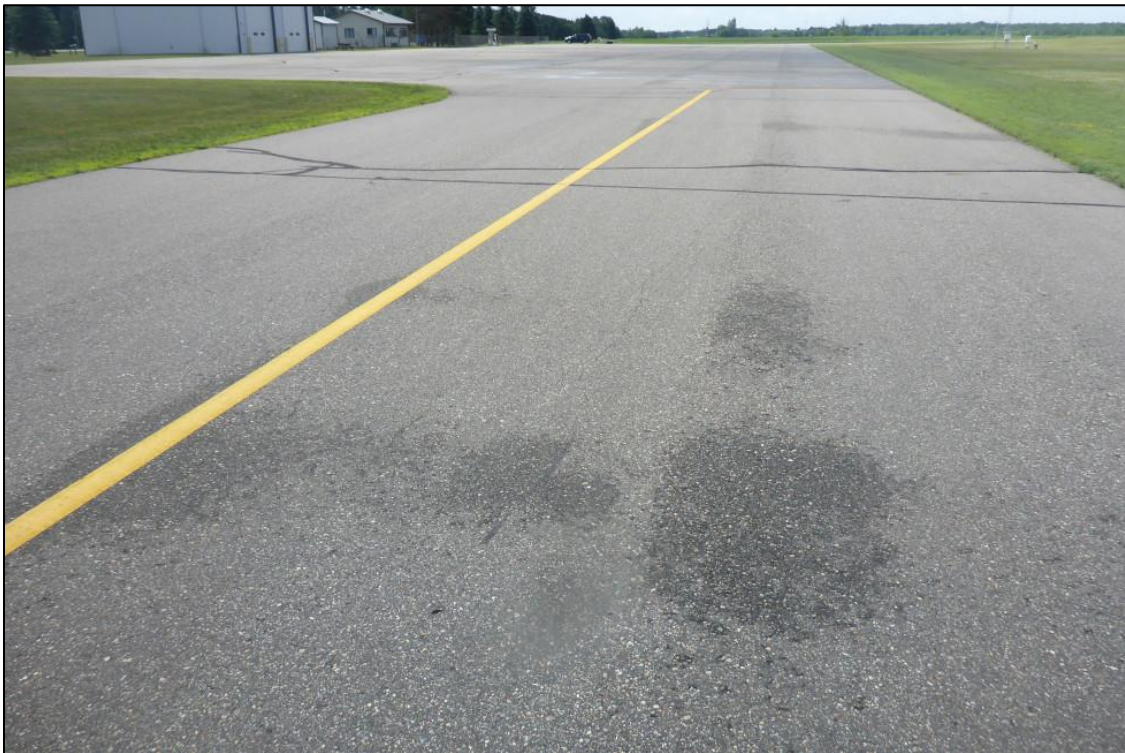
SAZ CTA 003 (PCI = 84)

Network:	SAZ	Name:	STAPLES						
Branch:	CTA	Name:	CONNECTING TAXIWAY A	Use:	TAXIWAY	Area:	44,377 SqFt		
Section:	003	of 3	From:	110	To:	apron	Last Const.:	6/1/2012	
Surface:	AC	Family:	MN2018 Asphalt Runway- Taxiways	Zone:	W	Category:	3	Rank:	P
Area:	5,000 SqFt	Length:	120 Ft	Width:	40 Ft				
Slabs:		Slab Length:	Ft	Slab Width:	Ft	Joint Length:	Ft		
Shoulder:		Street Type:		Grade:	0	Lanes:	0		
Section Comments:									
Last Insp. Date:	7/16/2019	TotalSamples:	1	Surveyed:	1				
Conditions:	PCI: 84								
Inspection Comments:									
Sample Number:	111	Type:	R	Area:	4200.00 SqFt	PCI:	84		
Sample Comments:	p068								
48	L & T CR	L	228.00	Ft

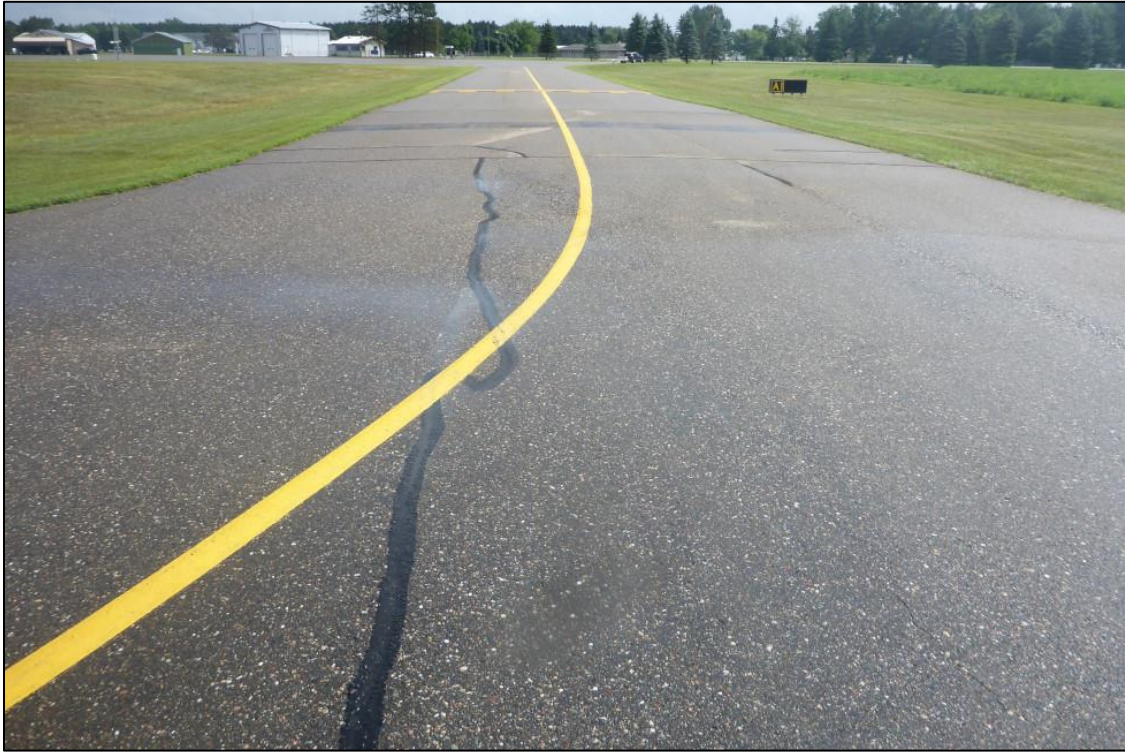
SAZ CTA1 001 (PCI = 76)

Conditions: PCI: 76

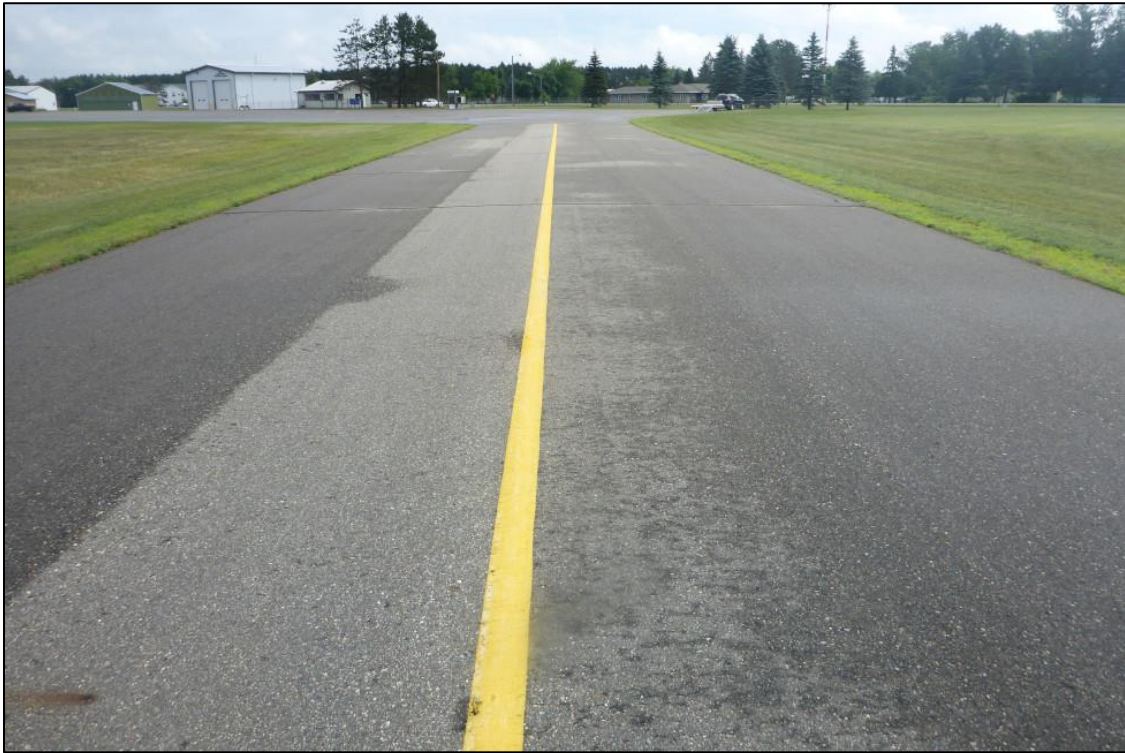
SAZ CTA1 002 (PCI = 86)

Network:	SAZ	Name:	STAPLES						
Branch:	CTA1	Name:	CONNECTING TAXIWAY A1	Use:	TAXIWAY	Area:	19,215 SqFt		
Section:	002	of 2	From:	201+12	To:	203	Last Const.:	6/1/2012	
Surface:	AC	Family:	MN2018 Asphalt Runway- Taxiways	Zone:	W	Category:	3	Rank:	P
Area:	14,400 SqFt	Length:	305 Ft	Width:	40 Ft				
Slabs:		Slab Length:	Ft	Slab Width:	Ft	Joint Length:	Ft		
Shoulder:		Street Type:		Grade:	0	Lanes:	0		
Section Comments:									
Last Insp. Date:	7/16/2019	TotalSamples:	4	Surveyed:	1				
Conditions:	PCI: 86								
Inspection Comments:									
Sample Number:	202	Type:	R	Area:	4000.00 SqFt	PCI:	86		
Sample Comments:	p065 c.s.								
48	L & T CR	L	114.00 Ft						
57	WEATHERING	L	2000.00 SqFt

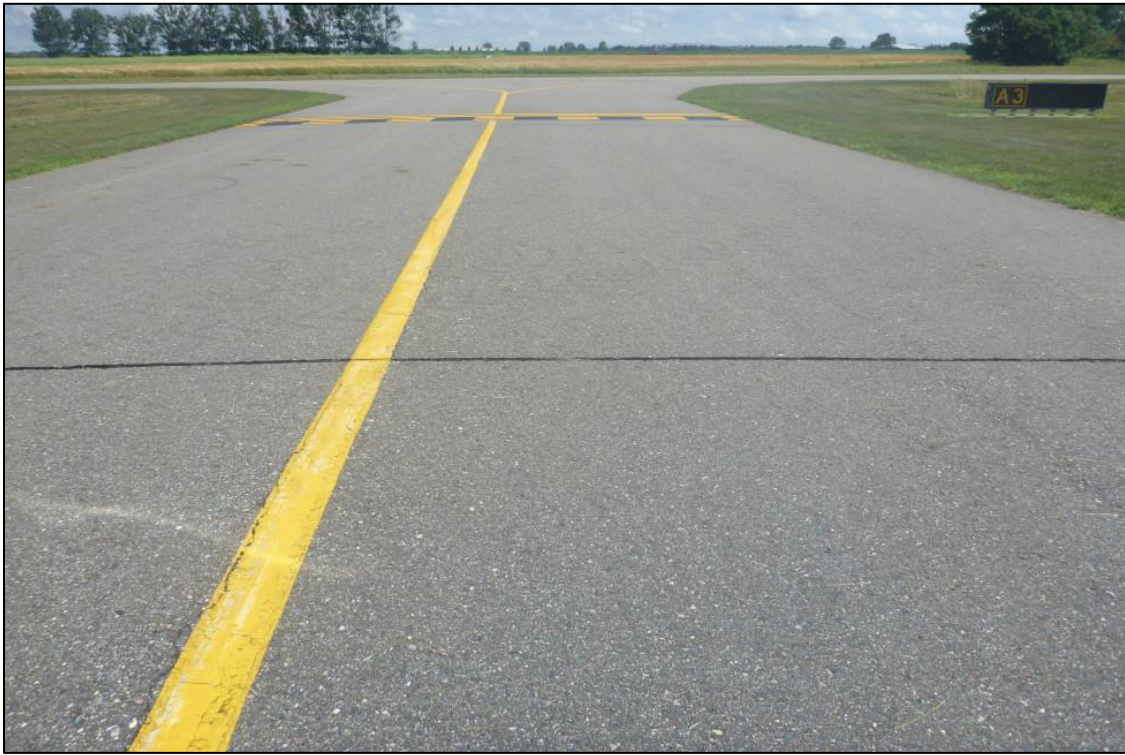
SAZ CTA3 001 (PCI = 85)

Network:	SAZ	Name:	STAPLES				
Branch:	CTA3	Name:	CONNECTING TAXIWAY A3	Use:	TAXIWAY	Area:	11,207 SqFt
Section:	001	of 1	From:	A	To:	B	Last Const.: 10/10/2013
Surface:	AC	Family:	MN2018 Asphalt Runway- Taxiways	Zone:		Category:	Rank: P
Area:	11,207 SqFt	Length:	320 Ft	Width:	35 Ft		
Slabs:		Slab Length:	Ft	Slab Width:	Ft	Joint Length:	Ft
Shoulder:		Street Type:		Grade:	0	Lanes:	0
Section Comments:							
Last Insp. Date:	7/16/2019	TotalSamples:	3	Surveyed:	1		
Conditions:	PCI: 85						
Inspection Comments:							
Sample Number:	101	Type:	R	Area:	3500.00 SqFt	PCI:	85
Sample Comments:	pic 525 saw cuts not included						
48	L & T CR	L	109.00	Ft			
48	L & T CR	M	20.00	Ft

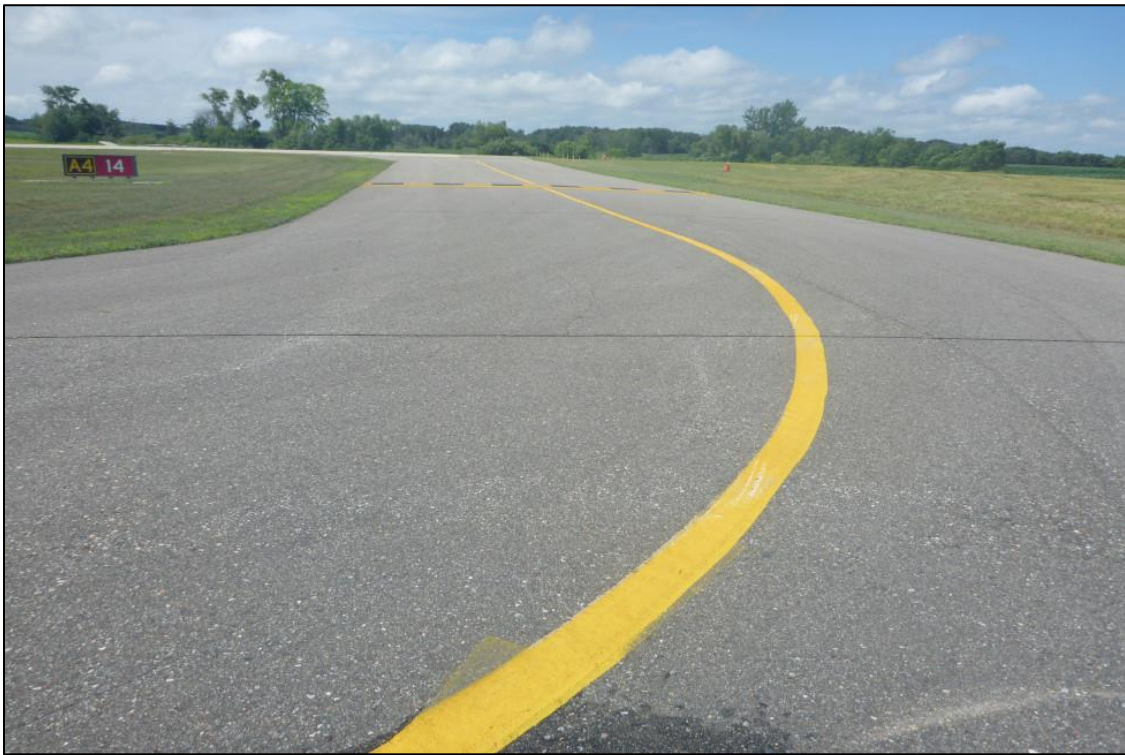
SAZ PPTA 001 (PCI = 89)

Network:	SAZ	Name:	STAPLES				
Branch:	PPTA	Name:	PARALLEL TAXIWAY A	Use:	TAXIWAY	Area:	90,826 SqFt
Section:	001	of 1	From:	A	To:	B	Last Const.: 10/10/2013
Surface:	AC	Family:	MN2018 Asphalt Runway- Taxiways	Zone:		Category:	Rank: P
Area:	90,826 SqFt	Length:	2,590 Ft	Width:	35 Ft		
Slabs:		Slab Length:	Ft	Slab Width:	Ft	Joint Length:	Ft
Shoulder:		Street Type:		Grade:	0	Lanes:	0
Section Comments:							
Last Insp. Date:	7/16/2019	TotalSamples:	25	Surveyed:	5		
Conditions:	PCI: 89						
Inspection Comments:							
Sample Number:	101	Type:	R	Area:	3500.00 SqFt	PCI:	91
Sample Comments:	pic 524						
48	L & T CR	L	70.00 Ft				
57	WEATHERING	L	250.00 SqFt				
Sample Number:	105	Type:	R	Area:	3500.00 SqFt	PCI:	88
Sample Comments:							
48	L & T CR	L	107.00 Ft				
57	WEATHERING	L	250.00 SqFt				
Sample Number:	110	Type:	R	Area:	3500.00 SqFt	PCI:	88
Sample Comments:							
48	L & T CR	L	115.00 Ft				
57	WEATHERING	L	250.00 SqFt

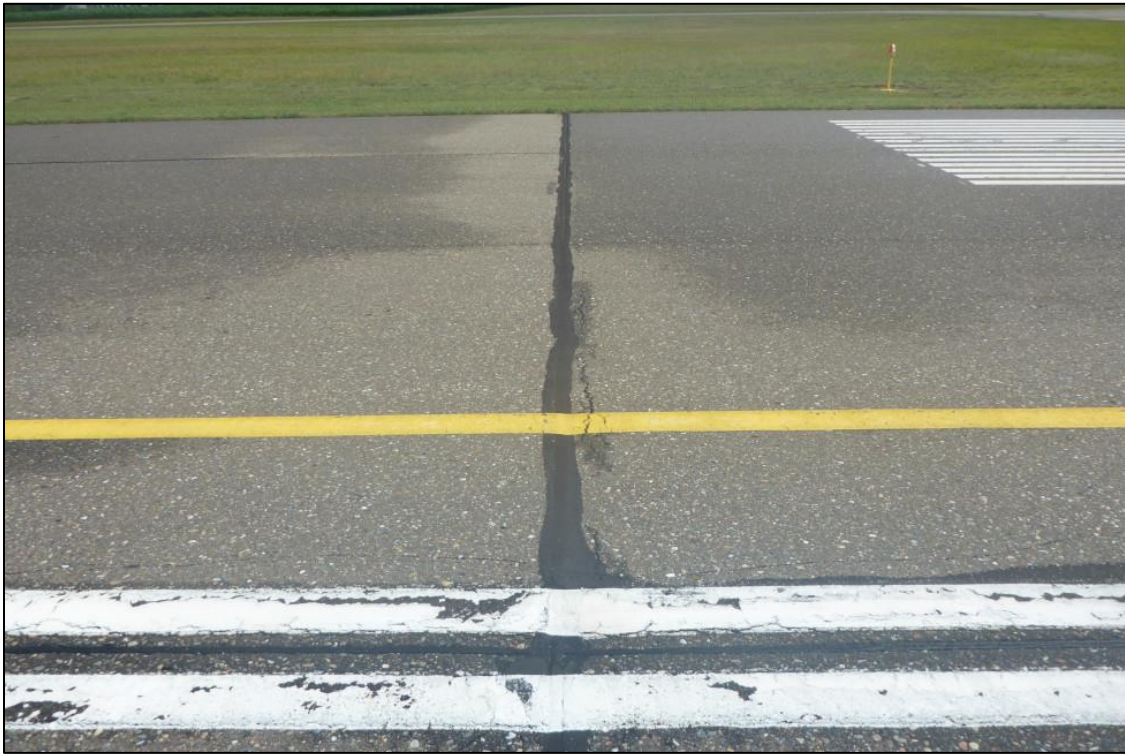
SAZ RY1432 001 (PCI = 72)

Network:	SAZ	Name:	STAPLES						
Branch:	RY1432	Name:	RUNWAY 14-32	Use:	RUNWAY	Area:	247,800 SqFt		
Section:	001	of 1	From:	100	To:	165	Last Const.: 9/1/2006		
Surface:	AAC	Family:	MN2018 Asphalt Runway- Taxiways	Zone:	W	Category:	3	Rank:	P
Area:	247,800 SqFt	Length:	3,304 Ft	Width:	75 Ft				
Slabs:		Slab Length:	Ft	Slab Width:	Ft	Joint Length:	Ft		
Shoulder:		Street Type:		Grade:	0	Lanes:	0		
Section Comments:									
Last Insp. Date:	7/16/2019	TotalSamples:	66	Surveyed:	7				
Conditions:	PCI: 72								
Inspection Comments:									
Sample Number:	103	Type:	R	Area:	3750.00 SqFt	PCI:	72		
Sample Comments:	pic 521								
48	L & T CR	L	266.00	Ft					
48	L & T CR	M	58.00	Ft					
57	WEATHERING	L	1500.00	SqFt					
Sample Number:	113	Type:	R	Area:	3750.00 SqFt	PCI:	71		
Sample Comments:									
48	L & T CR	L	283.00	Ft					
48	L & T CR	M	42.00	Ft					
57	WEATHERING	L	1500.00	SqFt					
Sample Number:	123	Type:	R	Area:	3750.00 SqFt	PCI:	74

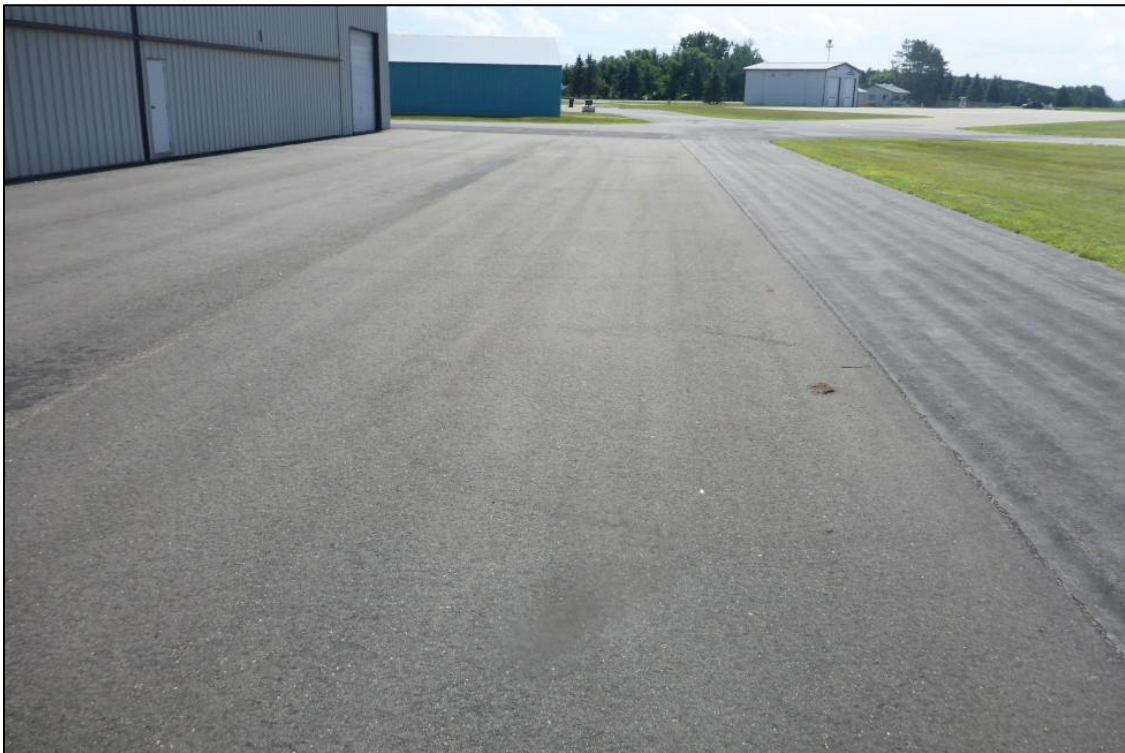
SAZ TLA 001 (PCI = 90)

Network:	SAZ	Name:	STAPLES						
Branch:	TLA	Name:	TAXILANE A	Use:	TAXILANE	Area:	85,740 SqFt		
Section:	001	of 3	From:	100	To:	108	Last Const.:	9/15/2017	
Surface:	AC	Family:	MN2018 Asphalt Taxilanes	Zone:	W	Category:	3	Rank:	T
Area:	23,300 SqFt	Length:	550 Ft	Width:	50 Ft				
Slabs:	Slab Length:	Ft	Slab Width:	Ft	Joint Length:	Ft			
Shoulder:	Street Type:	Grade:	0	Lanes:	0				
Section Comments:									
Last Insp. Date:	7/16/2019	TotalSamples:	7	Surveyed:	2				
Conditions:	PCI: 90								
Inspection Comments:									
Sample Number:	101	Type:	R	Area:	5000.00 SqFt	PCI:	89		
Sample Comments:	p070								
48	L & T CR	L	170.00	Ft					
Sample Number:	104	Type:	R	Area:	5000.00 SqFt	PCI:	90		
Sample Comments:									
48	L & T CR	L	140.00	Ft

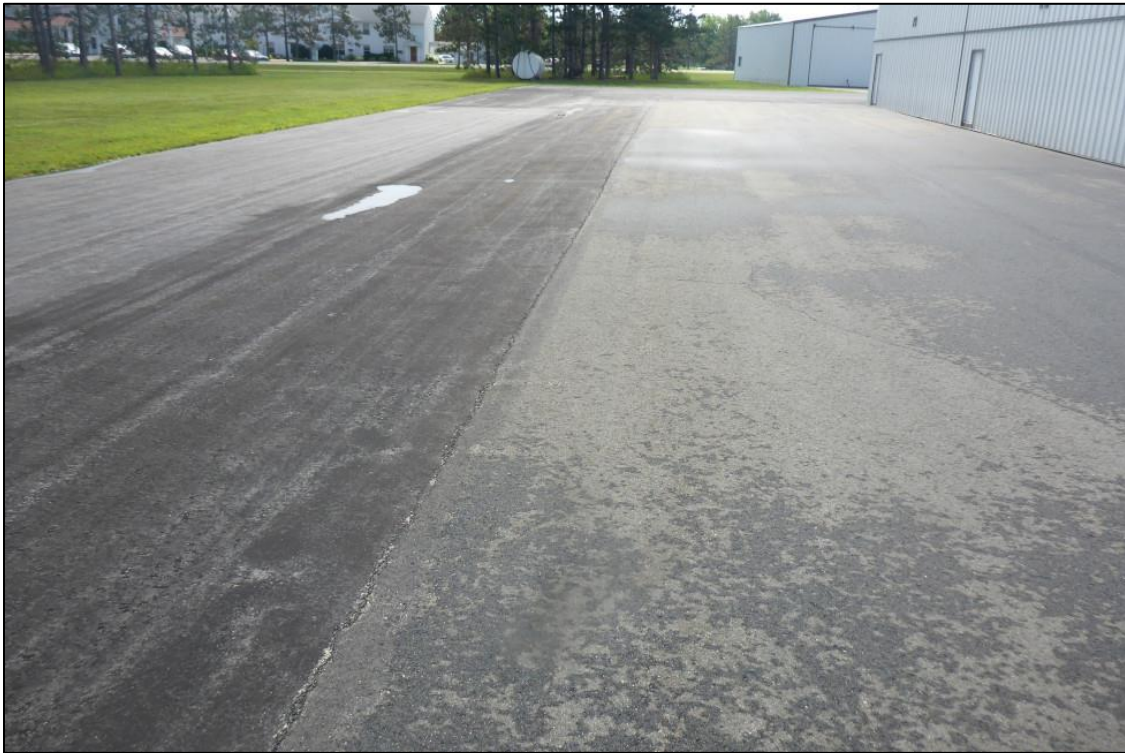
SAZ TLA 002 (PCI = 83)

Network:	SAZ	Name:	STAPLES						
Branch:	TLA	Name:	TAXILANE A	Use:	TAXILANE	Area:	85,740 SqFt		
Section:	002	of 3	From:	103	To:	110	Last Const.:	9/15/2017	
Surface:	AC	Family:	MN2018 Asphalt Taxilanes	Zone:	W	Category:	3	Rank:	T
Area:	49,750 SqFt	Length:	995 Ft	Width:	50 Ft				
Slabs:	Slab Length:	Ft	Slab Width:	Ft	Joint Length:	Ft			
Shoulder:	Street Type:	Grade:	0	Lanes:	0				
Section Comments:									
Last Insp. Date:	7/16/2019	TotalSamples:	4	Surveyed:	1				
Conditions:	PCI: 83								
Inspection Comments:									
Sample Number:	201	Type:	R	Area:	5000.00 SqFt	PCI:	83		
Sample Comments:									
48	L & T CR	L	206.00	Ft					
48	L & T CR	M	2.00	Ft

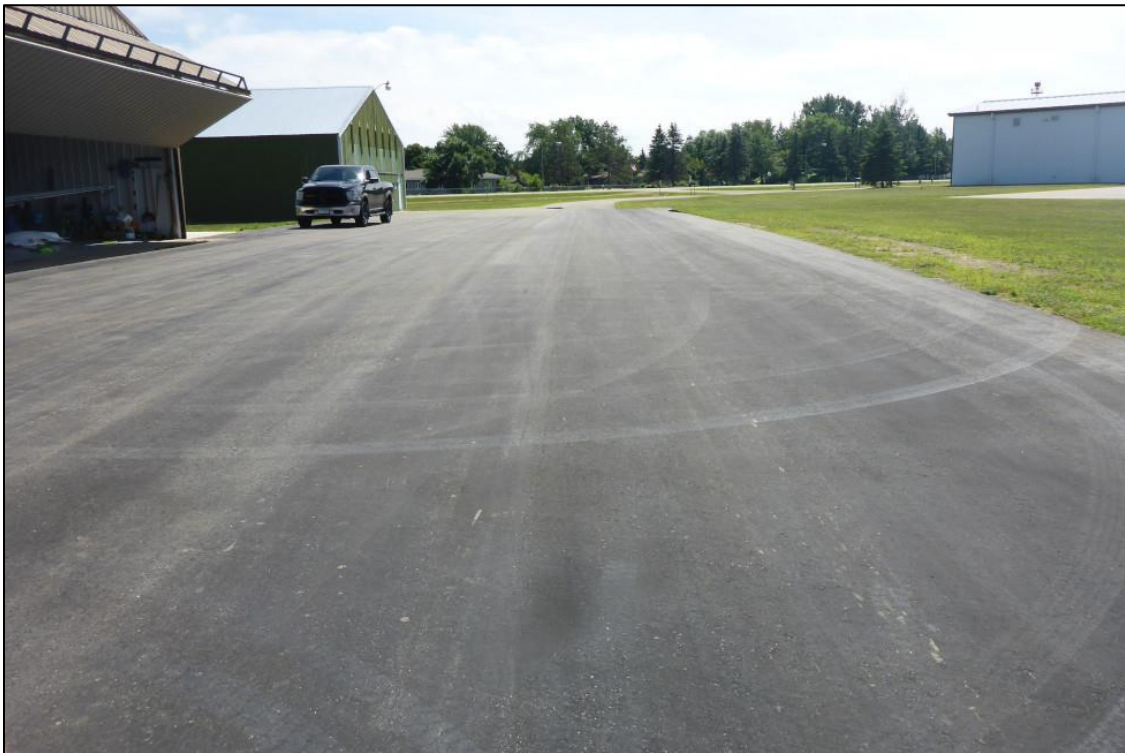
SAZ TLA 003 (PCI = 89)

Network:	SAZ	Name:	STAPLES					
Branch:	TLA	Name:	TAXILANE A	Use:	TAXILANE	Area:	85,740 SqFt	
Section:	003	of 3	From:	100	To:	102	Last Const.:	9/15/2017
Surface:	AC	Family:	DEFAULT	Zone:		Category:	Rank:	P
Area:	12,690 SqFt	Length:	270 Ft	Width:	47 Ft			
Slabs:		Slab Length:	Ft	Slab Width:	Ft	Joint Length:	Ft	
Shoulder:		Street Type:		Grade:	0	Lanes:	0	
Section Comments:	find const date							
Last Insp. Date:	7/16/2019	TotalSamples:	3	Surveyed:	1			
Conditions:	PCI: 89							
Inspection Comments:								
Sample Number:	101	Type:	R	Area:	4700.00 SqFt	PCI:	89	
Sample Comments:	p073							
48	L & T CR	L	150.00	Ft
