# Pavement Condition Report

## Granite Falls Municipal Airport (GDB)

**December 2016**

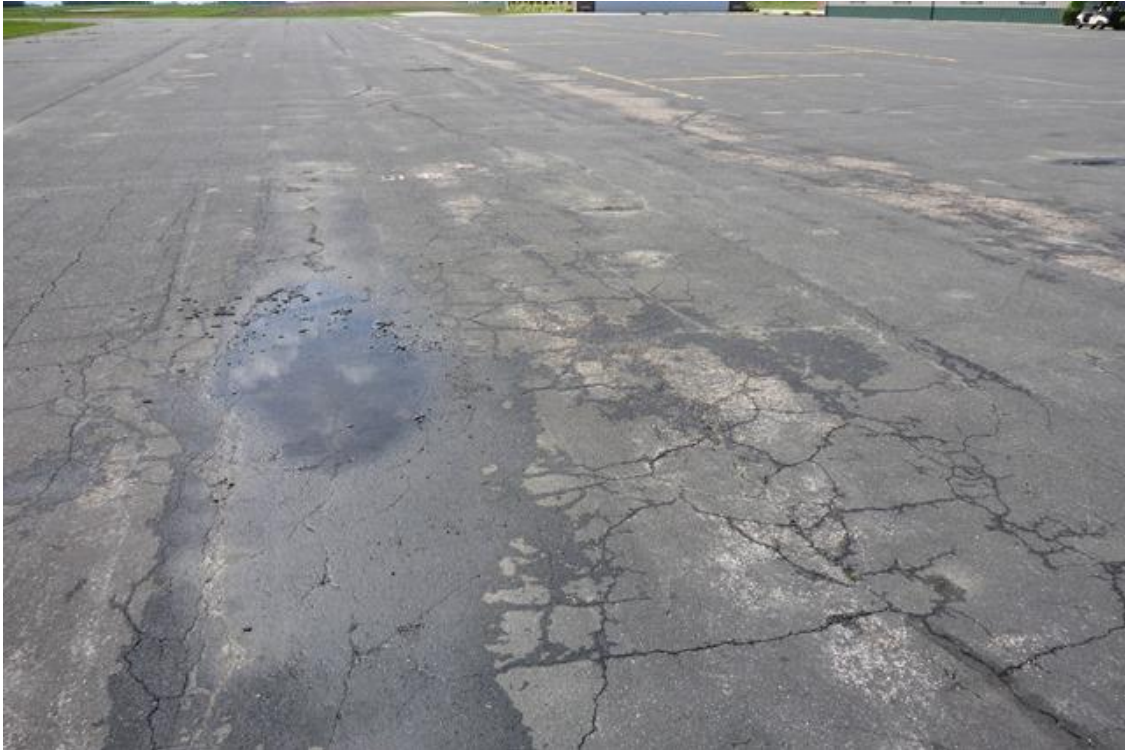
GDB APA 001 (PCI = 56)

**Conditions:** PCI: 56

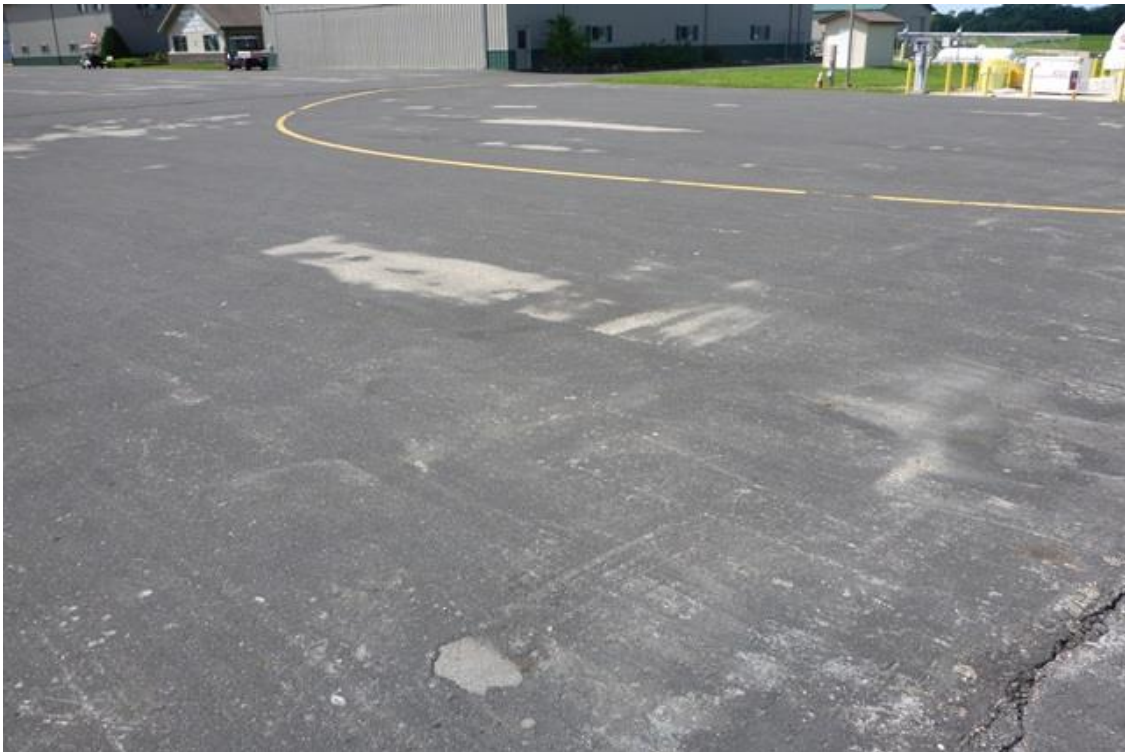
GDB APA 002 (PCI = 86)

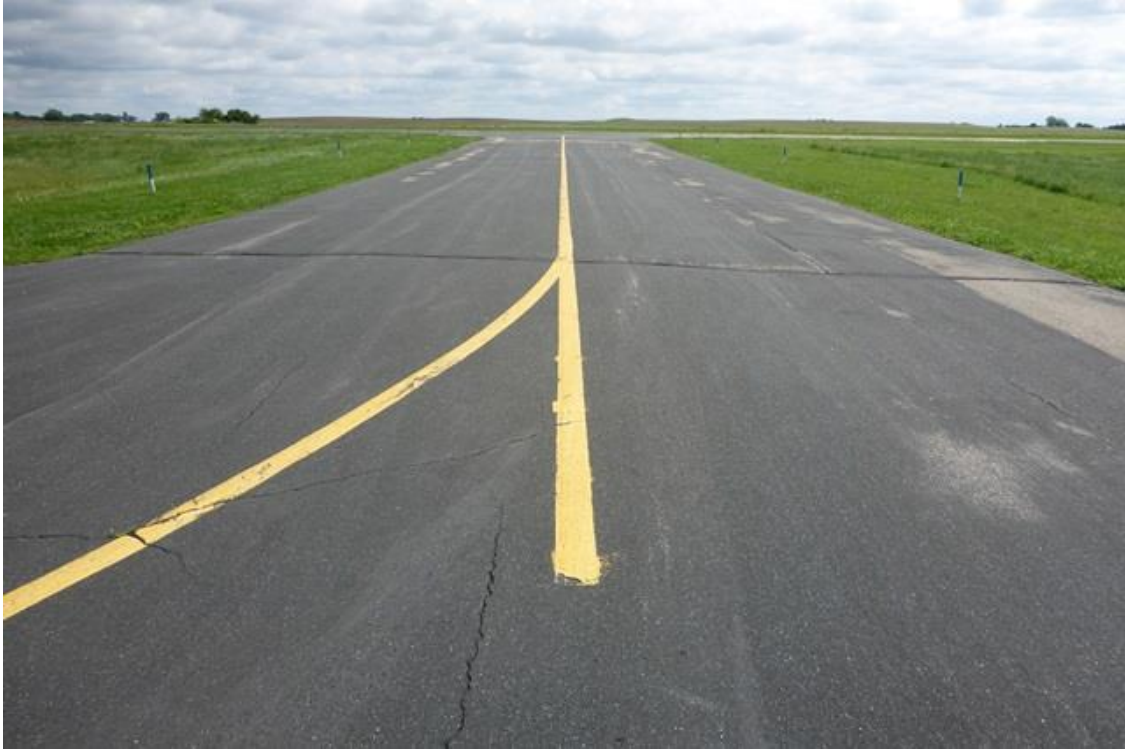
GDB CTA 001 (PCI = 62)

**Conditions:** PCI: 62

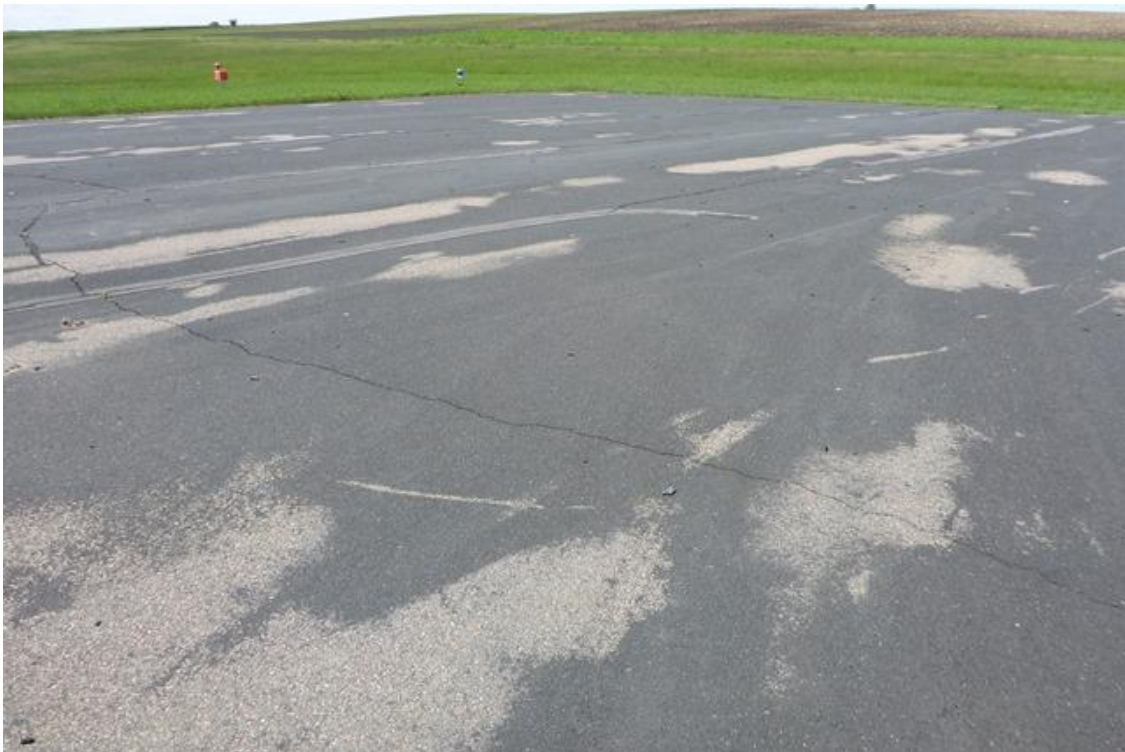
GDB RTA 001 (PCI = 35)

**Conditions:** PCI: 35

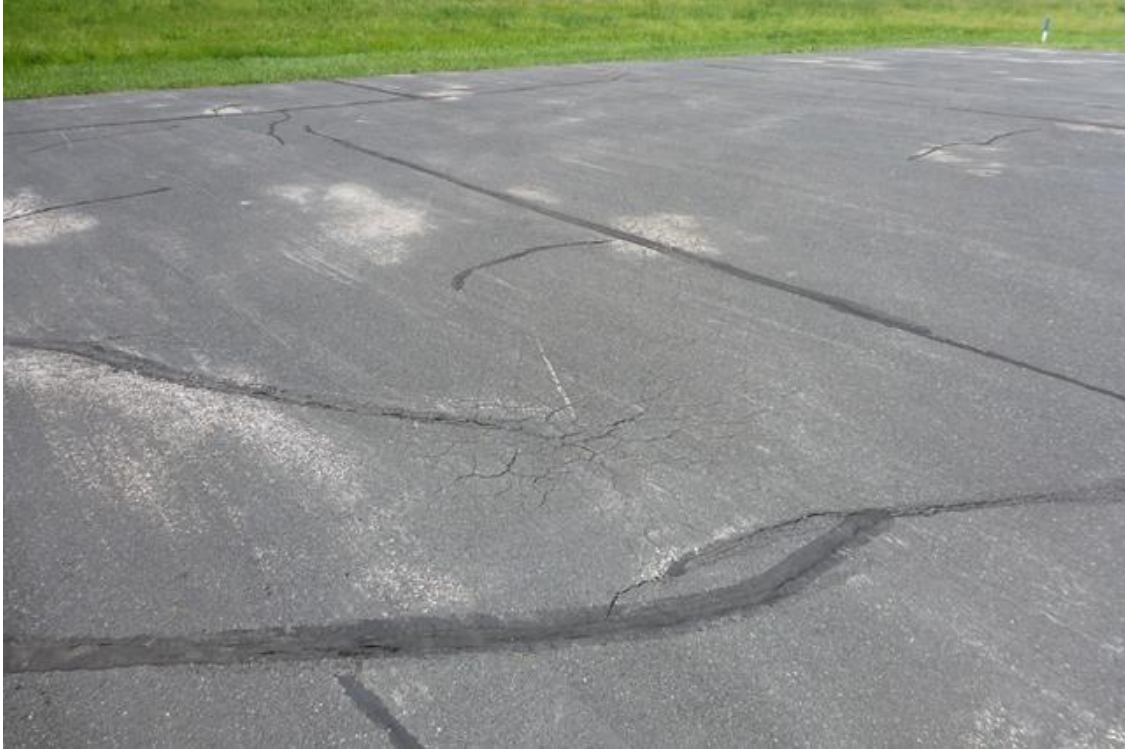
GDB RTA 002 (PCI = 55)

**Conditions:** PCI: 55

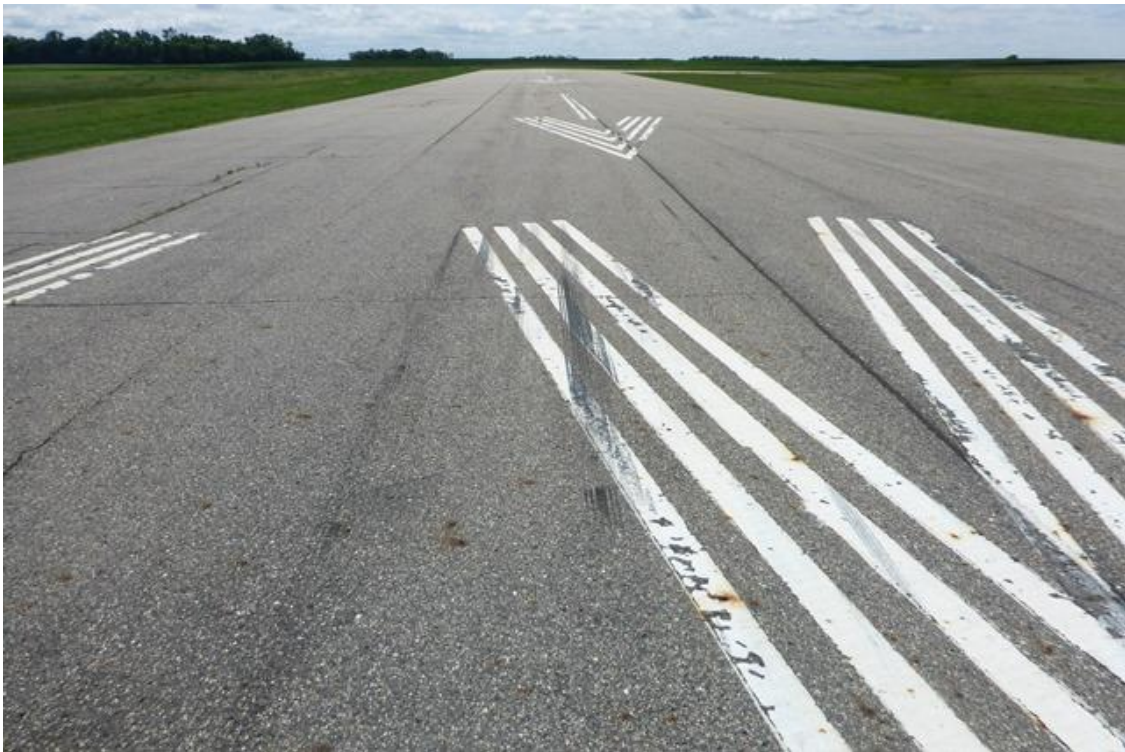
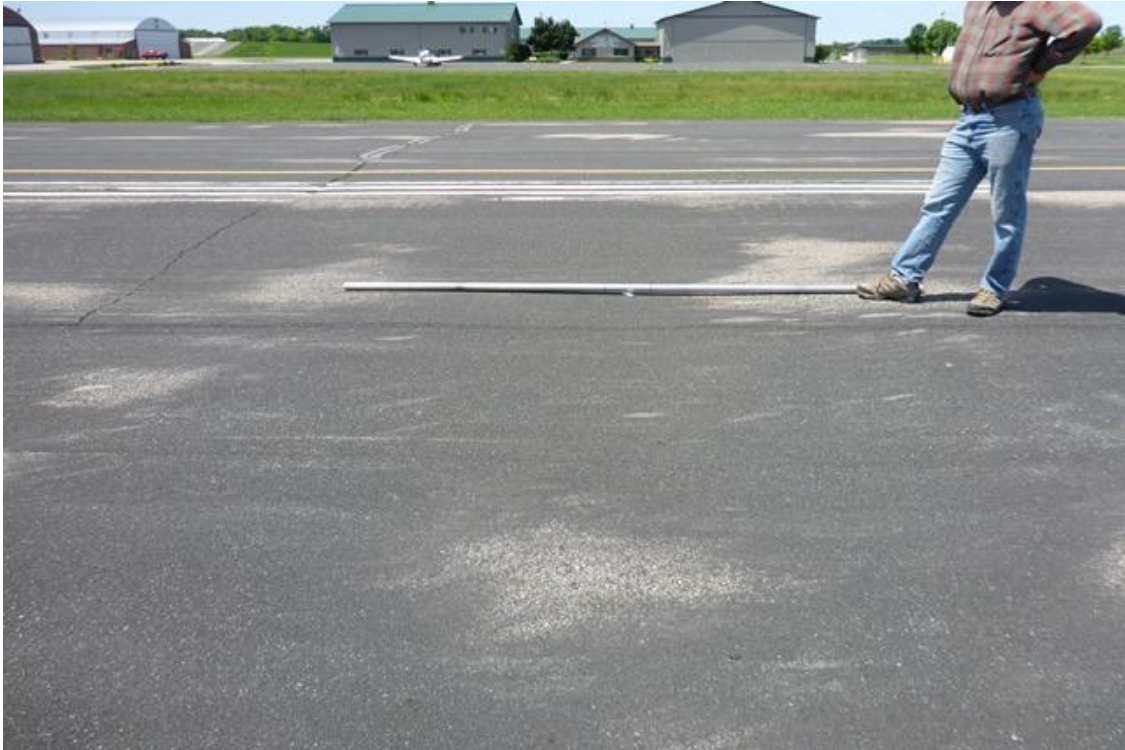
GDB RY1533 001 (PCI = 66)

**Conditions:** PCI: 66

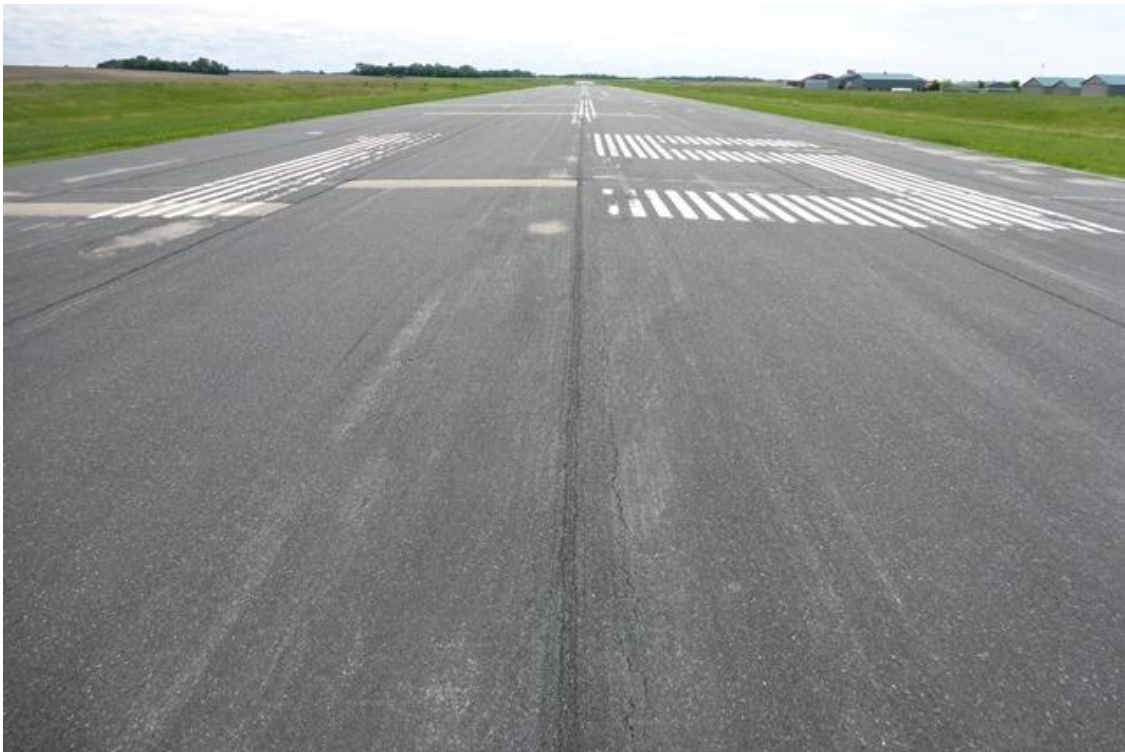
GDB RY1533 002 (PCI = 73)

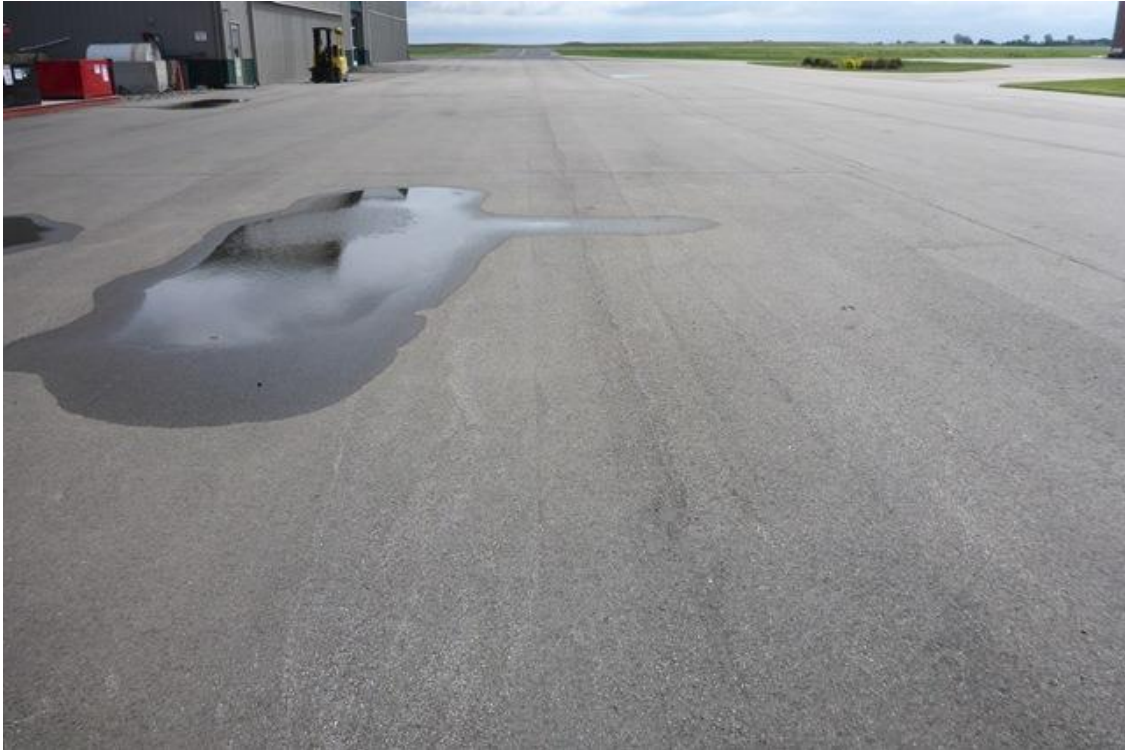
GDB TLA 001 (PCI = 93)

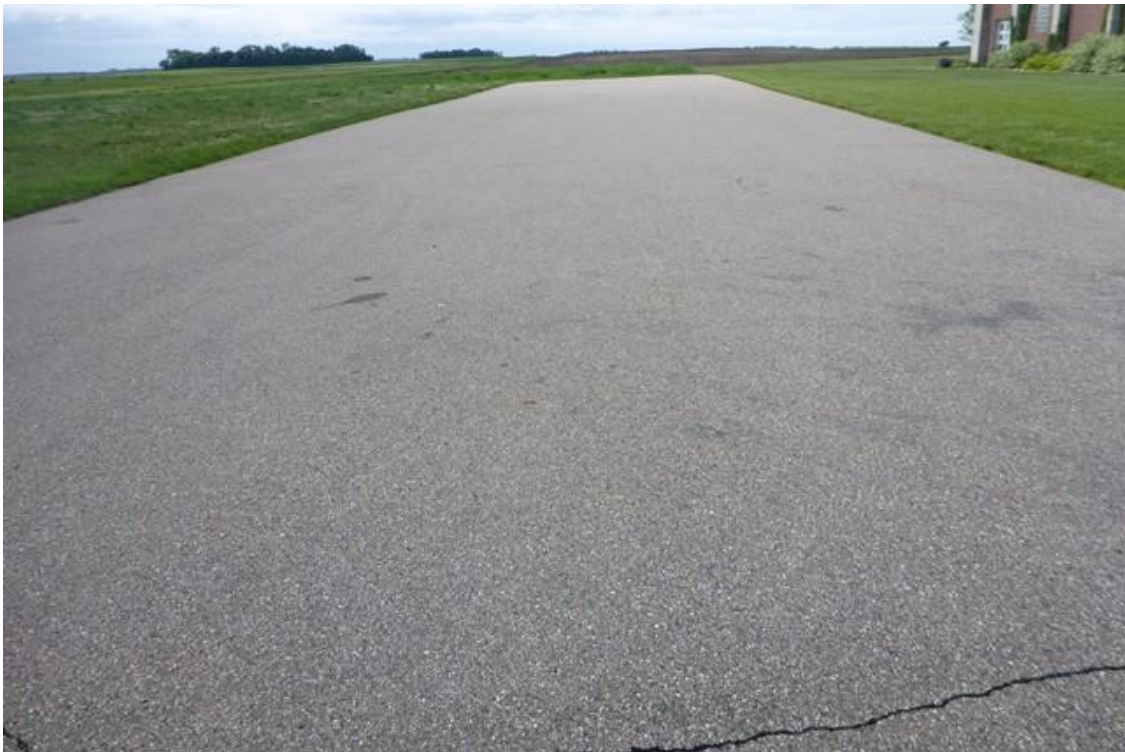
GDB TLA 002 (PCI = 82)

**Conditions:** PCI: 82

<b>TLA::002</b>	<b>Preventative: PCI Before 82 After: 91</b>	<b>627</b>
Crack Sealing - AC	514	627
<b>TLA::003</b>	<b>Preventative: PCI Before 85 After: 93</b>	<b>161</b>
Crack Sealing - AC	132	161
<b>Grand Total</b>		<b>32,378</b>

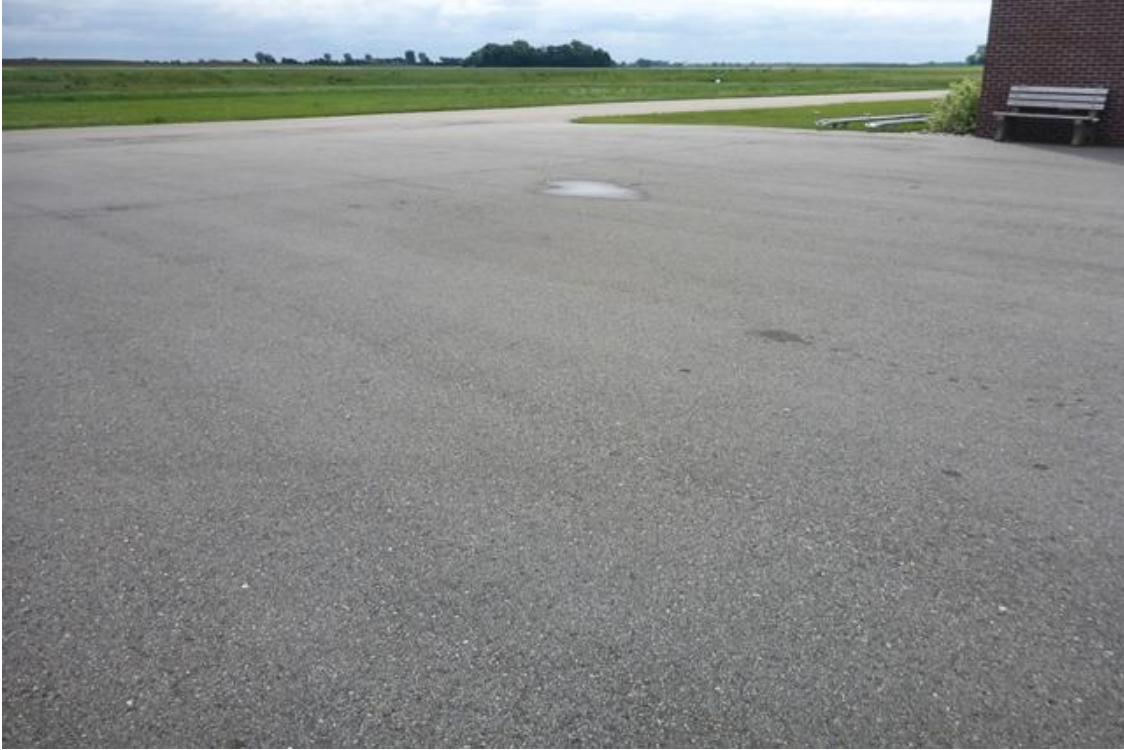
GDB TLA 003 (PCI = 85)

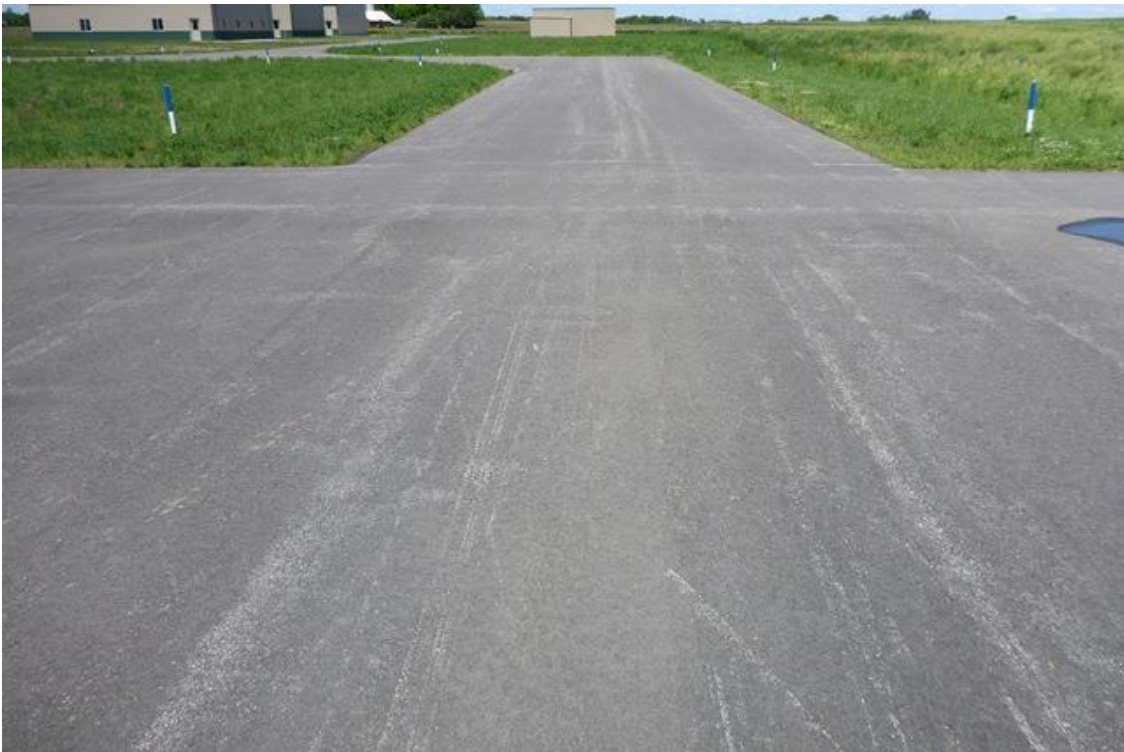
GDB TLA 004 (PCI = 100)

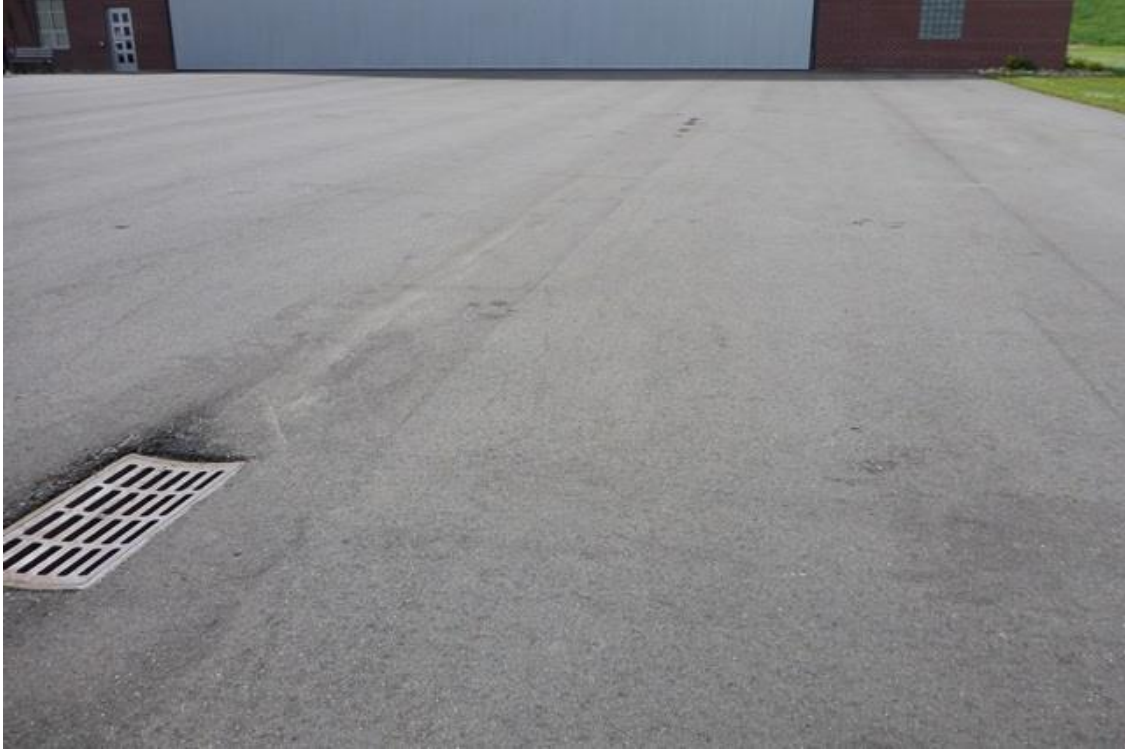
GDB TLA 005 (PCI = 96)
