Pavement Condition Report

Tracy Municipal Airport (TKC)

December 2016

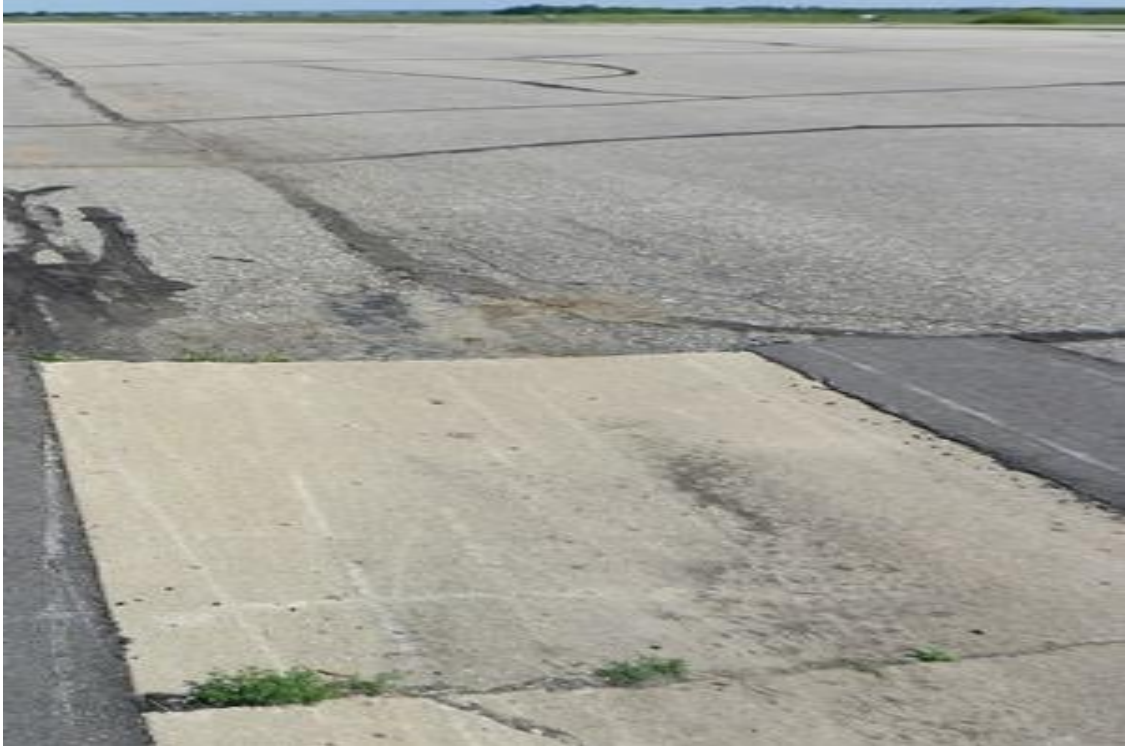
TKC APA 001 (PCI = 71)

Conditions: PCI: 71

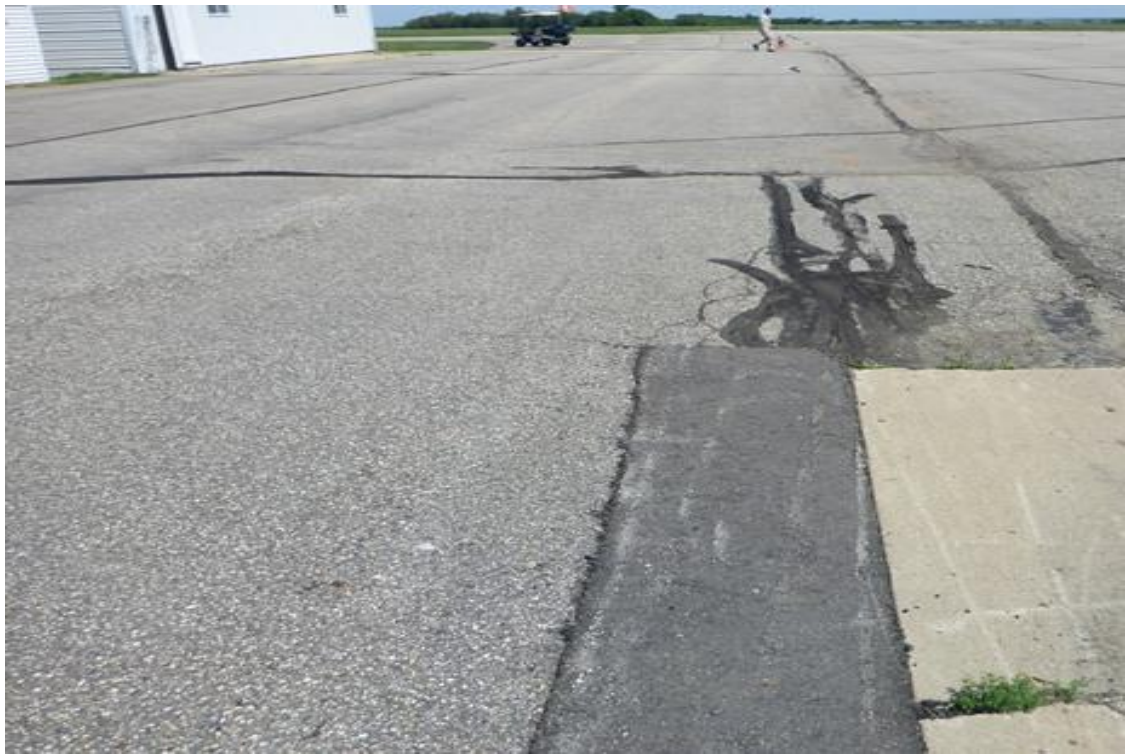
TKC APA 002 (PCI = 50)

Conditions: PCI: 50

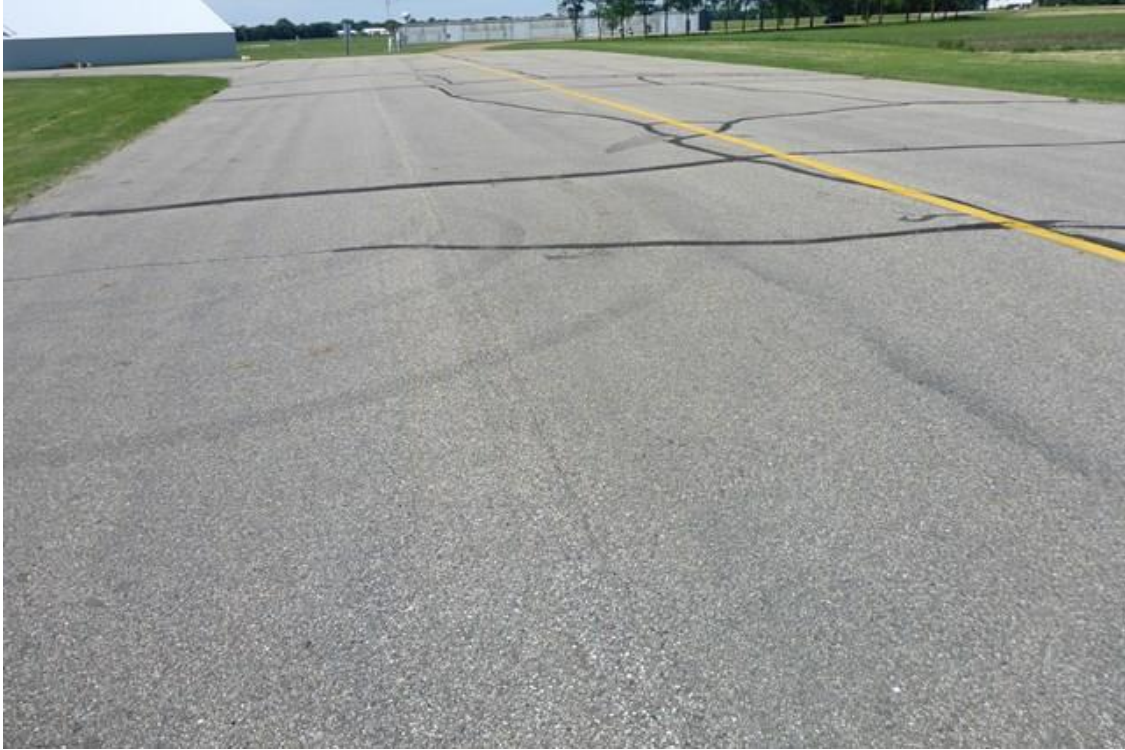
TKC CTA 001 (PCI = 70)

Conditions: PCI: 70

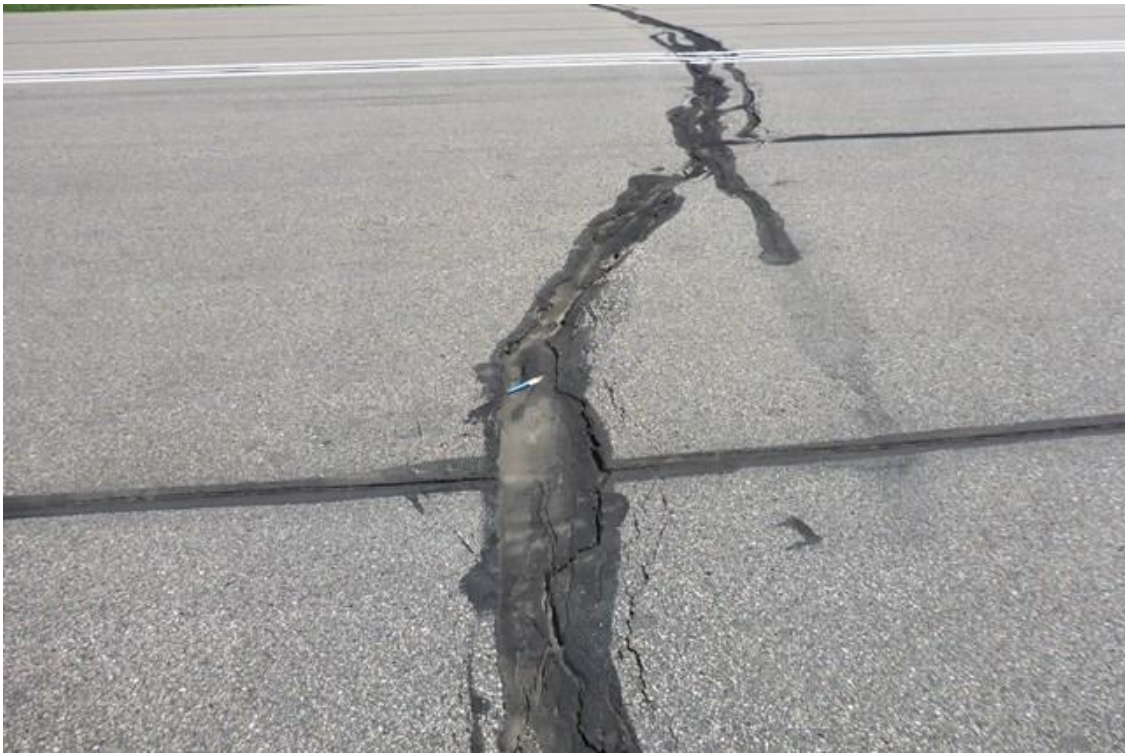
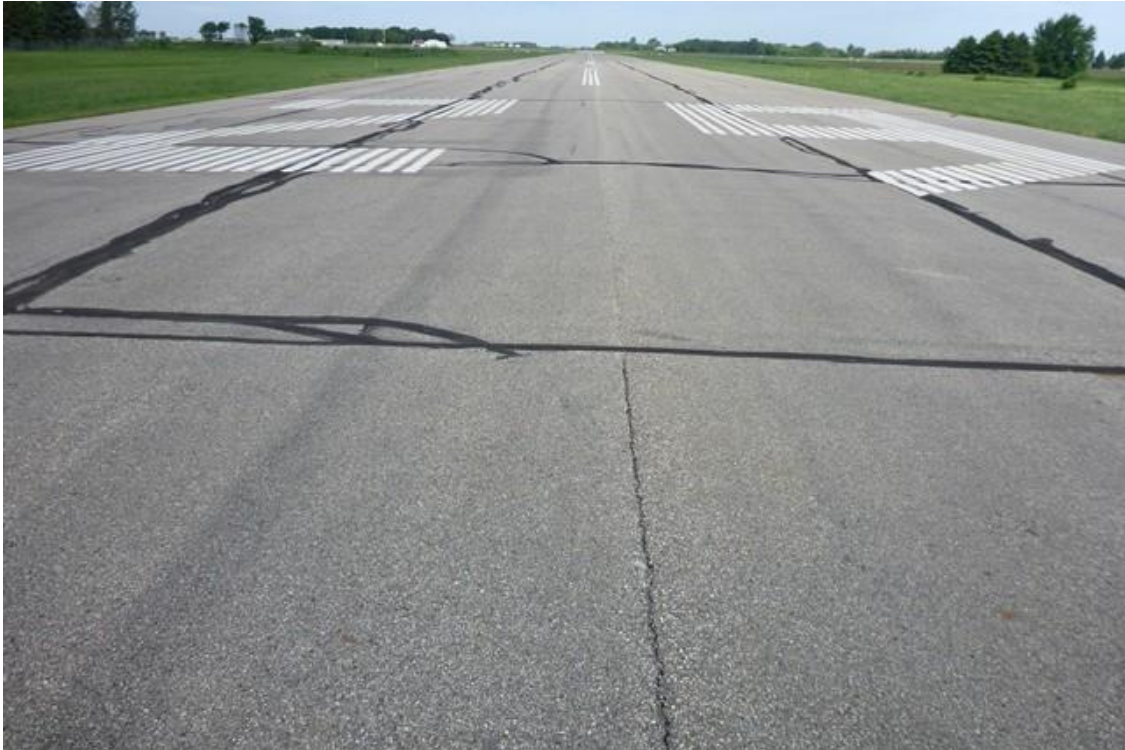
TKC RY1129 001 (PCI = 72)

Conditions: PCI: 72

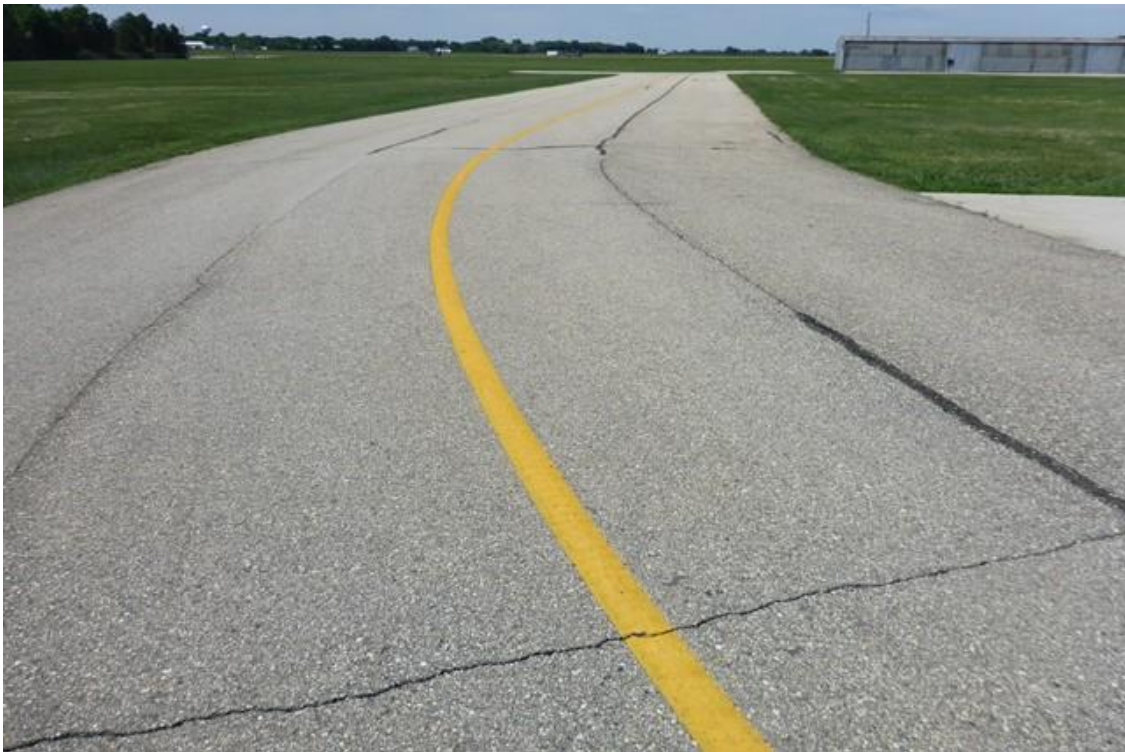
TKC TLA 001 (PCI = 74)

Conditions: PCI: 74

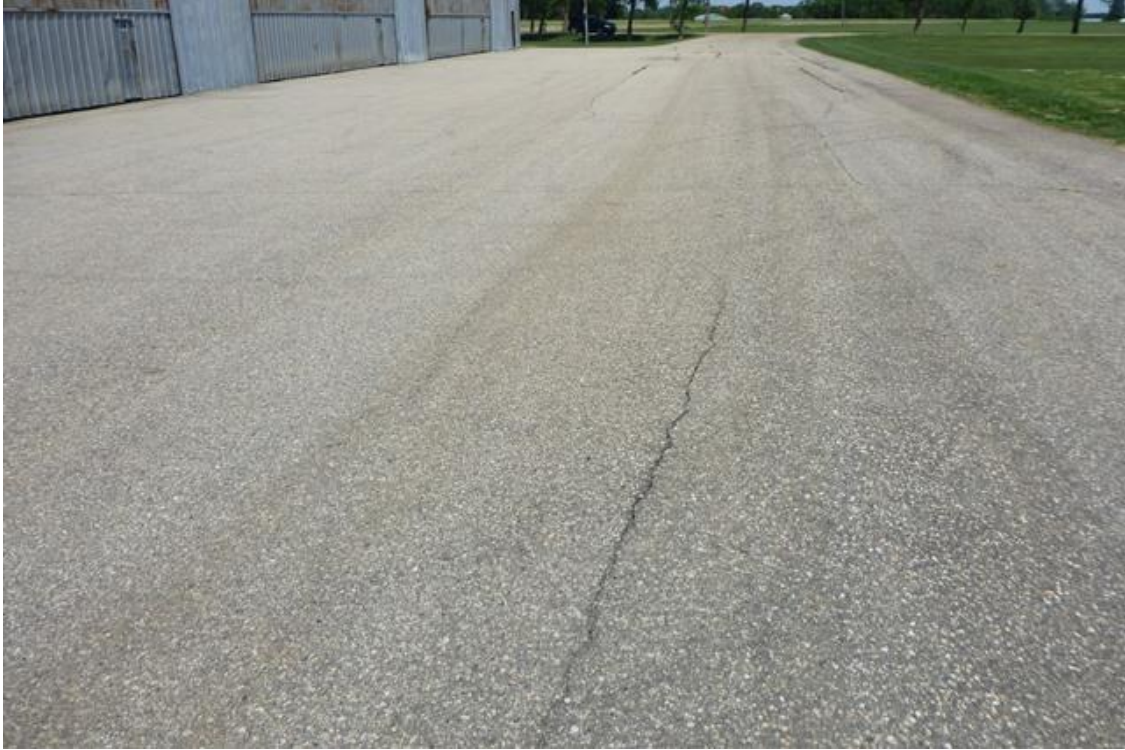
TKC TLA 002 (PCI = 62)

Section Comments: seperate section due to condition

Conditions: PCI: 62
