Pavement Condition Report

Detroit Lakes Airport-Wething Field (DTL)

December 2017

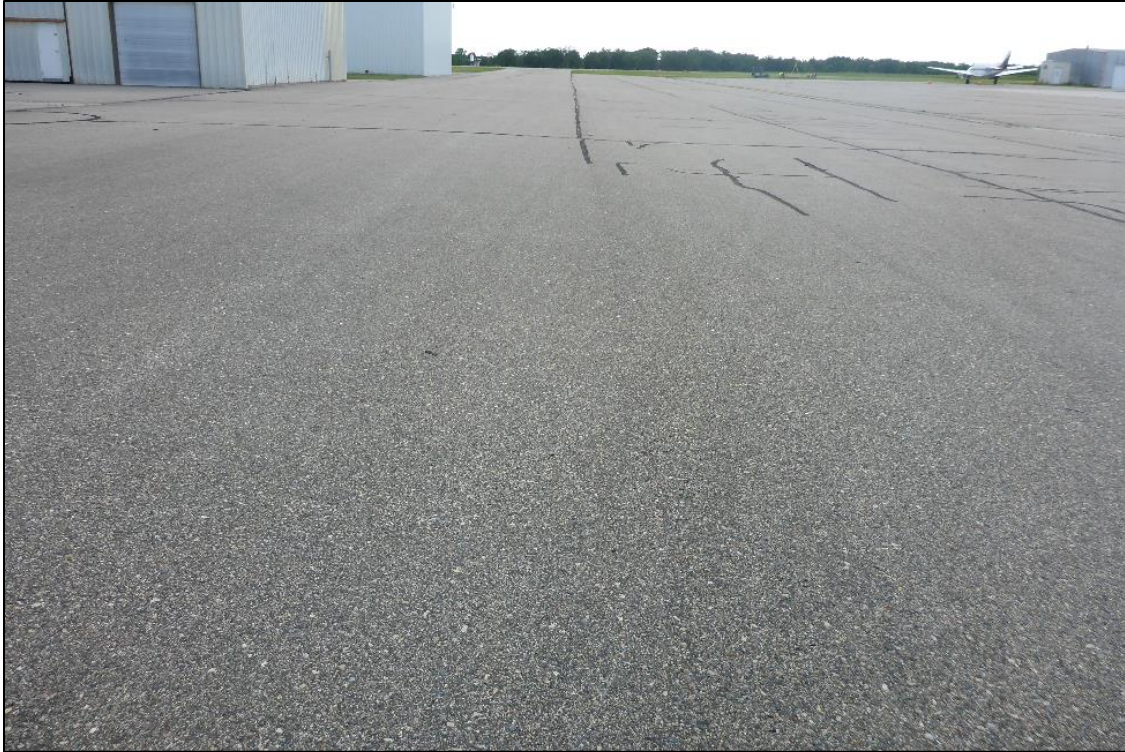
DTL APA 001 (PCI = 74)

Branch ID	Section ID	Surface type ¹	Section area (SF)	LCD ²	2014 PCI	2017 PCI	Drop in PCI/Yr ³	% Deduct due to		Distress types
								Load ⁴	Climate ⁵	
APA	001	AC	64,400	2002	73	74	1.7	-	100	L&T cr, patching, weathering
APA	002	AC	84,300	2002	66	72	1.8	-	100	L&T cr, weathering
APA	003	PCC	46,500	2002	86	85	1.0	-	70	Corner spall, joint spall, joint seal dmg
CTA	001	AC	14,550	1996	51	50	2.4	19	81	Alligator cr, block cr, L&T cr, weathering
CTA	002	AC	7,500	2002	85	75	1.6	-	100	L&T cr, weathering
CTB	001	AAC	15,200	2002	74	70	2.0	-	100	L&T cr, weathering
PPTA	001	AC	93,200	2002	80	74	1.7	-	100	L&T cr, weathering
RY1331	001	AC	168,500	2013	64	59	10.0 ⁶	-	100	Block cr, weathering
RY1331	002	AC	187,500	2013	71	60	9.8 ⁶	-	100	Block cr, L&T cr, weathering
TLA	001	AC	15,000	2002	74	74	1.7	-	100	L&T cr, weathering
TLB	001	AC	17,850	2002	81	78	1.4	-	100	L&T cr, raveling, weathering
TLB	002	PCC	6,000	2002	80	80	1.3	38	52	Linear cr, joint seal dmg, joint spall

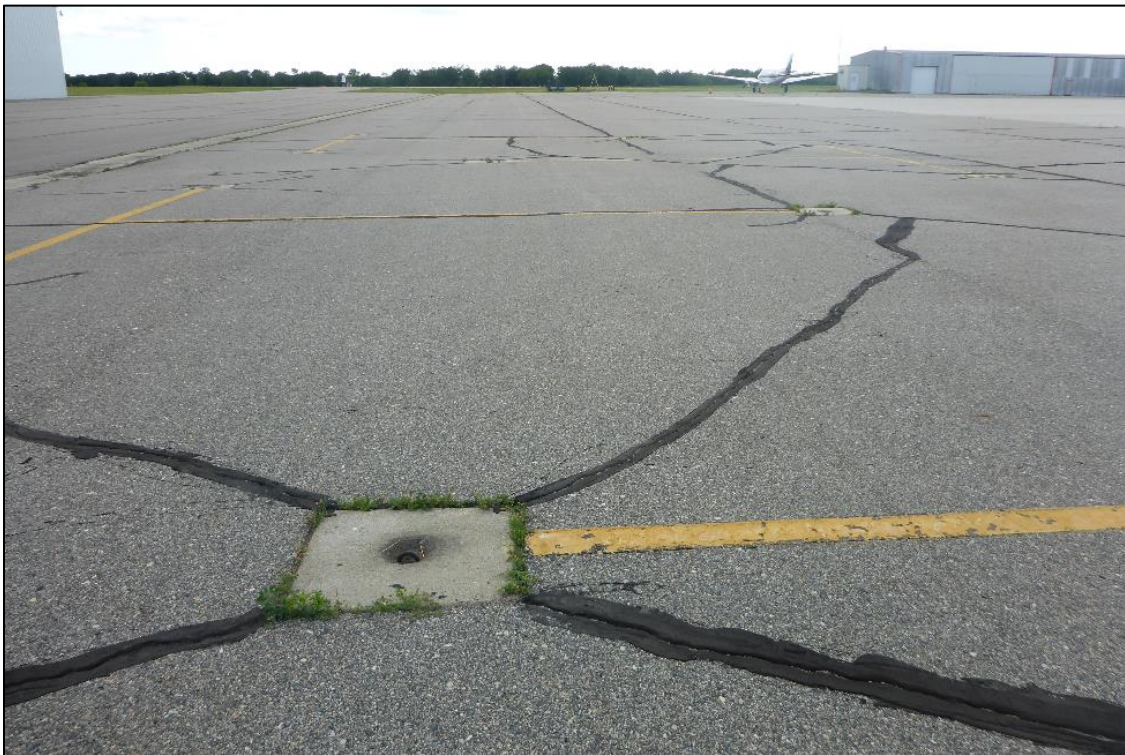
DTL APA 002 (PCI = 72)

Network:	DTL		Name:	DETROIT LAKES					
Branch:	APA	Name:	APRON A	Use:	APRON	Area:	195,200 SqFt		
Section:	002	of 3	From:	200	To:	410	Last Const.:	7/26/2002	
Surface:	AC	Family:	MN2013 Asphalt Aprons	Zone:	N	Category:	1	Rank:	S
Area:	84,300 SqFt	Length:	600 Ft	Width:	85 Ft				
Slabs:	227	Slab Length:	15 Ft	Slab Width:	15 Ft	Joint Length:	5,720 Ft		
Shoulder:		Street Type:		Grade:	0	Lanes:	0		
Section Comments:									
Last Insp. Date:	6/14/2017		TotalSamples:	20	Surveyed:	4			
Conditions:	PCI:	72							
Inspection Comments:									
Sample Number:	202	Type:	R	Area:	4250.00 SqFt	PCI:	70		
Sample Comments:									
48	L & T CR	L	353.00	Ft					
48	L & T CR	M	75.00	Ft					
57	WEATHERING	L	2000.00	SqFt					
Sample Number:	206	Type:	R	Area:	4250.00 SqFt	PCI:	74		
Sample Comments:									
48	L & T CR	L	253.00	Ft					
48	L & T CR	M	34.00	Ft					
57	WEATHERING	L	2000.00	SqFt					
Sample Number:	210	Type:	R	Area:	4250.00 SqFt	PCI:	71

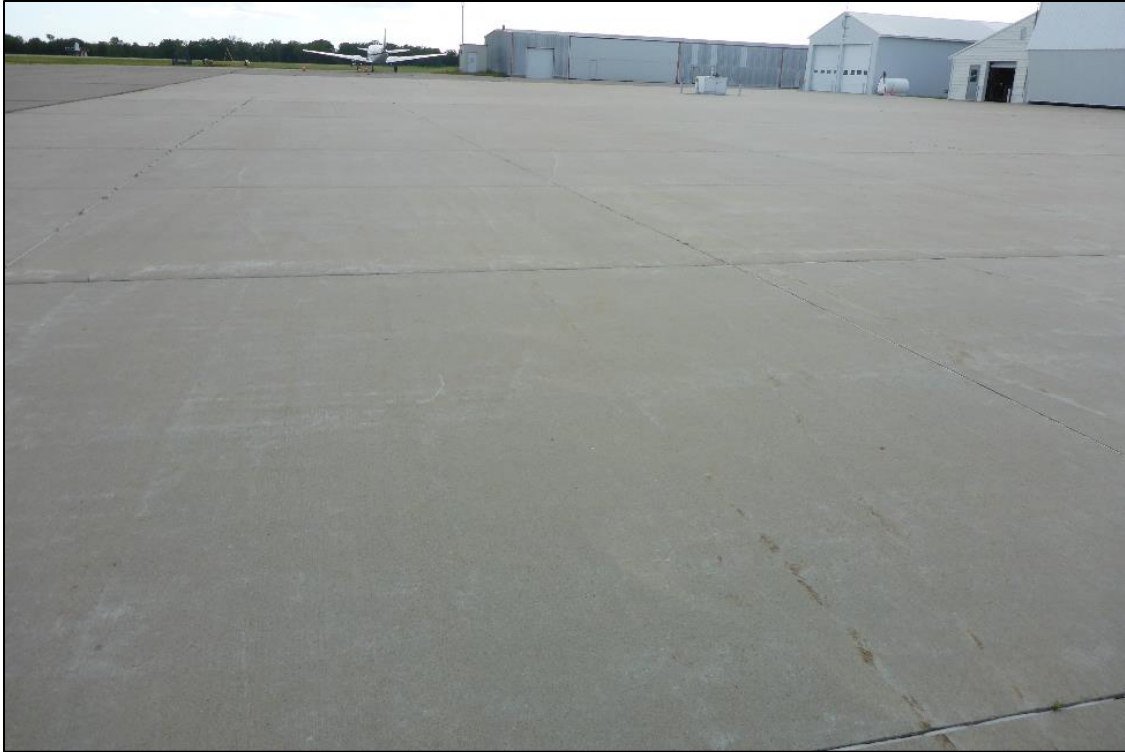
DTL APA 003 (PCI = 85)

Network:	DTL		Name:	DETROIT LAKES					
Branch:	APA	Name:	APRON A	Use:	APRON	Area:	195,200 SqFt		
Section:	003	of 3	From:	100	To:	204	Last Const.:	7/30/2002	
Surface:	PCC	Family:	MN2013 PCC	Zone:	N	Category:	1	Rank:	S
Area:	46,500 SqFt	Length:	310 Ft	Width:	150 Ft				
Slabs:	210	Slab Length:	15 Ft	Slab Width:	15 Ft	Joint Length:	5,790 Ft		
Shoulder:		Street Type:		Grade:	0	Lanes:	0		
Section Comments:									
Last Insp. Date:	6/14/2017		TotalSamples:	10	Surveyed:	5			
Conditions:	PCI:	85							
Inspection Comments:									
Sample Number:	100	Type:	R	Area:	20.00 Slabs	PCI:	85		
Sample Comments:									
74	JOINT SPALL	L	2.00	Slabs					
65	JT SEAL DMG	H	20.00	Slabs					
Sample Number:	200	Type:	R	Area:	20.00 Slabs	PCI:	86		
Sample Comments:									
74	JOINT SPALL	L	1.00	Slabs					
65	JT SEAL DMG	H	20.00	Slabs					
Sample Number:	202	Type:	R	Area:	20.00 Slabs	PCI:	80		
Sample Comments:									
74	JOINT SPALL	H	1.00	Slabs

65	JT SEAL DMG	H	20.00	Slabs					
Sample Number:	203	Type:	R	Area:	20.00 Slabs	PCI:	86		
Sample Comments:									
75	CORNER SPALL	L	1.00	Slabs					
65	JT SEAL DMG	H	20.00	Slabs					
Sample Number:	204	Type:	R	Area:	25.00 Slabs	PCI:	85		
Sample Comments:									
74	JOINT SPALL	L	2.00	Slabs					
65	JT SEAL DMG	H	25.00	Slabs

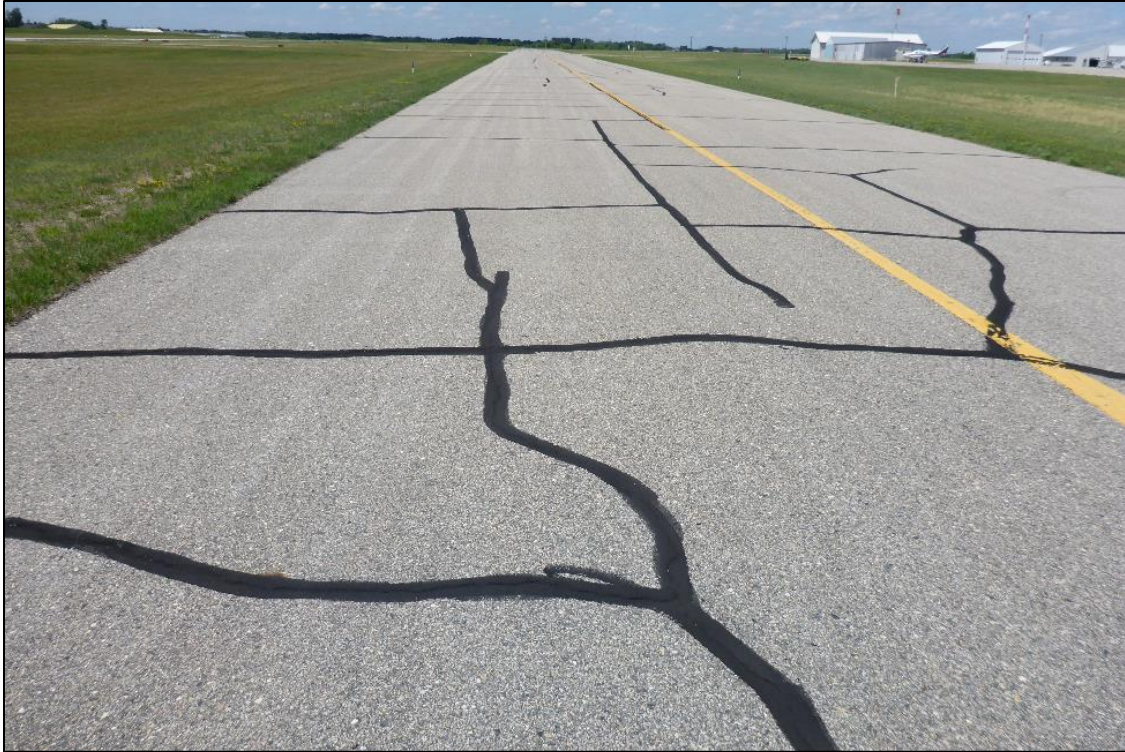
DTL PPTA 001 (PCI = 74)

Network:	DTL		Name:	DETROIT LAKES					
Branch:	PPTA	Name:	PARTIAL PARALLEL TXWY A	Use:	TAXIWAY	Area:	93,200 SqFt		
Section:	001	of 1	From:	100	To:	123+62	Last Const.:	7/27/2002	
Surface:	AC	Family:	MN2013 Asphalt Taxiways	Zone:	N	Category:	1	Rank:	P
Area:	93,200 SqFt	Length:	2,362 Ft	Width:	40 Ft				
Slabs:		Slab Length:	Ft	Slab Width:	Ft	Joint Length:	Ft		
Shoulder:		Street Type:		Grade:	0	Lanes:	0		
Section Comments:									
Last Insp. Date:	6/14/2017		TotalSamples:	23	Surveyed:	6			
Conditions:	PCI:	74							
Inspection Comments:									
Sample Number:	102	Type:	R	Area:	4000.00 SqFt	PCI:	75		
Sample Comments:									
48	L & T CR	L	215.00	Ft					
48	L & T CR	M	29.00	Ft					
57	WEATHERING	L	2000.00	SqFt					
Sample Number:	106	Type:	R	Area:	4000.00 SqFt	PCI:	73		
Sample Comments:									
48	L & T CR	L	358.00	Ft					
57	WEATHERING	L	2000.00	SqFt					
Sample Number:	110	Type:	R	Area:	4000.00 SqFt	PCI:	77

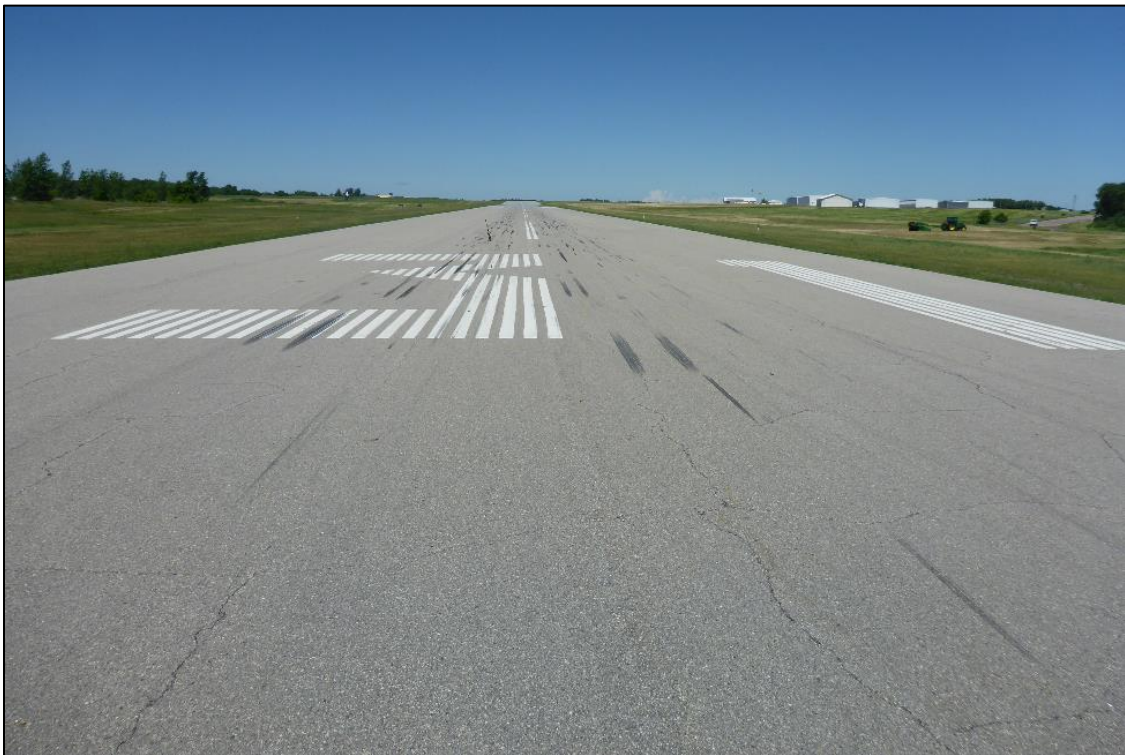
DTL RY1331 001 (PCI = 59)

⁶Overlay applied in 2013. L&T cracking and block cracking (recorded in 2014) had migrated to the surface and are apparent in current photography

Network:	DTL		Name:	DETROIT LAKES					
Branch:	RY1331	Name:	RUNWAY 13-31	Use:	RUNWAY	Area:	356,000 SqFt		
Section:	001	of 2	From:	100	To:	139	Last Const.:	9/30/2013	
Surface:	AC	Family:	MN2013 Asphalt Runways	Zone:	N	Category:	1	Rank:	P
Area:	168,500 SqFt	Length:	2,000 Ft	Width:	75 Ft				
Slabs:		Slab Length:	Ft	Slab Width:	Ft	Joint Length:	Ft		
Shoulder:		Street Type:		Grade:	0	Lanes:	0		
Section Comments:									
Last Insp. Date:	6/14/2017	TotalSamples:	44	Surveyed:	4				
Conditions:	PCI: 59								
Inspection Comments:									
Sample Number:	105	Type:	R	Area:	3750.00 SqFt	PCI:	59		
Sample Comments:									
43	BLOCK CR	L	3750.00	SqFt					
57	WEATHERING	L	3750.00	SqFt					
Sample Number:	115	Type:	R	Area:	3750.00 SqFt	PCI:	59		
Sample Comments:									
43	BLOCK CR	L	3750.00	SqFt					
57	WEATHERING	L	3750.00	SqFt					
Sample Number:	125	Type:	R	Area:	3750.00 SqFt	PCI:	59		
Sample Comments:									
43	BLOCK CR	L	3750.00	SqFt

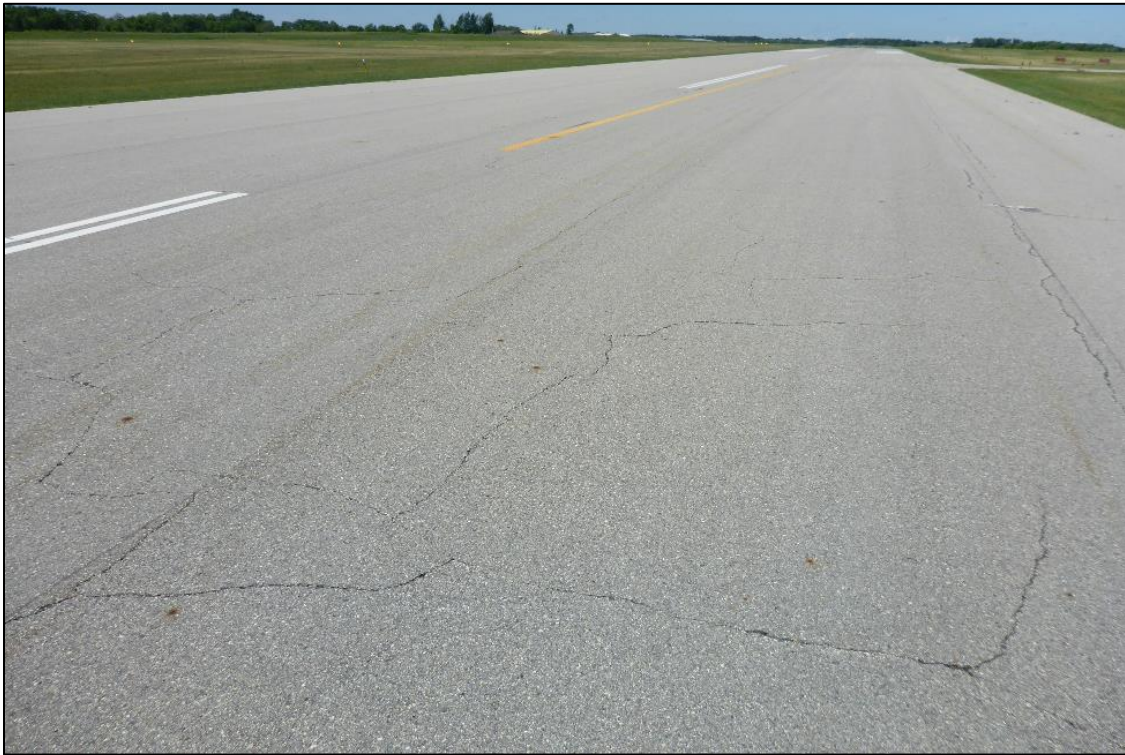
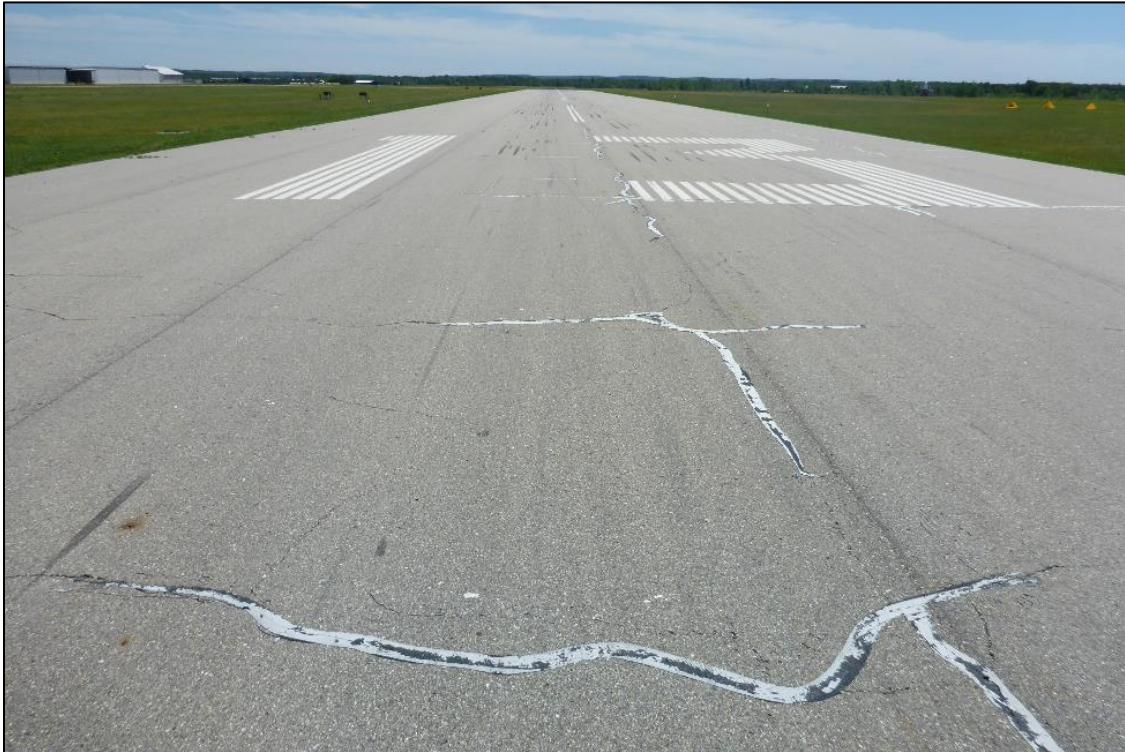
DTL RY1331 002 (PCI = 60)

Network:	DTL		Name:	DETROIT LAKES					
Branch:	RY1331	Name:	RUNWAY 13-31	Use:	RUNWAY	Area:	356,000 SqFt		
Section:	002	of 2	From:	140	To:	189	Last Const.:	9/30/2013	
Surface:	AC	Family:	MN2013 Asphalt Runways	Zone:	N	Category:	1	Rank:	P
Area:	187,500 SqFt	Length:	2,500 Ft	Width:	75 Ft				
Slabs:	Slab Length:	Ft	Slab Width:	Ft	Joint Length:	Ft			
Shoulder:	Street Type:		Grade:	0	Lanes:	0			
Section Comments:									
Last Insp. Date:	6/14/2017	TotalSamples:	50	Surveyed:	5				
Conditions:	PCI: 60								
Inspection Comments:									
Sample Number:	144	Type:	R	Area:	3750.00 SqFt	PCI:	64		
Sample Comments:									
48	L & T CR	L	636.00 Ft						
57	WEATHERING	L	3750.00 SqFt						
Sample Number:	154	Type:	R	Area:	3750.00 SqFt	PCI:	58		
Sample Comments:									
48	L & T CR	L	703.00 Ft						
48	L & T CR	M	24.00 Ft						
57	WEATHERING	L	3750.00 SqFt						
Sample Number:	164	Type:	R	Area:	3750.00 SqFt	PCI:	57		
Sample Comments:

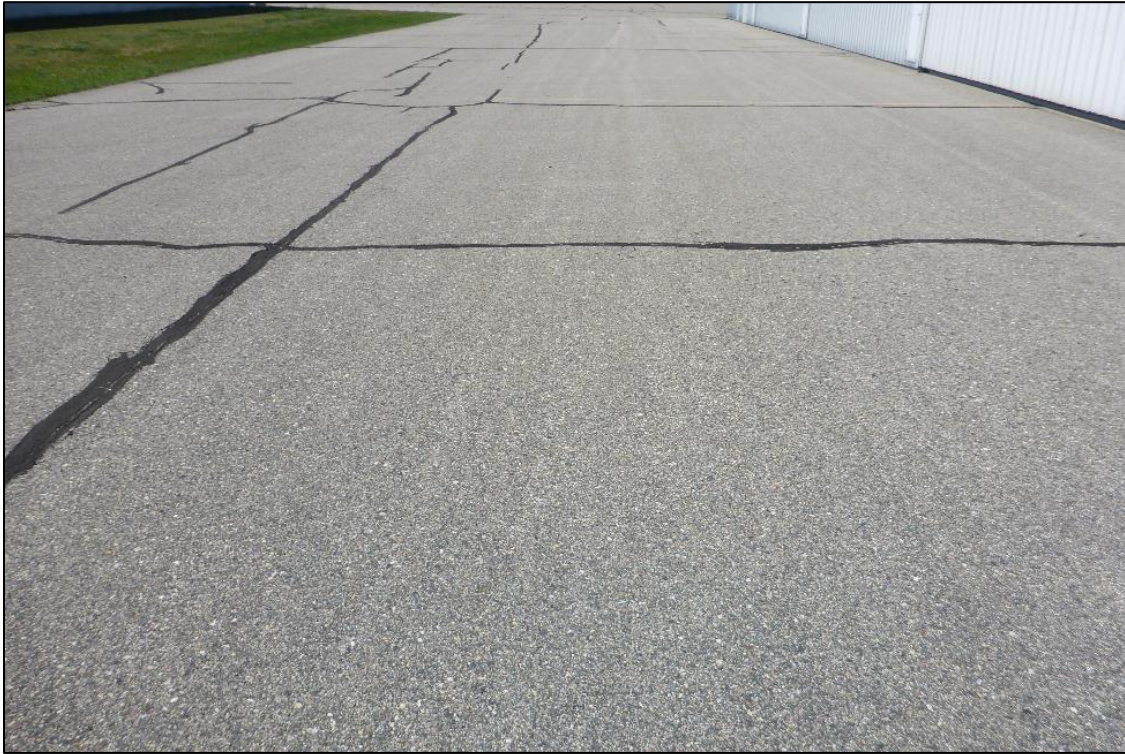
DTL TLA 001 (PCI = 74)

Network:	DTL		Name:	DETROIT LAKES					
Branch:	TLA	Name:	TAXILANE A	Use:	TAXILANE	Area:	15,000 SqFt		
Section:	001	of 1	From:	100	To:	102	Last Const.:	7/26/2002	
Surface:	AC	Family:	MN2013 Asphalt Taxilanes	Zone:	N	Category:	1	Rank:	T
Area:	15,000 SqFt	Length:	300 Ft	Width:	50 Ft	Joint Length:	Ft		
Slabs:		Slab Length:	Ft	Slab Width:	Ft	Joint Length:	Ft		
Shoulder:		Street Type:		Grade:	0	Lanes:	0		
Section Comments:									
Last Insp. Date:	6/14/2017		TotalSamples:	3	Surveyed:	2			
Conditions:	PCI:	74							
Inspection Comments:									
Sample Number:	100	Type:	R	Area:	5000.00 SqFt	PCI:	77		
Sample Comments:									
48	L & T CR	L	345.00	Ft					
57	WEATHERING	L	2500.00	SqFt					
Sample Number:	101	Type:	R	Area:	5000.00 SqFt	PCI:	70		
Sample Comments:									
48	L & T CR	L	382.00	Ft					
48	L & T CR	M	31.00	Ft					
57	WEATHERING	L	2500.00	SqFt

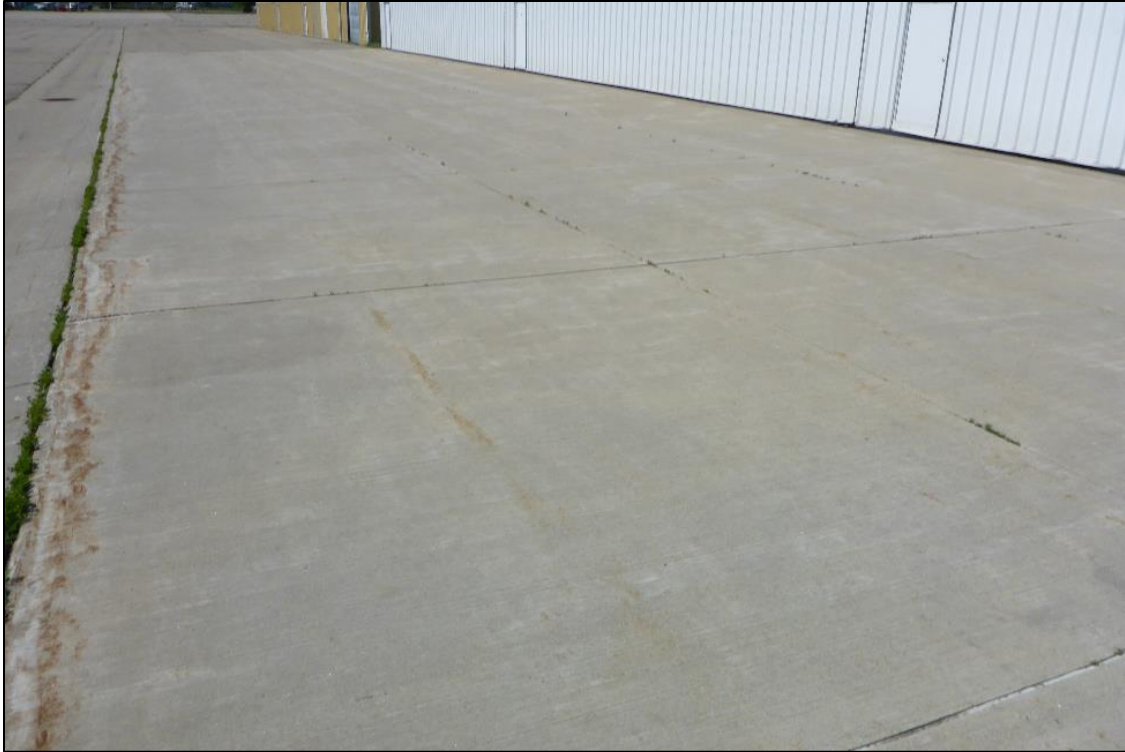
DTL TLB 002 (PCI = 80)

Network:	DTL		Name:	DETROIT LAKES					
Branch:	TLB	Name:	TAXILANE B	Use:	TAXILANE	Area:	23,850 SqFt		
Section:	002	of 2	From:	201	To:	201	Last Const.:	7/27/2002	
Surface:	PCC	Family:	MN2013 PCC	Zone:	N	Category:	1	Rank:	T
Area:	6,000 SqFt	Length:	166 Ft	Width:	36 Ft				
Slabs:	36	Slab Length:	14 Ft	Slab Width:	12 Ft	Joint Length:	716 Ft		
Shoulder:		Street Type:		Grade:	0	Lanes:	0		
Section Comments:									
Last Insp. Date:	6/14/2017		TotalSamples:	2	Surveyed:	2			
Conditions:	PCI:	80							
Inspection Comments:									
Sample Number:	203	Type:	R	Area:	18.00 Slabs	PCI:	84		
Sample Comments:									
74	JOINT SPALL	M	1.00	Slabs					
65	JT SEAL DMG	H	18.00	Slabs					
Sample Number:	204	Type:	R	Area:	18.00 Slabs	PCI:	77		
Sample Comments:									
63	LINEAR CR	H	1.00	Slabs					
65	JT SEAL DMG	H	18.00	Slabs
