Pavement Condition Report

Elbow Lake Municipal - Pride of the Prairie Airport (Y63)

December 2017

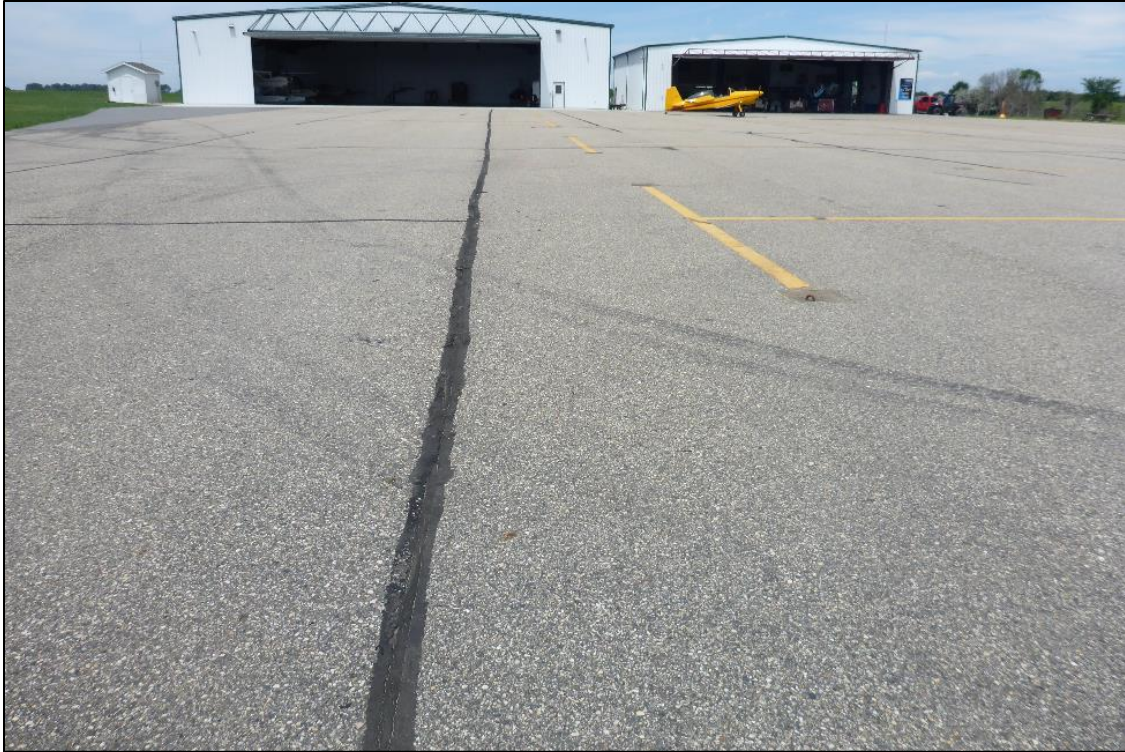
Y63 APA 001 (PCI = 79)

Conditions: PCI: 79

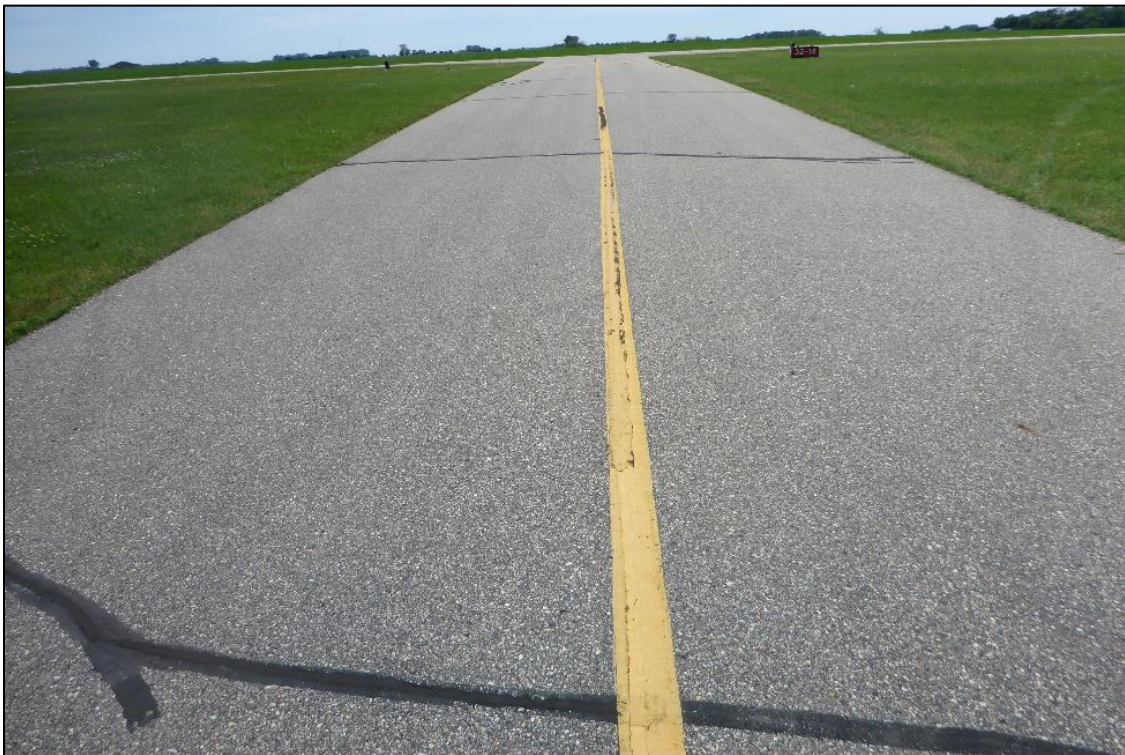
Y63 CTA 001 (PCI = 72)

Conditions: PCI: 72

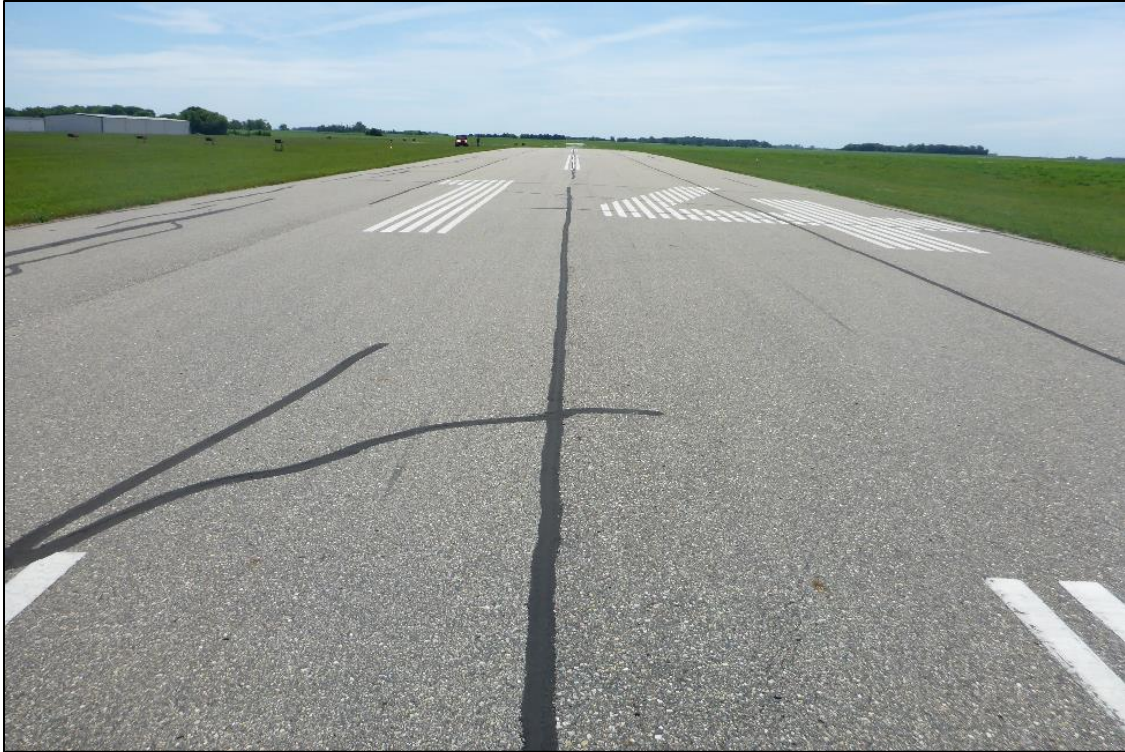
Y63 RY1432 (PCI = 68)

Network:	Y63	Name:	ELBOW LAKE				
Branch:	RY1432	Name:	Runway 14-32	Use:	RUNWAY	Area:	210,100 SqFt
Section:	001	of 1	From:	100	To:	167	Last Const.: 9/25/2006
Surface:	AC	Family:	MN2013 Asphalt Runways	Zone:	W	Category:	1
Area:	210,100 SqFt	Length:	3,400 Ft	Width:	60 Ft	Rank:	P
Slabs:	Slab Length:	Ft	Slab Width:	Ft	Joint Length:	Ft	
Shoulder:	Street Type:		Grade:	0	Lanes:	0	
Section Comments:							
Last Insp. Date:	6/16/2017	TotalSamples:	68	Surveyed:	8		
Conditions:	PCI: 68	Inspection Comments:					
Sample Number:	104	Type:	R	Area:	3000.00 SqFt	PCI:	67
Sample Comments:							
48	L & T CR	M	40.00	Ft			
57	WEATHERING	L	500.00	SqFt			
48	L & T CR	L	350.00	Ft			
Sample Number:	114	Type:	R	Area:	3000.00 SqFt	PCI:	73
Sample Comments:							
48	L & T CR	L	225.00	Ft			
48	L & T CR	M	16.00	Ft			
57	WEATHERING	L	500.00	SqFt			
Sample Number:	124	Type:	R	Area:	3000.00 SqFt	PCI:	72
Sample Comments: crack seal since 2014

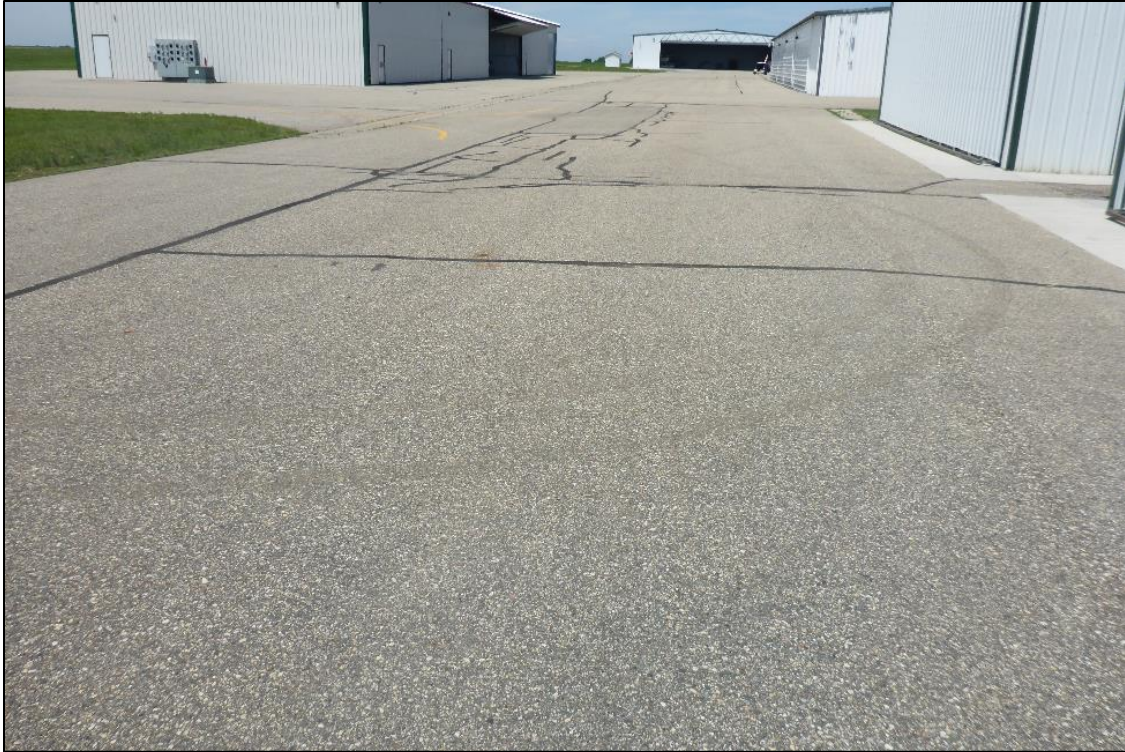
Y63 TLA 001 (PCI = 71)

Conditions: PCI: 71

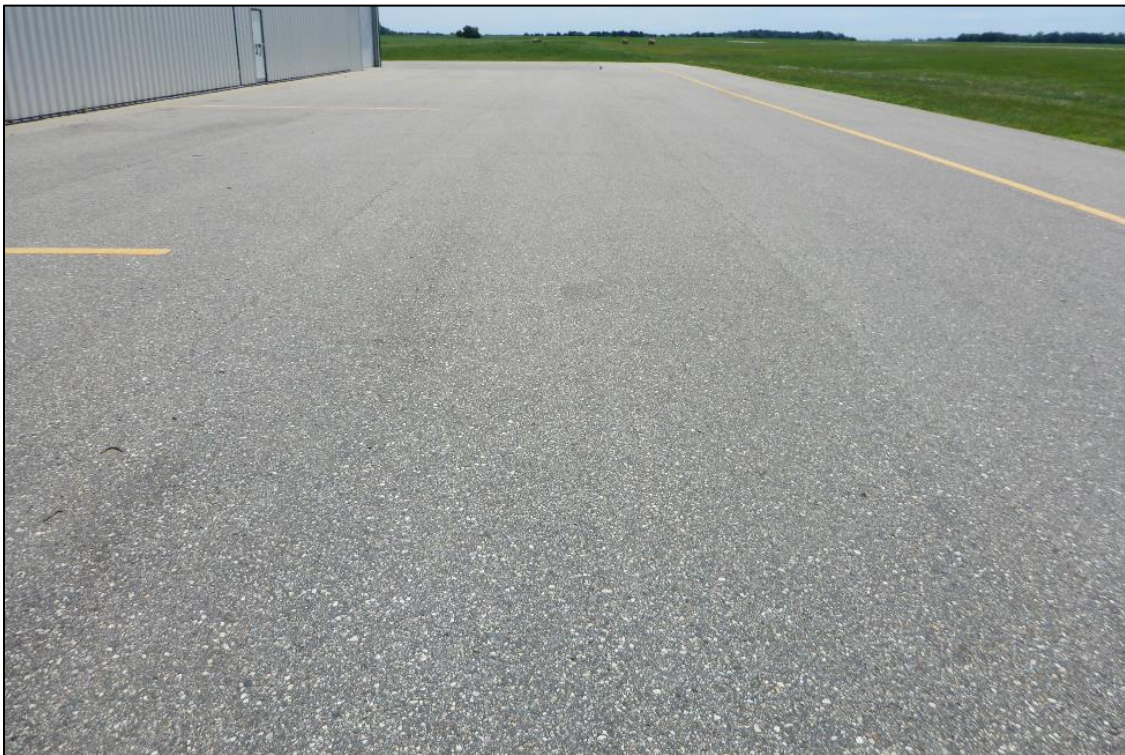
Y63 TLB 001 (PCI = 93)

Network:	Y63	Name:	ELBOW LAKE				
Branch:	TLB	Name:	Taxilane B	Use:	TAXILANE	Area:	30,700 SqFt
Section:	001	of 1	From:	100	To:	105	Last Const.: 6/1/2010
Surface:	AC	Family:	MN2013 Asphalt Taxilanes	Zone:		Category:	Rank: T
Area:	30,700 SqFt	Length:	330 Ft	Width:	135 Ft		
Slabs:		Slab Length:	Ft	Slab Width:	Ft	Joint Length:	Ft
Shoulder:		Street Type:		Grade:	0	Lanes:	0
Section Comments:							
Last Insp. Date:	6/16/2017	TotalSamples:	6	Surveyed:	3		
Conditions:	PCI: 93						
Inspection Comments:							
Sample Number:	101	Type:	R	Area:	5000.00 SqFt	PCI:	97
Sample Comments:							
57	WEATHERING	L		1000.00	SqFt		
Sample Number:	102	Type:	R	Area:	6500.00 SqFt	PCI:	92
Sample Comments:							
48	L & T CR	L		82.00	Ft		
57	WEATHERING	L		1000.00	SqFt		
Sample Number:	104	Type:	R	Area:	2500.00 SqFt	PCI:	88
Sample Comments:							
48	L & T CR	L		24.00	Ft		
48	L & T CR	M		3.00	Ft		
57	WEATHERING	L		500.00	SqFt
