Pavement Condition Report

Bagley Municipal Airport (7Y4)

December 2019

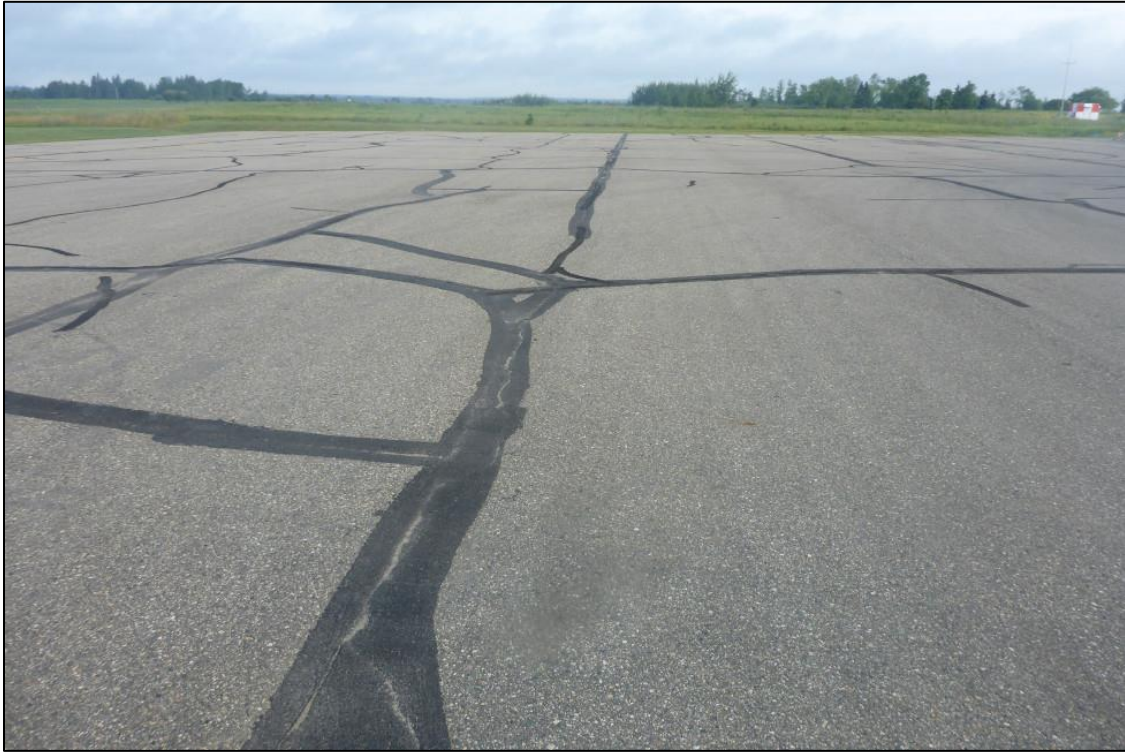
7Y4 APA 001 (PCI = 59)

Conditions: PCI: 59

Inspection Comments: c.s. since last insp. in good condition

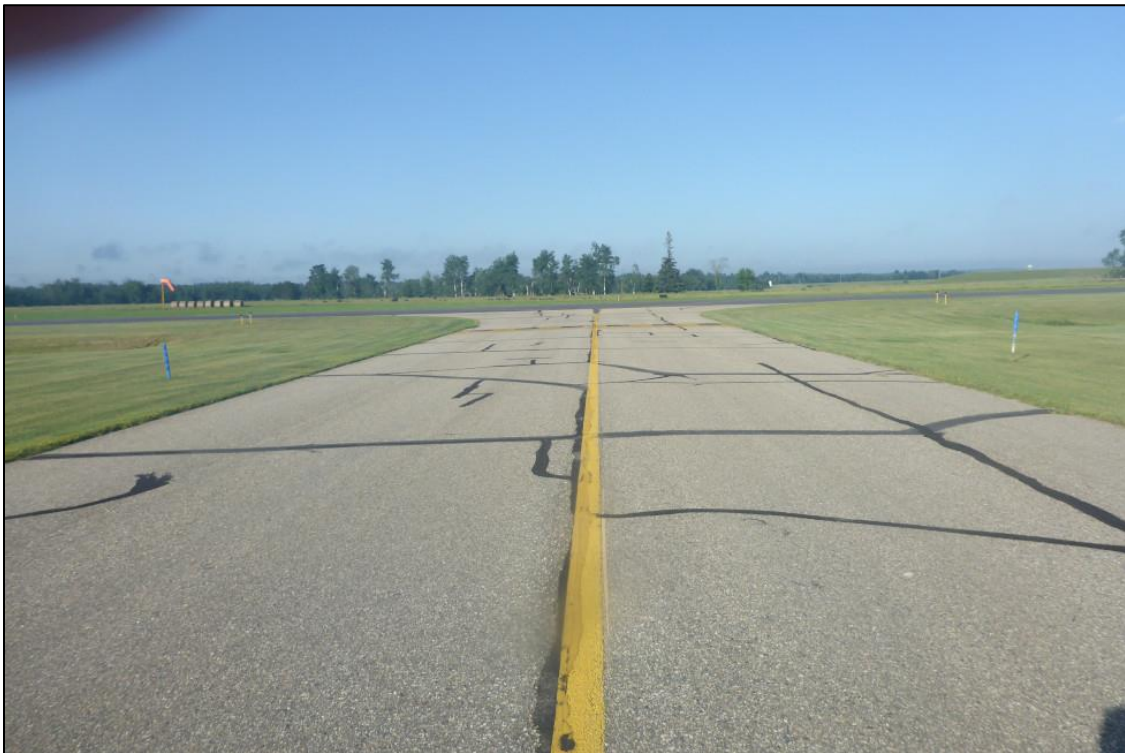
7Y4 CTA 001 (PCI = 64)

Network:	7Y4	Name:	BAGLEY						
Branch:	CTA	Name:	CONNECTING TAXIWAY A	Use:	TAXIWAY	Area:	9,538 SqFt		
Section:	001	of 1	From:	100	To:	102	Last Const.:	10/28/2004	
Surface:	AC	Family:	MN2018 Asphalt Runway- Taxiways	Zone:	N	Category:	3	Rank:	P
Area:	9,538 SqFt	Length:	253 Ft	Width:	35 Ft				
Slabs:		Slab Length:	Ft	Slab Width:	Ft	Joint Length:	Ft		
Shoulder:		Street Type:		Grade:	0	Lanes:	0		
Section Comments:									
Last Insp. Date:	7/16/2019	TotalSamples:	3	Surveyed:	1				
Conditions:	PCI: 64								
Inspection Comments:	c.s. since last insp. in good condition								
Sample Number:	101	Type:	R	Area:	3500.00 SqFt	PCI:	64		
Sample Comments: p231									
48	L & T CR	L	506.00	Ft					
48	L & T CR	M	14.00	Ft					
57	WEATHERING	L	500.00	SqFt

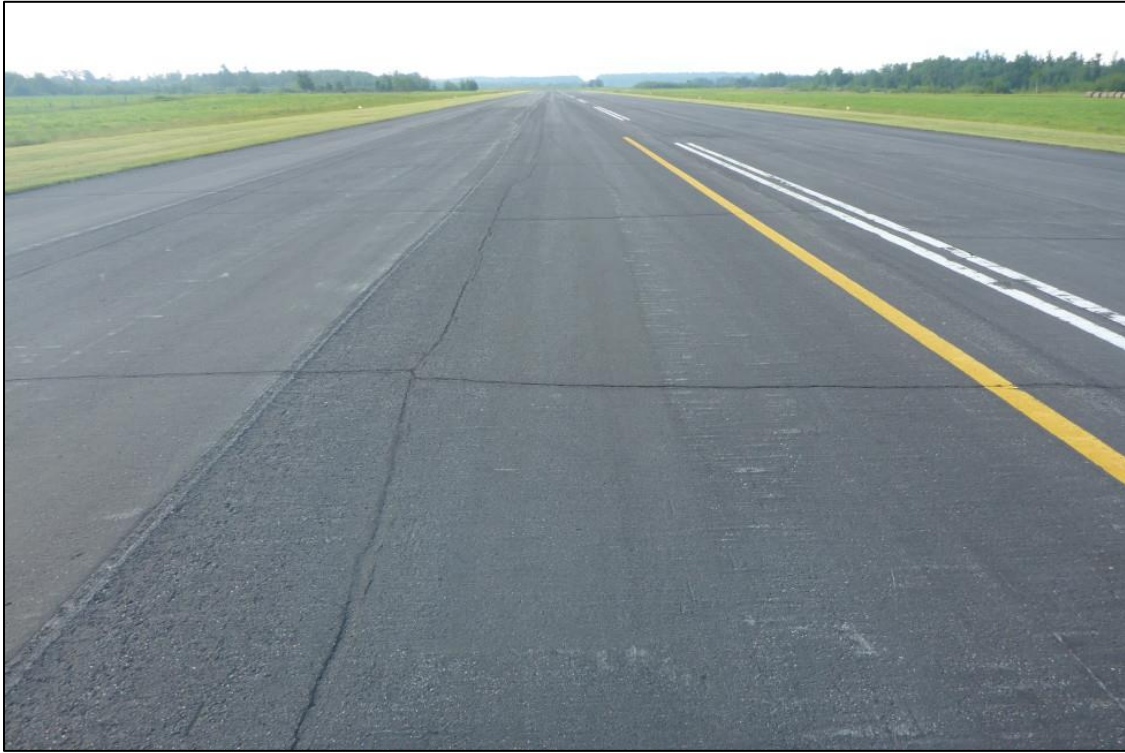
7Y4 RY1432 001 (PCI = 73)

Network:	7Y4	Name:	BAGLEY						
Branch:	RY1432	Name:	RUNWAY 14-32	Use:	RUNWAY	Area:	301,000 SqFt		
Section:	001	of 1	From:	100	To:	175	Last Const.: 10/28/2004		
Surface:	AC	Family:	MN2018 Asphalt Runway- Taxiways	Zone:	N	Category:	3	Rank:	P
Area:	301,000 SqFt	Length:	3,800 Ft	Width:	75 Ft				
Slabs:		Slab Length:	Ft	Slab Width:	Ft	Joint Length:	Ft		
Shoulder:		Street Type:		Grade:	0	Lanes:	0		
Section Comments:									
Last Insp. Date:	7/16/2019	TotalSamples:	80	Surveyed:	8				
Conditions:	PCI: 73								
Inspection Comments:									
Sample Number:	103	Type:	R	Area:	3750.00 SqFt	PCI:	70		
Sample Comments:	pic 720 new ms								
48	L & T CR	L	598.00	Ft					
Sample Number:	113	Type:	R	Area:	3750.00 SqFt	PCI:	74		
Sample Comments:									
48	L & T CR	L	448.00	Ft					
Sample Number:	123	Type:	R	Area:	3750.00 SqFt	PCI:	72		
Sample Comments:									
48	L & T CR	L	519.00	Ft					
Sample Number:	133	Type:	R	Area:	3750.00 SqFt	PCI:	74

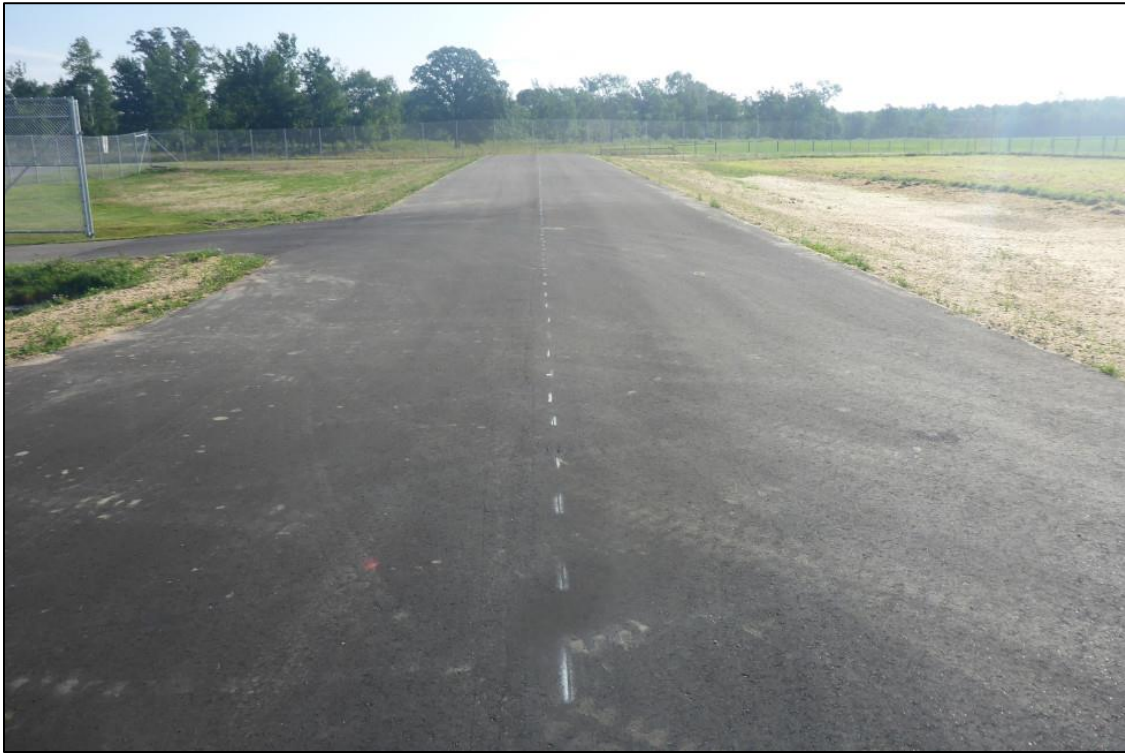
7Y4 TLA 001 (PCI = 100)

Network:	7Y4	Name:	BAGLEY					
Branch:	TLA	Name:	TAXILANE A	Use:	TAXILANE	Area:	6,750 SqFt	
Section:	001	of 1	From:	100	To:	102	Last Const.:	5/15/2019
Surface:	AC	Family:	DEFAULT	Zone:		Category:	Rank:	P
Area:	6,750 SqFt	Length:	270 Ft	Width:	25 Ft			
Slabs:		Slab Length:	Ft	Slab Width:	Ft	Joint Length:	Ft	
Shoulder:		Street Type:		Grade:	0	Lanes:	0	
Section Comments:								
Last Insp. Date:	7/16/2019	TotalSamples:	3	Surveyed:	1			
Conditions:	PCI: 100							
Inspection Comments:								
Sample Number:	101	Type:	R	Area:	2500.00 SqFt	PCI:	100	
Sample Comments:	p232 nd pci 100 new AC							
<No Distress>
