Pavement Condition Report

Albert Lea Municipal Airport (AEL)

December 2019

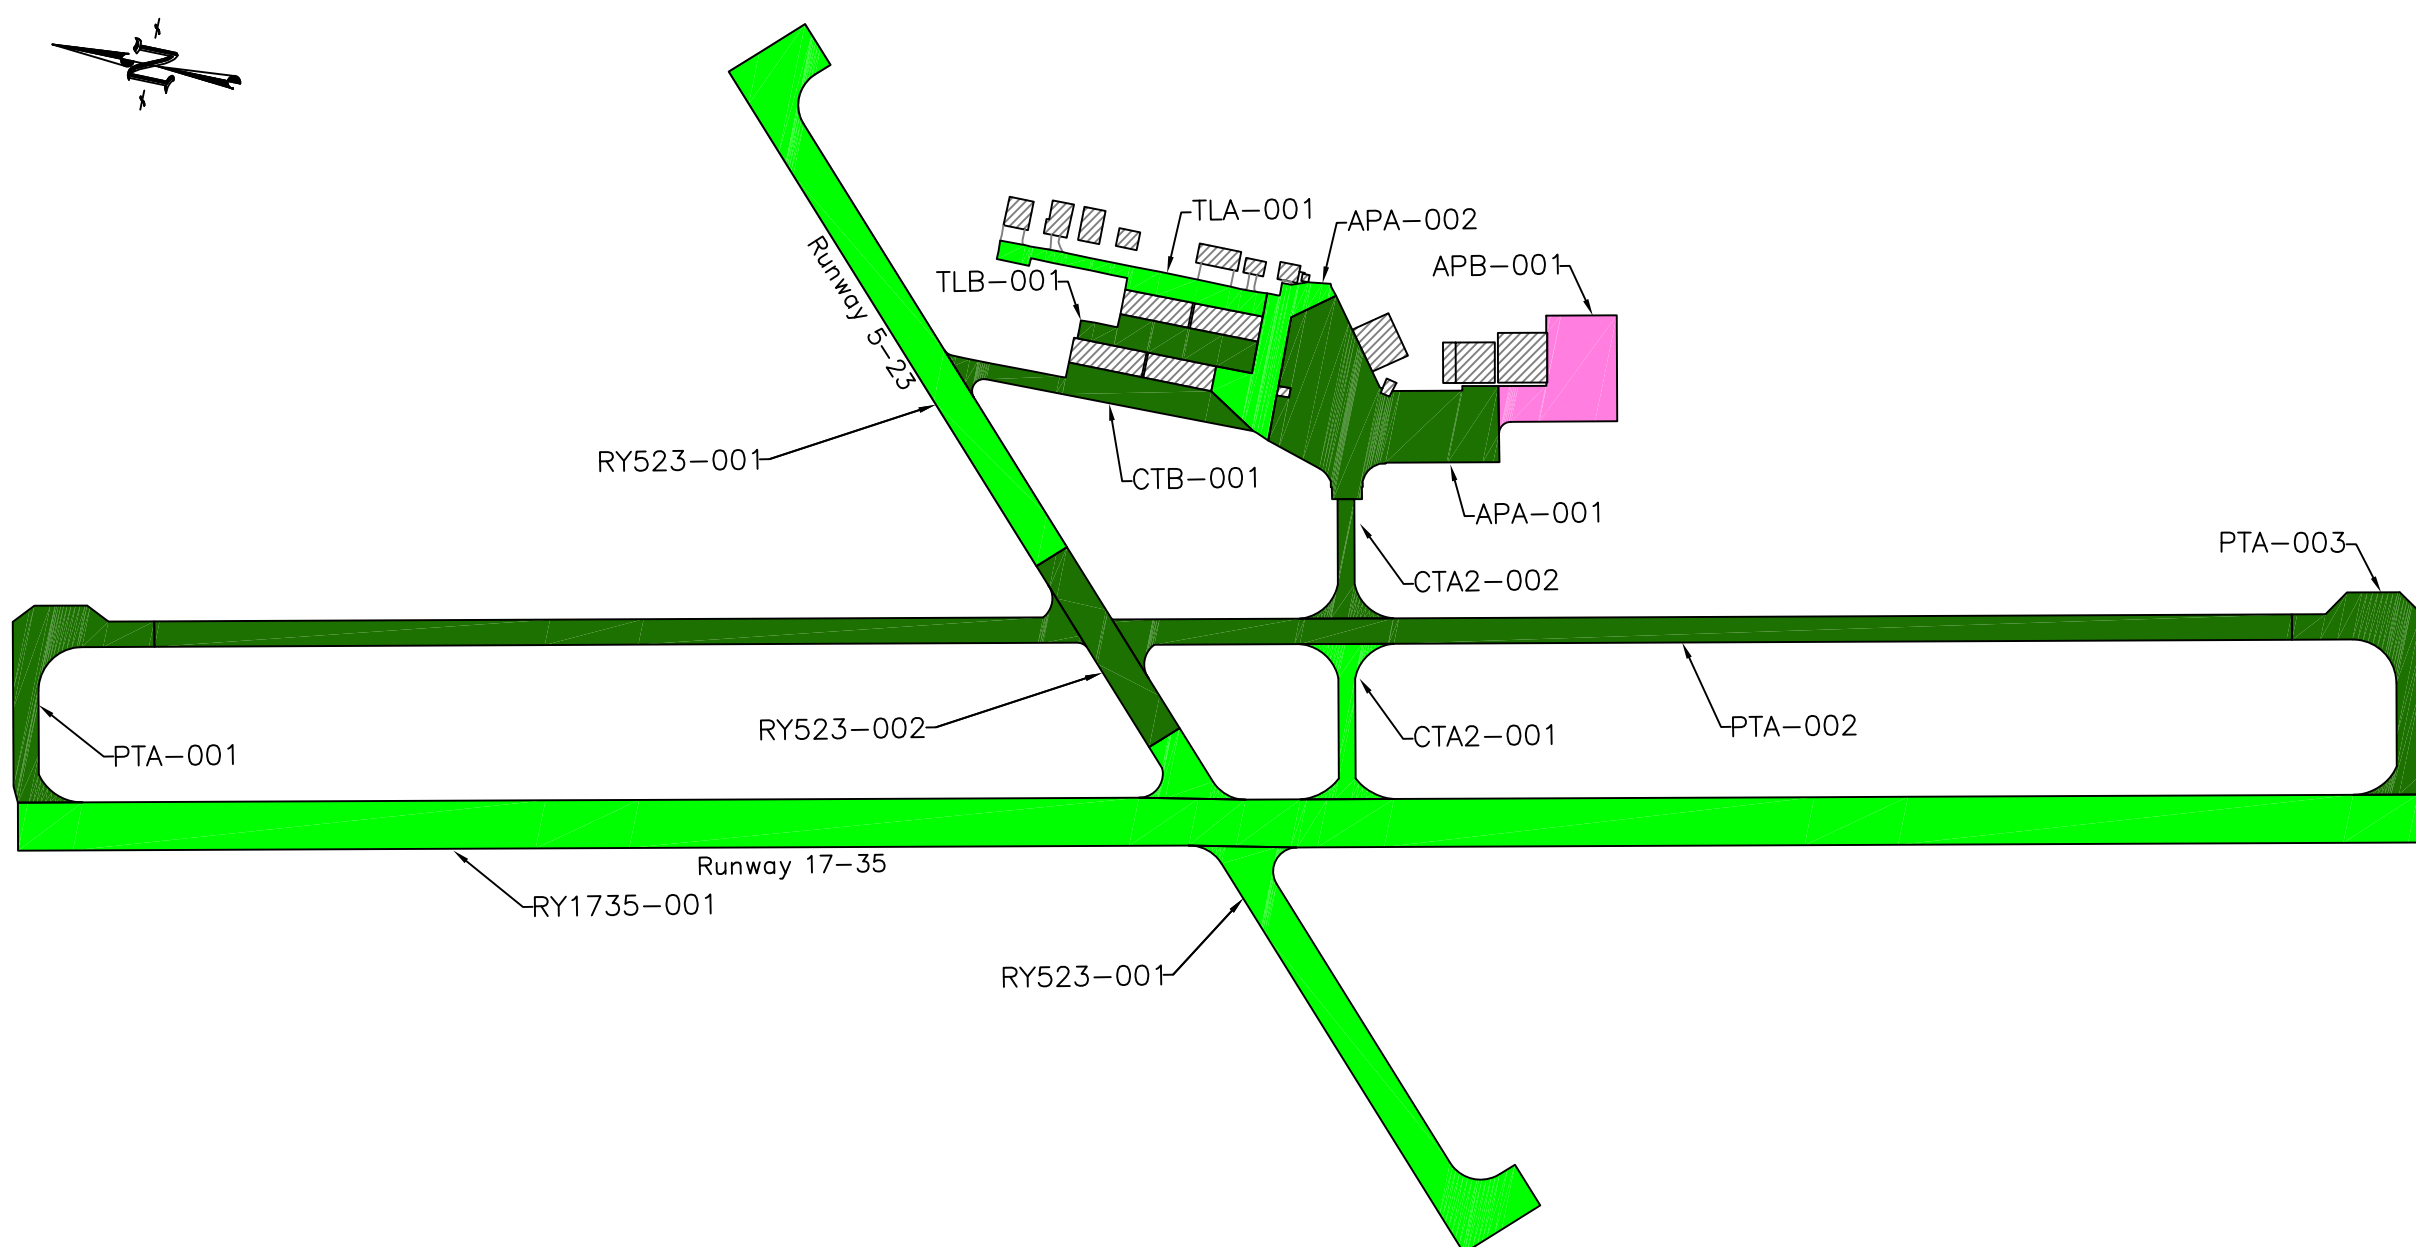
Figure 4. 2019 Pavement Condition Index Rating at Albert Lea Municipal Airport (AEL).

Figures 5 and 6 present the overall PCI for AEL by area distribution and pavement use, respectively. Table 3 presents the PCI summary for each section at AEL, including the drop in PCI per year. Generally, pavement sections will deteriorate between 1 and 3 PCI points per year. Sections deteriorating at higher rates may need maintenance above the normal application rates and should be closely monitored in case major repairs become necessary earlier than expected.

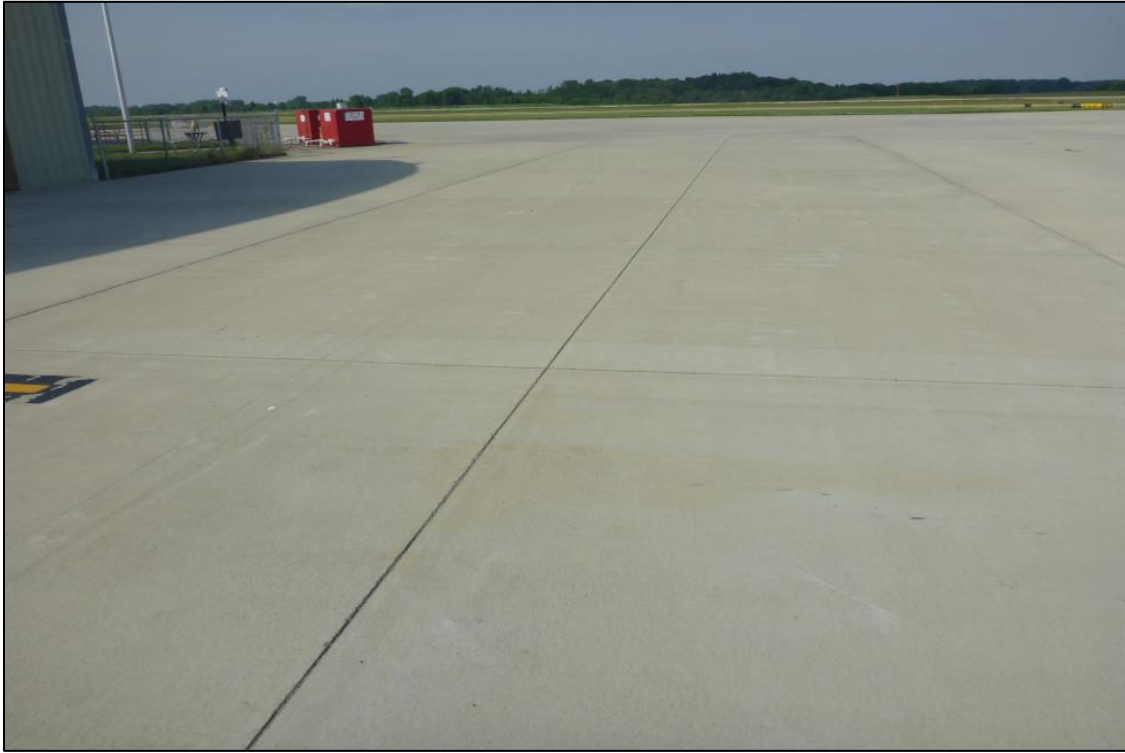
AEL APA 001 (PCI = 97)

Conditions: PCI: 97

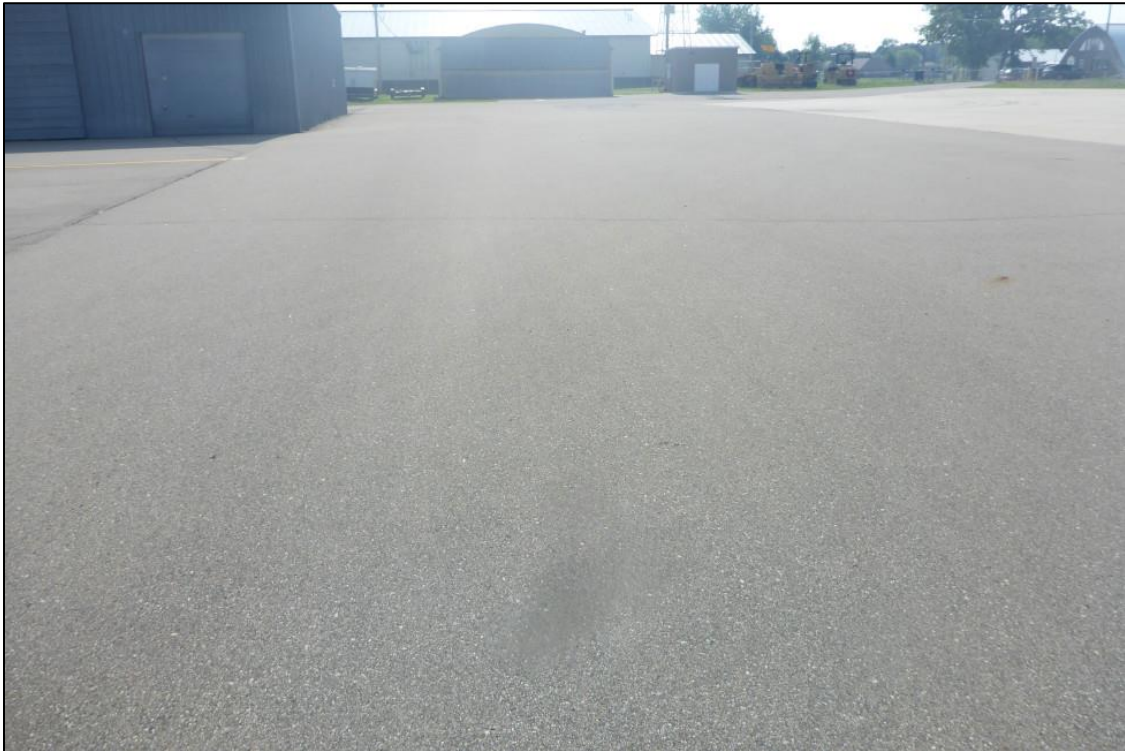
AEL APA 002 (PCI = 81)

Network:	AEL		Name:	ALBERT LEA					
Branch:	APA	Name:	APRON A	Use:	APRON	Area:	131,030 SqFt		
Section:	002	of 2	From:	99	To:	103	Last Const.:	8/1/2013	
Surface:	AC	Family:	MN2018 Asphalt Aprons	Zone:		Category:		Rank:	S
Area:	28,000 SqFt	Length:	300 Ft	Width:	60 Ft				
Slabs:		Slab Length:	Ft	Slab Width:	Ft	Joint Length:	Ft		
Shoulder:		Street Type:		Grade:	0	Lanes:	0		
Section Comments:	defined as a new section for 2013 recon project								
Last Insp. Date:	6/11/2019		TotalSamples:	5		Surveyed:	2		
Conditions:	PCI:	81							
Inspection Comments:									
Sample Number:	101	Type:	R	Area:	5900.00 SqFt	PCI:	85		
Sample Comments:	p928								
48	L & T CR	L	94.00	Ft					
48	L & T CR	M	44.00	Ft					
Sample Number:	102	Type:	R	Area:	5900.00 SqFt	PCI:	78		
Sample Comments:	p929,930								
48	L & T CR	L	74.00	Ft					
48	L & T CR	M	74.00	Ft					
50	PATCHING	L	293.00	SqFt

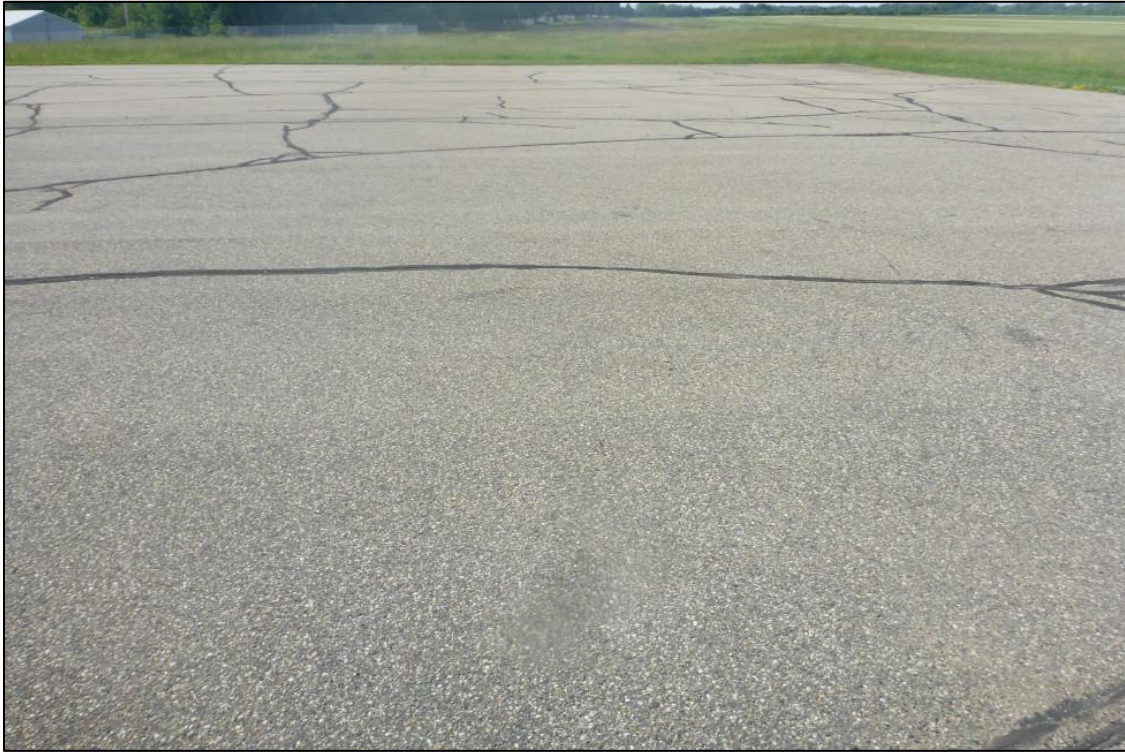
AEL APB 001 (PCI = 52)

Network:	AEL		Name:	ALBERT LEA					
Branch:	APB	Name:	APRON B	Use:	APRON	Area:	37,600 SqFt		
Section:	001	of 1	From:	101	To:	400	Last Const.:	9/30/1993	
Surface:	AAC	Family:	MN2018 Asphalt Aprons	Zone:	S	Category:	3	Rank:	S
Area:	37,600 SqFt	Length:	220 Ft	Width:	145 Ft				
Slabs:	Slab Length:	Ft	Slab Width:	Ft	Joint Length:	Ft			
Shoulder:	Street Type:	Grade:	0	Lanes:	0				
Section Comments:	no repairs planned								
Last Insp. Date:	6/11/2019	TotalSamples:	8	Surveyed:	3				
Conditions:	PCI: 52								
Inspection Comments:									
Sample Number:	101	Type:	R	Area:	5750.00 SqFt	PCI:	69		
Sample Comments:	p364,365								
48	L & T CR	L	511.00	Ft					
48	L & T CR	M	10.00	Ft					
57	WEATHERING	M	5000.00	SqFt					
Sample Number:	300	Type:	R	Area:	4500.00 SqFt	PCI:	44		
Sample Comments:	p935,936								
41	ALLIGATOR CR	L	300.00	SqFt					
48	L & T CR	L	504.00	Ft					
48	L & T CR	M	142.00	Ft					
57	WEATHERING	L	3000.00	SqFt

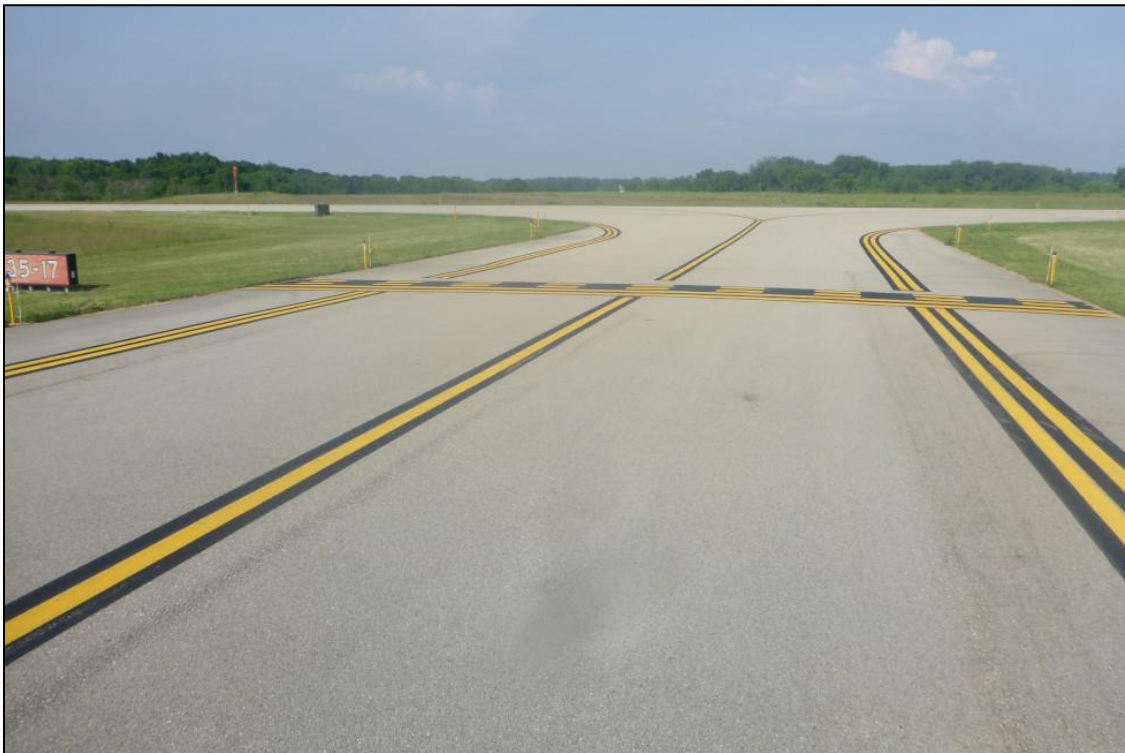
AEL CTA2 001 (PCI = 84)

Network:	AEL	Name:	ALBERT LEA						
Branch:	CTA2	Name:	CONNECTING TAXIWAY A2	Use:	TAXIWAY	Area:	28,530 SqFt		
Section:	001	of 2	From:	100	To:	102	Last Const.:	9/29/2010	
Surface:	AC	Family:	MN2018 Asphalt Runway- Taxiways	Zone:	S	Category:	3	Rank:	P
Area:	16,740 SqFt	Length:	330 Ft	Width:	35 Ft				
Slabs:		Slab Length:	Ft	Slab Width:	Ft	Joint Length:	Ft		
Shoulder:		Street Type:		Grade:	0	Lanes:	0		
Section Comments:	new pavement built in 2010								
Last Insp. Date:	6/11/2019	TotalSamples:	3	Surveyed:	1				
Conditions:	PCI: 84								
Inspection Comments:									
Sample Number:	101	Type:	R	Area:	3500.00 SqFt	PCI:	84		
Sample Comments:	p922								
48	L & T CR	L	60.00 Ft						
48	L & T CR	M	36.00 Ft

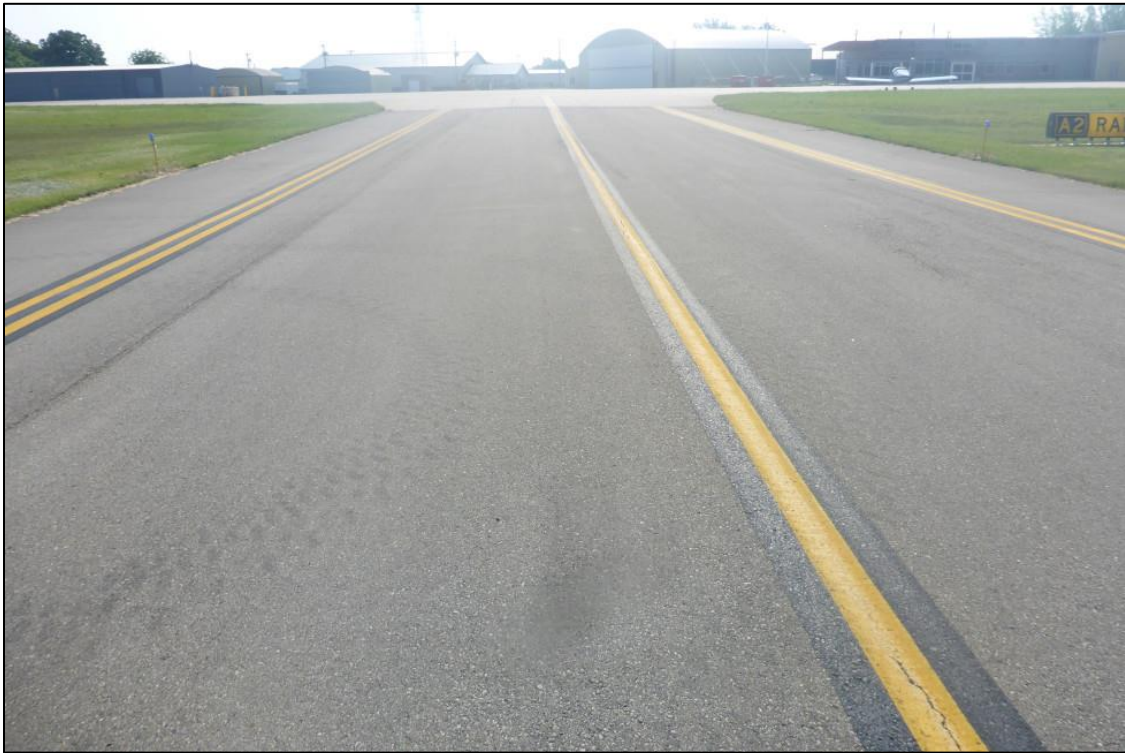
AEL CTA2 002 (PCI = 93)

Network:	AEL	Name:	ALBERT LEA						
Branch:	CTA2	Name:	CONNECTING TAXIWAY A2	Use:	TAXIWAY	Area:	28,530 SqFt		
Section:	002	of 2	From:	200	To:	202	Last Const.:	9/1/2011	
Surface:	AC	Family:	MN2018 Asphalt Runway- Taxiways	Zone:	S	Category:	3	Rank:	P
Area:	11,790 SqFt	Length:	300 Ft	Width:	35 Ft				
Slabs:		Slab Length:	Ft	Slab Width:	Ft	Joint Length:	Ft		
Shoulder:		Street Type:		Grade:	0	Lanes:	0		
Section Comments:									
Last Insp. Date:	6/11/2019	TotalSamples:	3	Surveyed:	1				
Conditions:	PCI: 93								
Inspection Comments:									
Sample Number:	201	Type:	R	Area:	3500.00 SqFt	PCI:	93		
Sample Comments:	p923								
48	L & T CR	L	61.00	Ft

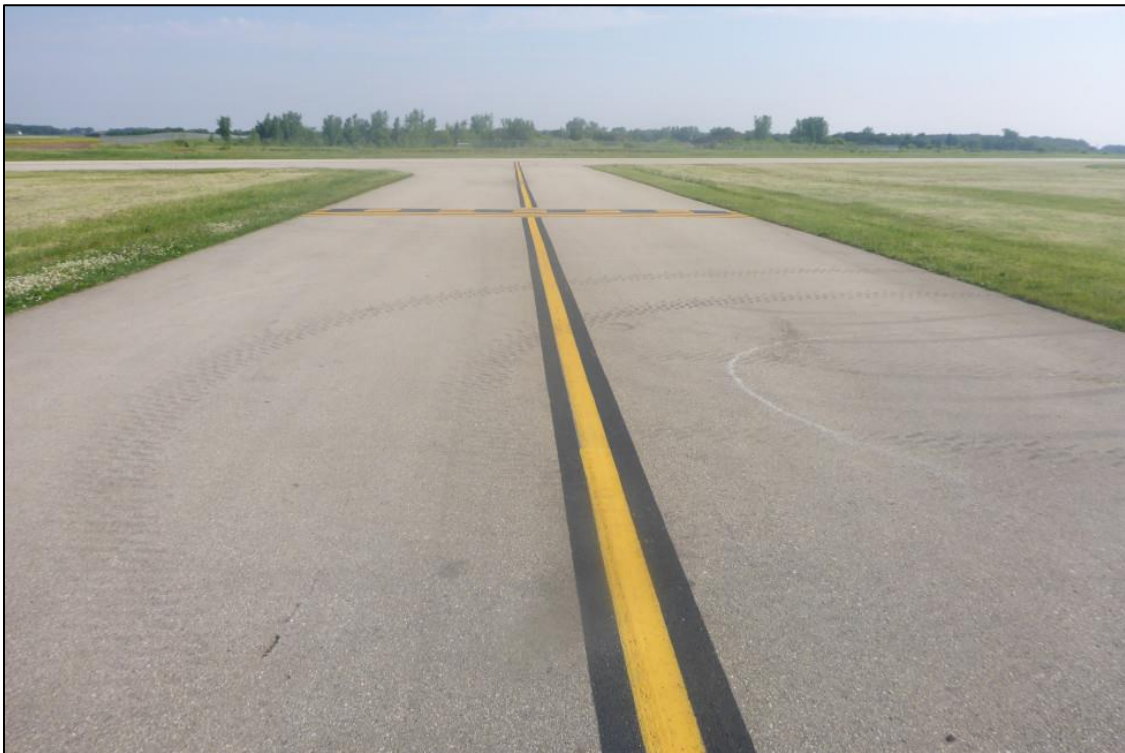
AEL CTB 001 (PCI = 95)

Conditions: PCI: 95

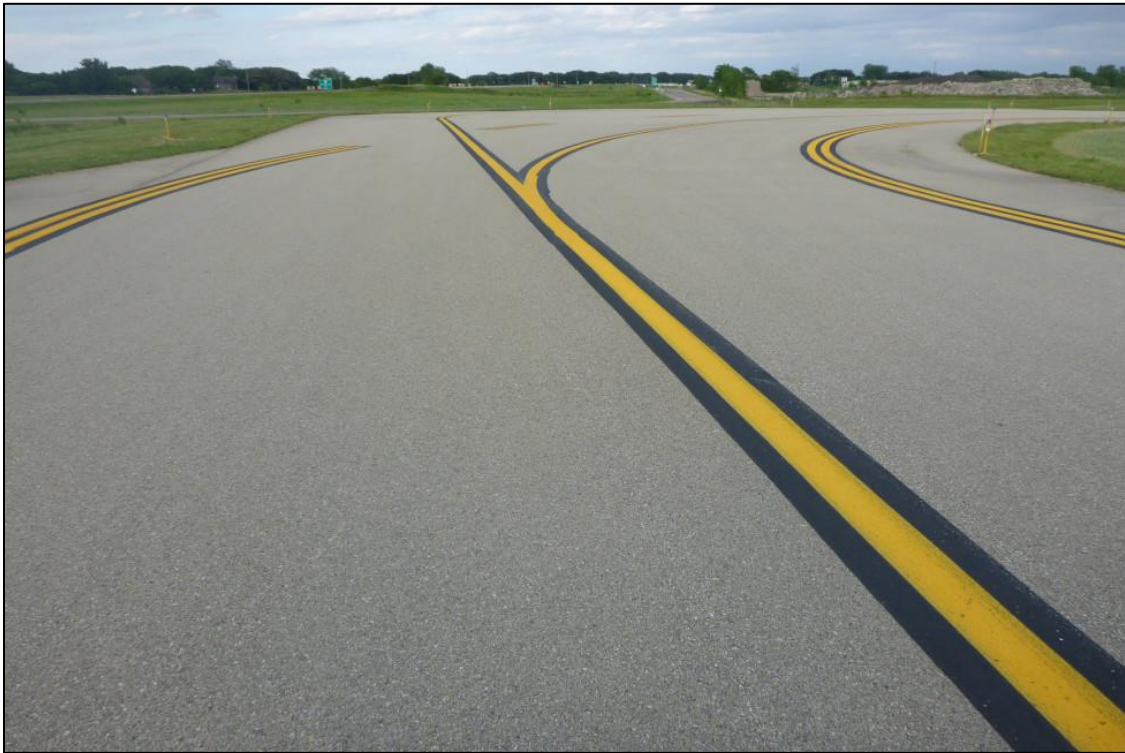
AEL PTA 001 (PCI = 92)

Network:	AEL		Name:	ALBERT LEA					
Branch:	PTA	Name:	Parallel Taxiway A	Use:	TAXIWAY	Area:	240,000 SqFt		
Section:	001	of 3	From:	RY 17	To:	PTA-002	Last Const.:	9/29/2010	
Surface:	AC	Family:	MN2018 Asphalt Runway- Taxiways	Zone:	S	Category:	3	Rank:	P
Area:	41,000 SqFt	Length:	520 Ft	Width:	35 Ft				
Slabs:		Slab Length:	Ft	Slab Width:	Ft	Joint Length:	Ft		
Shoulder:		Street Type:		Grade:	0	Lanes:	0		
Section Comments:									
Last Insp. Date:	6/11/2019		TotalSamples:	7		Surveyed:	2		
Conditions:	PCI:	92							
Inspection Comments:									
Sample Number:	101	Type:	R	Area:	3500.00 SqFt	PCI:	89		
Sample Comments:	p 352 353								
48	L & T CR		M	35.00	Ft				
Sample Number:	103	Type:	R	Area:	3500.00 SqFt	PCI:	95		
Sample Comments:									
48	L & T CR		L	37.00	Ft

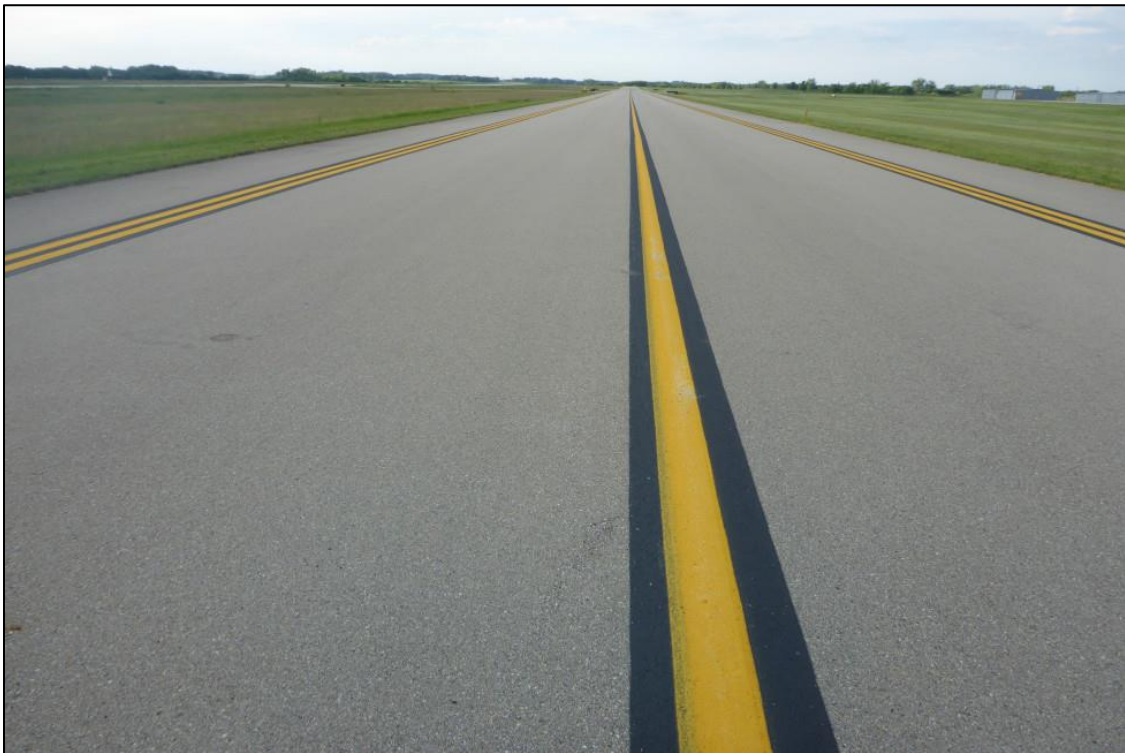
AEL PTA 002 (PCI = 99)

Conditions: PCI: 99

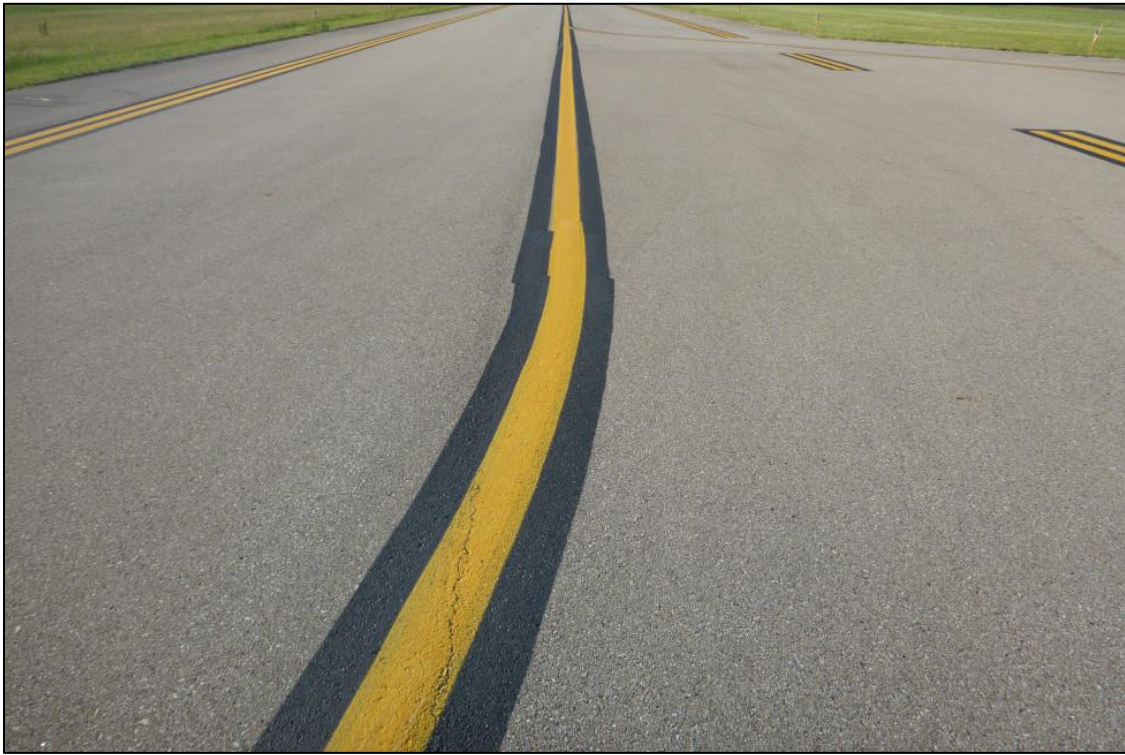
AEL PTA 003 (PCI = 98)

Network:	AEL	Name:	ALBERT LEA						
Branch:	PTA	Name:	Parallel Taxiway A	Use:	TAXIWAY	Area:	240,000 SqFt		
Section:	003	of 3	From:	150	To:	RY 35	Last Const.:	9/29/2010	
Surface:	AC	Family:	MN2018 Asphalt Runway- Taxiways	Zone:	S	Category:	3	Rank:	P
Area:	41,500 SqFt	Length:	500 Ft	Width:	35 Ft				
Slabs:		Slab Length:	Ft	Slab Width:	Ft	Joint Length:	Ft		
Shoulder:		Street Type:		Grade:	0	Lanes:	0		
Section Comments:	signed as A3								
Last Insp. Date:	6/11/2019	TotalSamples:	7	Surveyed:	2				
Conditions:	PCI: 98								
Inspection Comments:									
Sample Number:	151	Type:	R	Area:	3500.00 SqFt	PCI:	96		
Sample Comments:	p 355								
48	L & T CR	L	12.00	Ft					
Sample Number:	153	Type:	R	Area:	3500.00 SqFt	PCI:	100		
Sample Comments:	nd								
<No Distress>

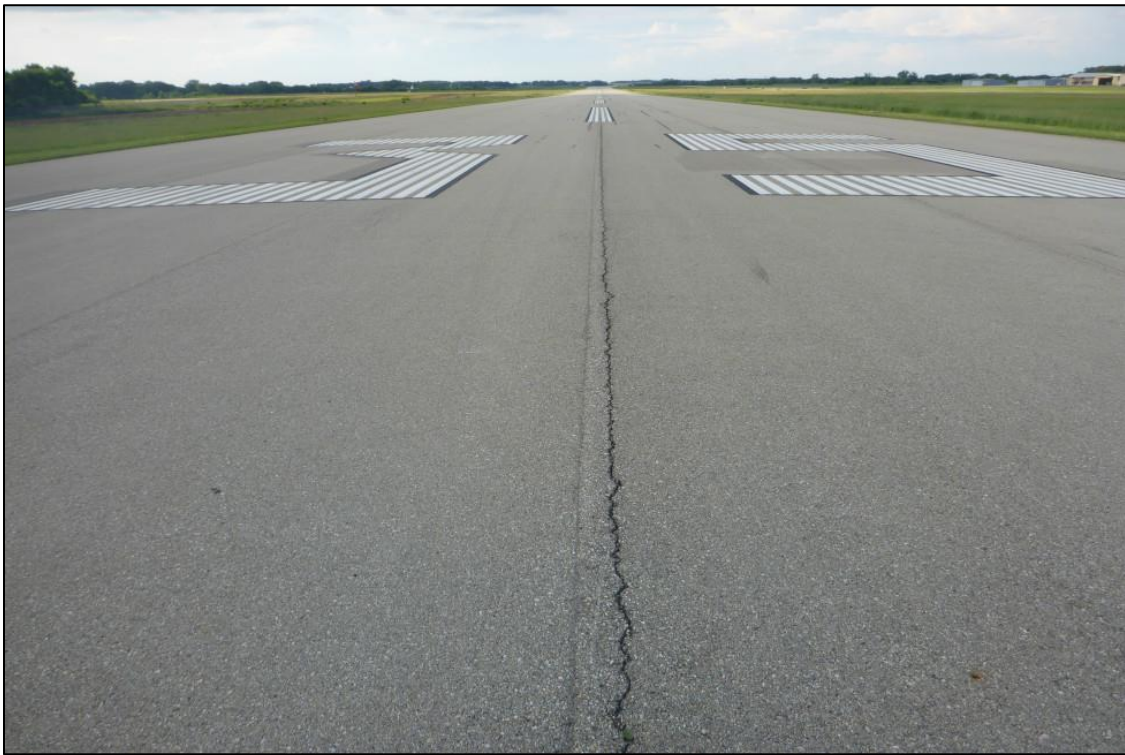
AEL RY1735 001 (PCI = 82)

Network:	AEL		Name:	ALBERT LEA					
Branch:	RY1735	Name:	Runway 17-35	Use:	RUNWAY	Area:	500,000 SqFt		
Section:	001	of 1	From:	100	To:	200	Last Const.:	9/29/2010	
Surface:	AC	Family:	MN2018 Asphalt Runway- Taxiways	Zone:	S	Category:	3	Rank:	P
Area:	500,000 SqFt	Length:	5,000 Ft	Width:	100 Ft				
Slabs:		Slab Length:	Ft	Slab Width:	Ft	Joint Length:	Ft		
Shoulder:		Street Type:		Grade:	0	Lanes:	0		
Section Comments:	new pavement built in 2010								
Last Insp. Date:	6/11/2019		TotalSamples:	100		Surveyed:	10		
Conditions:	PCI:	82							
Inspection Comments:									
Sample Number:	104	Type:	R	Area:	5000.00 SqFt	PCI:	88		
Sample Comments:	p 348								
48	L & T CR	L	195.00	Ft					
Sample Number:	114	Type:	R	Area:	5000.00 SqFt	PCI:	85		
Sample Comments:									
48	L & T CR	L	252.00	Ft					
Sample Number:	124	Type:	R	Area:	5000.00 SqFt	PCI:	79		
Sample Comments:									
48	L & T CR	L	249.00	Ft					
57	WEATHERING	M	48.00	SqFt

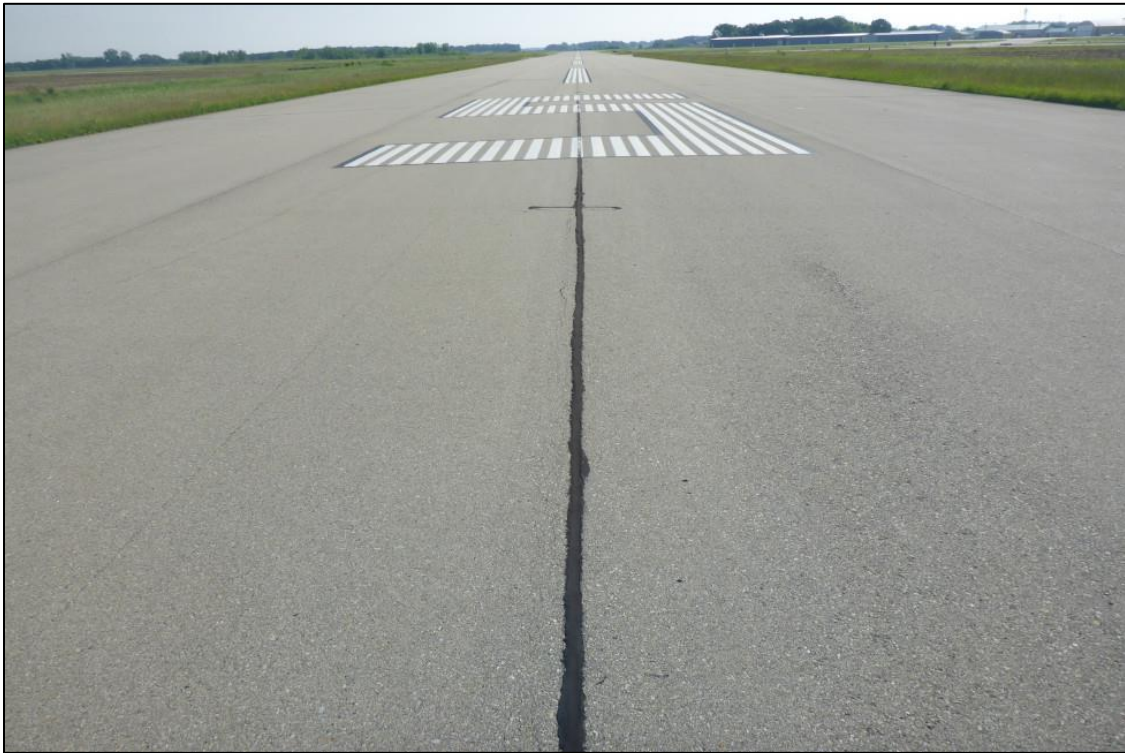
AEL RY523 001 (PCI = 83)

Network:	AEL		Name:	ALBERT LEA					
Branch:	RYS23	Name:	RUNWAY 5-23	Use:	RUNWAY	Area:	237,850 SqFt		
Section:	001	of 2	From:	100	To:	157	Last Const.:	9/29/2010	
Surface:	AC	Family:	MN2018 Asphalt Runway- Taxiways	Zone:	S	Category:	3	Rank:	S
Area:	204,530 SqFt		Length:	2,898 Ft	Width:	75 Ft			
Slabs:	Slab Length:		Ft	Slab Width:		Ft	Joint Length:		Ft
Shoulder:	Street Type:		Grade:		0	Lanes:		0	
Section Comments:	milled and ACOL in Oct 2010...added warmup pads at each end								
Last Insp. Date:	6/11/2019		TotalSamples:	52		Surveyed:			5
Conditions:	PCI:	83							
Inspection Comments:									
Sample Number:	106	Type:	R	Area:	3750.00 SqFt		PCI:	85	
Sample Comments:	p 356								
48	L & T CR	L	82.00 Ft						
48	L & T CR	M	28.00 Ft						
Sample Number:	116	Type:	R	Area:	3750.00 SqFt		PCI:	84	
Sample Comments:	p 357 cs looks new secondary cracks								
48	L & T CR	M	75.00 Ft						
Sample Number:	137	Type:	R	Area:	3750.00 SqFt		PCI:	83
