Pavement Condition Report

Lac Qui Parle County (Madison) Airport (DXX)

December 2019

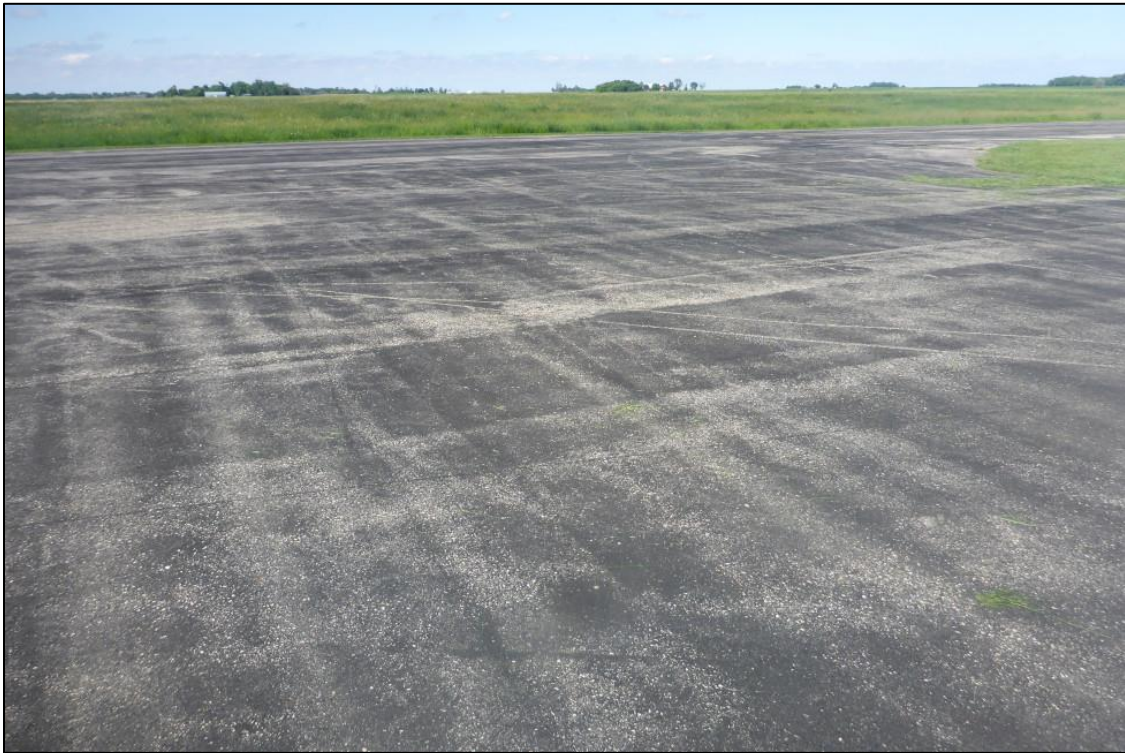
DXX APA 001 (PCI = 83)

Conditions: PCI: 83

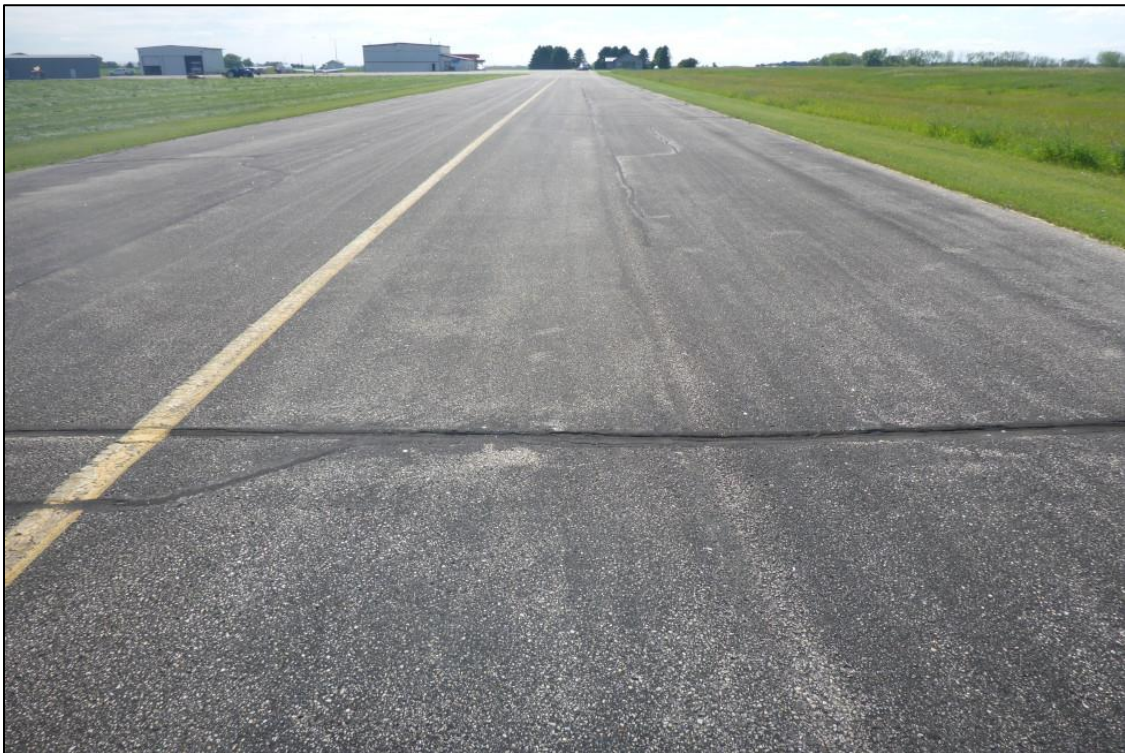
DXX CTA 001 (PCI = 73)

Conditions: PCI: 73

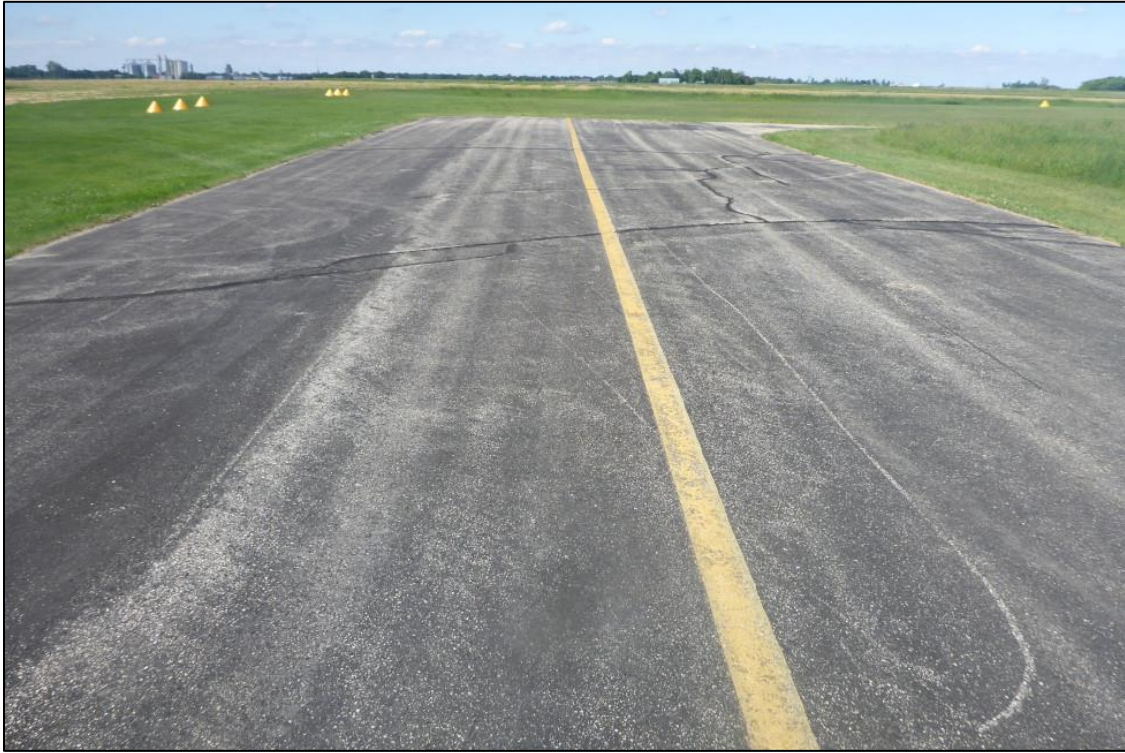
DXX CTB 001 (PCI = 77)

Network:	DXX	Name:	MADISON						
Branch:	CTB	Name:	Connecting Taxiway B	Use:	TAXIWAY	Area:	10,840 SqFt		
Section:	001	of 1	From:	100	To:	102	Last Const.:	9/30/2003	
Surface:	AC	Family:	MN2018 Asphalt Runway- Taxiways	Zone:	W	Category:	3	Rank:	S
Area:	10,840 SqFt	Length:	240 Ft	Width:	40 Ft				
Slabs:		Slab Length:	Ft	Slab Width:	Ft	Joint Length:	Ft		
Shoulder:		Street Type:		Grade:	0	Lanes:	0		
Section Comments:	maint. (R&E) CS								
Last Insp. Date:	6/11/2019	TotalSamples:	3	Surveyed:	1				
Conditions:	PCI: 77								
Inspection Comments:									
Sample Number:	101	Type:	R	Area:	4000.00 SqFt	PCI:	77		
Sample Comments:	p989								
48	L & T CR	L	102.00 Ft						
48	L & T CR	M	103.00 Ft

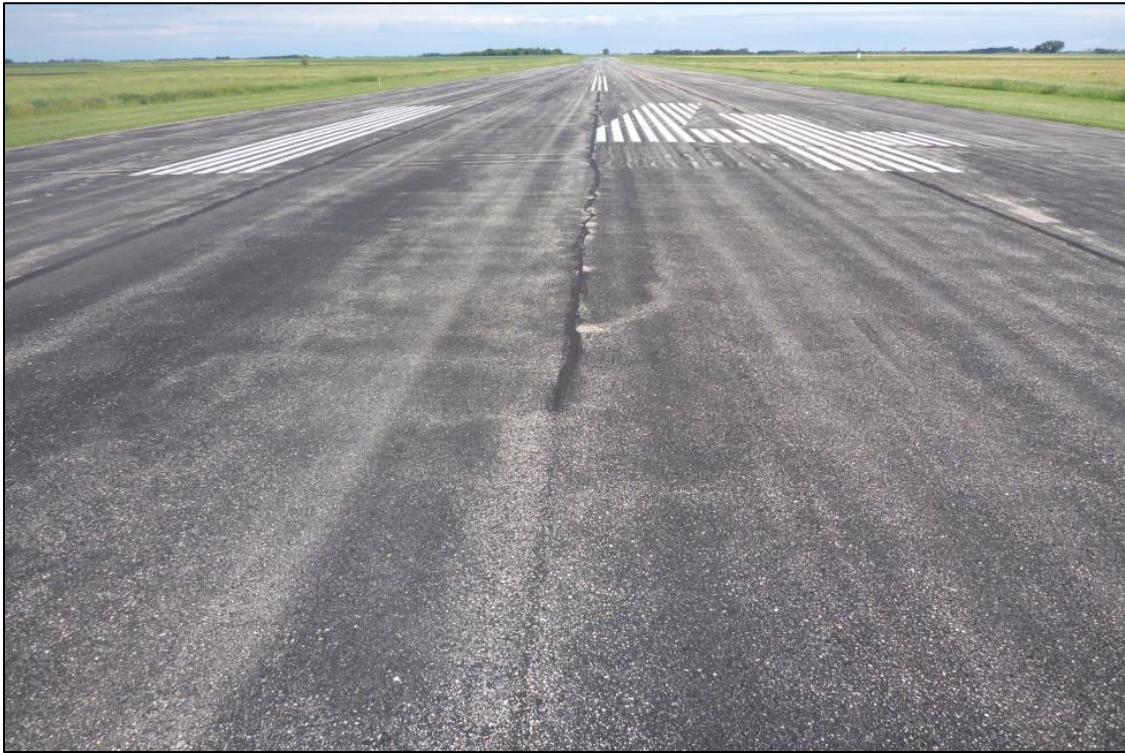
DXX RY1432 001 (PCI = 74)

Network:	DXX		Name:	MADISON					
Branch:	RY1432	Name:	RUNWAY 14-32	Use:	RUNWAY	Area:	261,300 SqFt		
Section:	001	of	1	From:	100	To:	165	Last Const.:	9/30/2003
Surface:	AAC	Family:	MN2018 Asphalt Runway- Taxiways	Zone:	W	Category:	3	Rank:	P
Area:	261,300 SqFt	Length:	3,300 Ft	Width:	75 Ft				
Slabs:		Slab Length:	Ft	Slab Width:	Ft	Joint Length:	Ft		
Shoulder:		Street Type:		Grade:	0	Lanes:	0		
Section Comments:	maint. (R&E) CS								
Last Insp. Date:	6/11/2019		TotalSamples:	66		Surveyed:	7		
Conditions:	PCI: 74								
Inspection Comments:									
Sample Number:	106	Type:	R	Area:	3750.00 SqFt	PCI:	73		
Sample Comments:	p 447 fog seal and cs								
48	L & T CR	L	330.00	Ft					
48	L & T CR	M	28.00	Ft					
48	L & T CR	H	9.00	Ft					
Sample Number:	115	Type:	R	Area:	3750.00 SqFt	PCI:	77		
Sample Comments:									
48	L & T CR	L	257.00	Ft					
48	L & T CR	M	40.00	Ft					
Sample Number:	124	Type:	R	Area:	3750.00 SqFt	PCI:	71

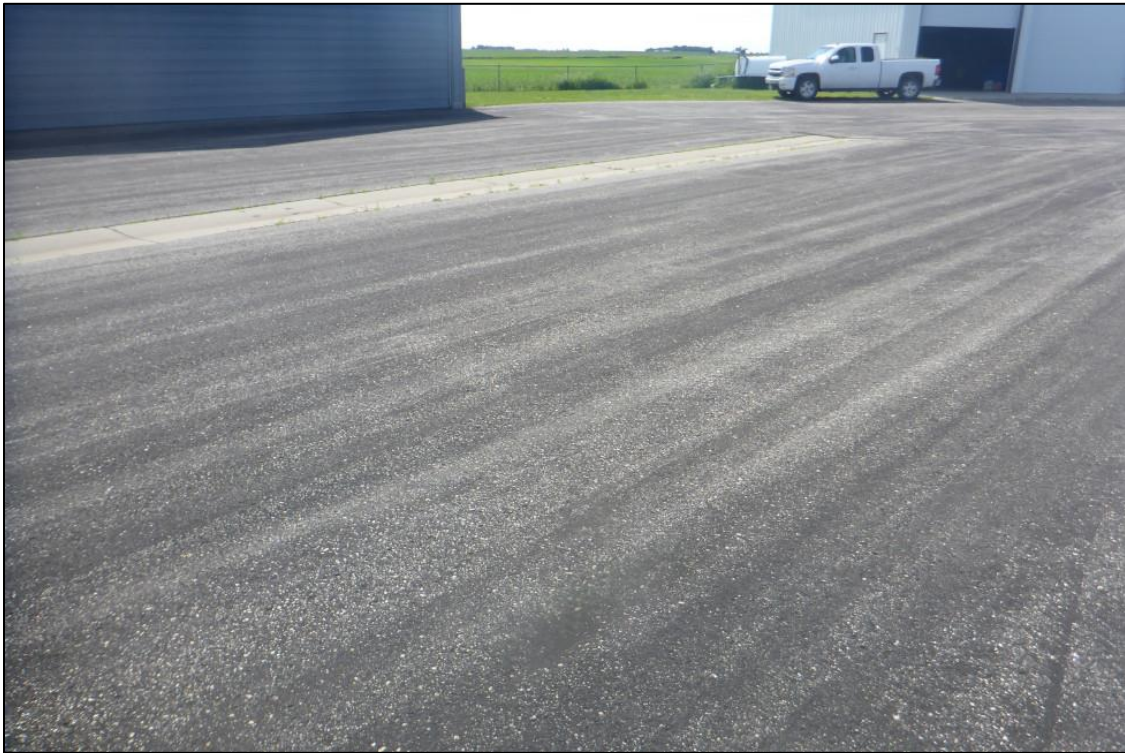
DXX TLA 001 (PCI = 98)

Network:	DXX		Name:	MADISON					
Branch:	TLA	Name:	Taxilane A	Use:	TAXILANE	Area:	33,016 SqFt		
Section:	001	of 2	From:	200	To:	204	Last Const.:	9/27/2003	
Surface:	AC	Family:	MN2018 Asphalt Taxilanes	Zone:	W	Category:	3	Rank:	T
Area:	23,800 SqFt	Length:	240 Ft	Width:	75 Ft				
Slabs:	Slab Length:	Ft	Slab Width:	Ft	Joint Length:	Ft			
Shoulder:	Street Type:		Grade:	0	Lanes:	0			
Section Comments:	complete reconstruction in 2003 (SP 3701-22)								
Last Insp. Date:	6/11/2019	TotalSamples:	6	Surveyed:	2				
Conditions:	PCI: 98								
Inspection Comments:									
Sample Number:	201	Type:	R	Area:	3750.00 SqFt	PCI:	96		
Sample Comments:	p994								
48	L & T CR	L	23.00	Ft					
Sample Number:	203	Type:	R	Area:	3750.00 SqFt	PCI:	100		
Sample Comments:	p995								
<No Distress>

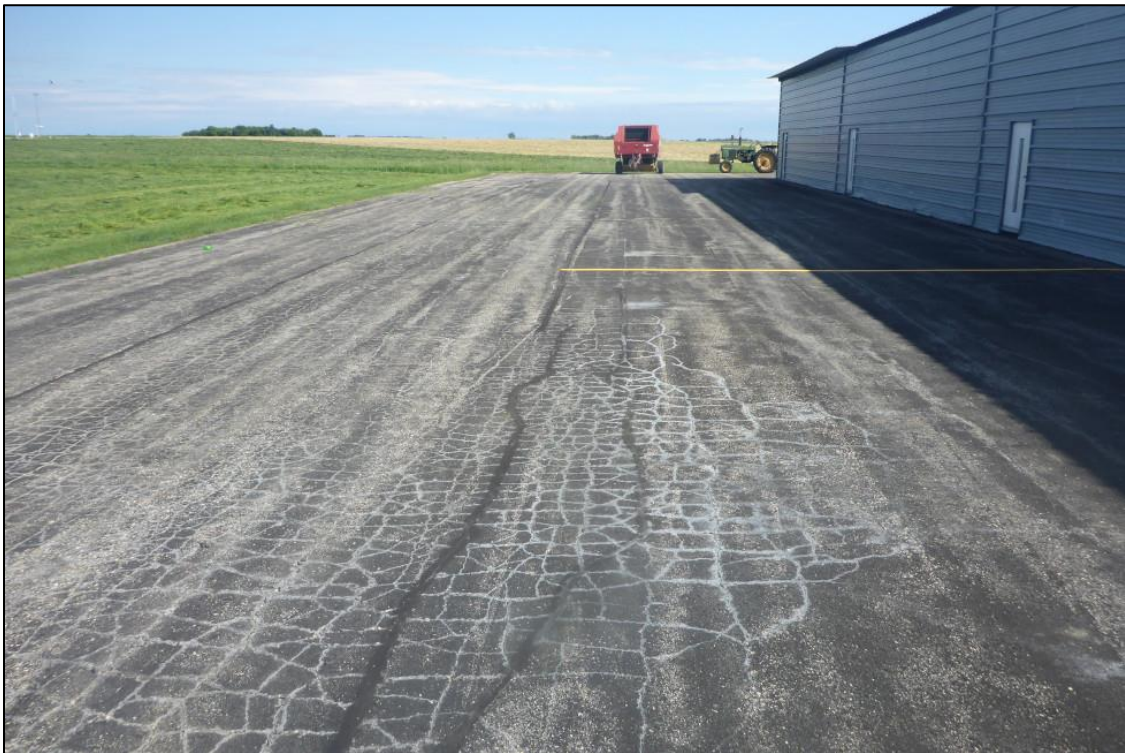
DXX TLA 002 (PCI = 11)

Network:	DXX		Name:	MADISON					
Branch:	TLA	Name:	Taxilane A	Use:	TAXILANE	Area:	33,016 SqFt		
Section:	002	of 2	From:	100	To:	101	Last Const.:	9/27/2003	
Surface:	AC	Family:	MN2018 Asphalt Taxilanes	Zone:	W	Category:	3	Rank:	T
Area:	9,216 SqFt	Length:	192 Ft	Width:	48 Ft				
Slabs:	Slab Length:	Ft	Slab Width:	Ft	Joint Length:	Ft			
Shoulder:	Street Type:	Grade:	0	Lanes:	0				
Section Comments:	seperate section due to condition								
Last Insp. Date:	6/11/2019	TotalSamples:	2	Surveyed:	1				
Conditions:	PCI: 11								
Inspection Comments:									
Sample Number:	101	Type:	R	Area:	4800.00 SqFt	PCI:	11		
Sample Comments:	p996,997 fog seal								
41	ALLIGATOR CR	M	2400.00	SqFt					
41	ALLIGATOR CR	H	20.00	SqFt					
48	L & T CR	L	160.00	Ft					
48	L & T CR	M	35.00	Ft
