Pavement Condition Report

Granite Falls Municipal Airport (GDB)

December 2019

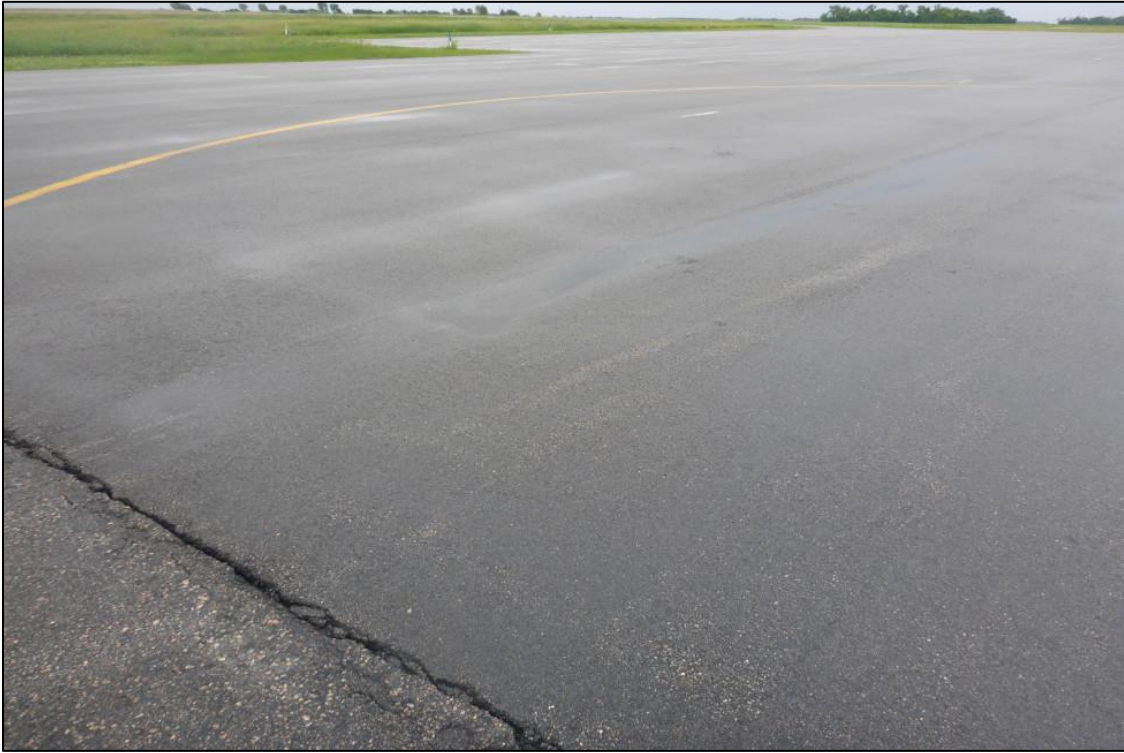
GDB APA 001 (PCI = 94)

Conditions: PCI: 94

Sample Comments: additional bc of crack on feature line p446,447

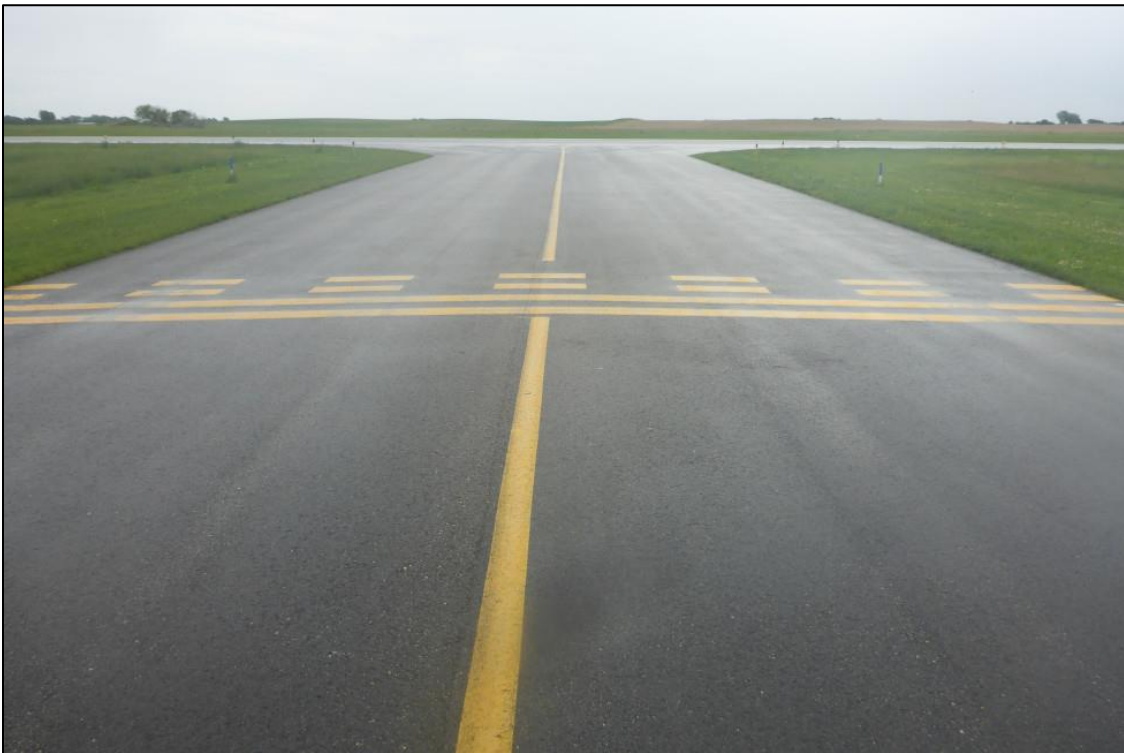
GDB CTA 001 (PCI = 100)

Conditions: PCI: 100

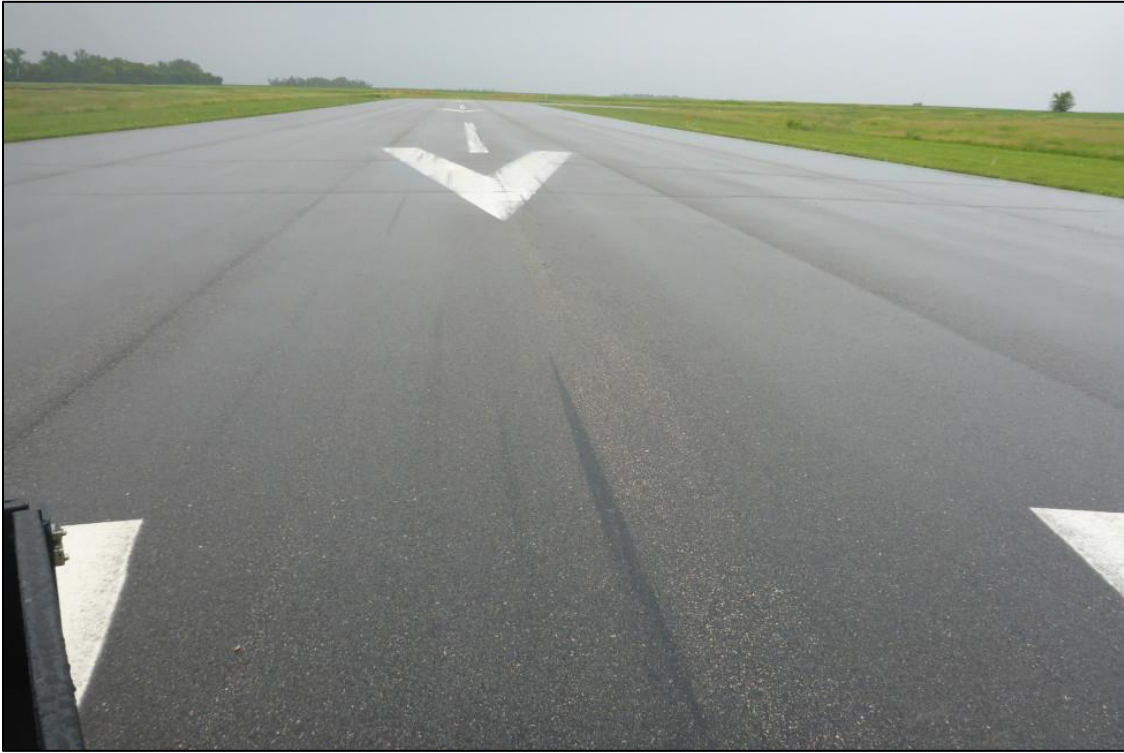
GDB RY1533 001 (PCI = 87)

Network:	GDB	Name:	GRANITE FALLS						
Branch:	RY1533	Name:	RUNWAY 15-33	Use:	RUNWAY	Area:	342,920 SqFt		
Section:	001	of 2	From:	87	To:	99	Last Const.:	9/15/2017	
Surface:	AC	Family:	MN2018 Asphalt Runway- Taxiways	Zone:	S	Category:	3	Rank:	P
Area:	57,085 SqFt	Length:	650 Ft	Width:	75 Ft				
Slabs:		Slab Length:	Ft	Slab Width:	Ft	Joint Length:	Ft		
Shoulder:		Street Type:		Grade:	0	Lanes:	0		
Section Comments:									
Last Insp. Date:	6/11/2019	TotalSamples:	15	Surveyed:	4				
Conditions:	PCI: 87								
Inspection Comments:									
Sample Number:	102	Type:	R	Area:	3750.00 SqFt	PCI:	82		
Sample Comments: p 439									
48	L & T CR	L	150.00	Ft					
48	L & T CR	M	8.00	Ft					
Sample Number:	107	Type:	R	Area:	3750.00 SqFt	PCI:	85		
Sample Comments:									
48	L & T CR	L	120.00	Ft					
48	L & T CR	M	5.00	Ft					
Sample Number:	111	Type:	R	Area:	3750.00 SqFt	PCI:	94		
Sample Comments: p 440									
48	L & T CR	L	55.00	Ft

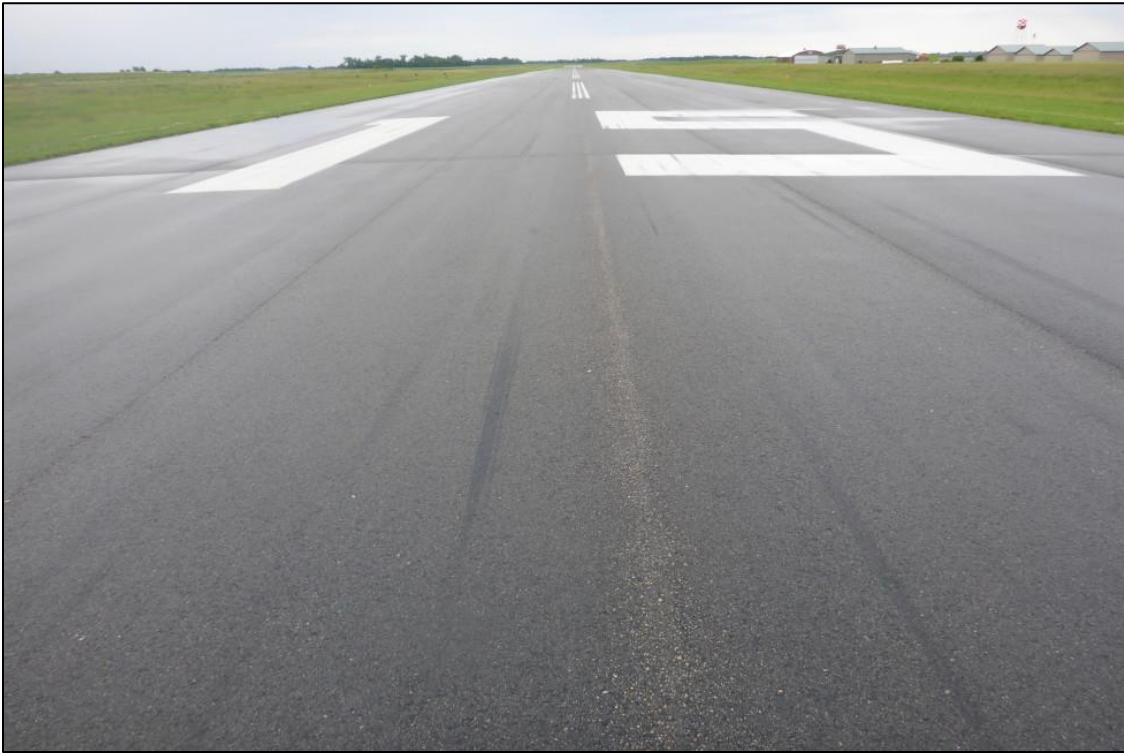
GDB RY1533 002 (PCI = 98)

Network:	GDB		Name:	GRANITE FALLS					
Branch:	RY1533	Name:	RUNWAY 15-33	Use:	RUNWAY	Area:	342,920 SqFt		
Section:	002	of 2	From:	100	To:	173	Last Const.:	9/15/2017	
Surface:	AC	Family:	MN2018 Asphalt Runway- Taxiways	Zone:	S	Category:	3	Rank:	P
Area:	285,835 SqFt	Length:	3,700 Ft	Width:	75 Ft				
Slabs:		Slab Length:	Ft	Slab Width:	Ft	Joint Length:	Ft		
Shoulder:		Street Type:		Grade:	0	Lanes:	0		
Section Comments:	patched runway summer 2012								
Last Insp. Date:	6/11/2019		TotalSamples:	74		Surveyed:	8		
Conditions:	PCI:	98							
Inspection Comments:									
Sample Number:	116	Type:	R	Area:	3750.00 SqFt	PCI:	100		
Sample Comments:	p 441 nd								
<No Distress>									
Sample Number:	126	Type:	R	Area:	3750.00 SqFt	PCI:	100		
Sample Comments:	nd								
<No Distress>									
Sample Number:	136	Type:	R	Area:	3750.00 SqFt	PCI:	100		
Sample Comments:	nd								
<No Distress>									
Sample Number:	146	Type:	R	Area:	3750.00 SqFt	PCI:	96

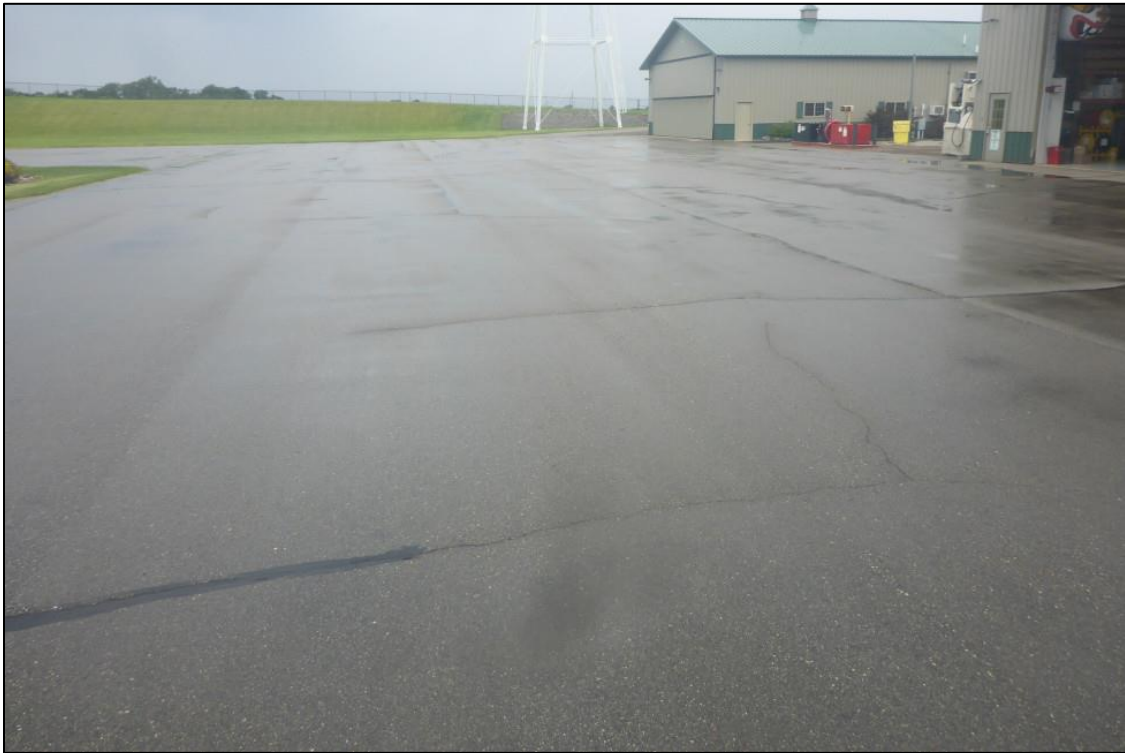
GDB TLA 001 (PCI = 79)

Network:	GDB	Name:	GRANITE FALLS						
Branch:	TLA	Name:	Taxilane A	Use:	TAXILANE	Area:	120,735 SqFt		
Section:	001	of 5	From:	100	To:	102	Last Const.: 10/1/2014		
Surface:	AC	Family:	MN2018 Asphalt Taxilanes	Zone:	S	Category:	3	Rank:	T
Area:	28,560 SqFt	Length:	310 Ft	Width:	76 Ft				
Slabs:	Slab Length:	Ft	Slab Width:	Ft	Joint Length:	Ft			
Shoulder:	Street Type:	Grade:	0	Lanes:	0				
Section Comments:	Estimated LCD								
Last Insp. Date:	6/11/2019	TotalSamples:	3	Surveyed:	1				
Conditions:	PCI: 79								
Inspection Comments:									
Sample Number:	101	Type:	R	Area:	5000.00 SqFt	PCI:	79		
Sample Comments:	p985								
48	L & T CR	L	286.00	Ft					
48	L & T CR	M	11.00	Ft

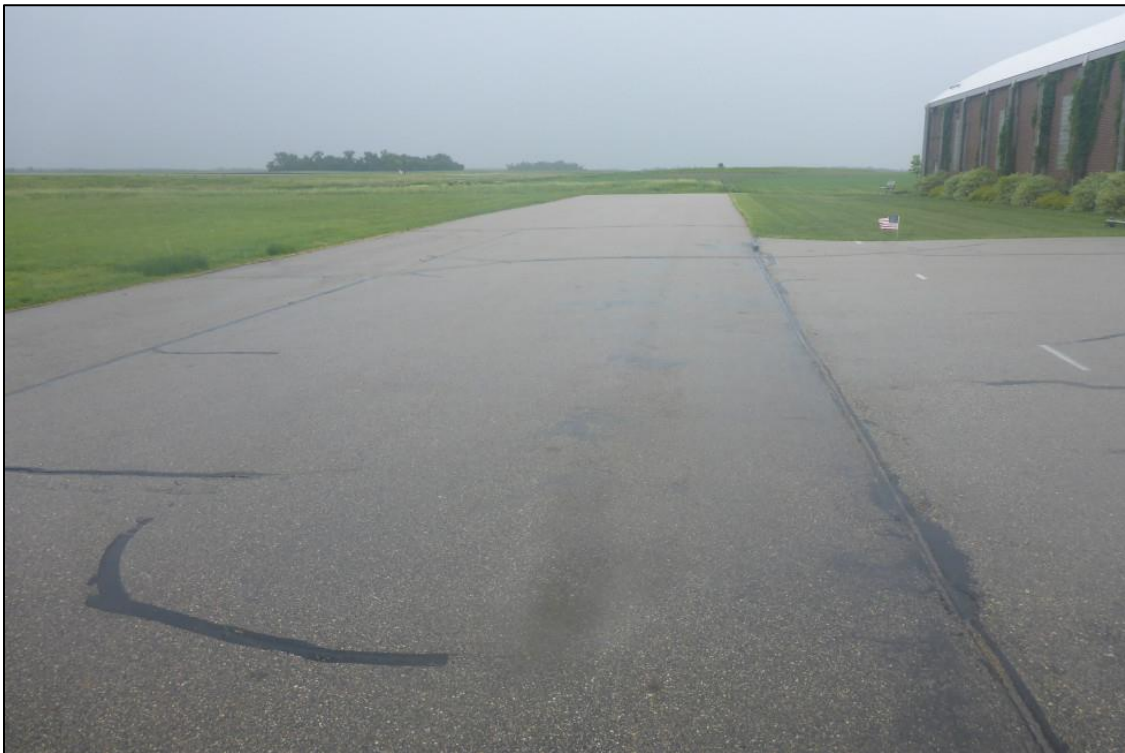
GDB TLA 002 (PCI = 83)

Network:	GDB		Name:	GRANITE FALLS					
Branch:	TLA	Name:	Taxilane A	Use:	TAXILANE	Area:	120,735 SqFt		
Section:	002	of 5	From:	100	To:	305	Last Const.:	9/30/2007	
Surface:	AC	Family:	MN2018 Asphalt Taxilanes	Zone:	S	Category:	3	Rank:	T
Area:	29,690 SqFt	Length:	900 Ft	Width:	50 Ft				
Slabs:	Slab Length:	Ft	Slab Width:	Ft	Joint Length:	Ft			
Shoulder:	Street Type:		Grade:	0	Lanes:	0			
Section Comments:									
Last Insp. Date:	6/11/2019	TotalSamples:	6	Surveyed:	2				
Conditions:	PCI: 83								
Inspection Comments:									
Sample Number:	101	Type:	R	Area:	3600.00 SqFt	PCI:	82		
Sample Comments:	p983								
48	L & T CR	L	148.00	Ft					
48	L & T CR	M	47.00	Ft					
Sample Number:	201	Type:	R	Area:	5300.00 SqFt	PCI:	84		
Sample Comments:	p982								
48	L & T CR	L	177.00	Ft					
48	L & T CR	M	15.00	Ft

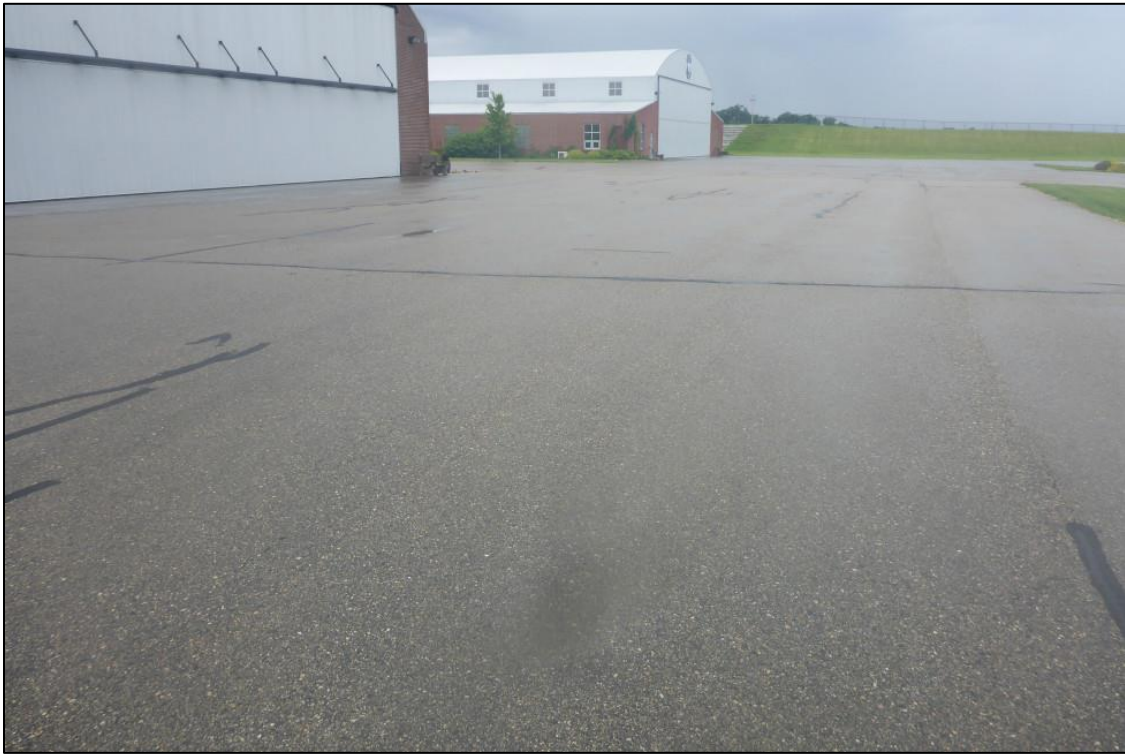
GDB TLA 003 (PCI = 77)

⁶Higher than expected deterioration rate of 6.5 PCI/year due to the development of low and medium-severity L&T cracking in pavement that is only a few years old.

Network:	GDB	Name:	GRANITE FALLS				
Branch:	TLA	Name:	Taxilane A	Use:	TAXILANE	Area:	120,735 SqFt
Section:	003	of 5	From:	-	To:	-	Last Const.: 6/1/2011
Surface:	AC	Family:	MN2018 Asphalt Taxilanes	Zone:		Category:	Rank: T
Area:	12,740 SqFt	Length:	160 Ft	Width:	79 Ft		
Slabs:		Slab Length:	Ft	Slab Width:	Ft	Joint Length:	Ft
Shoulder:		Street Type:		Grade:	0	Lanes:	0
Section Comments:							
Last Insp. Date:	6/11/2019	TotalSamples:	2	Surveyed:	1		
Conditions:	PCI: 77						
Inspection Comments:							
Sample Number:	400	Type:	R	Area:	6370.00 SqFt	PCI:	77
Sample Comments: p984							
48	L & T CR	L	409.00	Ft			
48	L & T CR	M	66.00	Ft

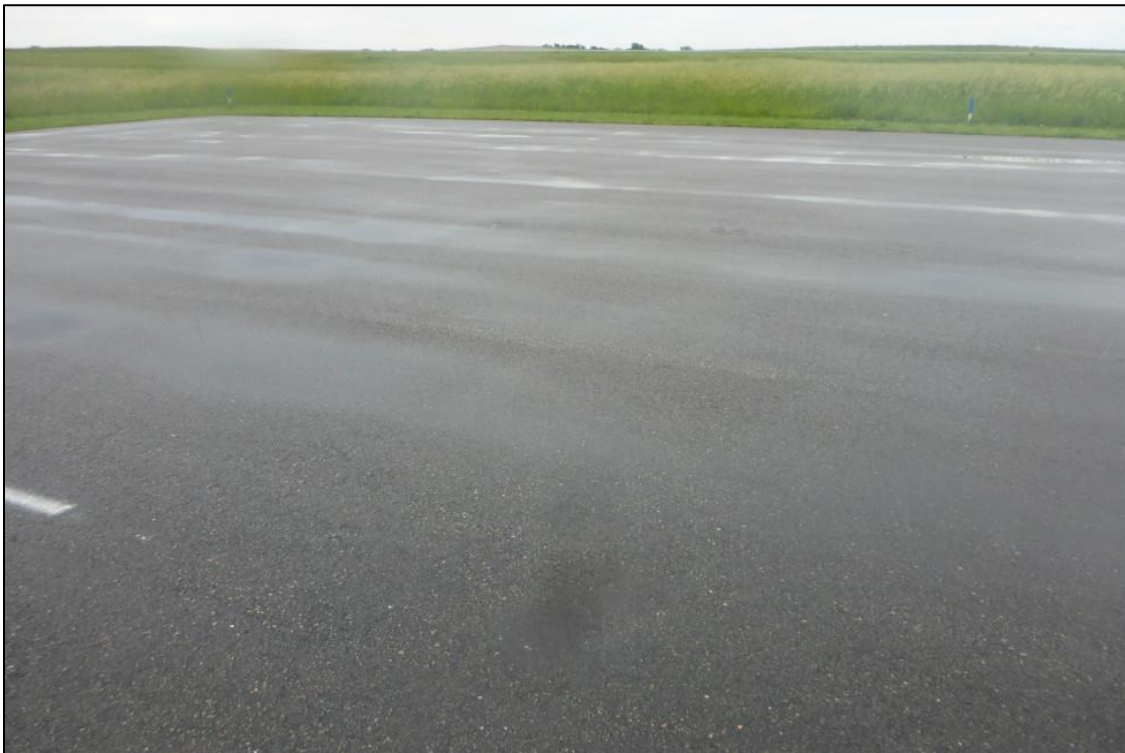
GDB TLA 004 (PCI = 95)

Network:	GDB	Name:	GRANITE FALLS					
Branch:	TLA	Name:	Taxilane A	Use:	TAXILANE	Area:	120,735 SqFt	
Section:	004	of 5	From:	A	To:	B	Last Const.:	10/1/2014
Surface:	AC	Family:	MN2018 Asphalt Taxilanes	Zone:		Category:	Rank:	S
Area:	33,925 SqFt	Length:	730 Ft	Width:	47 Ft			
Slabs:		Slab Length:	Ft	Slab Width:	Ft	Joint Length:	Ft	
Shoulder:		Street Type:		Grade:	0	Lanes:	0	
Section Comments:								
Last Insp. Date:	6/11/2019	TotalSamples:	9	Surveyed:	2			
Conditions:	PCI: 95							
Inspection Comments:								
Sample Number:	101	Type:	R	Area:	5000.00 SqFt	PCI:	93	
Sample Comments: p988								
45	DEPRESSION	L	21.00	SqFt				
48	L & T CR	L	31.00	Ft				
Sample Number:	201	Type:	R	Area:	2000.00 SqFt	PCI:	100	
Sample Comments:								
<No Distress>

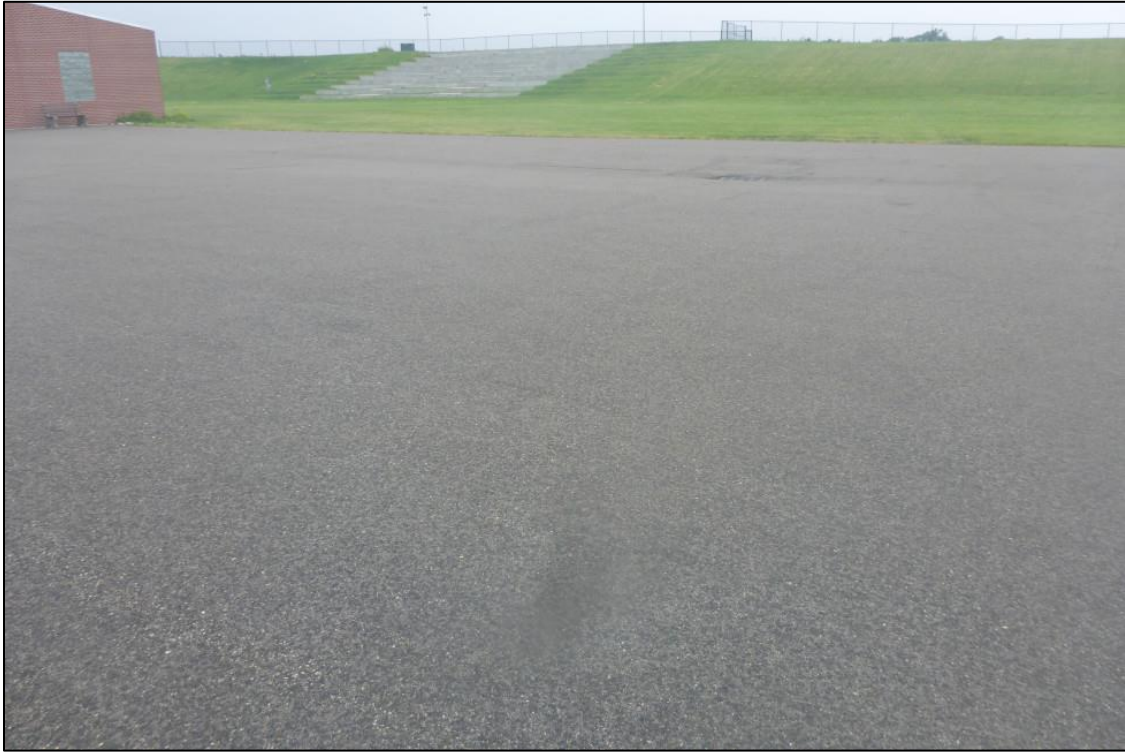
GDB TLA 005 (PCI = 90)

Network:	GDB		Name:	GRANITE FALLS					
Branch:	TLA	Name:	Taxilane A	Use:	TAXILANE	Area:	120,735 SqFt		
Section:	005	of 5	From:	A	To:	B	Last Const.:	10/1/2014	
Surface:	AC	Family:	MN2018 Asphalt Taxilanes	Zone:		Category:		Rank:	T
Area:	15,820 SqFt	Length:	145 Ft	Width:	110 Ft				
Slabs:		Slab Length:	Ft	Slab Width:	Ft	Joint Length:	Ft		
Shoulder:		Street Type:		Grade:	0	Lanes:	0		
Section Comments:									
Last Insp. Date:	6/11/2019		TotalSamples:	4		Surveyed:	2		
Conditions:	PCI:	90							
Inspection Comments:									
Sample Number:	300	Type:	R	Area:	4000.00 SqFt	PCI:	94		
Sample Comments:	p980								
48	L & T CR	L	61.00 Ft						
Sample Number:	301	Type:	R	Area:	4000.00 SqFt	PCI:	86		
Sample Comments:	p981								
48	L & T CR	L	57.00 Ft						
53	RUTTING	L	5.00 SqFt
