3RD AVENUE BRIDGE

Bridge Inspection and Condition Evaluation Report

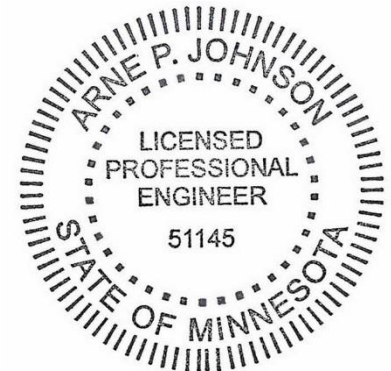
Prepared by:
Wiss, Janney, Elstner Associates, Inc.
330 Pflingsten Road
Northbrook, Illinois 60062
847.272.7400 tel | 847.291.9599 fax

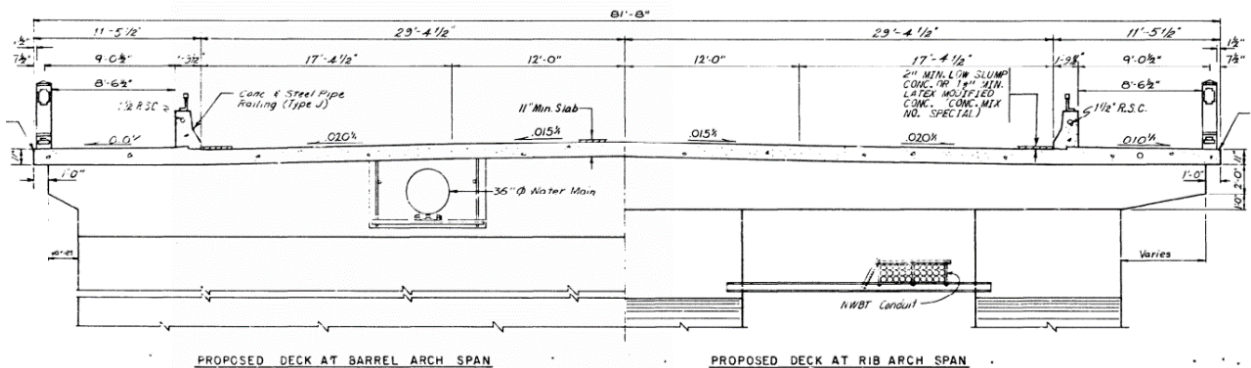
Figure 2.10. Typical bridge deck cross section in arch spans (from 1980 plans).

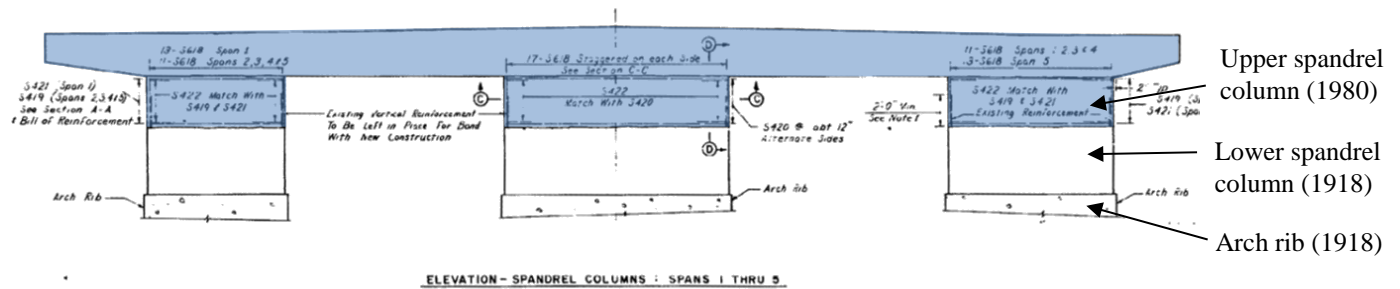
Figure 2.14. Typical bridge cross section from 1980 plans. Blue shading indicates cap beams and upper portions of spandrel columns that were replaced in 1980.

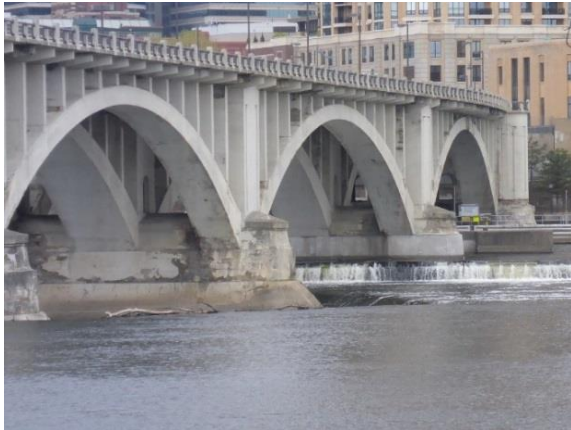
Figure 2.15. Overall view of arch ribs supporting spandrel columns and cap beams.

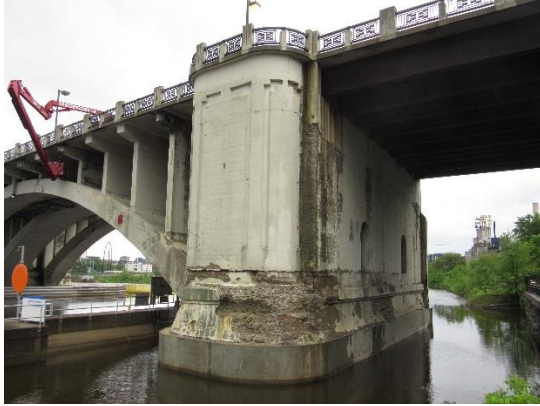
Figure 2.21. Overall view of Arch Pier 1 from upstream side.

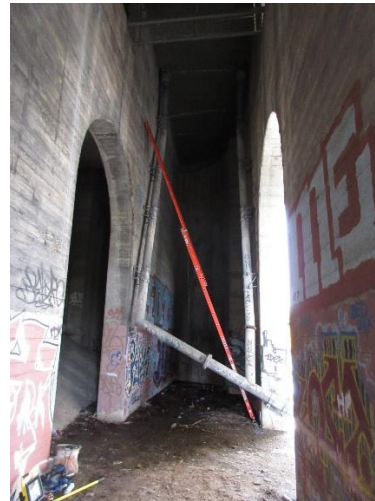
Figure 2.24. Interior of Pier 6.

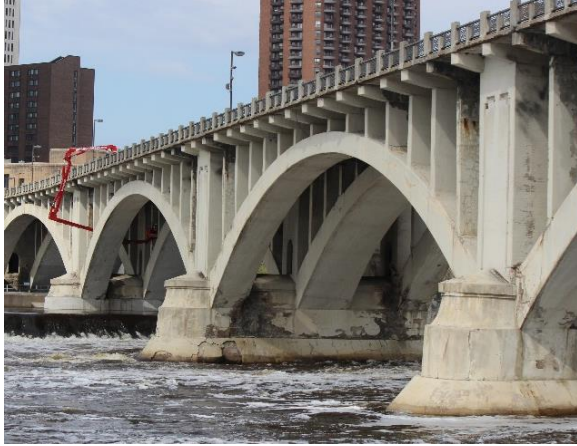
Figure 2.25. Typical view of piers with three pier columns (Piers 2, 3 and 4 shown).

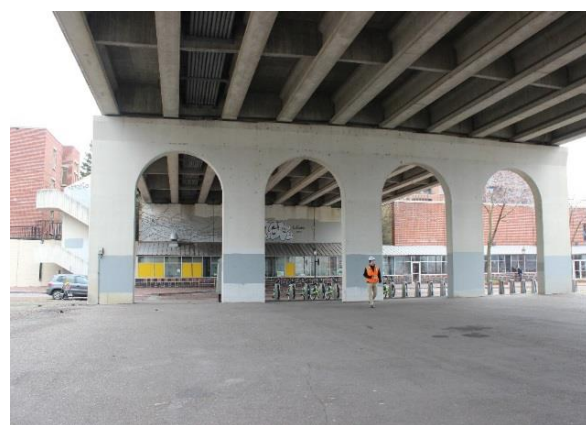
Figure 2.30. North approach framing, looking toward Bent Pier 2 and north abutment.

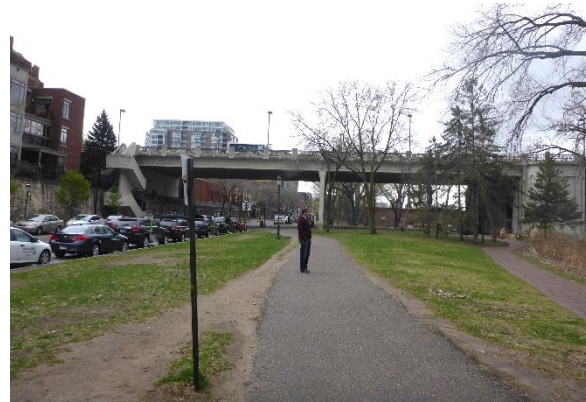
Figure 2.40. View looking east along Main Street below north approach.

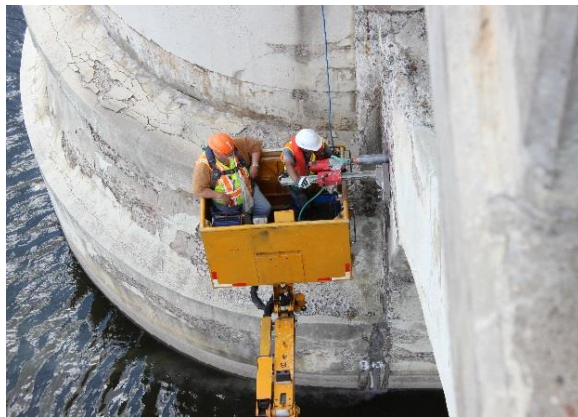
Figure 3.1. Example of concrete core removal.

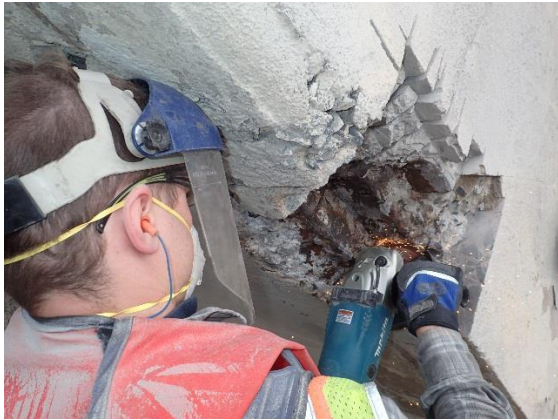
Figure 3.3. Sample removed from delaminated and spalling arch rib corner by cutting edge of angle.

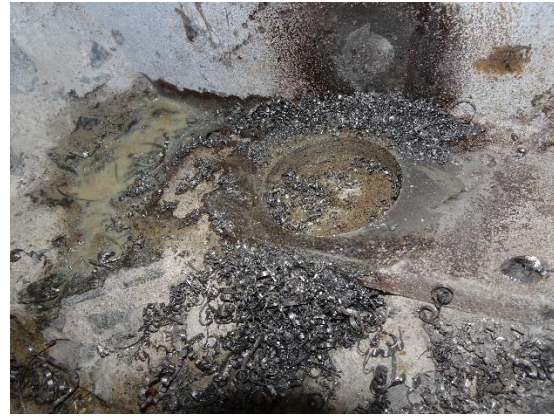
Figure 3.4. Melan truss steel sample removed by coring.

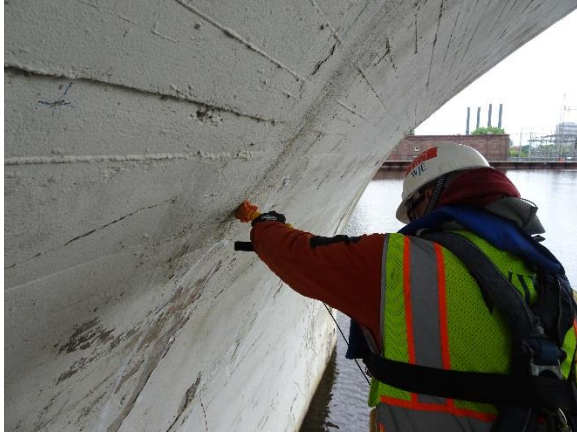
Figure 3.5. HCP survey with CSE electrode and volt meter (barrel arch underside).

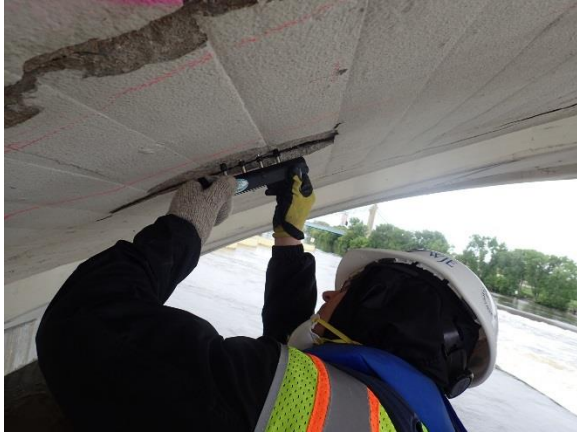
Figure 3.7. Resistivity survey with Resipod (arch rib underside).

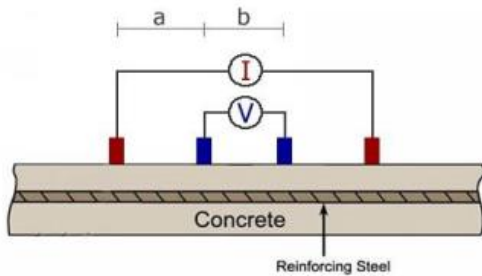
Figure 3.8. Configuration of four probes on the surface of concrete in CEPRA corrosion rate testing (from iCOR manual).

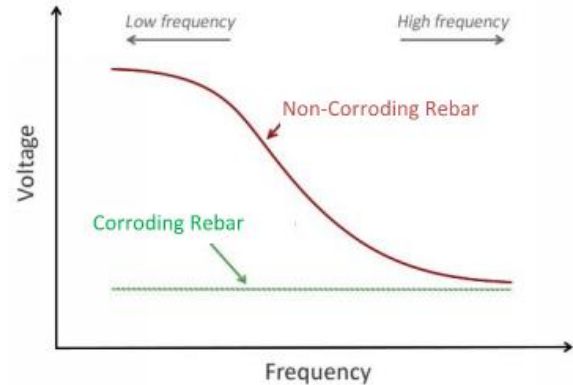
Figure 3.9. Schematic illustration of voltage-frequency response of a corroding and non-corroding rebar, as evaluated by CEPRA corrosion rate testing (from iCOR manual).

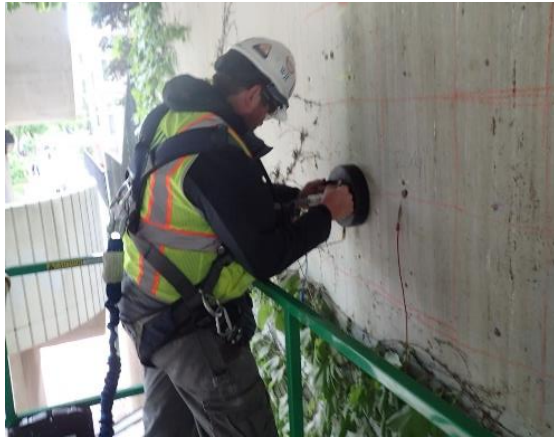
Figure 3.10. Corrosion rate survey (north abutment).

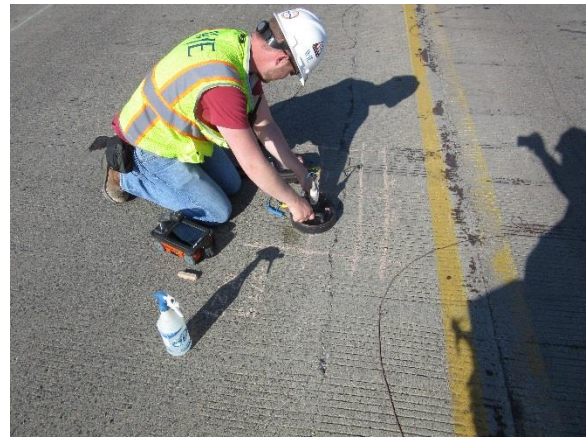
Figure 3.11. Corrosion rate survey (deck topside).

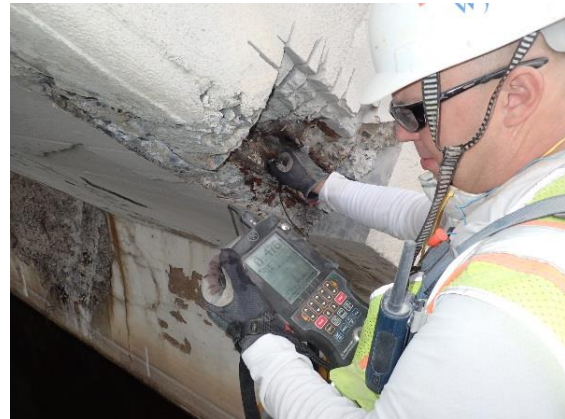
Figure 3.17. Ultrasonic thickness measurement on Melan truss angle in delaminated and spalling corner of arch rib.

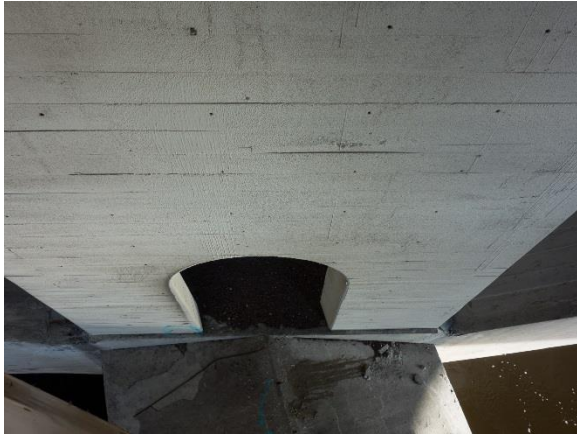
*Figure 4.2. Coating Condition State 1.
Sound, no distress.*

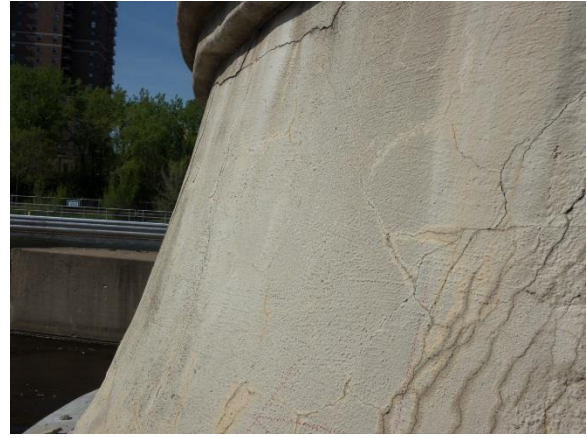
*Figure 4.3. Coating Condition State 2.
Fair, some distress, including cracking and
evidence of moisture movement behind coating.*

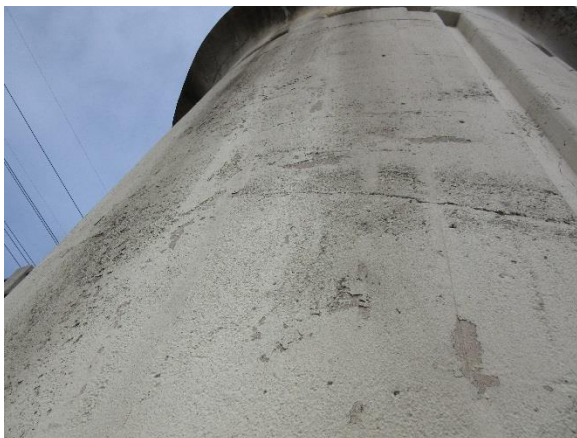
*Figure 4.4. Coating Condition State 3.
Flaking and small areas of debonding.*

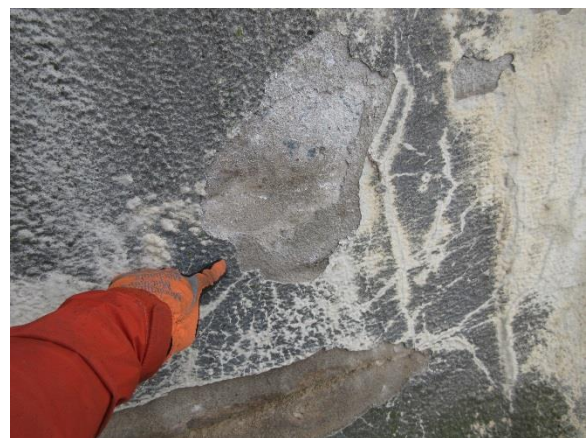
*Figure 4.5. Coating Condition State 4.
Debonding of large areas of coating.*

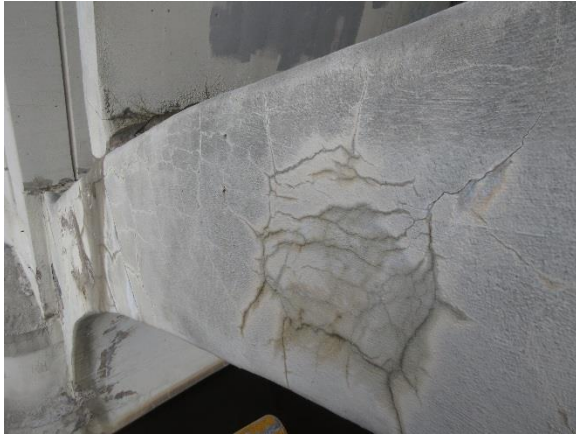
Figure 4.6. Freeze-Thaw Condition State 1. Map cracking and moisture staining only.

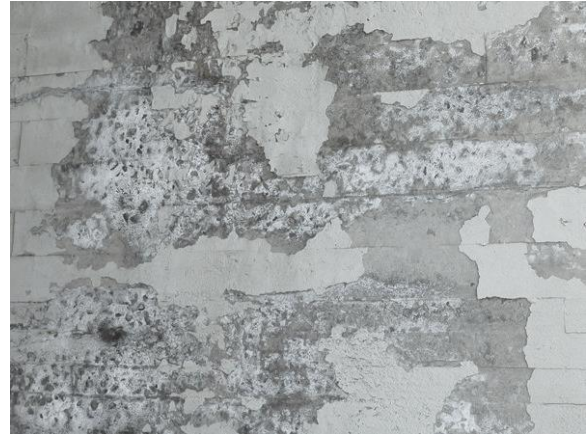
Figure 4.7. Freeze-Thaw Condition State 2. Surface scaling without substantial material loss.

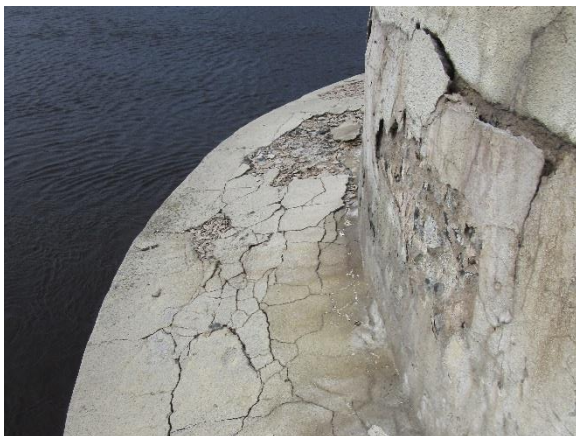
Figure 4.8. Freeze-Thaw Condition State 3. Up to 2 inches (by depth) of concrete deterioration.

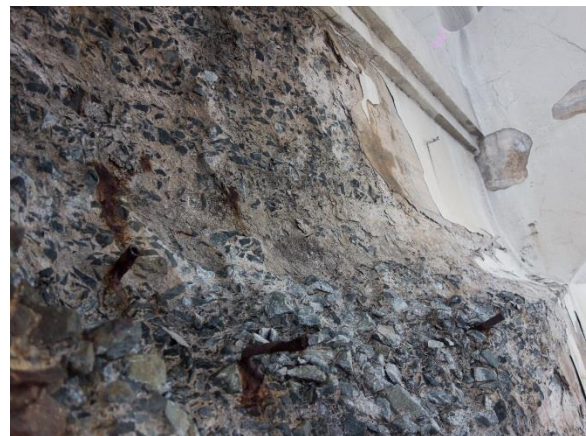
Figure 4.9. Freeze-Thaw Condition State 4. Concrete disintegration and erosion extending greater than 2 inches in depth from original section, or exposed bars.

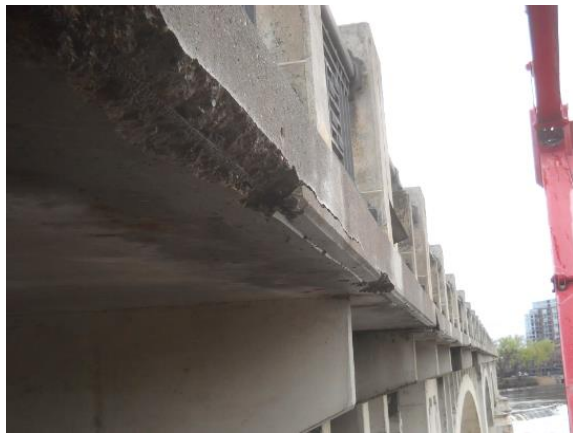
Figure 4.10. Downstream deck edge condition.

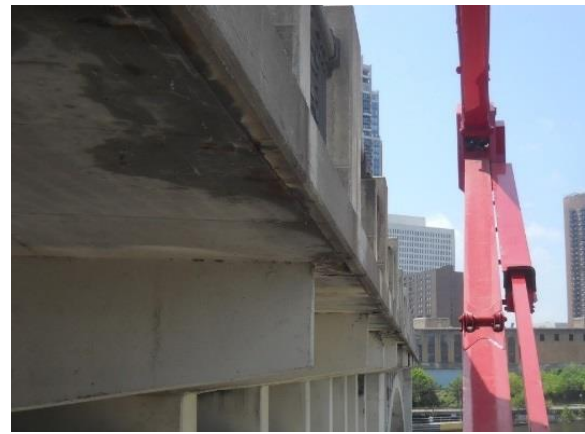
Figure 4.11. Upstream deck edge condition.

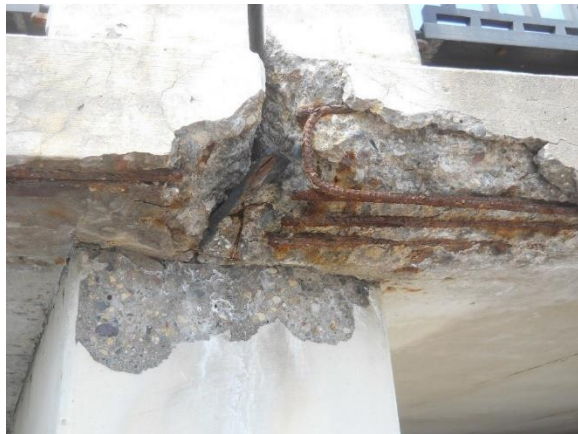
Figure 4.12. Downstream deck edge spall at expansion joint.

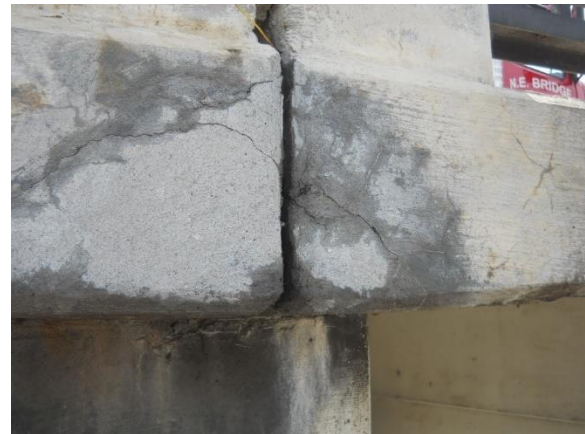
Figure 4.13. Upstream deck edge repair at expansion joint.

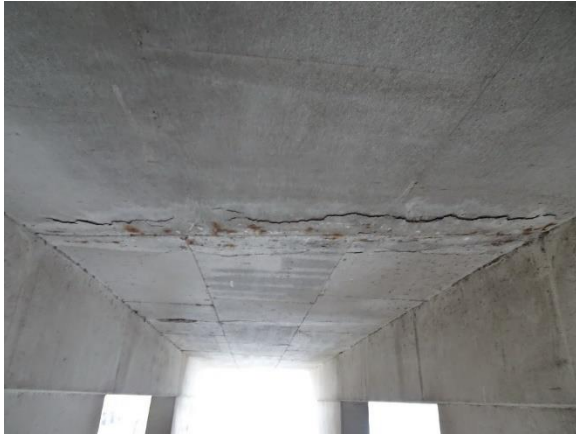
Figure 4.14. Slab underside delamination at centerline of deck.

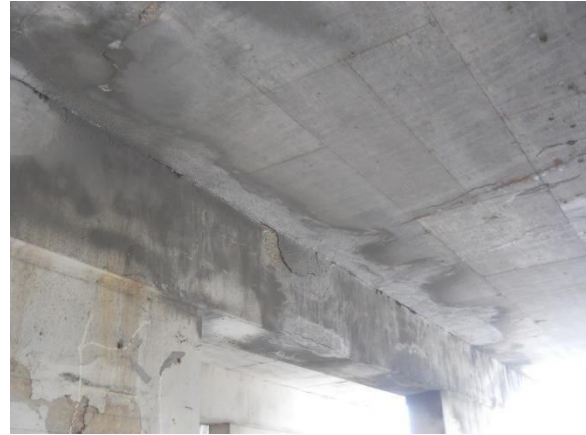
Figure 4.15. Slab underside concrete repair at expansion joints.

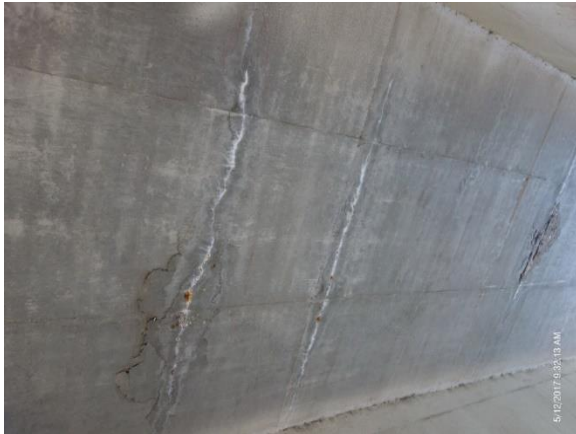
Figure 4.16. Slab underside cracks and delaminations throughout deck.

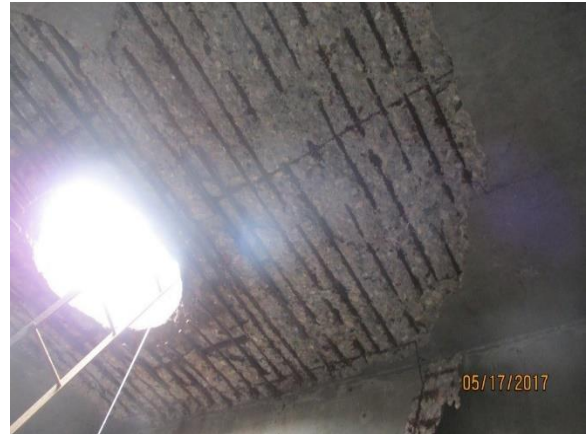
Figure 4.17. Slab underside spalls and rebar section loss at manholes in southbound lane.

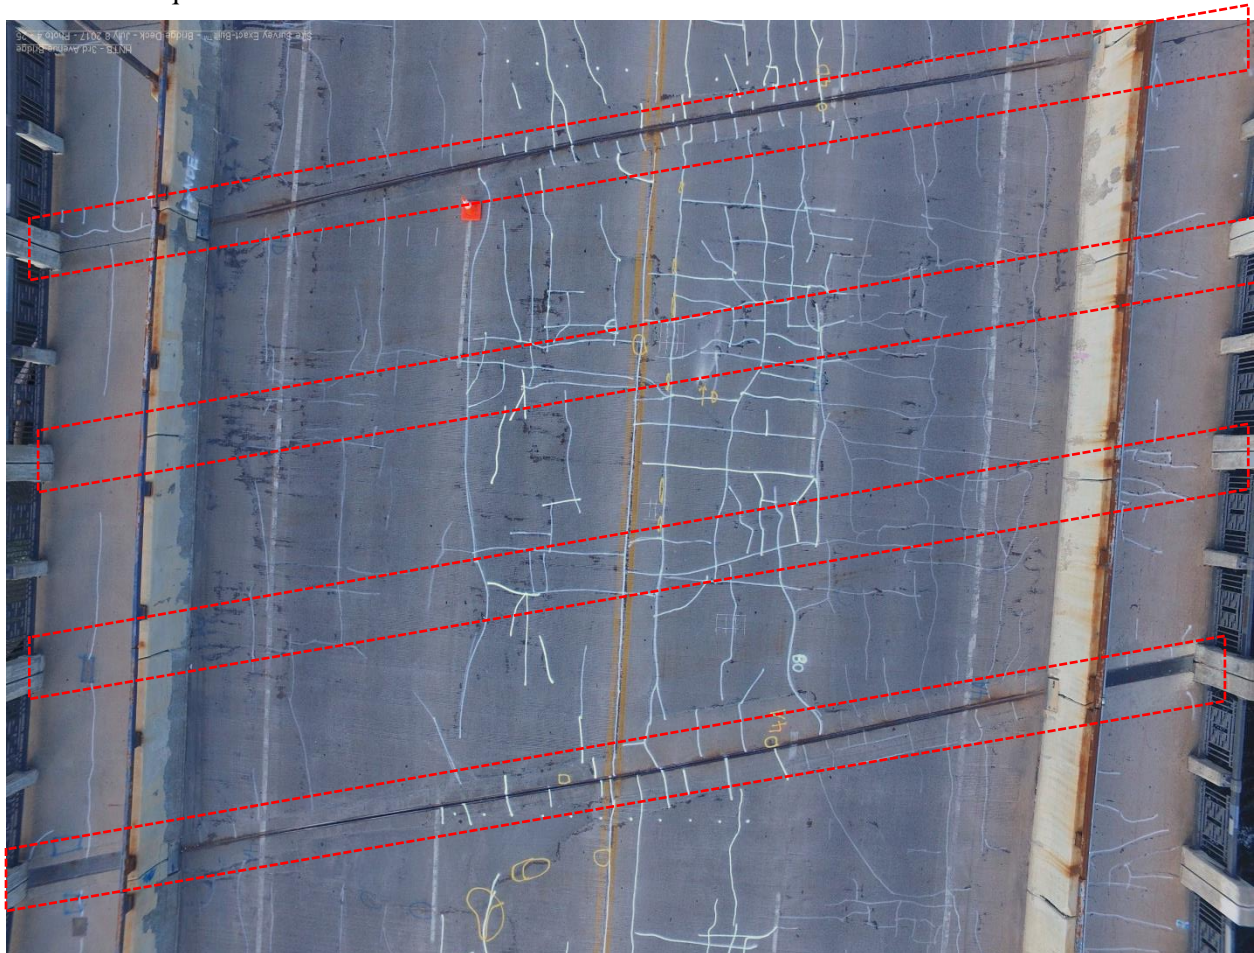
Figure 4.18. Sample aerial drone image of deck span 4A to 4D. Deck cracks were field-marked with non-permanent white spray chalk. Delaminations were circled in yellow. Locations of cap beams below indicated by dotted red lines.

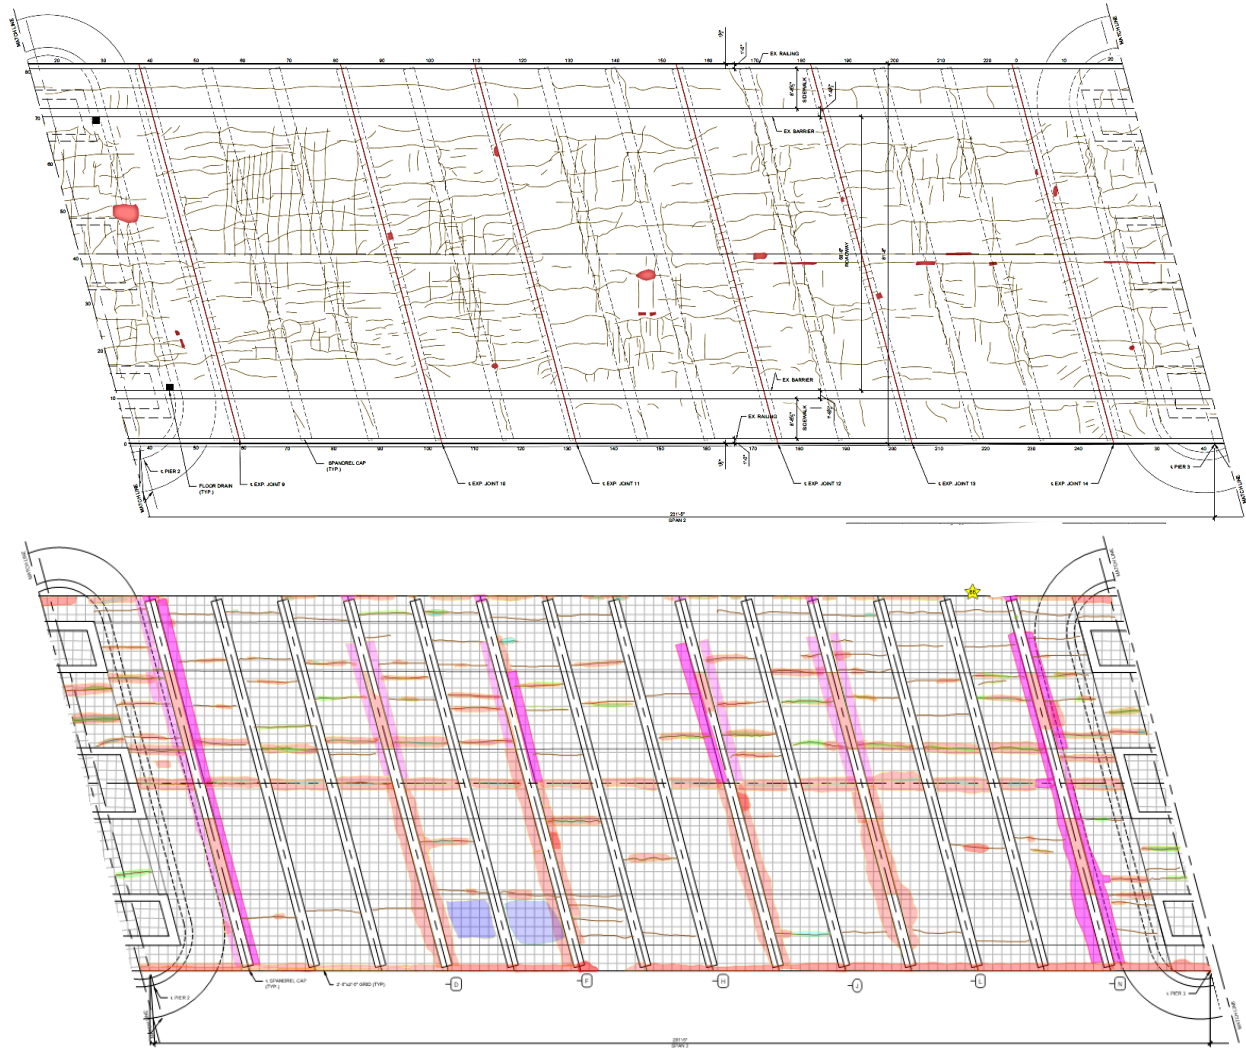
Figure 4.19. Concrete distress for representative arch span (Arch Span 2) deck topside (top figure) and deck underside (bottom figure). See legend in Figure 4.1. See Appendix 2 for field inspection sheets for all spans and all elements.

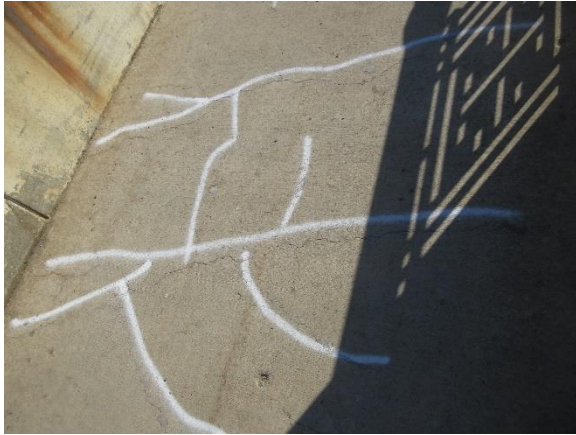
Figure 4.21. Sidewalk cracks over cap beam.

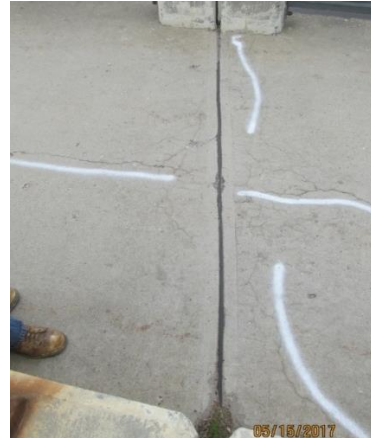
Figure 4.22. Longitudinal crack along upstream sidewalk.

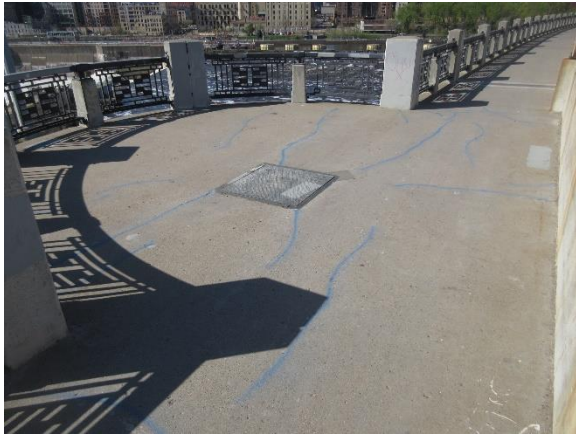
Figure 4.23. Cracks originating from catwalk access hatch.

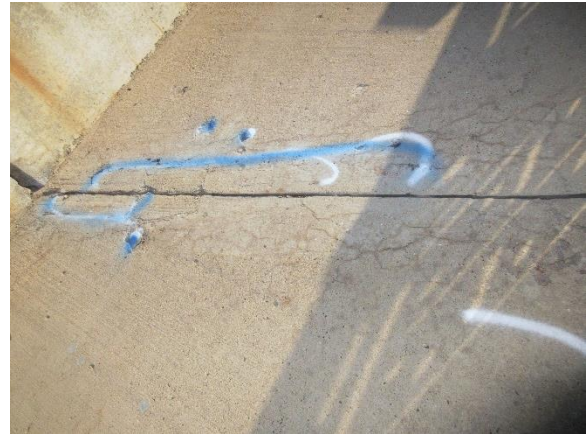
Figure 4.24. Distress similar to D-cracking at poured sealant joints.

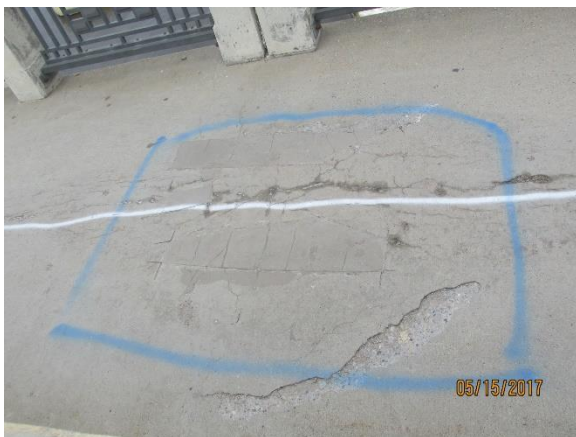
Figure 4.25. Large sidewalk delamination.

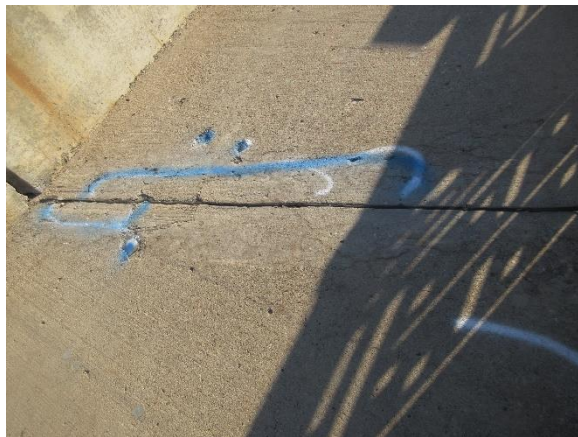
Figure 4.27. Concrete repair and delamination at poured seal.

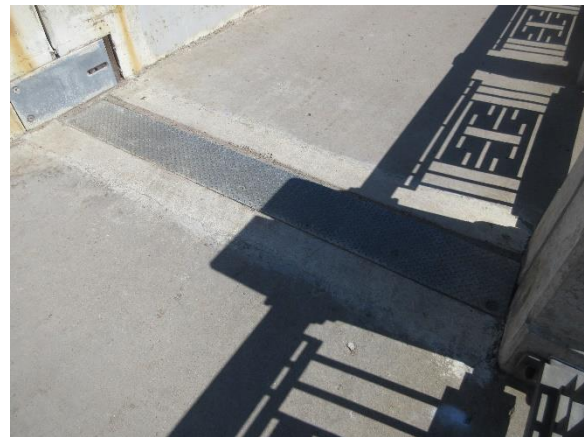
Figure 4.28. Repair material at steel cover plates over strip seal joints.

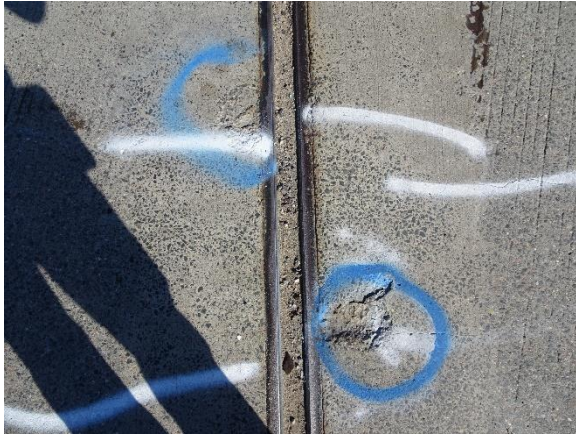
Figure 4.29. Strip seal gland filled with debris. Cracks and spalls are present in the nosing material.

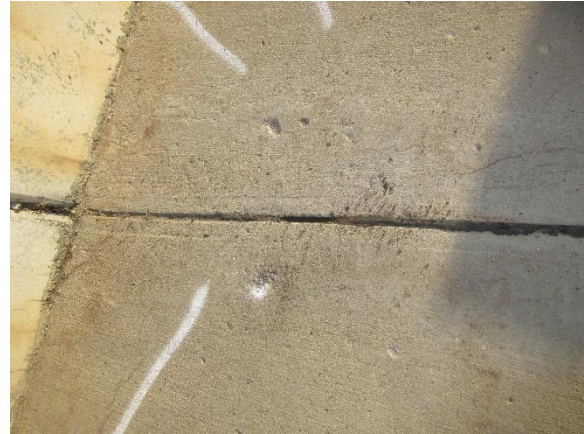
Figure 4.30. Missing section of poured sealant.

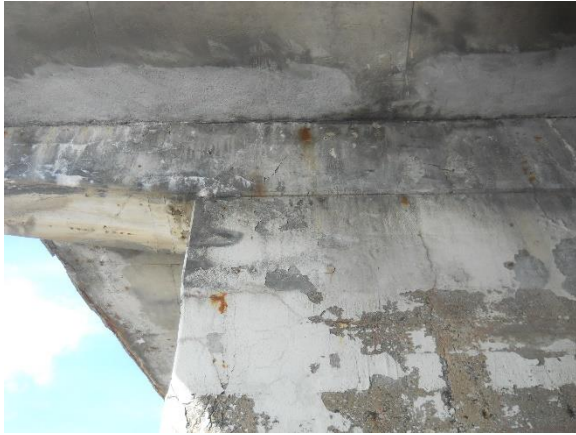
Figure 4.31. Cap beam conditions under expansion joints.

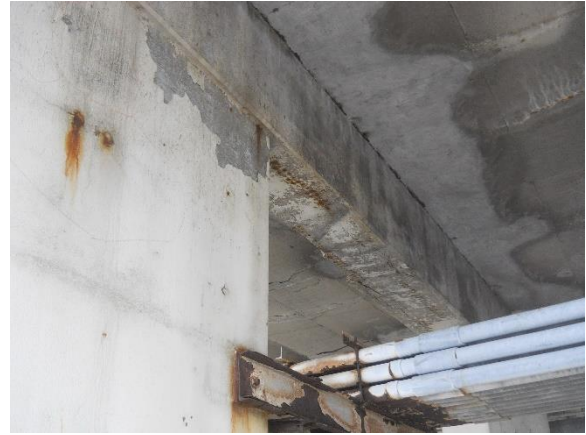
Figure 4.32. Cap beam underside delamination.

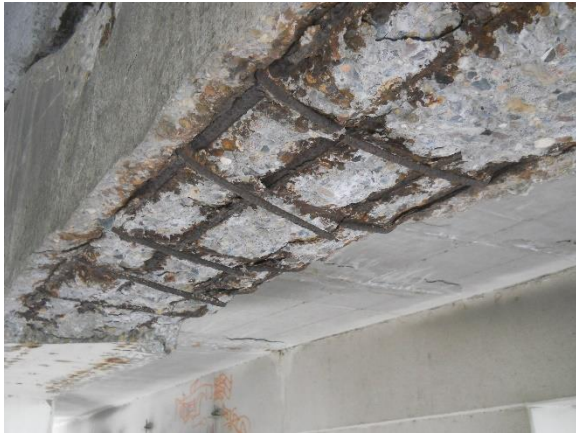
Figure 4.33. Cap beam stirrups corroded through.

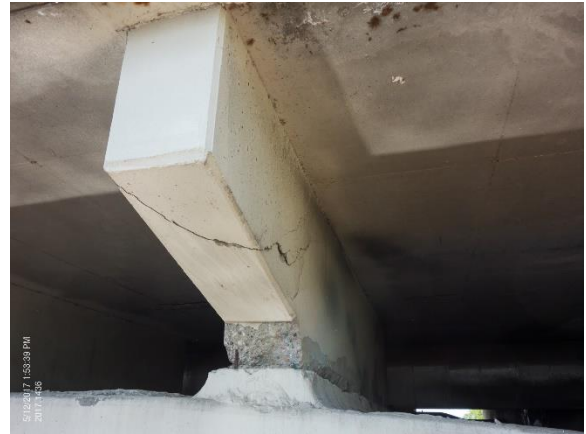
Figure 4.34. Cap beam shear or torsional crack.

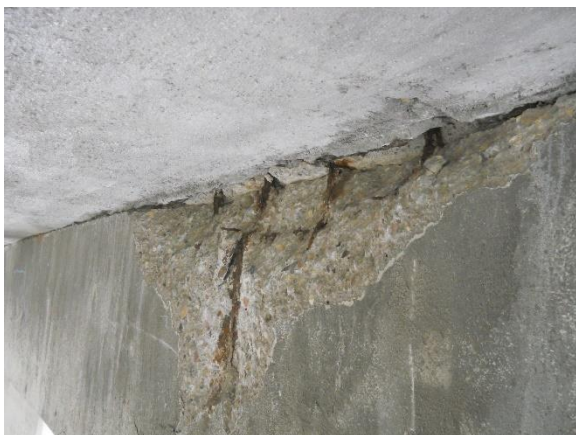
Figure 4.35. Deep cap beam spall with exposed vertical dowels into deck.

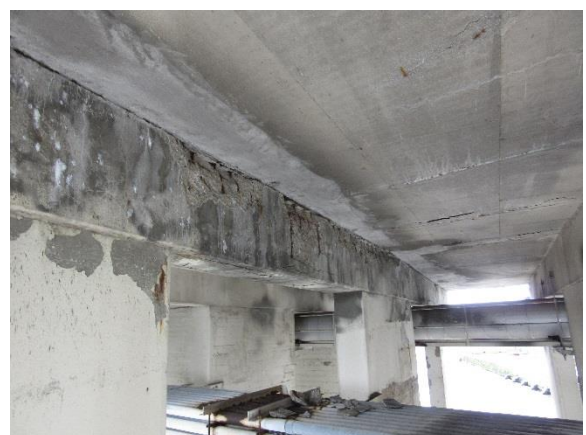
Figure 4.36. Deep spalling along top corner of cap beam.

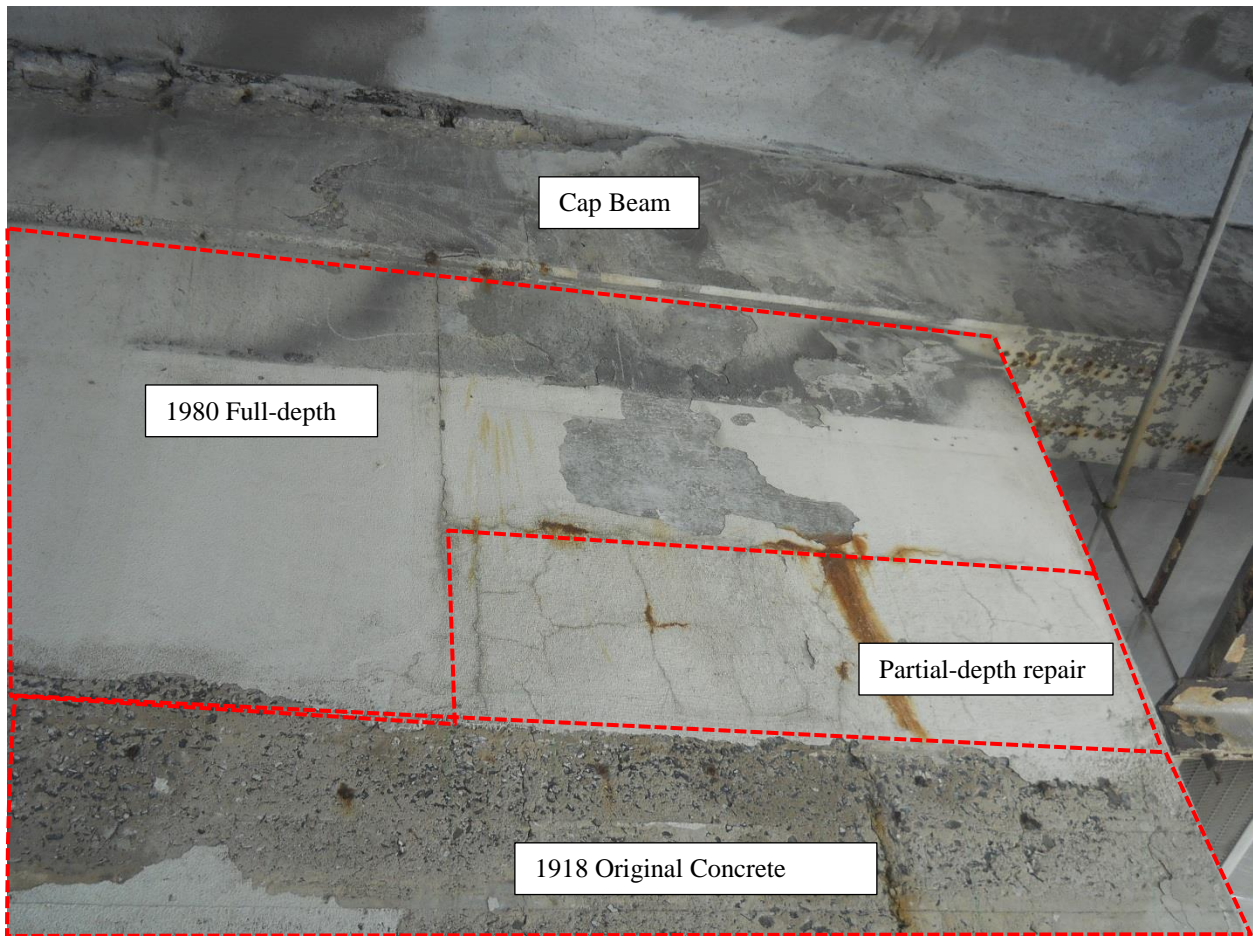
Figure 4.37. View of spandrel column with three types of concrete material illustrated (1980 full-depth concrete, partial-depth repair material, and original 1918 concrete). Note the difference in appearance among the three.

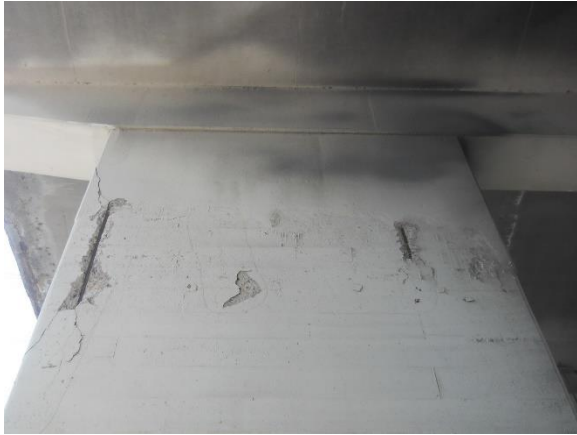
Figure 4.38. Spandrel column spalls at vertical rebar.

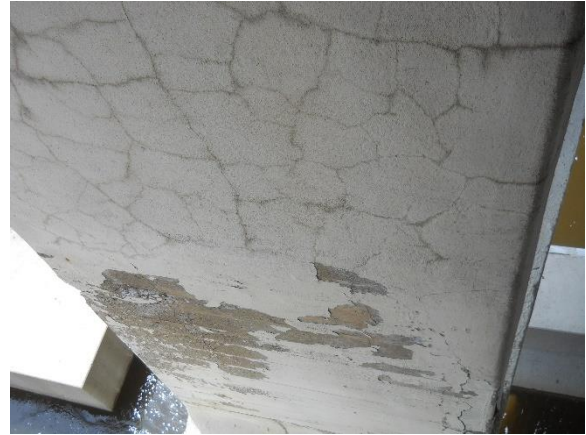
Figure 4.39. Spandrel column map cracking in repair material.

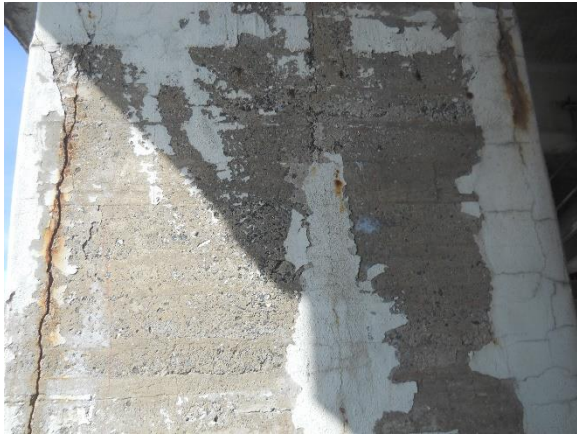
Figure 4.40. Spandrel column vertical cracking, coating failure and eroded concrete surface.

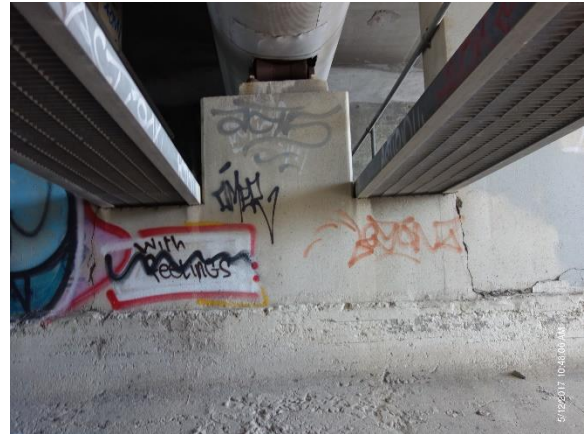
Figure 4.41. Spandrel column cracks at corners of catwalk opening.

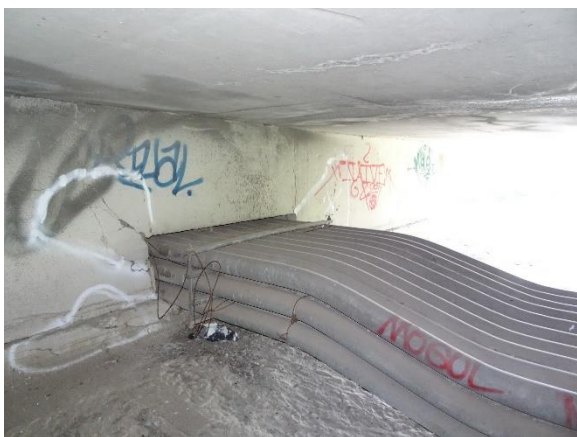
Figure 4.42. Cracks emanating from corners of utility duct opening.

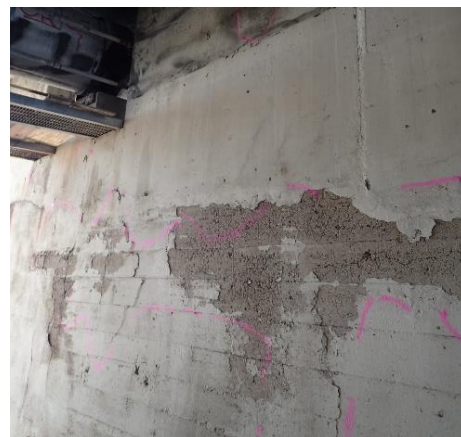
Figure 4.43. Delaminations along vertical and horizontal bars in original concrete.

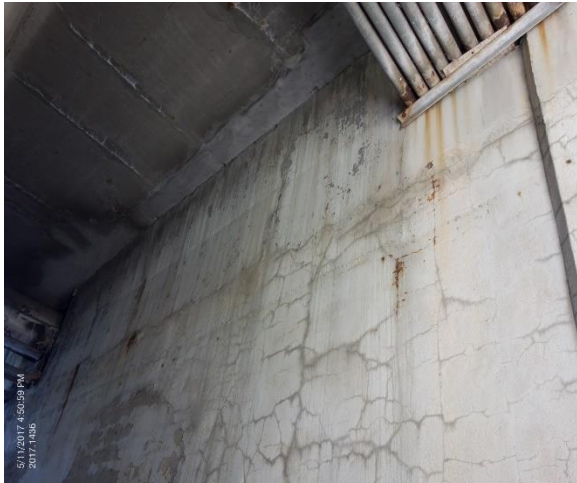
Figure 4.44. Map-cracked repair material.

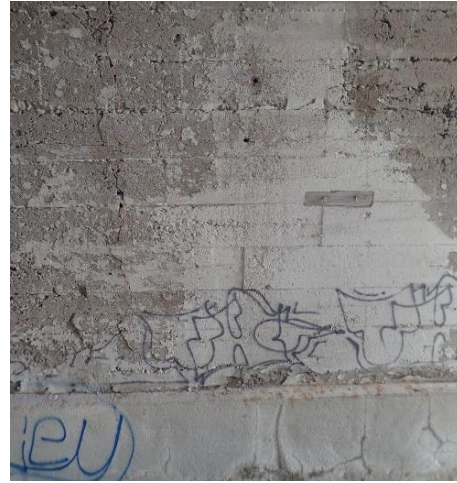
Figure 4.45. Surface erosion of cement paste.

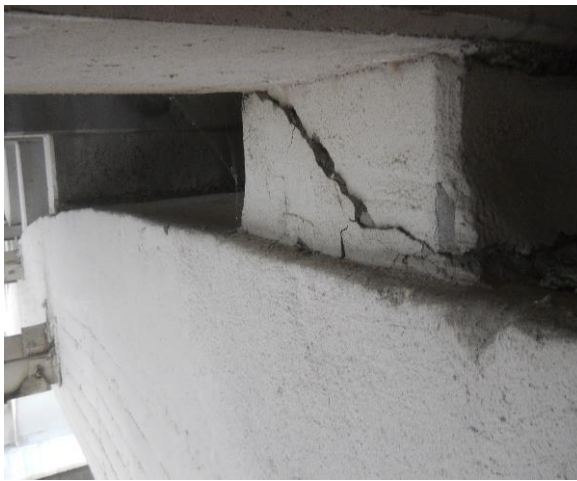
Figure 4.46. Spandrel column shear crack.

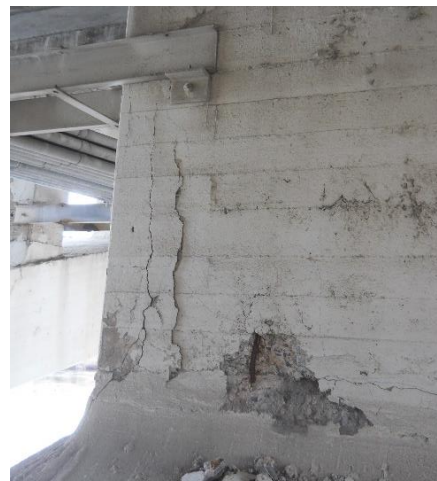
Figure 4.47. Spandrel column corner delamination near utility duct support.

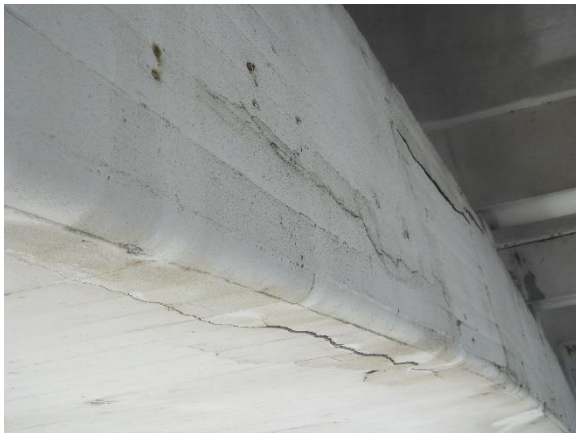
Figure 4.48. Arch rib corner delamination

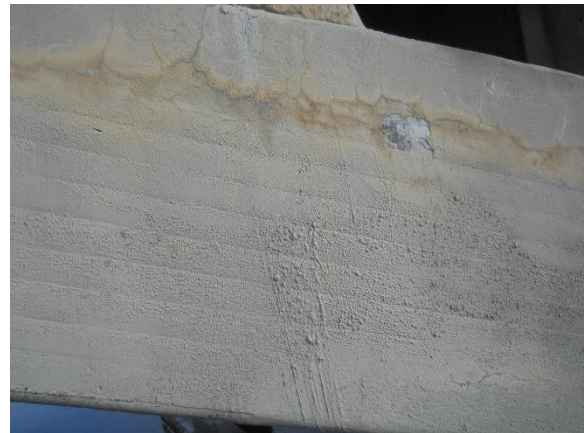
Figure 4.49. Arch rib deteriorated concrete repair.

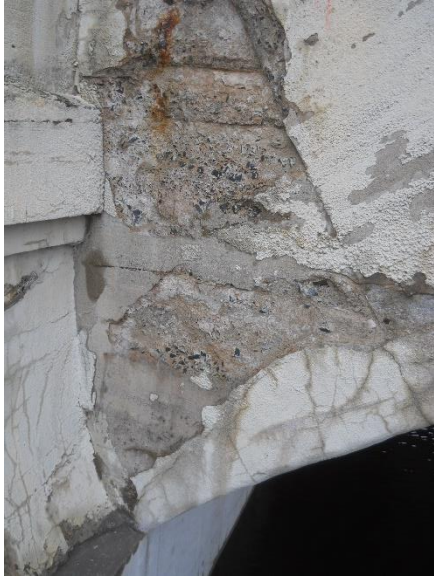
Figure 4.50. Arch rib freeze-thaw deterioration at spring line.

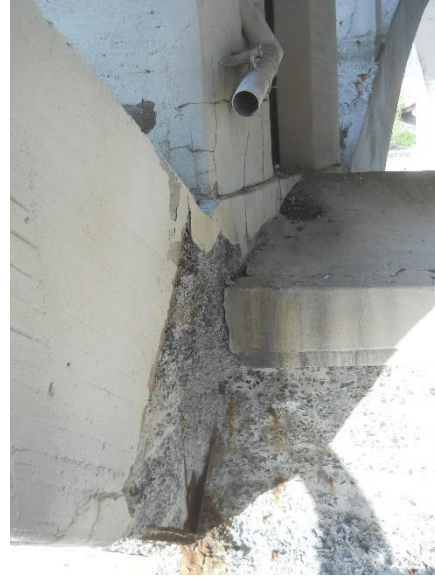
Figure 4.51. Arch rib freeze-thaw deterioration under drain outlet.

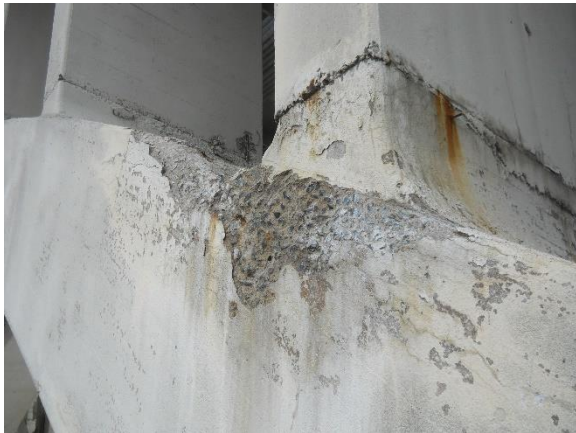
Figure 4.52. Arch rib freeze-thaw deterioration at spandrel column base.

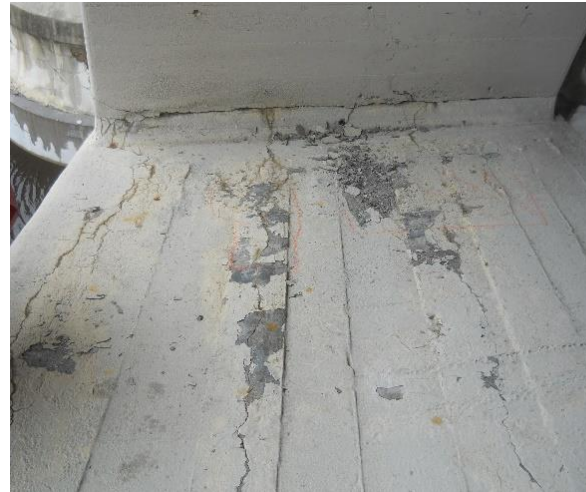
Figure 4.53. Arch rib topside cracks aligned with Melan truss angles.

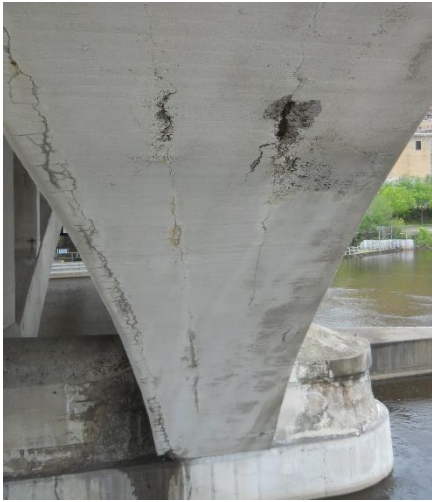
Figure 4.54. Arch rib underside cracks aligned with Melan truss angles.

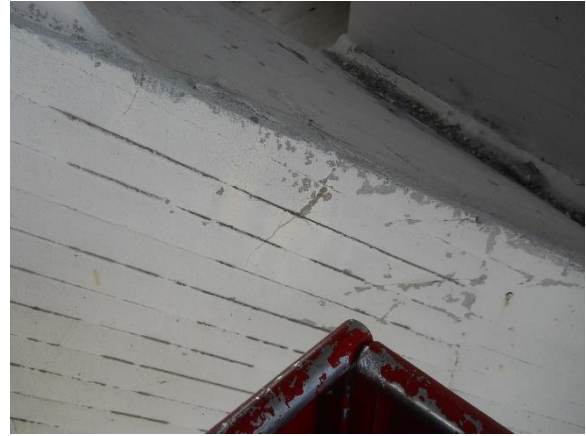
Figure 4.55. Arch rib transverse crack on upstream face.

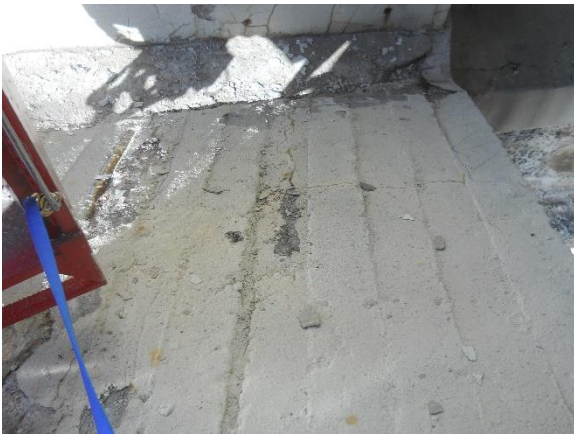
Figure 4.56. Arch rib transverse crack on topside.

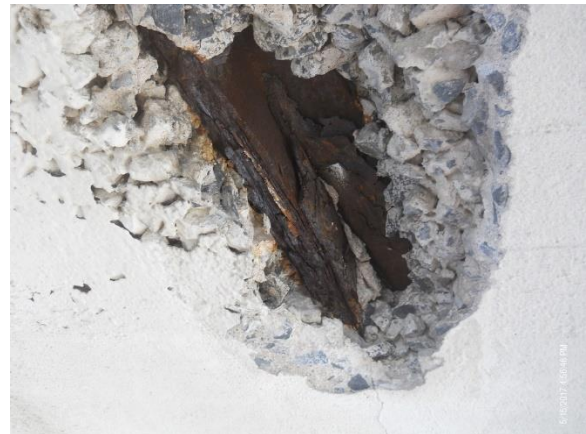
Figure 4.57. Arch rib exposed Melan truss angle at location of poor concrete consolidation.

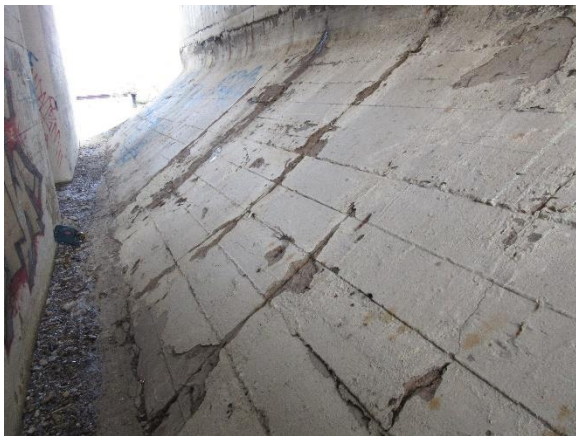
Figure 4.58. Barrel arch topside cracks aligned with Melan truss angles.

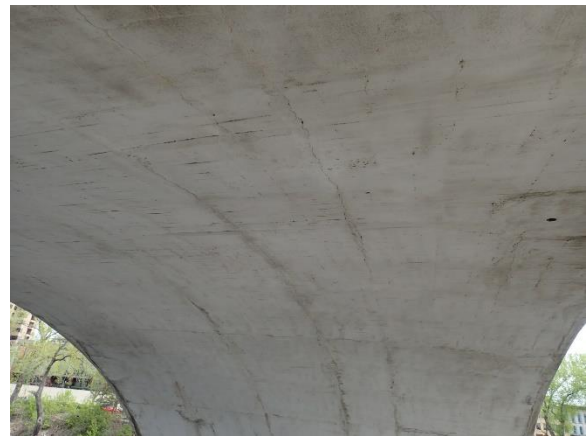
Figure 4.59. Barrel arch underside cracks aligned with Melan truss angles.
