3RD AVENUE BRIDGE

Bridge Inspection and Condition Evaluation Report

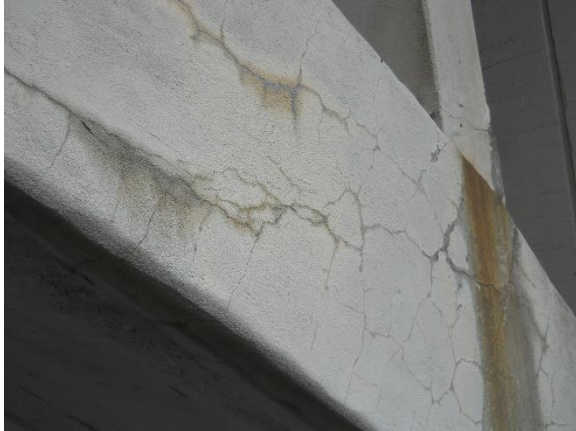
Figure 4.60. Barrel arch deteriorated concrete repair.

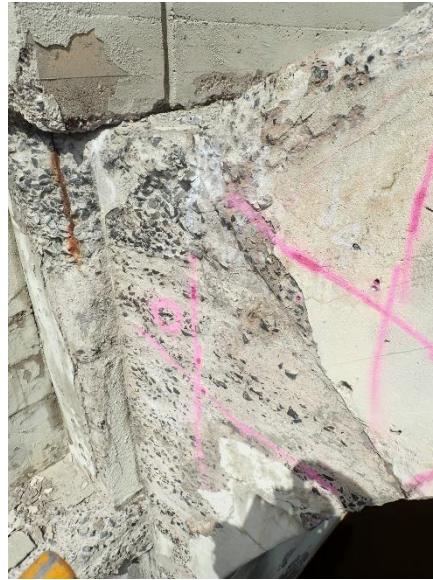
Figure 4.61. Barrel arch freeze-thaw deterioration at arch spring line.

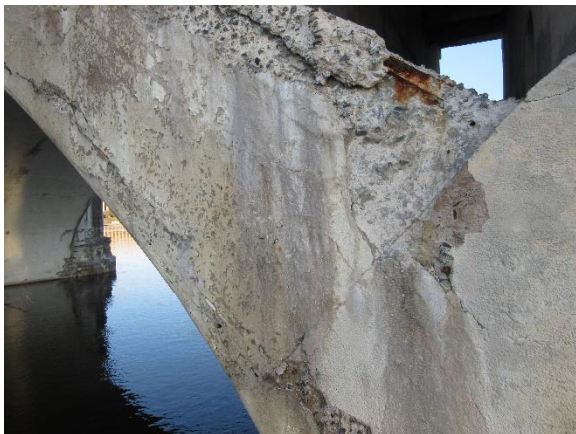
Figure 4.62. Exposed Melan truss angle at barrel arch.

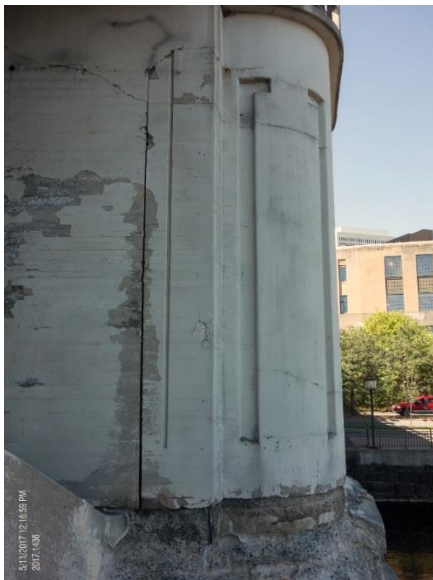
Figure 4.63. View of north face of Pier 1. Most of the wall face was sound with only isolated cracks and spalls.

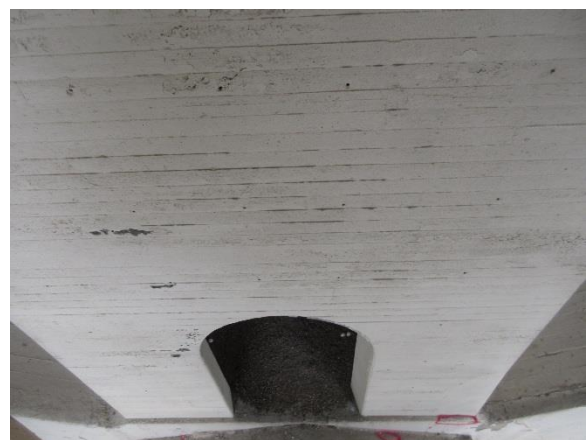
Figure 4.64. Typical appearance of pier wall in good condition. Note original form board texture.

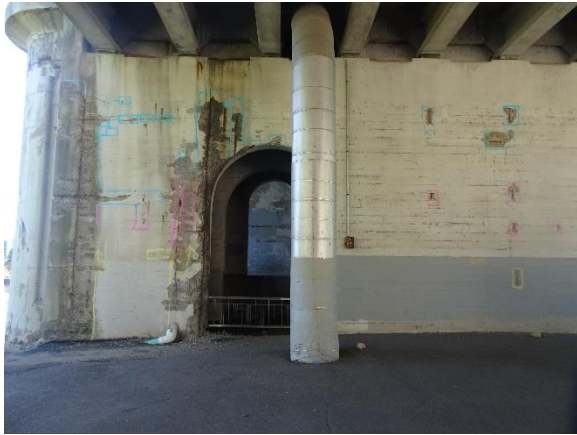
Figure 4.65. Deteriorated concrete on the north face of Pier 8 (outlined in spray chalk).

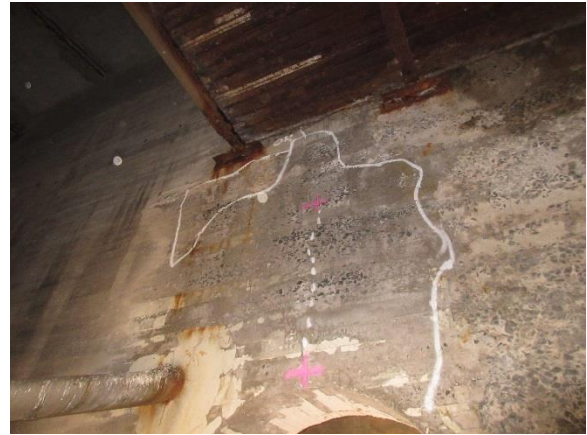
Figure 4.66. Deteriorated concrete below access platform on the inside of Pier 1.

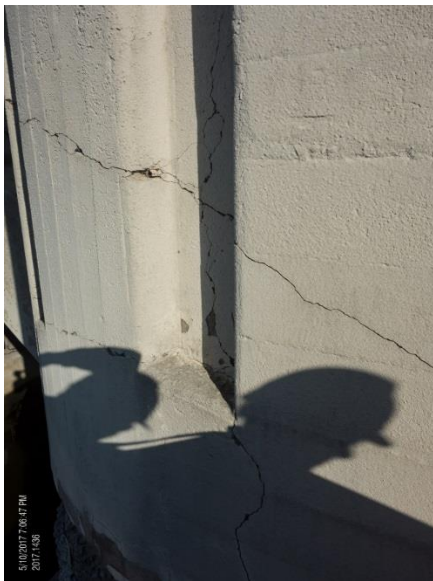
Figure 4.67. Wide diagonal crack at Pier 1, upstream face.

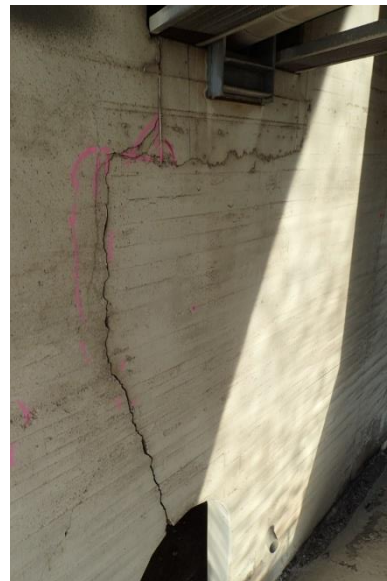
Figure 4.68. Wide crack over arched door opening in Pier 1.

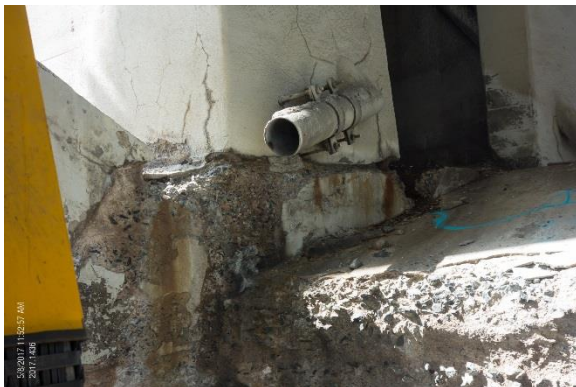
Figure 4.71. Drain outfall at Pier 2 and concrete deterioration below.

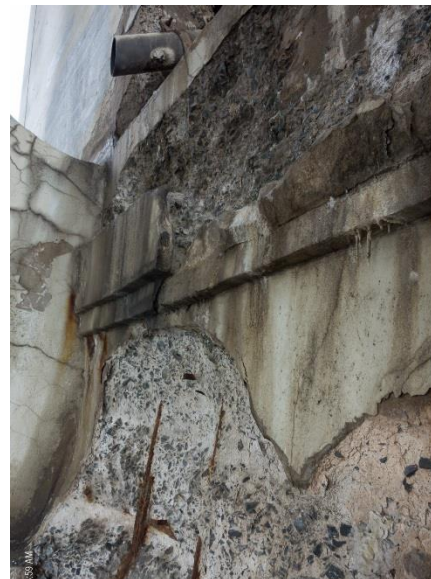
Figure 4.72. Drain outfall at Pier 6 and concrete deterioration below.

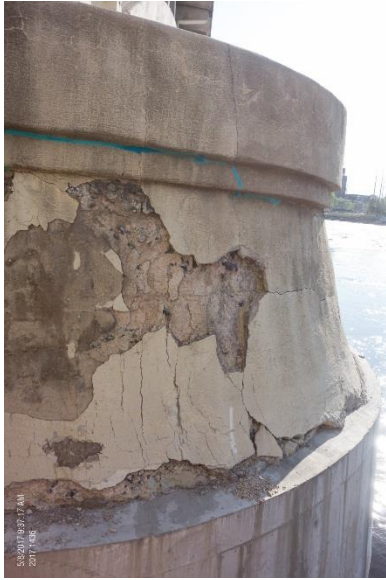
Figure 4.73. Deteriorated repair material at the base of Pier 2.

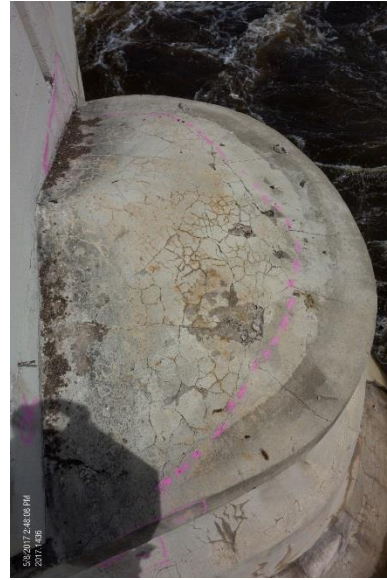
Figure 4.74. Deteriorated repair material at the base of Pier 3.

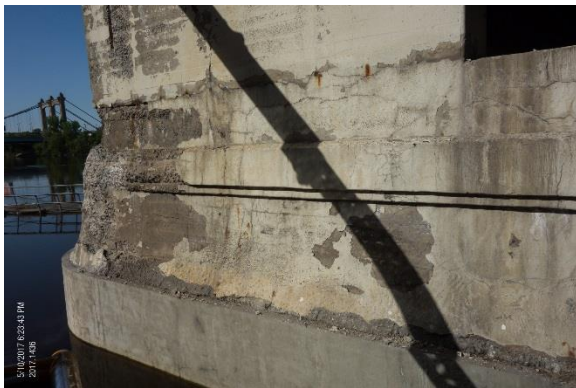
Figure 4.75. Concrete jacket at the base of Pier 1.

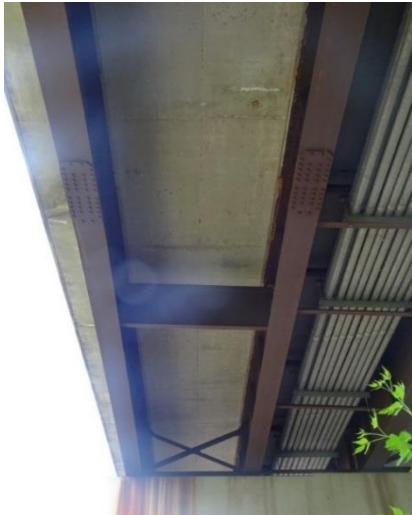
Figure 4.77. South approach transverse cracks on slab underside along sidewalk.

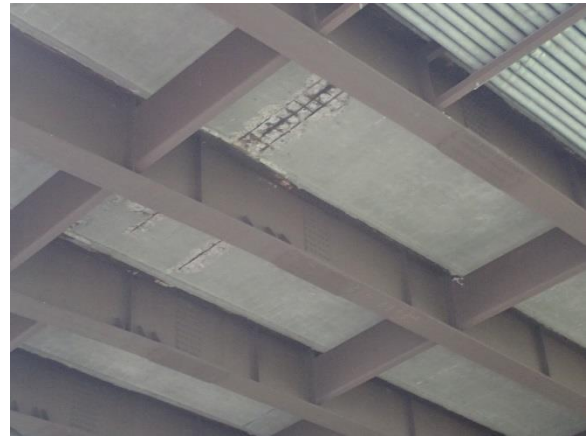
Figure 4.78. South approach slab underside spalls near south bent.

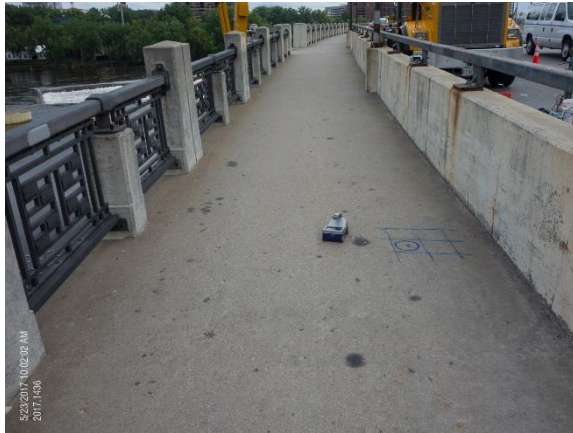
Figure 4.79. Overall view of sidewalk on approach.

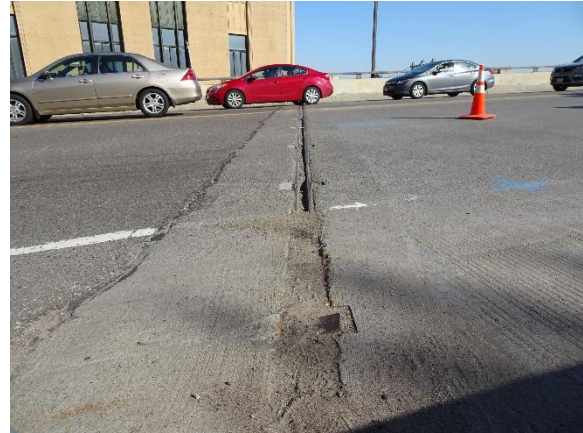
Figure 4.80. South approach strip seal joint with missing plow fingers.

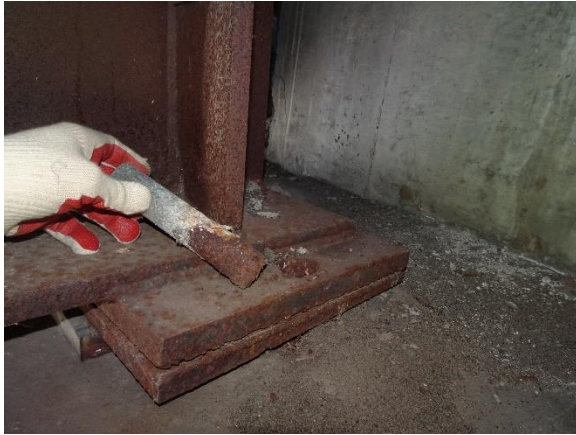
Figure 4.81. South abutment fixed bearing fractured anchor bolt.

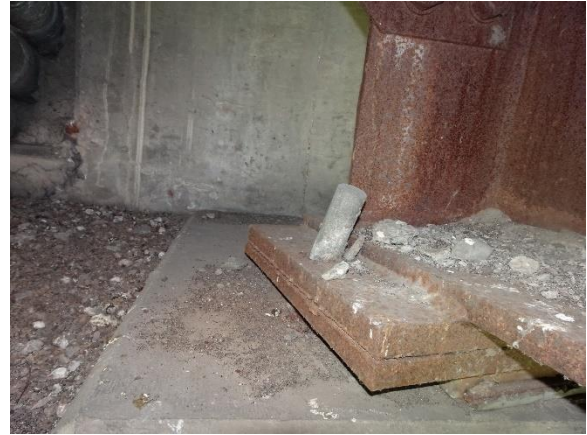
Figure 4.82. South abutment fixed bearing bent or rotated anchor bolt.

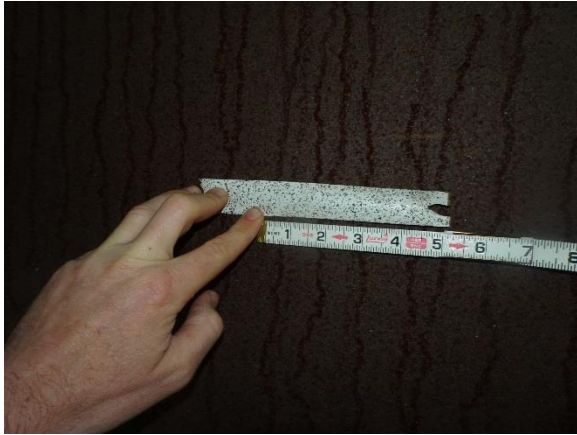
Figure 4.85. South approach, tape adhesion test of weathering steel patina in good condition (CS1 rating).

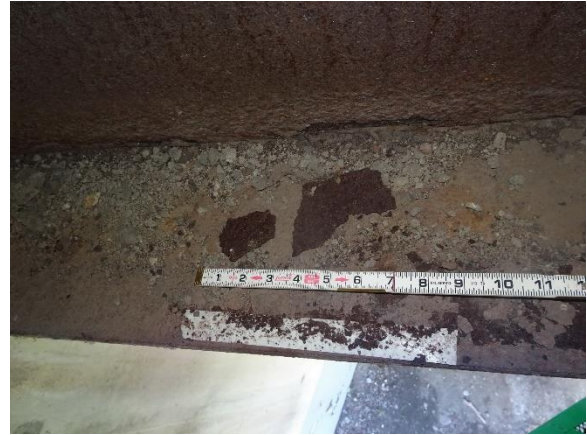
Figure 4.86. South approach, tape adhesion test of weathering steel patina in poor condition and flaking (CS4 rating).

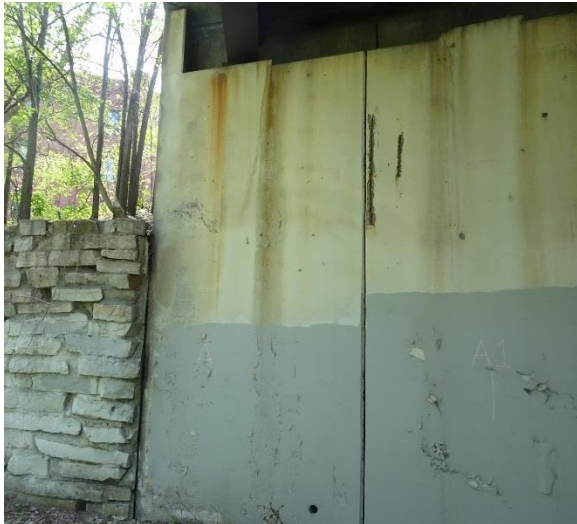
Figure 4.87. South abutment spalls.

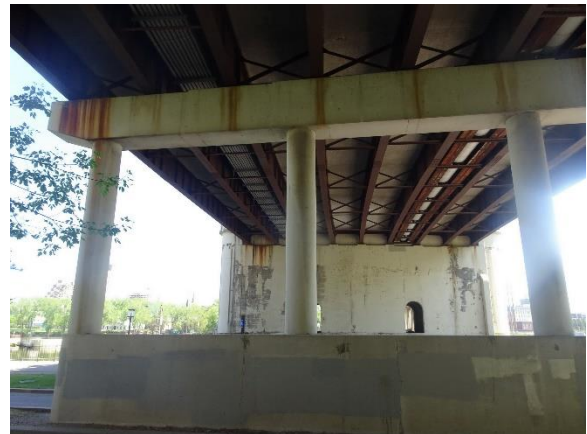
Figure 4.88. South bent pier cap rust stains.

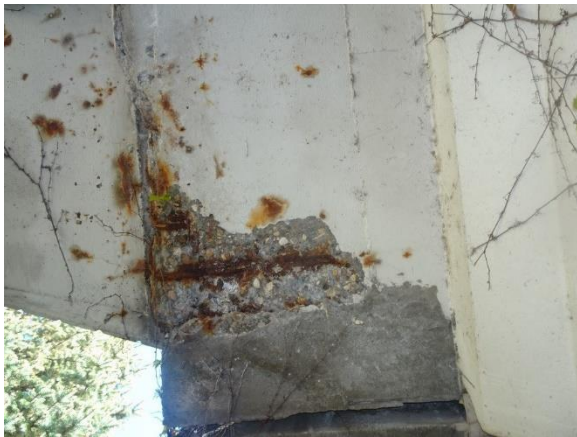
Figure 4.89. North approach slab underside spall near the north abutment.

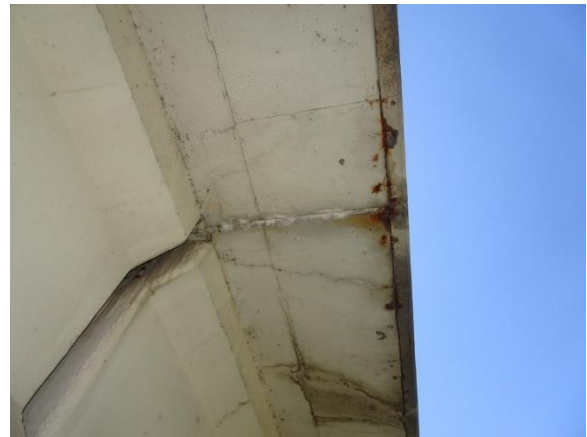
Figure 4.90. North approach slab underside diagonal cracking and efflorescence at the north bent.

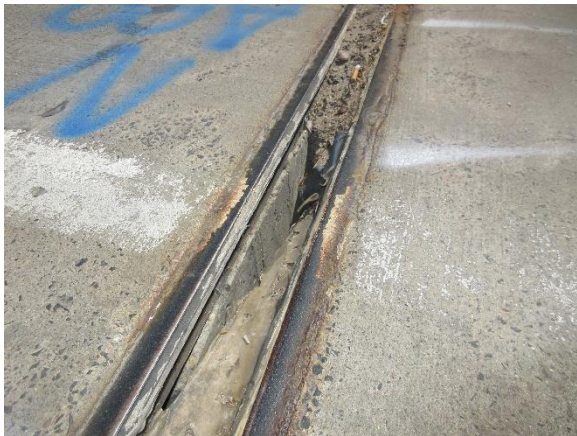
Figure 4.91. North approach strip seal gland tear.

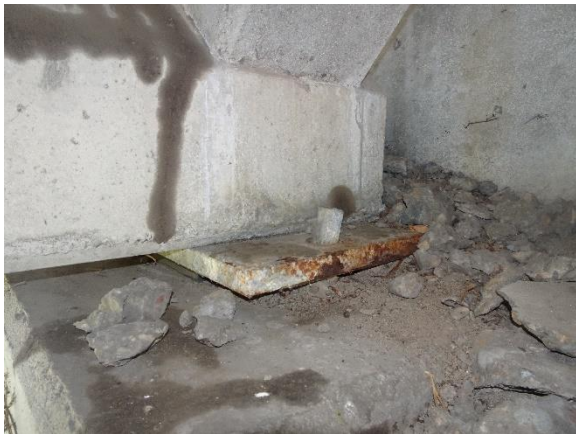
Figure 4.92. North abutment fixed bearing surface rust.

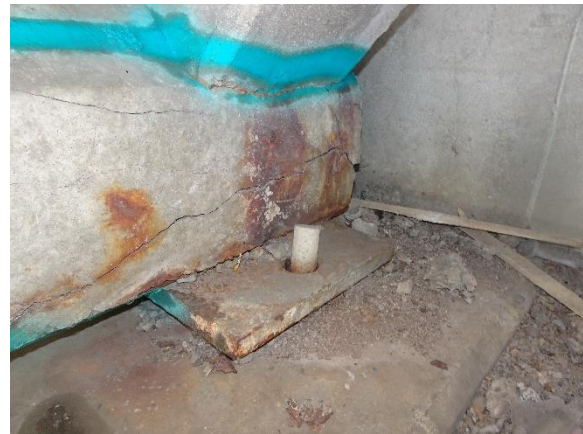
Figure 4.93. Precast beam concrete distress at north abutment.

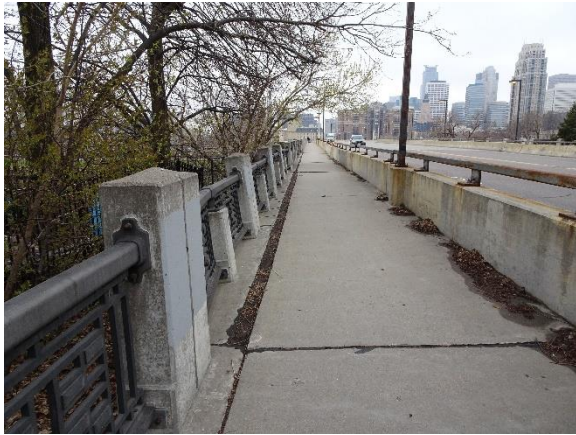
Figure 4.94. North approach, downstream railing leaning outward and gap at sidewalk due to retaining wall cap rotation.

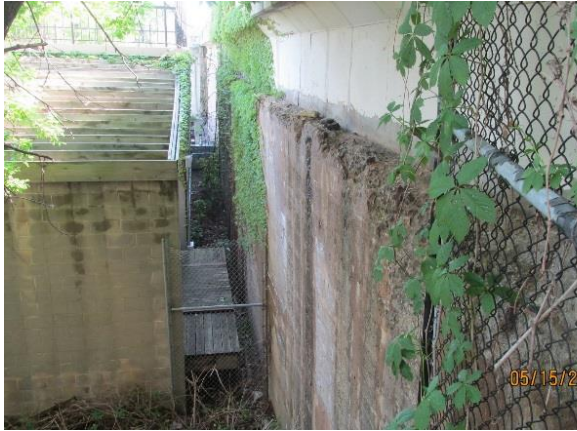
Figure 4.97. View looking south along downstream retaining wall. Note freeze-thaw damage at top of original concrete.

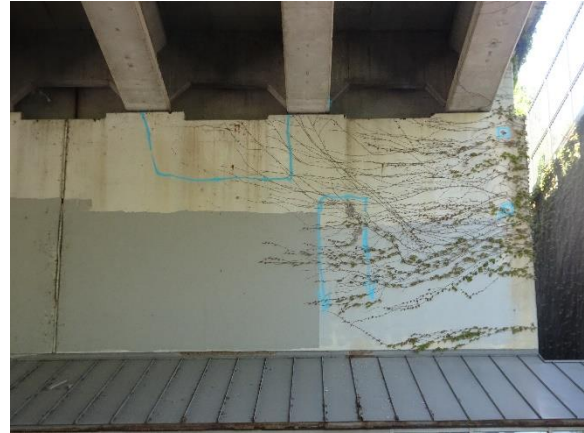
Figure 4.98. North abutment delaminations.

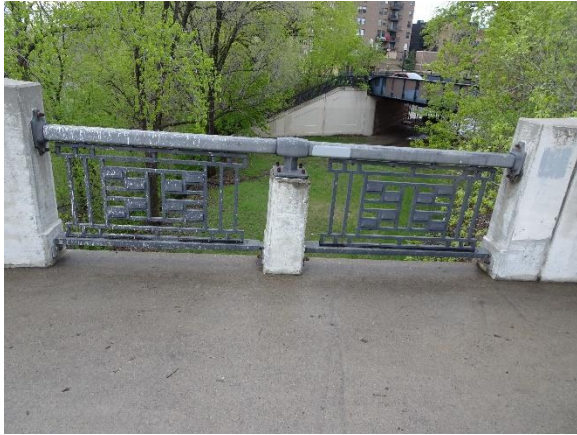
Figure 4.99. View of typical pedestrian railing panel.

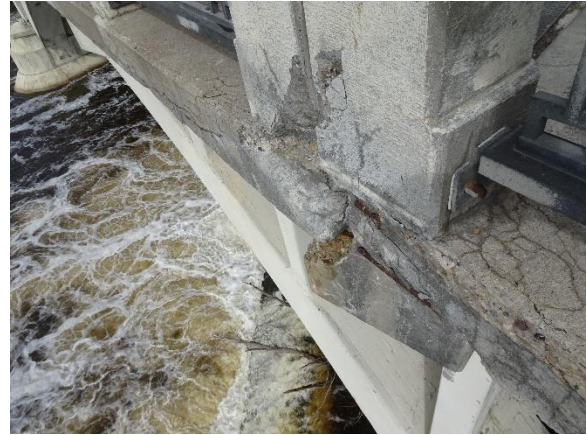
Figure 4.100. Deep spall in deck fascia below railing post.

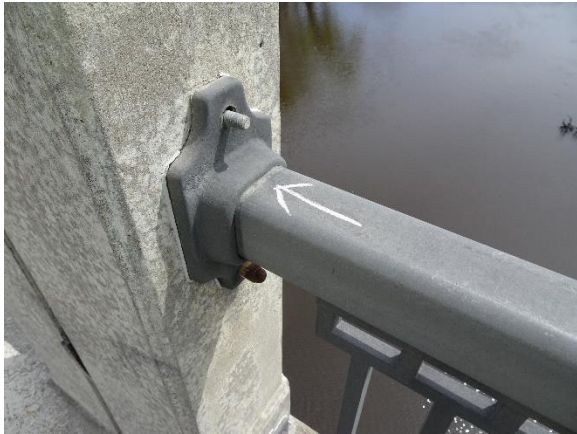
Figure 4.101. Aluminum railing connection missing fastener.

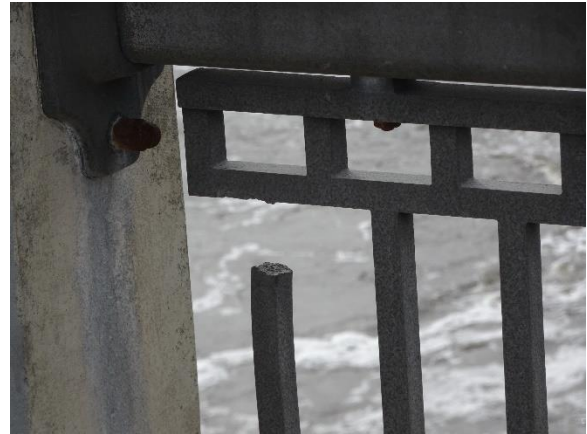
Figure 4.102. Aluminum railing missing member.

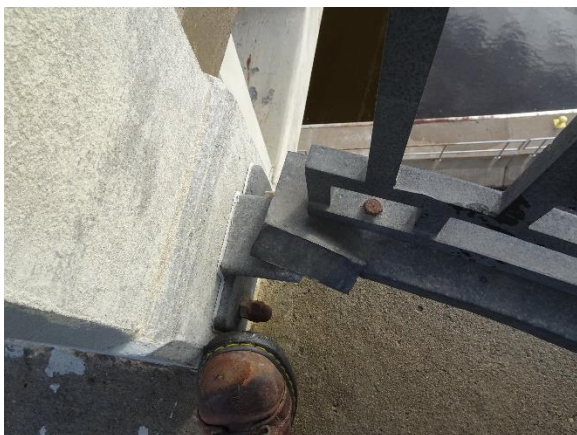
Figure 4.103. Bottom railing distorted, likely from impact.

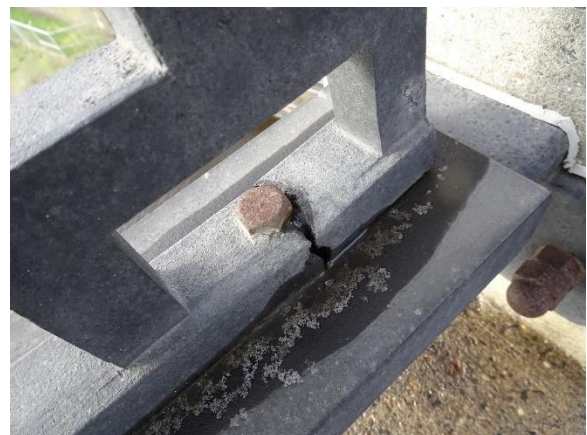
Figure 4.104. Aluminum railing crack.

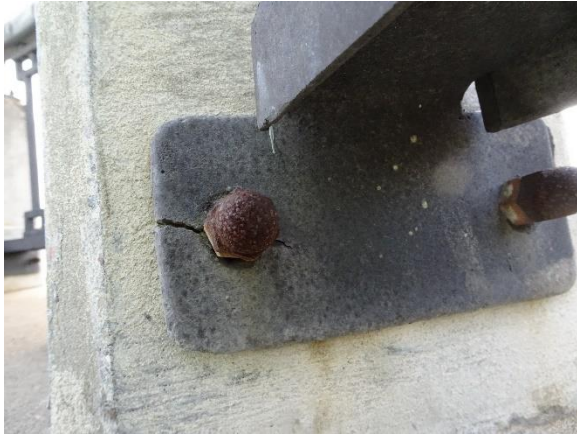
Figure 4.105. Pedestrian railing crack at post connection.

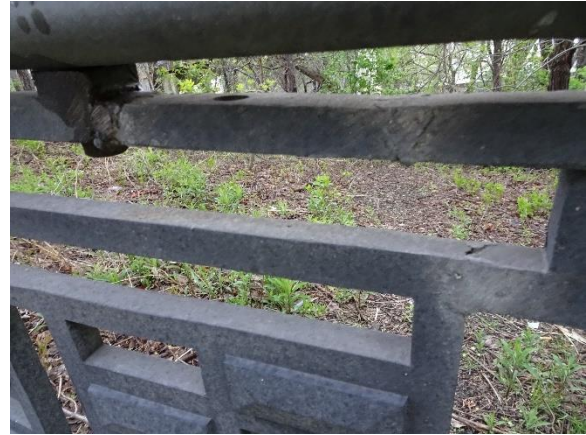
Figure 4.106. Pedestrian railing unsound metal repairs.

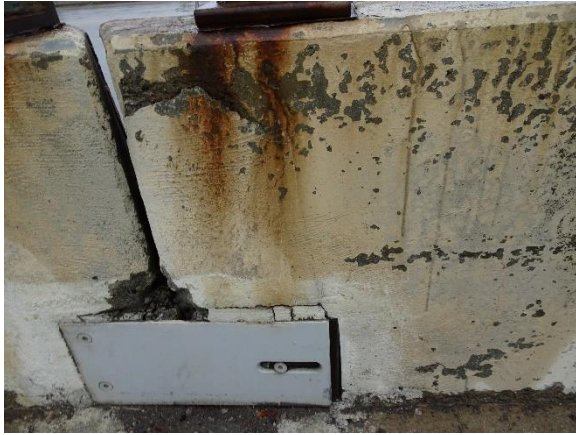
Figure 4.107. Spall in traffic barrier J-rail at expansion joint.

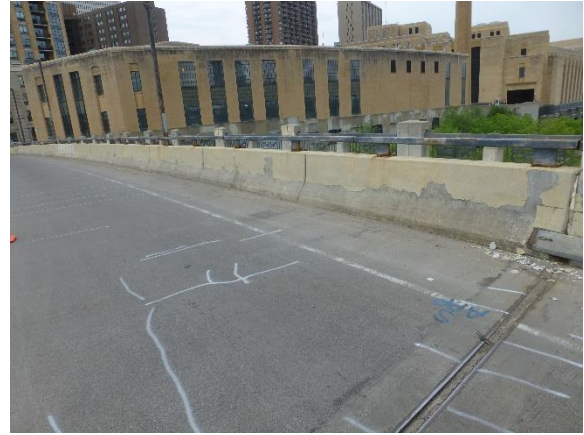
Figure 4.108. Traffic barrier failed coating.

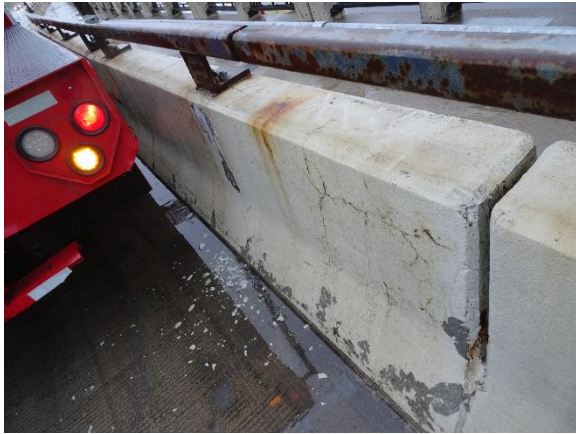
Figure 4.109. Traffic barrier metal railing surface corrosion.

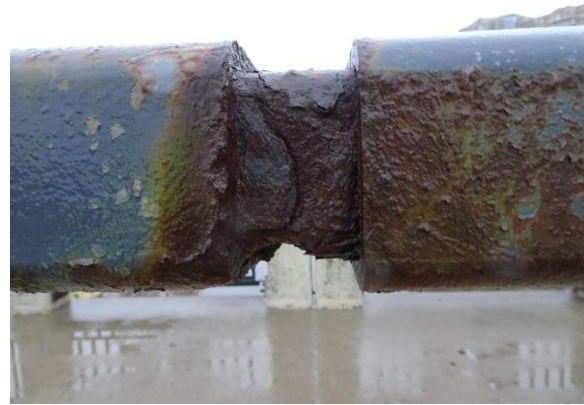
Figure 4.110. Traffic barrier metal railing pack rust at slip joint.

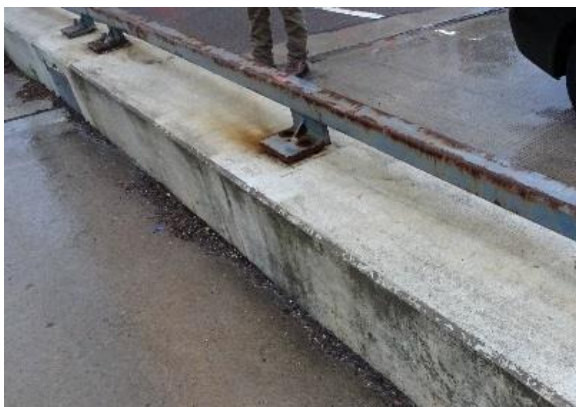
Figure 4.111. Traffic barrier metal railing missing fasteners.

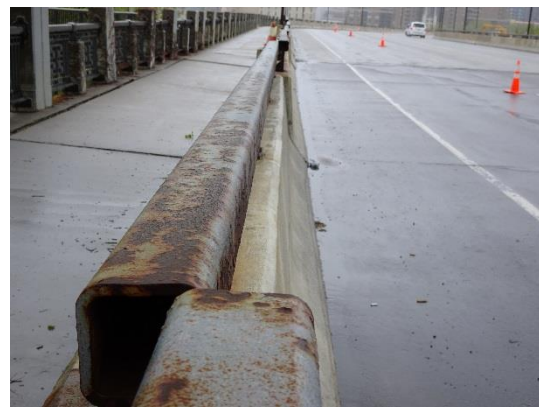
Figure 4.112. Traffic barrier metal railing out of alignment.

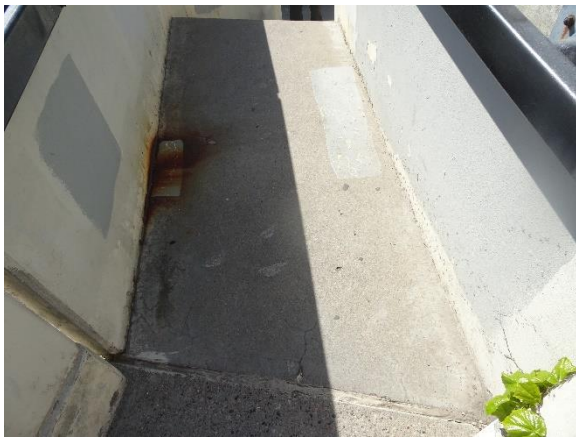
Figure 4.113. North vertical circulation staircase rust stains and cracks at walkway to bridge.

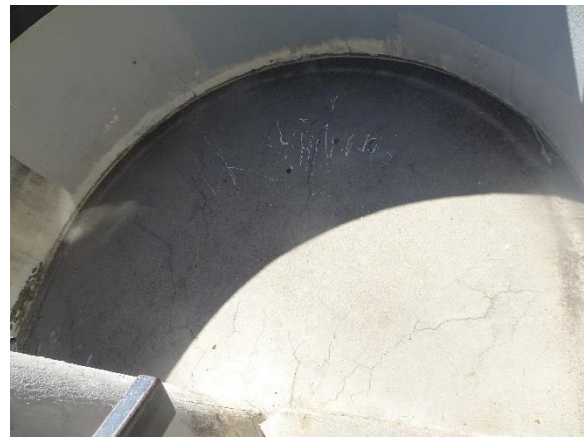
Figure 4.114. North vertical circulation staircase cracks at landing.

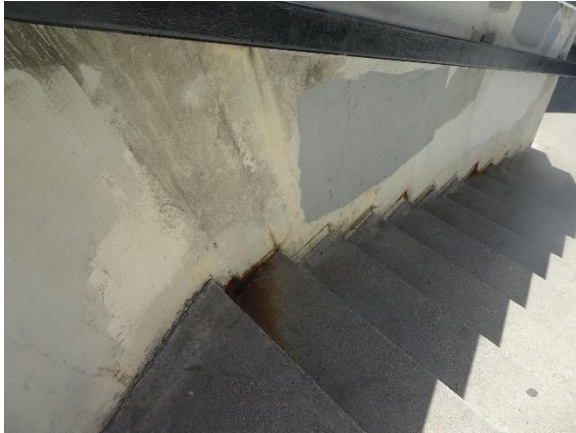
Figure 4.115. North vertical circulation staircase rust stains at stair treads.

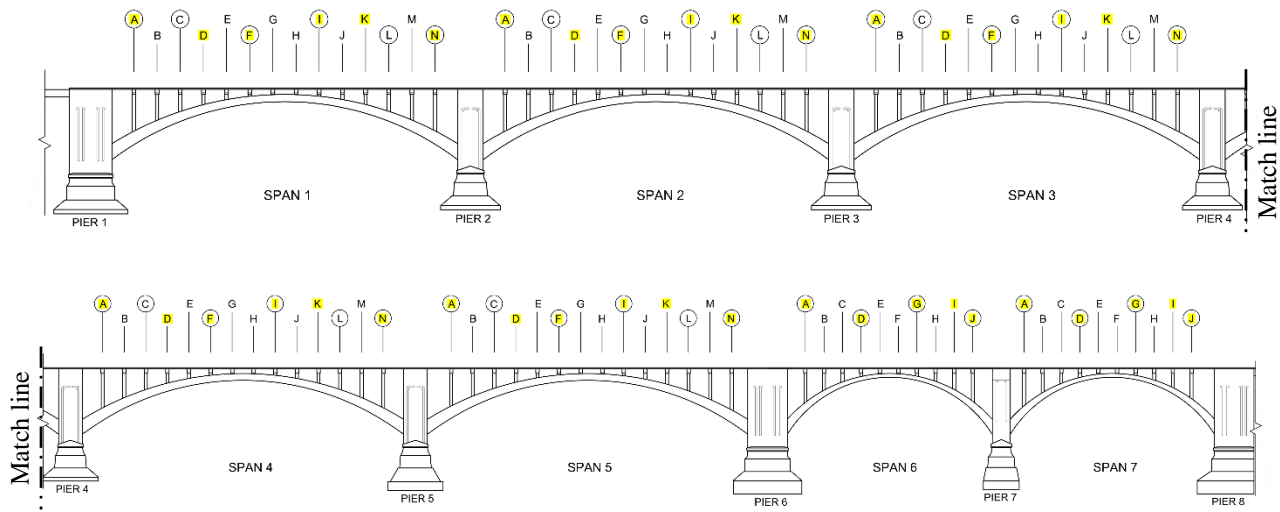
Figure 5.1. Elevation of bridge showing 1918 and 1980 deck joint locations. Column lines at original 1918 joints are circled; column lines at 1980 joints are highlighted in yellow.

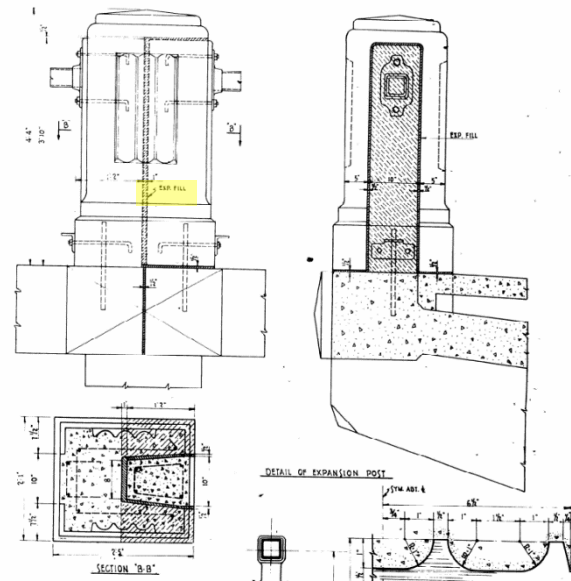
Figure 5.3. Detail from 1916 blue line plans with expansion joint shown in railing post (highlighted).

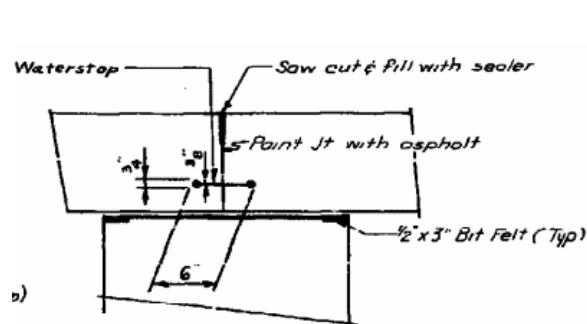
Figure 5.4. Typical joint detail from 1980 plans.

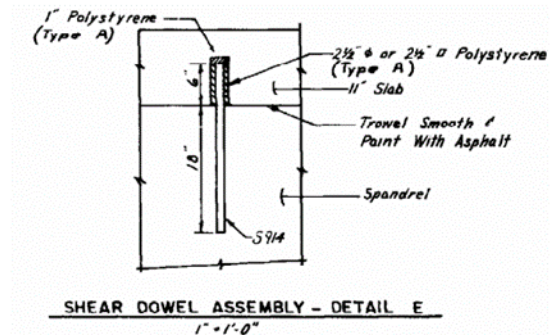
Figure 5.5. Detail of vertical dowels with foam surrounds, from 1980 plans.

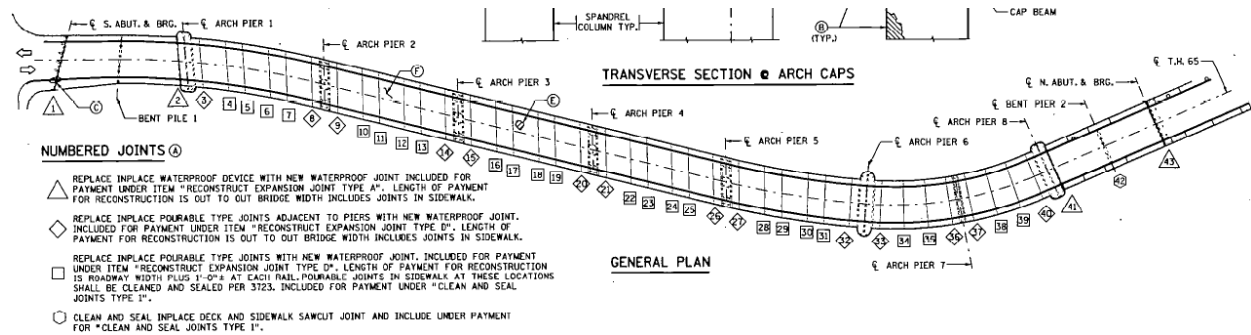
Figure 5.6. General plan of bridge deck showing 2003 deck joint locations and numbers (excerpted from 2003 joint replacement drawings).

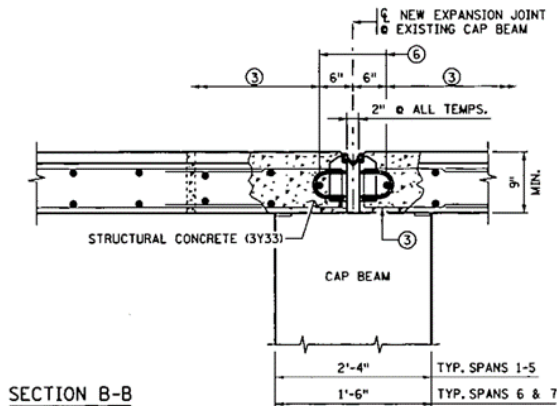
Figure 5.7. Typical joint repair detail from 2003 plans.

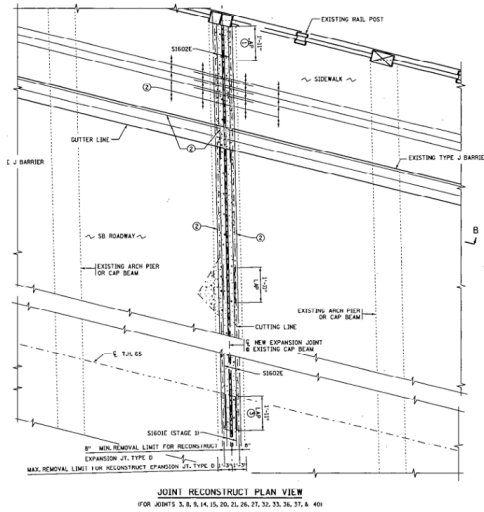
Figure 5.8. Half-deck plan showing strip seal joint in roadway and sidewalk for joints located adjacent to arch piers.

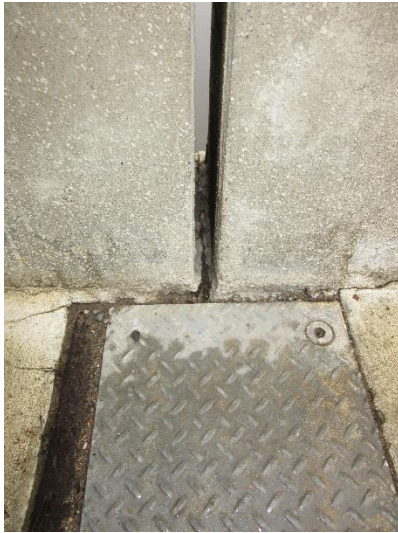
Figure 5.12. Termination of strip seal at inside face of railing post, with original poured sealant joint visible between posts.

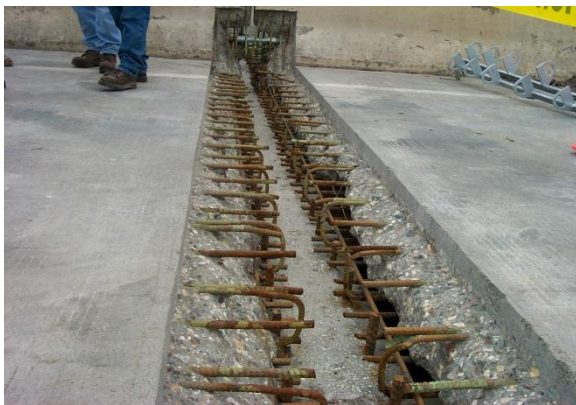
Figure 5.13. Construction photograph from 2003 joint replacement project (provided by MnDOT). Note vertical dowels exposed in repair area.

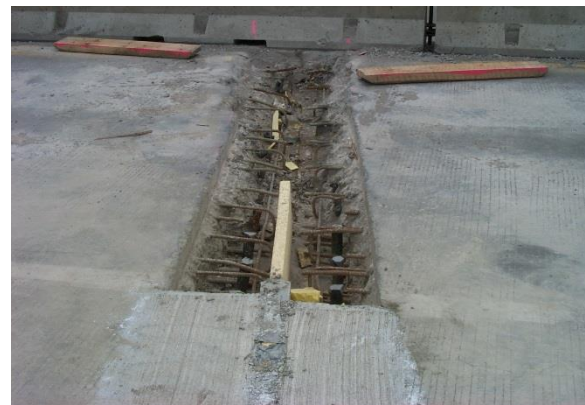
Figure 5.14. Construction photograph from 2003 joint replacement project (provided by MnDOT). Note foam surrounds installed over vertical dowels.

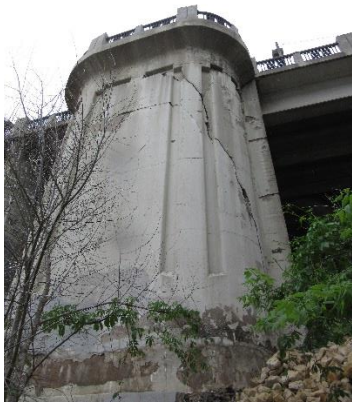
Figure 5.18. Pier 8, downstream face.

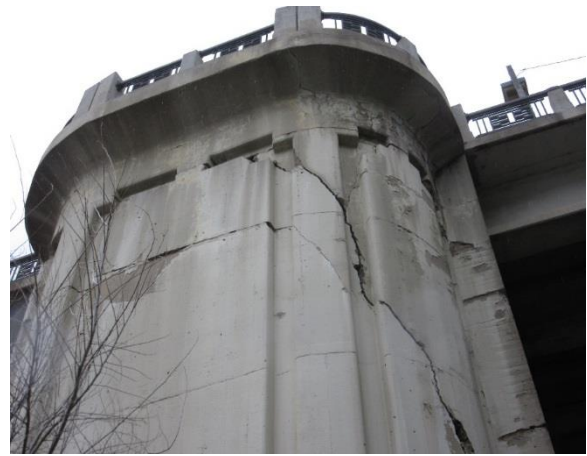
Figure 5.19. Pier 8, close-up of top of downstream face showing wide diagonal cracking.

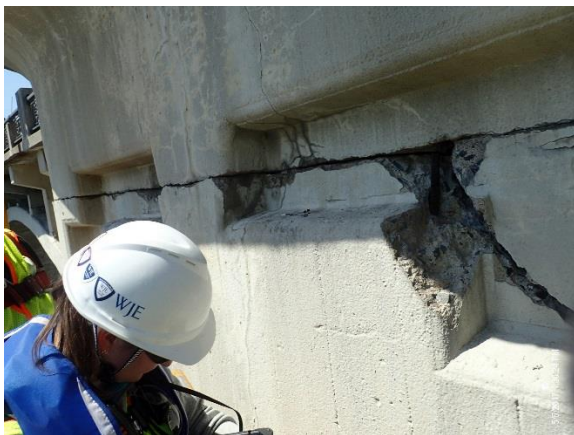
Figure 5.20. Pier 8, downstream face, sliding along horizontal joint near top.

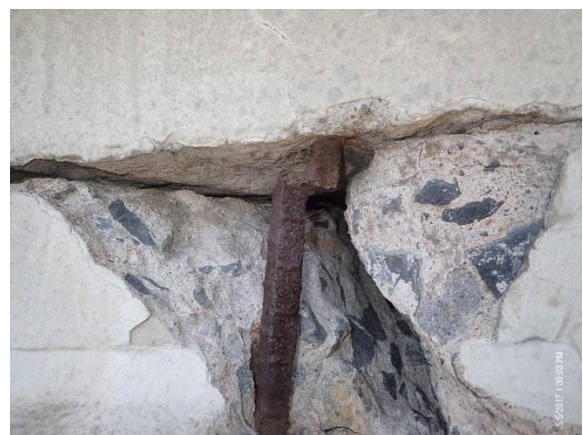
Figure 5.21. Pier 8, downstream face, fractured bar across horizontal joint near top.

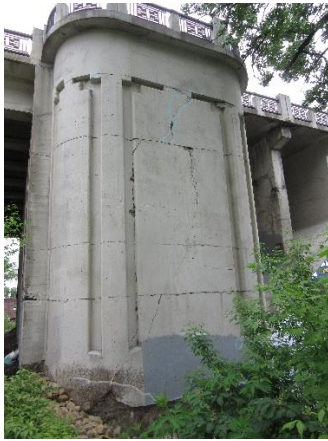
Figure 5.22. Pier 8, upstream face.

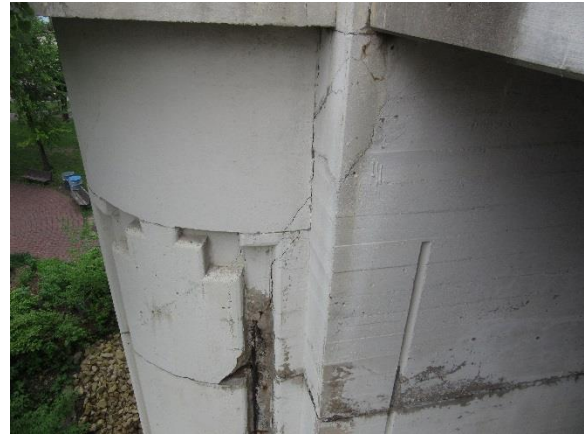
Figure 5.23. Pier 8, upstream face, close-up of shear cracking extending from deck.

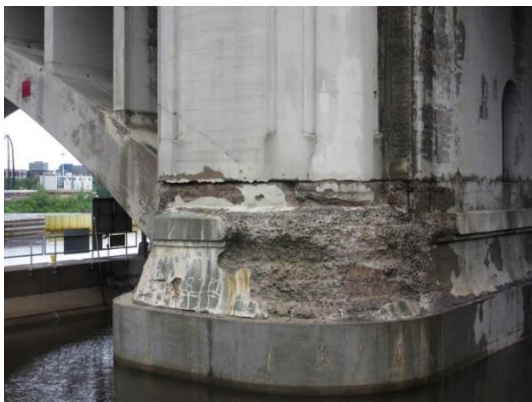
Figure 5.24. Pier 1, upstream face, shear cracking.

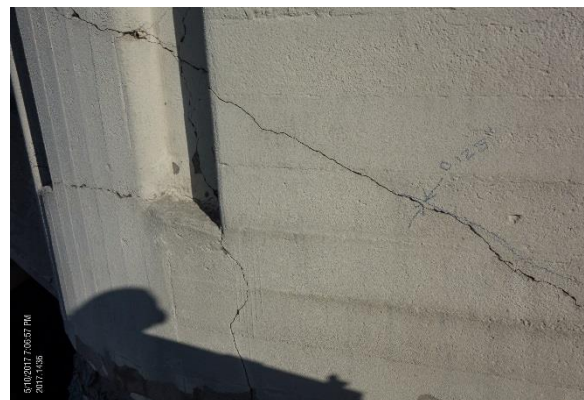
Figure 5.25. Pier 1, upstream face, close-up of shear cracking.

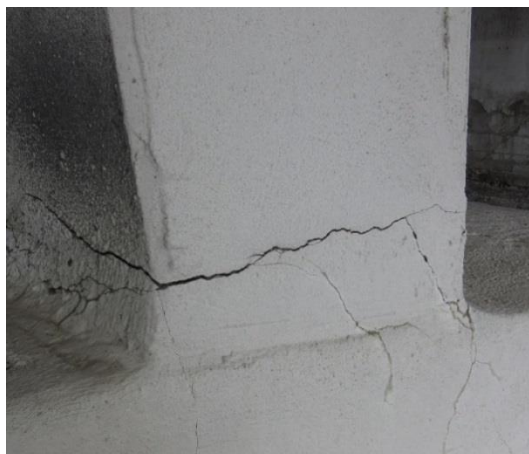
Figure 5.26. Spandrel column structural distress, distress category 1.

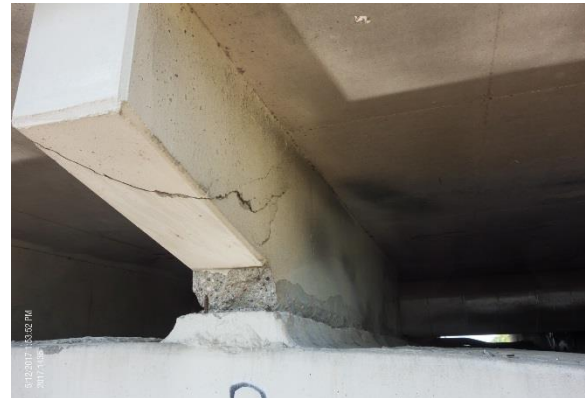
Figure 5.29. Spandrel wall structural distress, distress category 3.

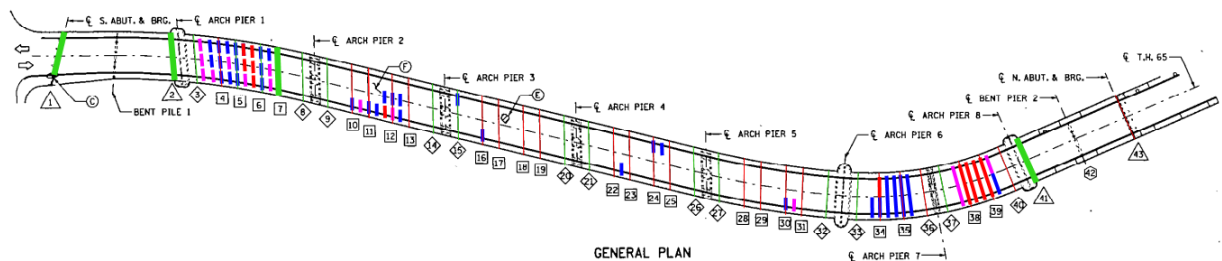
Figure 5.30. Plan view indicating locations of spandrel column distress overlaid on joint movement diagram (blue indicates distress category 1, purple indicates distress category 2, and red indicates distress category 3).

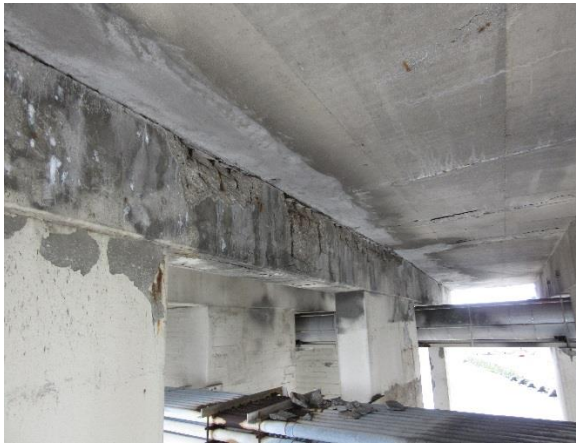
Figure 5.31. Spalling along top corner of cap beam.

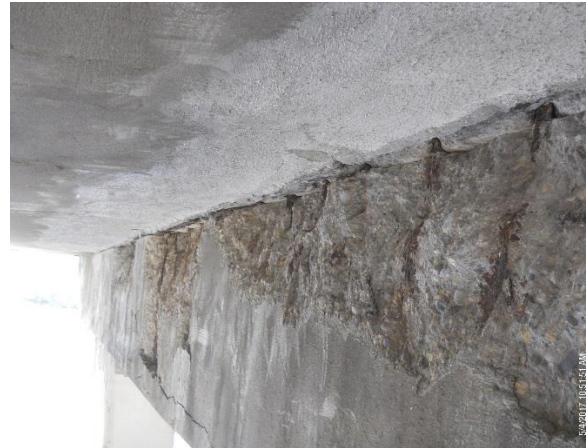
Figure 5.32. Close-up of cap beam spalling, showing exposed vertical dowels.

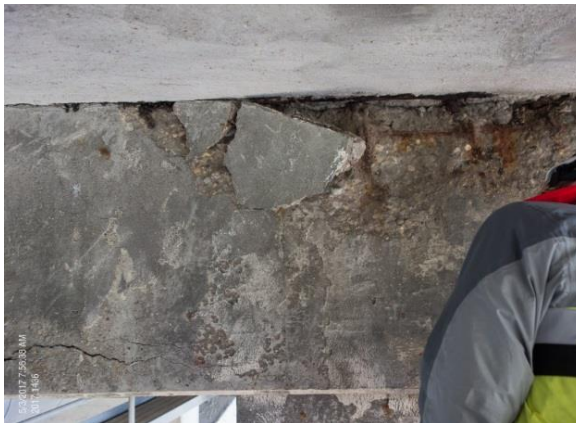
Figure 5.33. Cap beam spall that was developing at the time of the inspection.

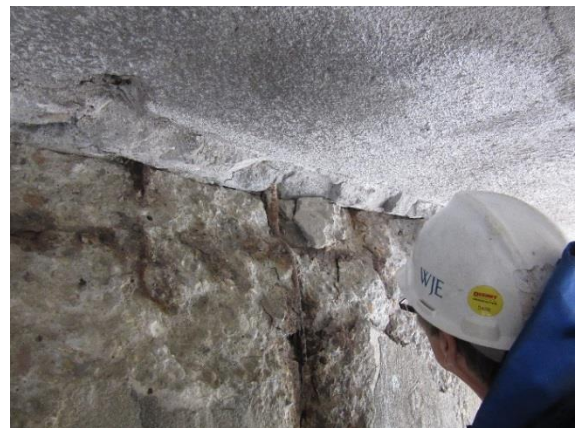
Figure 5.34. Close-up of vertical dowels, showing repair concrete tight against dowels.

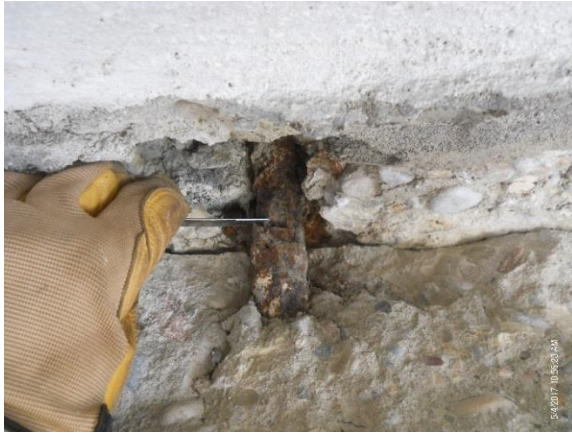
Figure 5.35. Close-up of vertical dowel, showing corrosion of dowel and direct contact between repair concrete and top of cap beam.

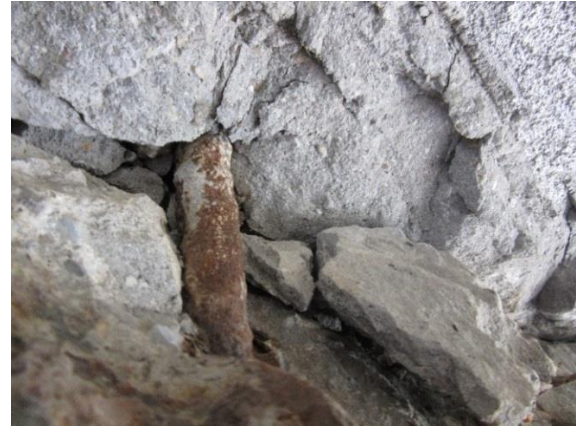
Figure 5.36. Close-up of vertical dowel, showing repair concrete tight against dowel.

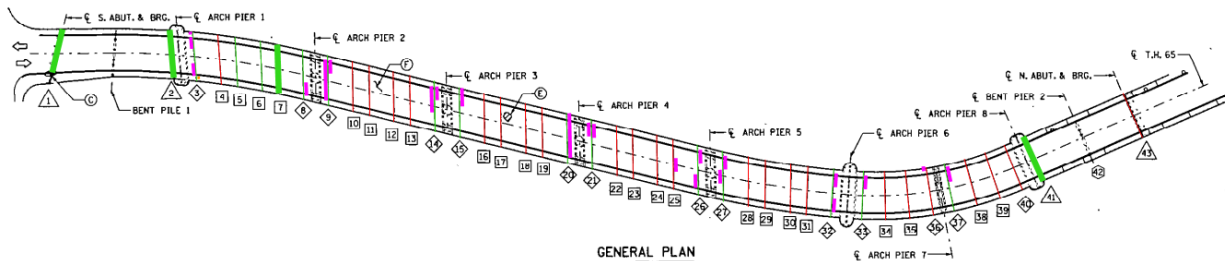
Figure 5.37. Plan view indicating locations of cap beam spalling, overlaid on joint movement diagram (purple indicates spall location).

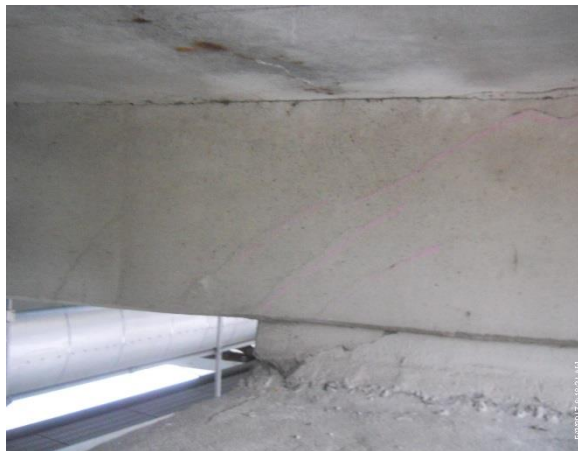
Figure 5.38. Shear or torsional cracking in cap beam in Span 1, downstream side.

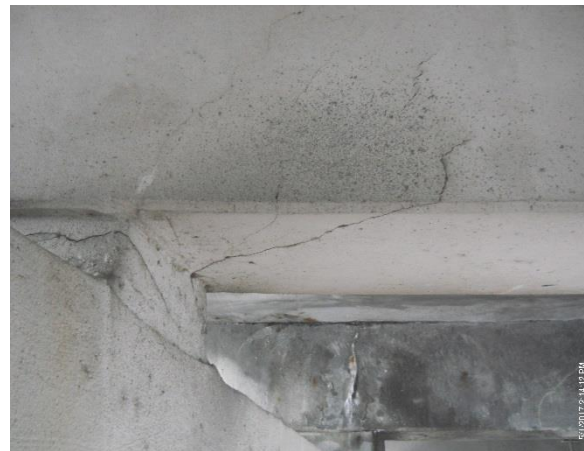
Figure 5.39. Shear or torsional cracking in cap beam in Span 1, downstream side.

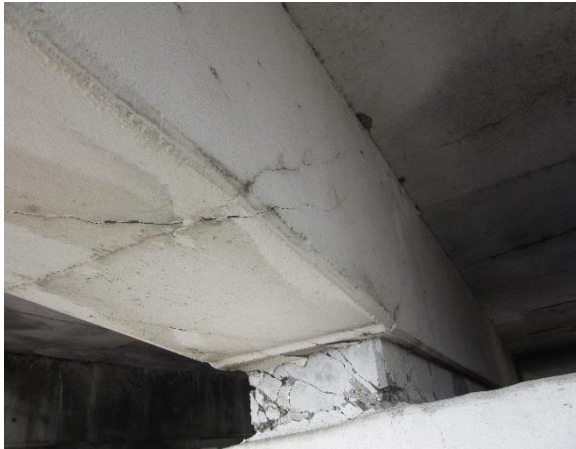
Figure 5.40. Shear or torsional cracking in cap beam in Span 1, upstream side.

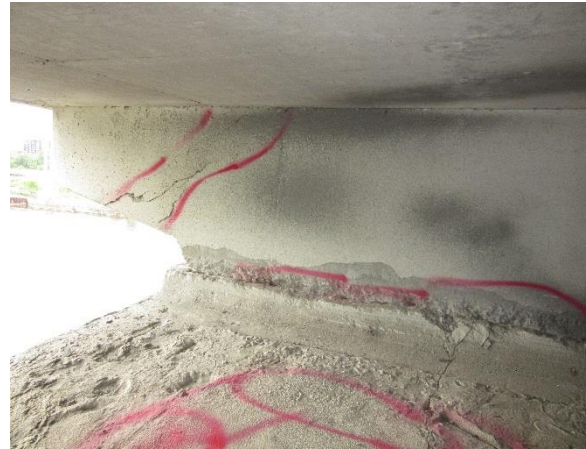
Figure 5.41. Shear or torsional cracking in cap beam in Span 7, downstream side.

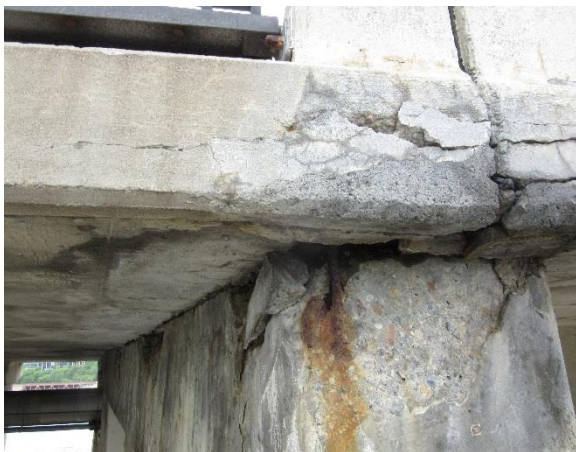
Figure 5.42. Spalling of deck fascia at deck joint.

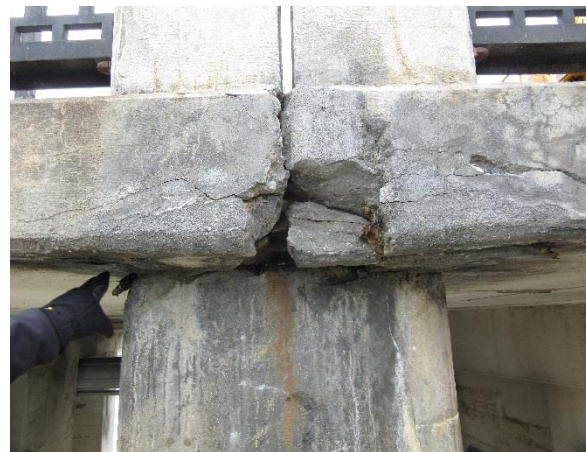
Figure 5.43. Spalling of deck fascia at deck joint.
