3RD AVENUE BRIDGE

Bridge Inspection and Condition Evaluation Report

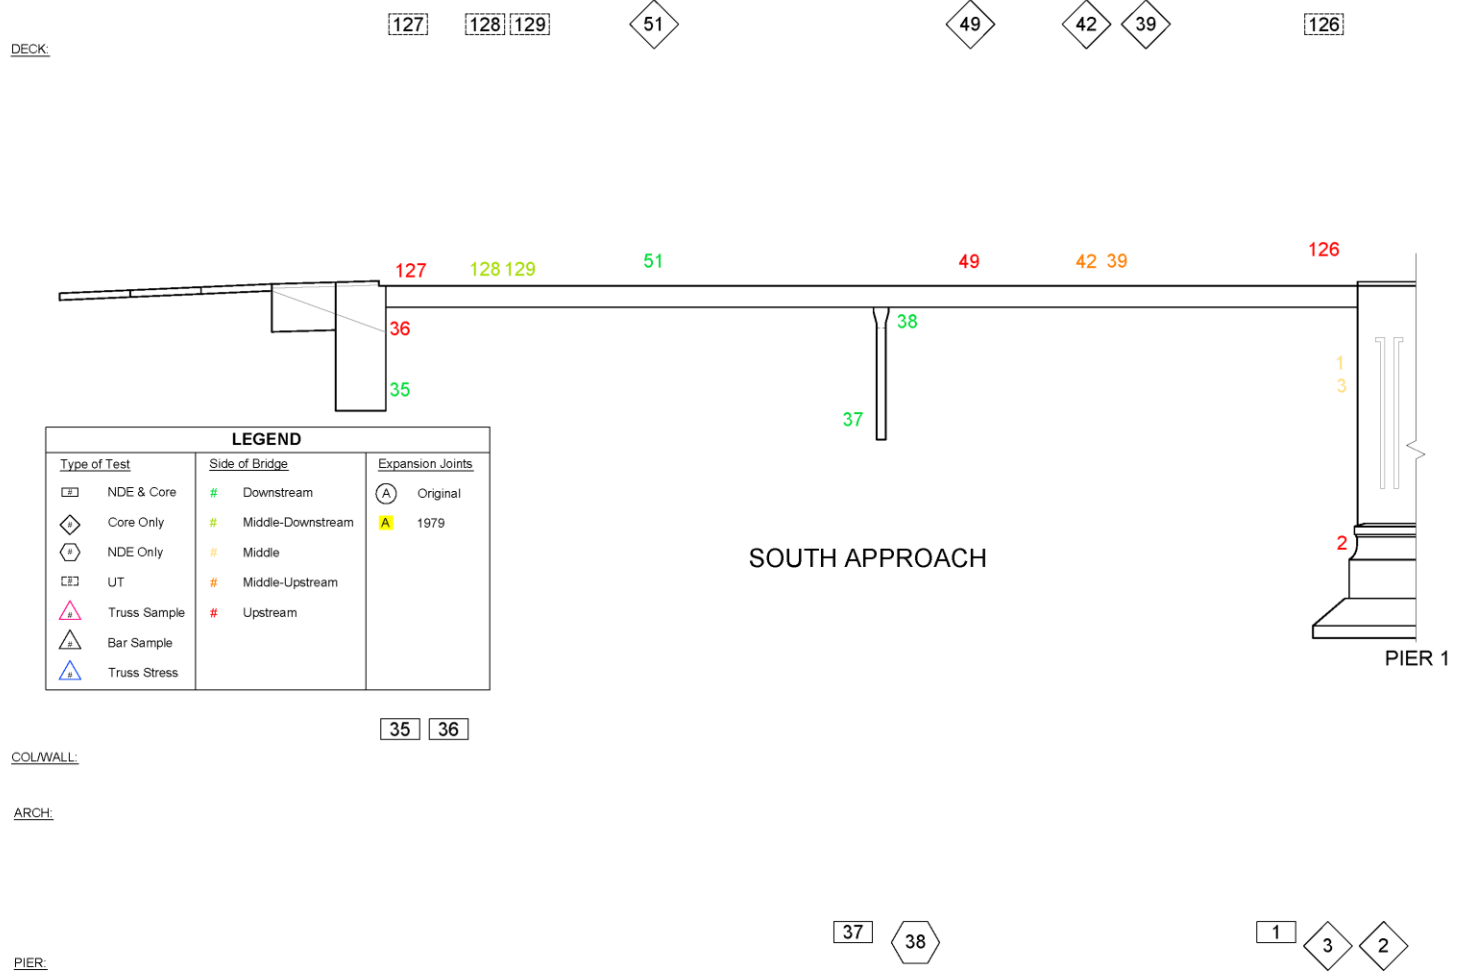
Figure 6.1. Follow-up Testing Location Summary - South Approach.

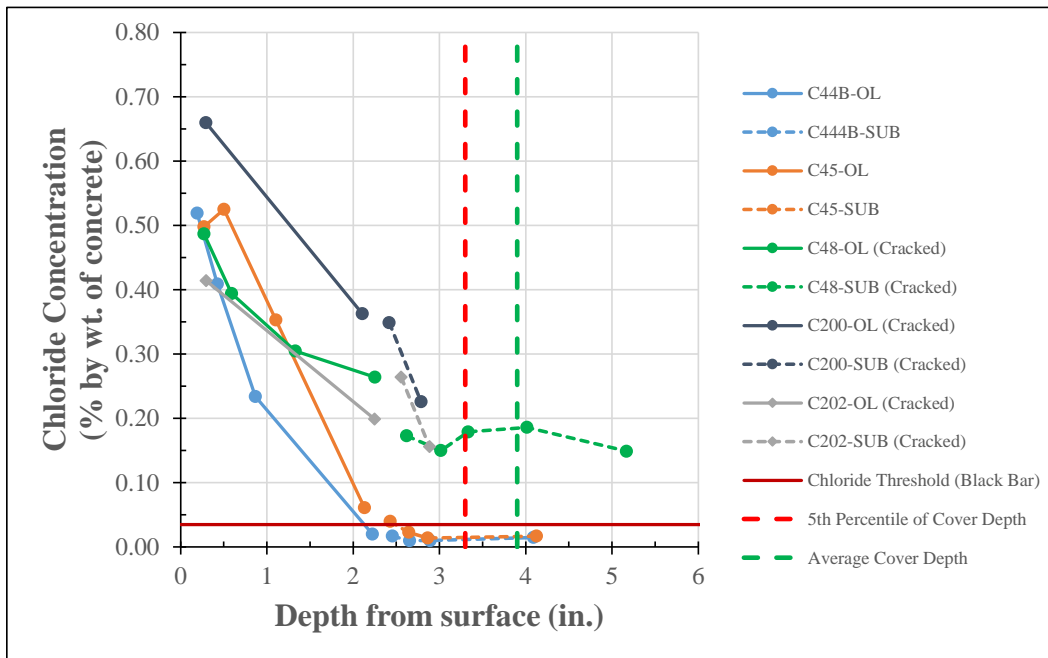
Figure 6.10. Chloride profiles for Deck Roadway - Arch Span (topside) cores compared to chloride threshold for corrosion initiation (for black bar as a reference) and reinforcement cover depth measurements. Note top bars are actually epoxy-coated, so threshold is higher - see Section 3.2.1.2.

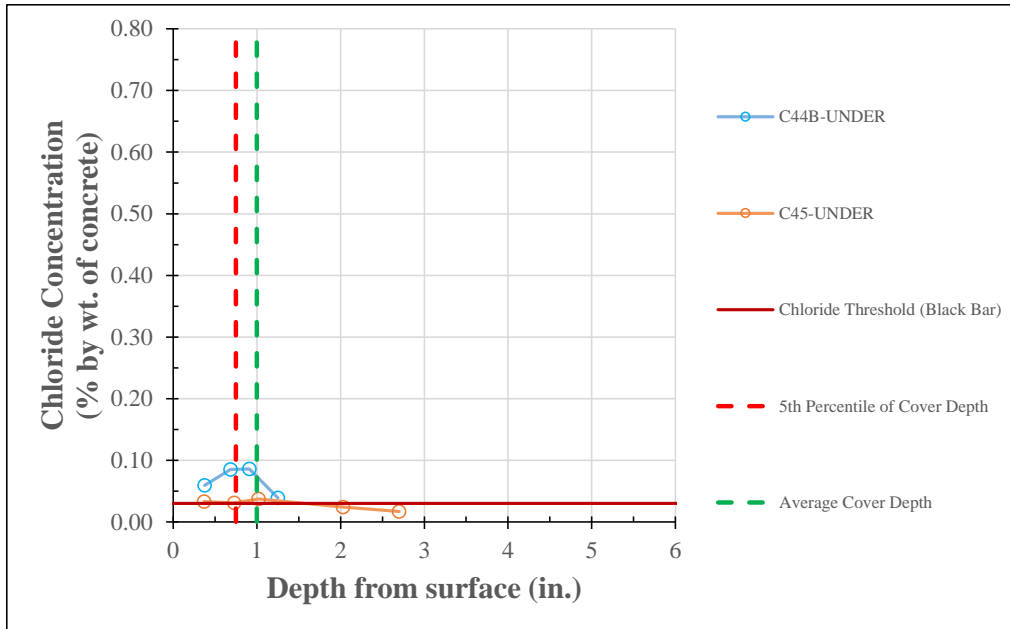
Figure 6.11. Chloride profiles for Deck Roadway - Arch Span (underside) cores compared to chloride threshold for corrosion initiation and reinforcement cover depth measurements.

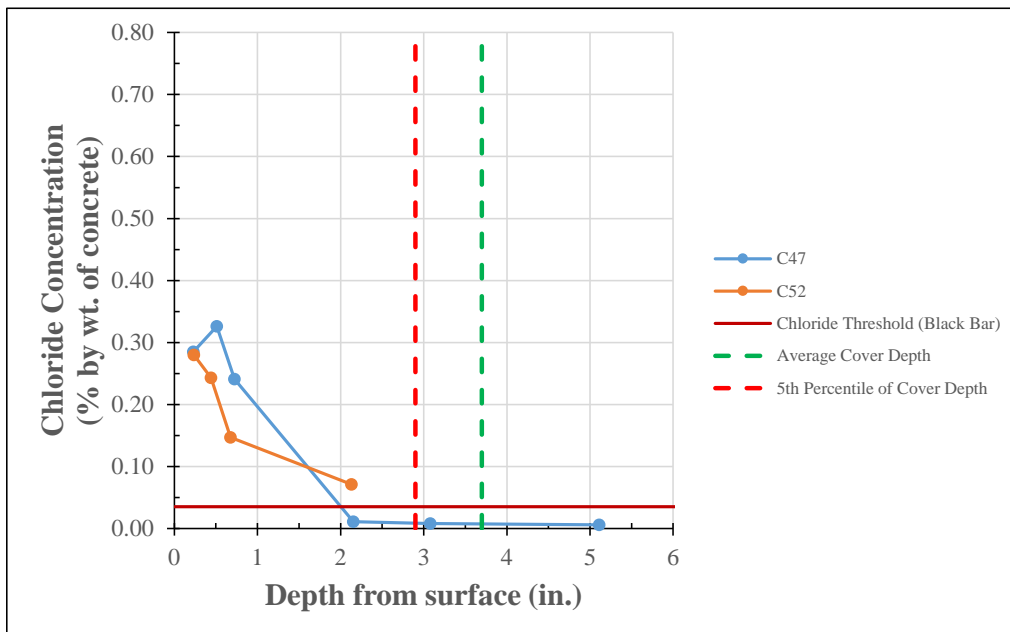
Figure 6.12. Chloride profiles for Deck Sidewalk - Arch Span (Topside) cores compared to chloride threshold for corrosion initiation (for black bar as a reference) and reinforcement cover depth measurements. Note top bars are actually epoxy-coated, so threshold is higher - see Section 3.2.1.2.

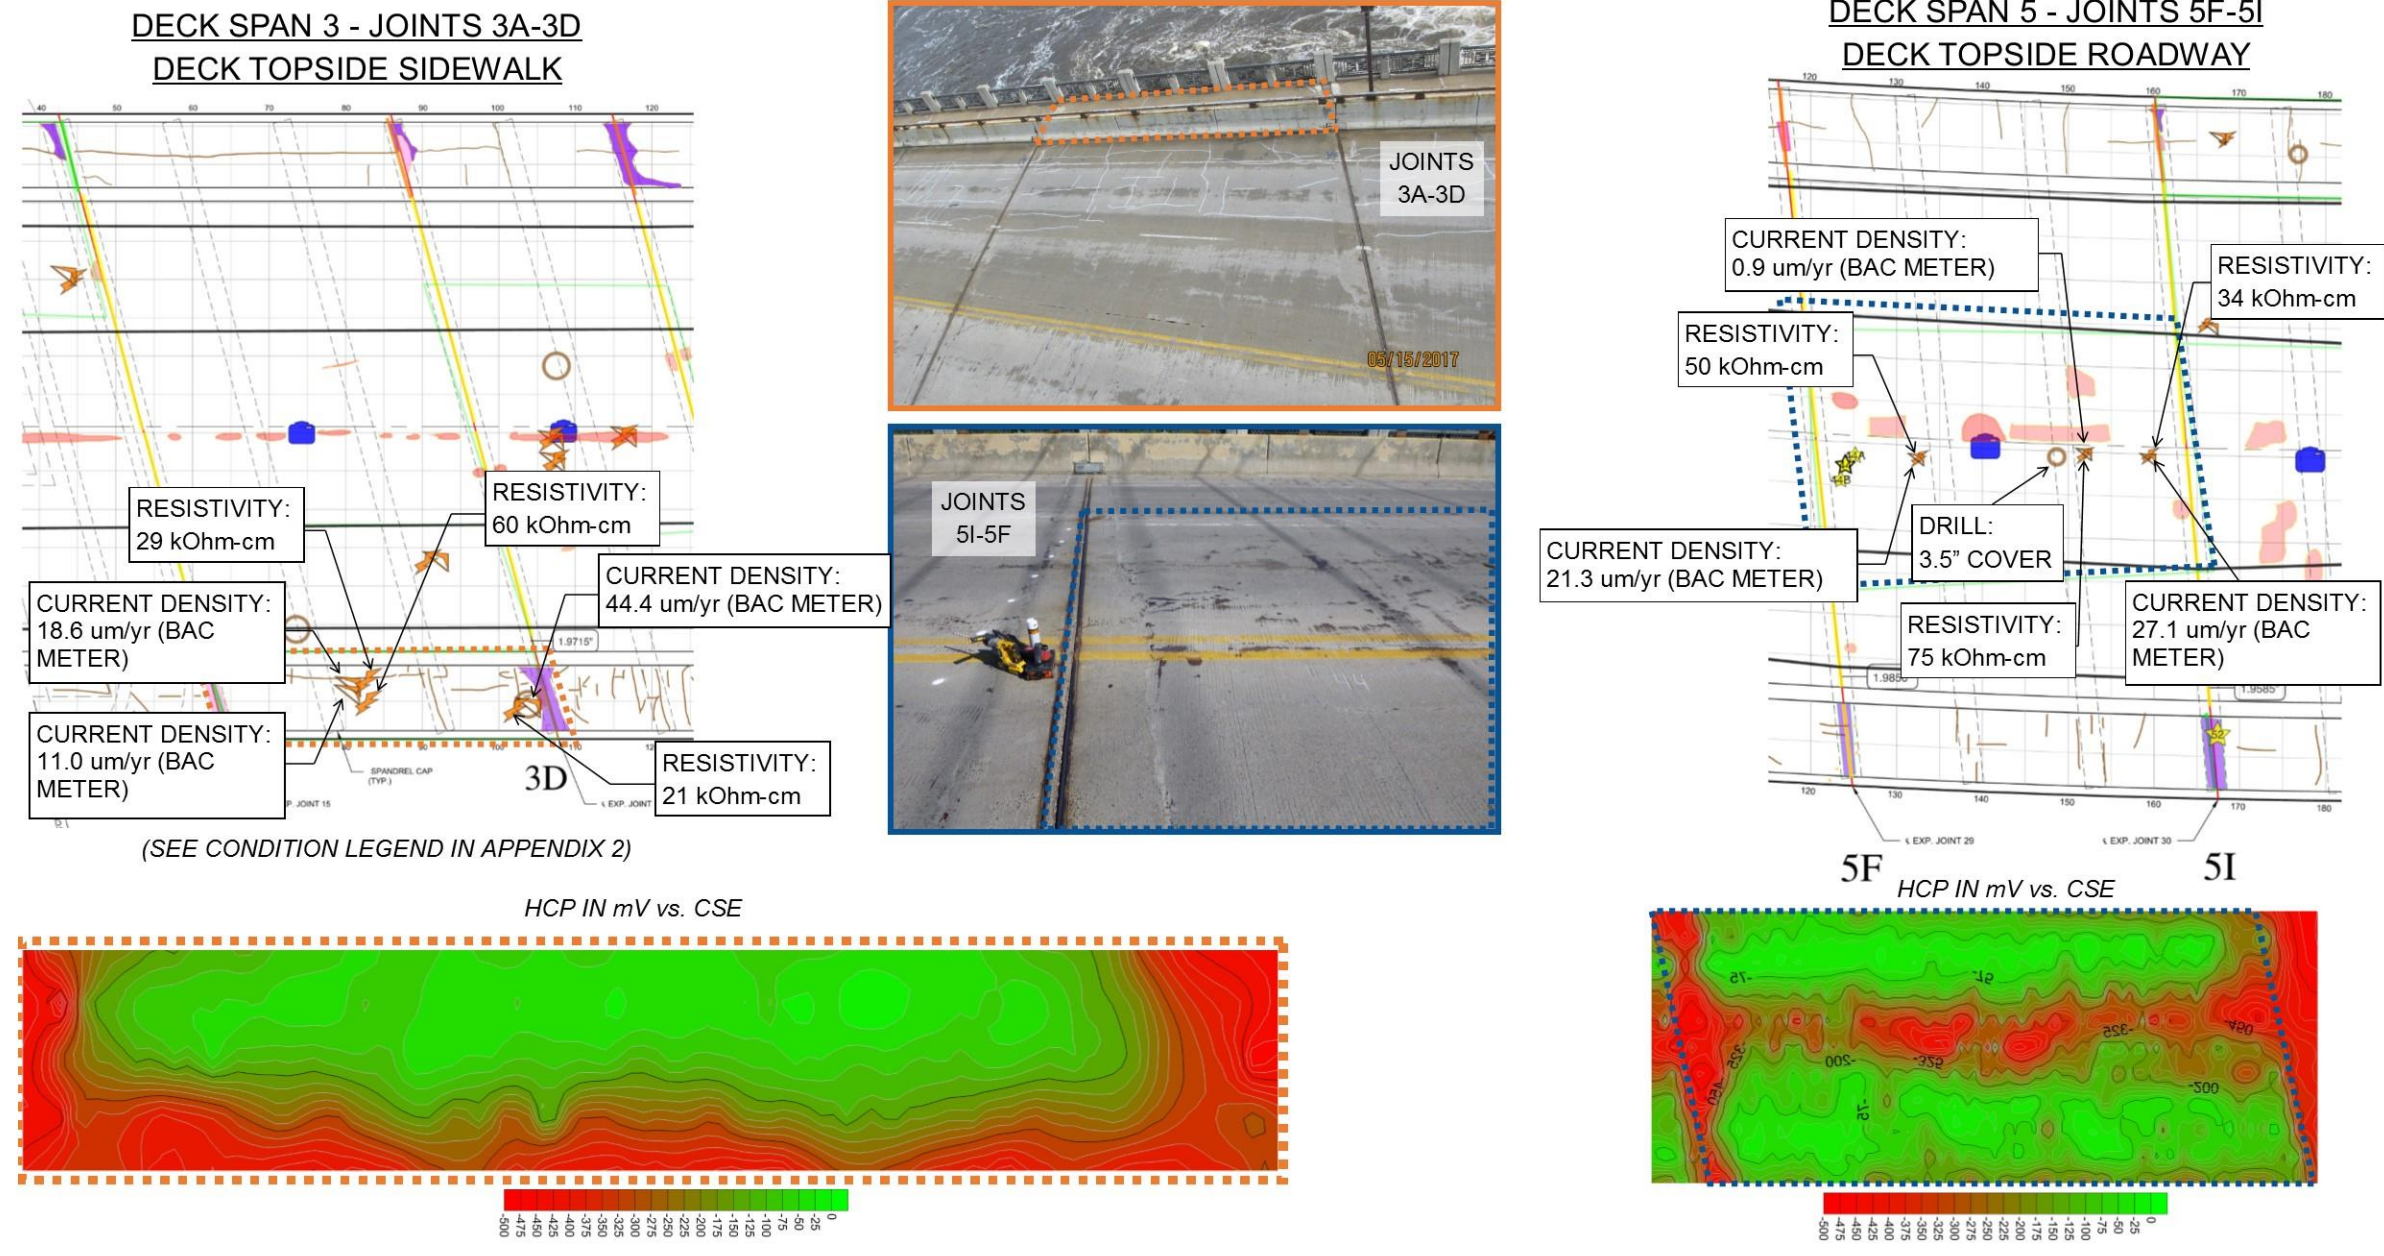
Study Area	Element	Inspection Date	Type	Distress Quantity (%)	Cores Sample(s)	HCP - Avg. (mV vs. CSE)	HCP - Min. (mV vs. CSE)	Resipod - Resistivity Avg. (kOhm-cm)	iCOR - Current Density Avg. ($\mu\text{A}/\text{cm}^2$)	iCOR - Resistivity Avg. (kOhm-cm)	BAC Meter - Current Density Avg. ($\mu\text{m}/\text{yr}$)	Cover Vertical Bars - Rep. Minimum (in.)	Cover Horizontal Bars - Rep. Minimum (in.)	Carbonation Avg. (in.)	Deterioration Mechanism(s)
3A-3D	Deck Sidewalk	5/25/2017	NDE ONLY	1 to 10	--	-365	-734	37	N/A	N/A	24.7	3.5	3.1	N/A	Chloride Exposure
5F-5I	Deck Roadway	7/8/2017	NDE & CORE	1 to 10	44A & 44B	-217	-616	54	N/A	N/A	16.4	4.0	3.1	N/A	Chloride Exposure

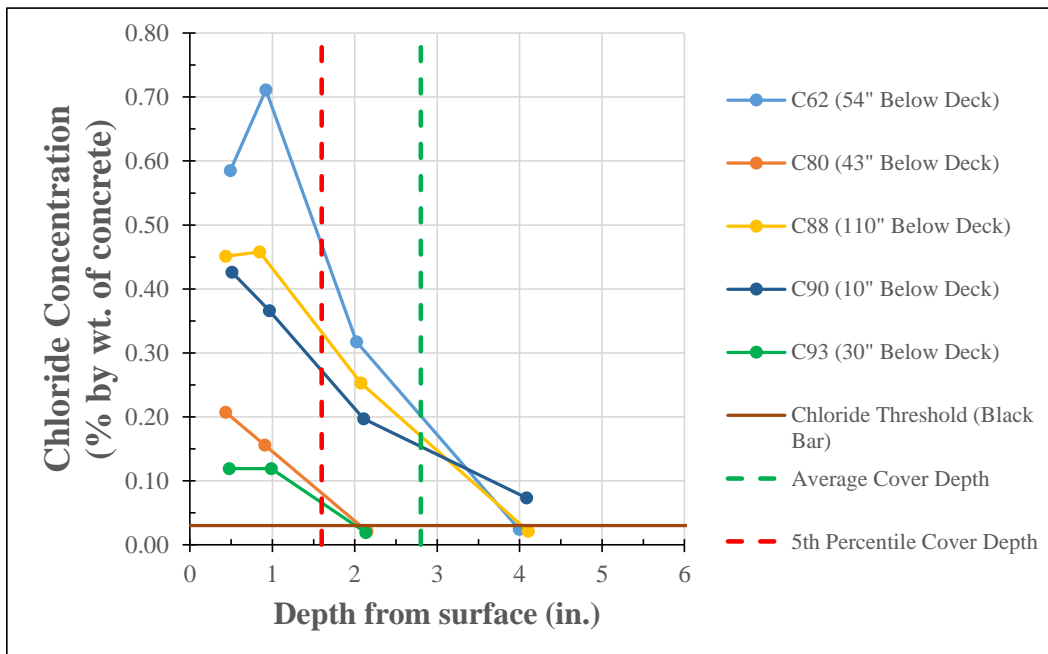
Figure 6.14. Chloride profiles for cores from Upper Spandrel Columns and Walls below 1980 expansion joints.

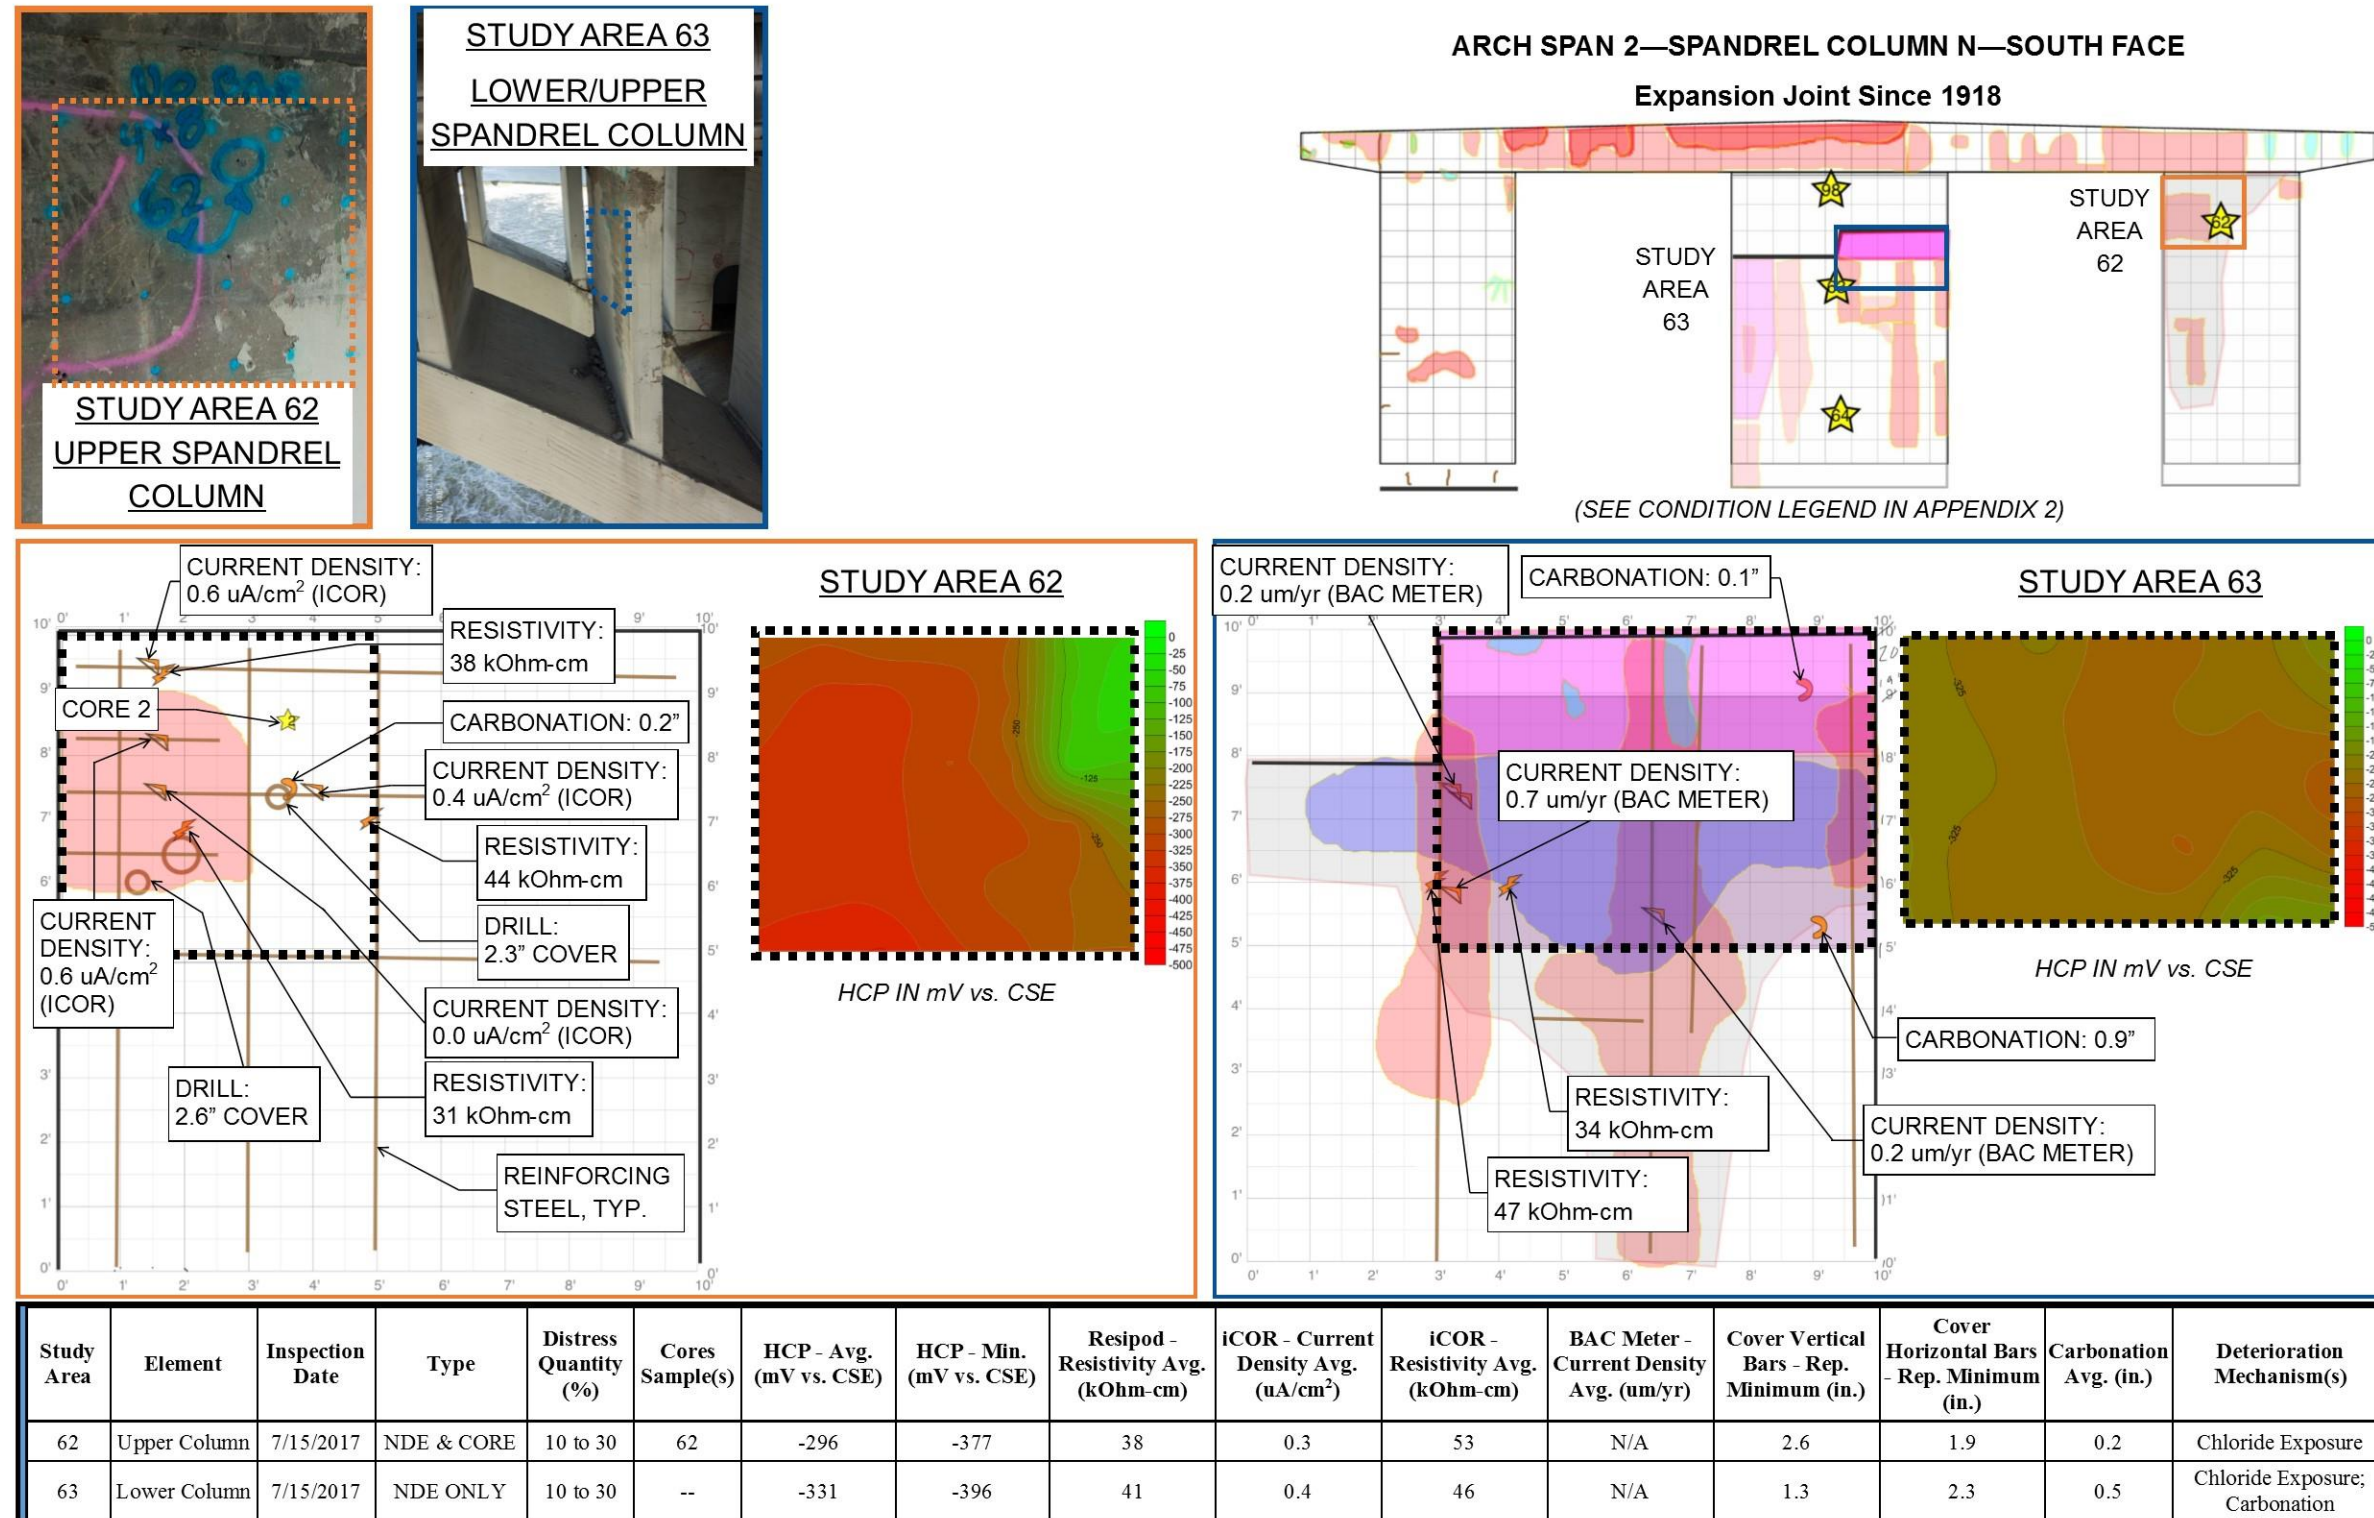
Figure 6.15. Graphical Summary of Testing Data for Study Areas 62 and 63 - Spandrel Column.

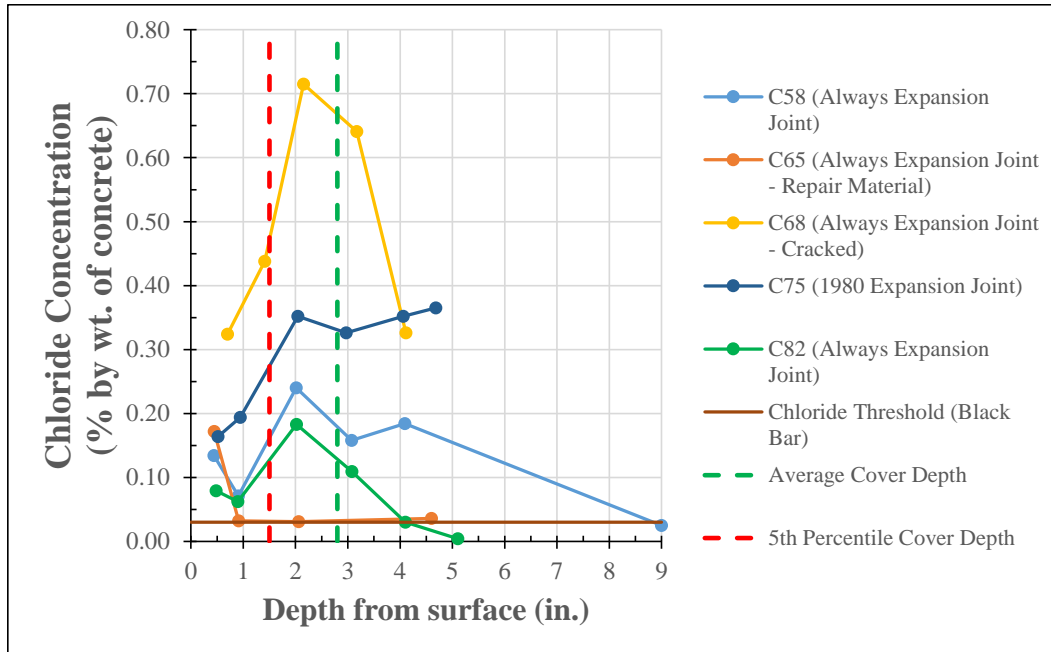
Figure 6.18. Chloride profiles for cores from Lower Spandrel Columns and Walls compared to chloride threshold.

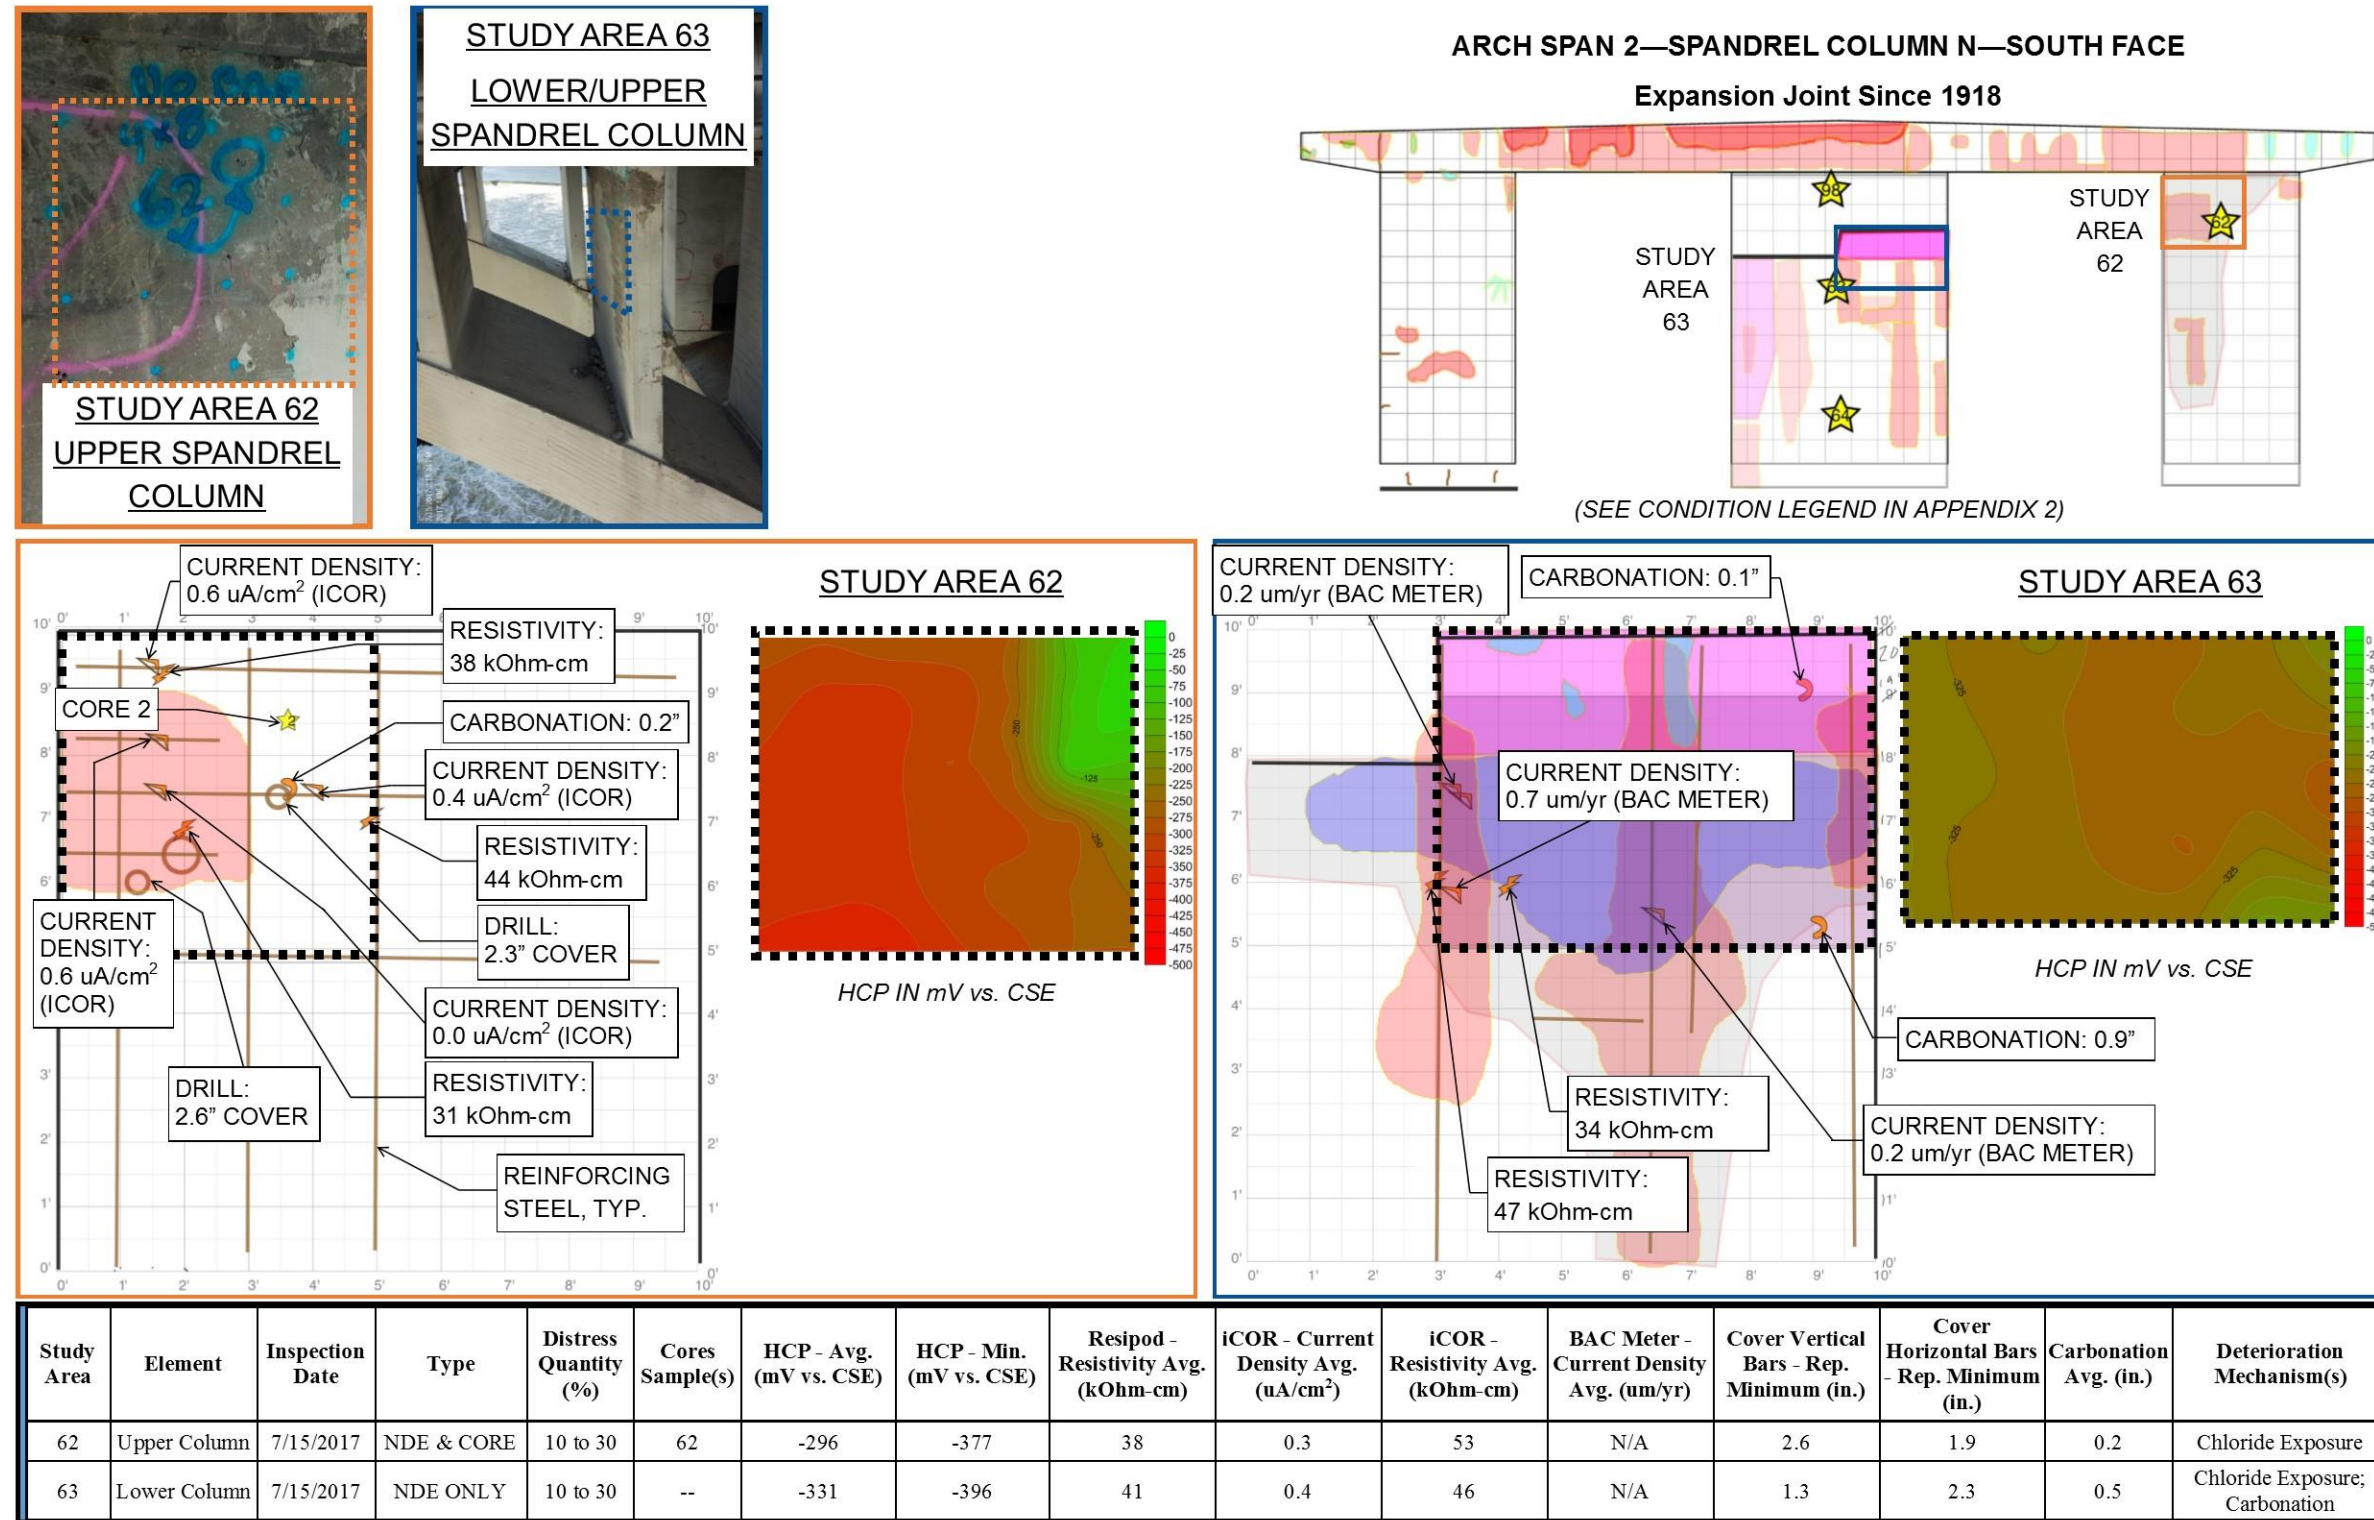
Figure 6.19. Graphical Summary of Testing Data for Study Areas 62 and 63 - Spandrel Column.

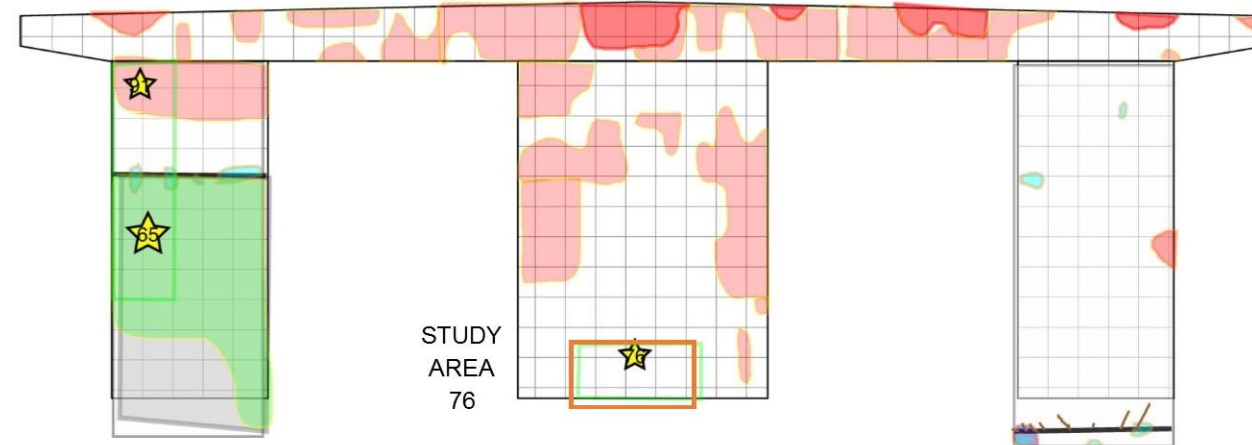
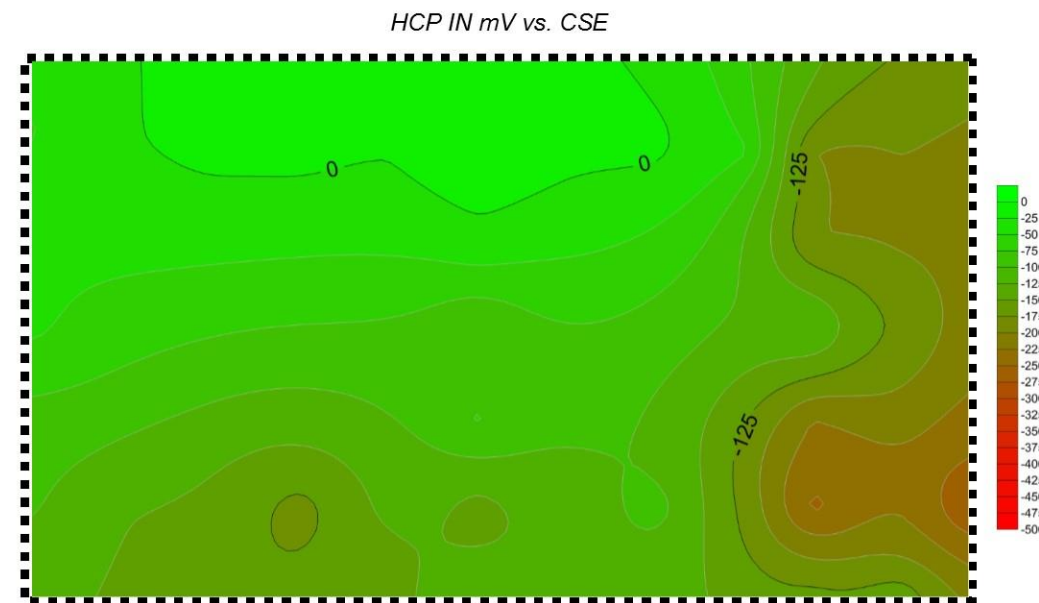
Study Area	Element	Inspection Date	Type	Distress Quantity (%)	Cores Sample(s)	HCP - Avg. (mV vs. CSE)	HCP - Min. (mV vs. CSE)	Resipod - Resistivity Avg. (kOhm-cm)	iCOR - Current Density Avg. (uA/cm ²)	iCOR - Resistivity Avg. (kOhm-cm)	BAC Meter - Current Density Avg. (um/yr)	Cover Vertical Bars - Rep. Minimum (in.)	Cover Horizontal Bars - Rep. Minimum (in.)	Carbonation Avg. (in.)	Deterioration Mechanism(s)
76	Lower Column	8/6/2017	NDE ONLY	1 to 10	--	-86	-224	306	N/A	N/A	N/A	3.0	5.0	3.0	Chloride Exposure; Carbonation

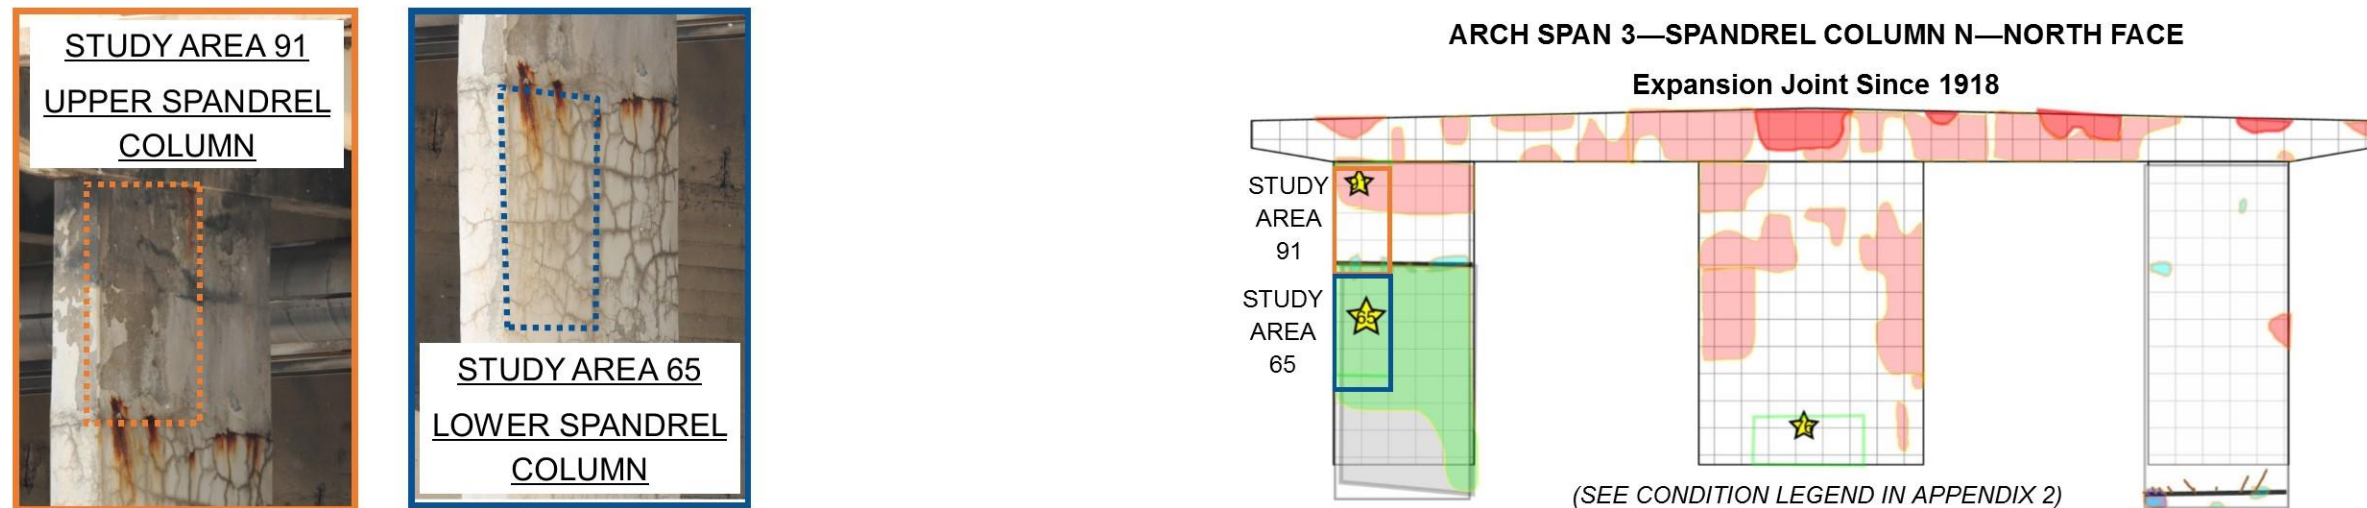
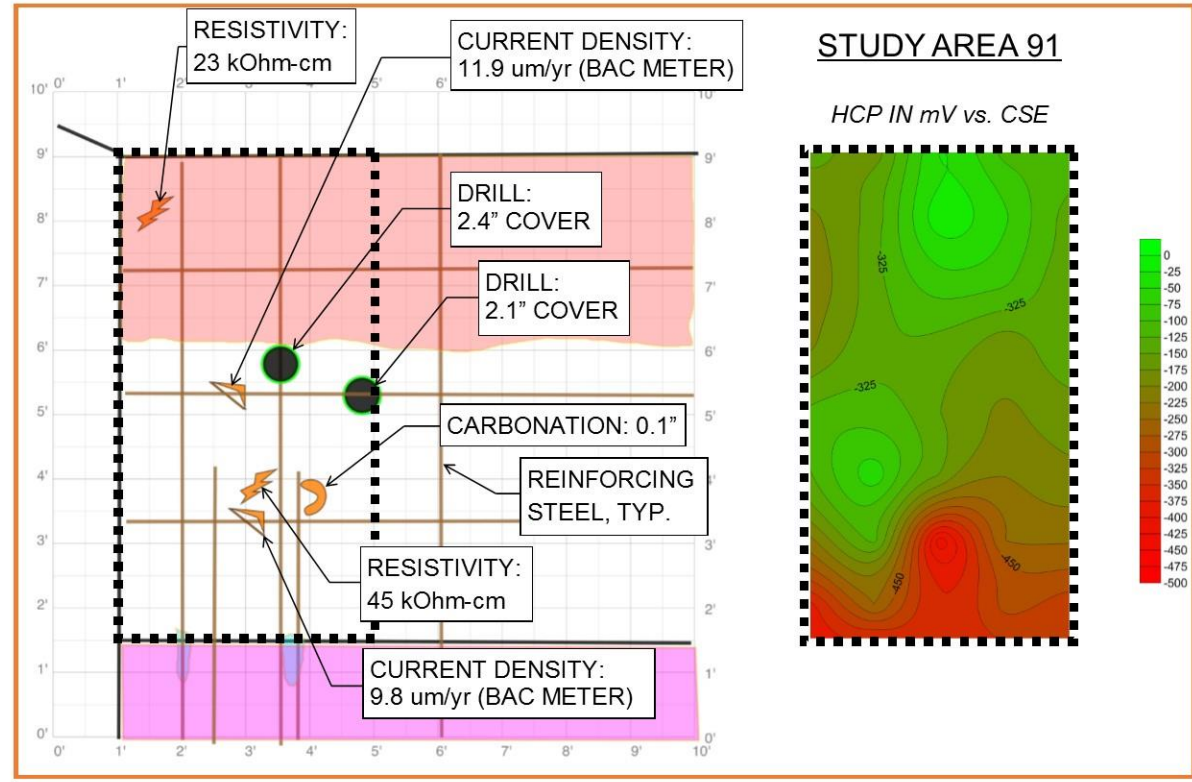
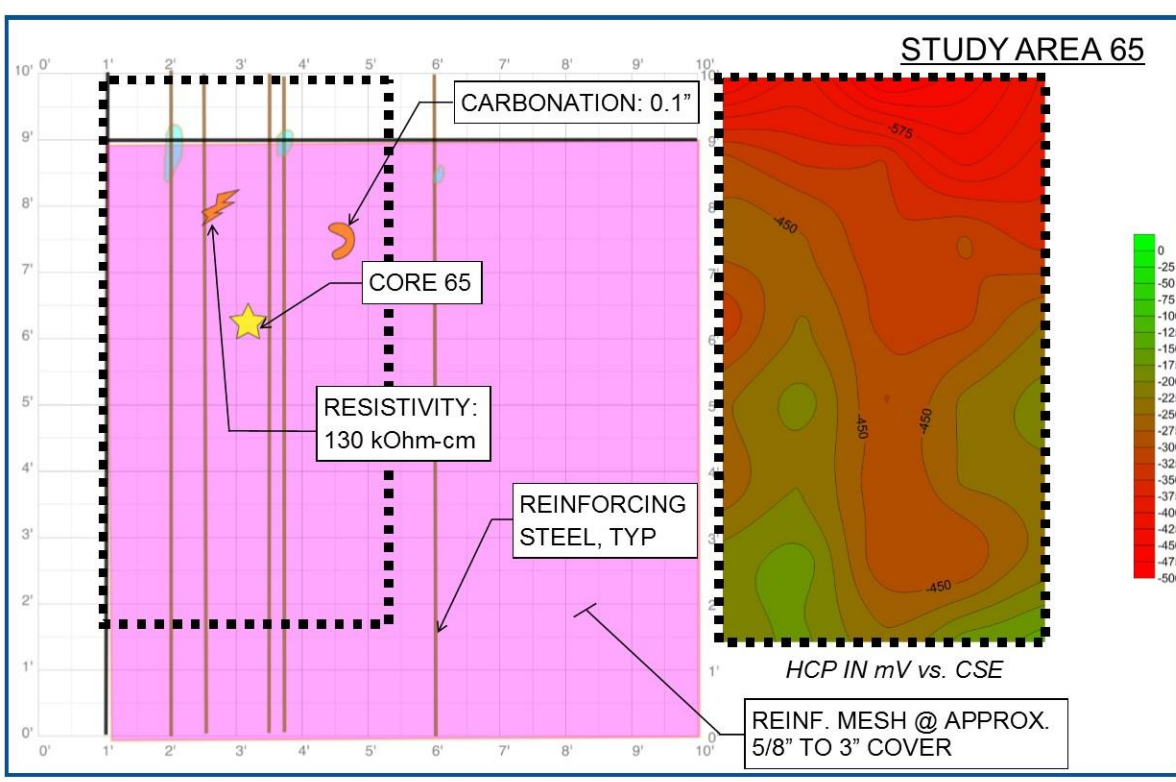
Study Area	Element	Inspection Date	Type	Distress Quantity (%)	Cores Sample(s)	HCP - Avg. (mV vs. CSE)	HCP - Min. (mV vs. CSE)	Resipod - Resistivity Avg. (kOhm-cm)	iCOR - Current Density Avg. (uA/cm ²)	iCOR - Resistivity Avg. (kOhm-cm)	BAC Meter - Current Density Avg. (um/yr)	Cover Vertical Bars - Rep. Minimum (in.)	Cover Horizontal Bars - Rep. Minimum (in.)	Carbonation Avg. (in.)	Deterioration Mechanism(s)
91	Upper Column	7/15/2017	NDE ONLY	> 30	--	-368	-595	34	N/A	N/A	9.2	2.4	2.1	0.1	Chloride Exposure
65	Lower Column	7/15/2017	NDE & CORE	> 30	65	-466	-683	130	N/A	N/A	N/A	5/8" MESH	N/A	0.1	Chloride Exposure; Moisture Ingress and Cracking

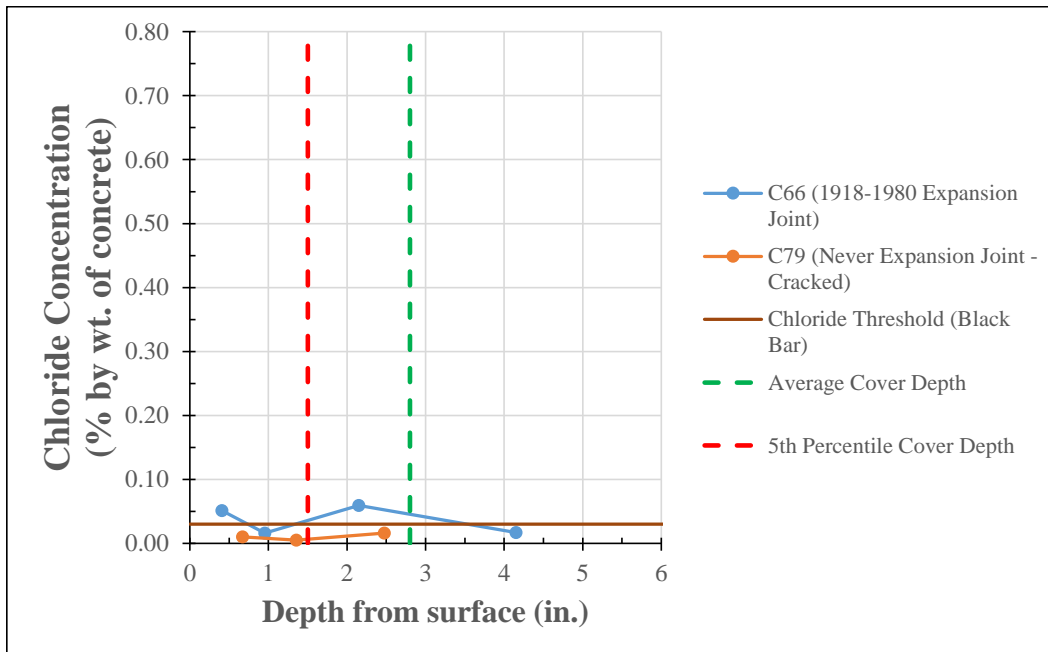
Figure 6.23. Chloride profiles for cores from Lower Spandrel Columns and Walls compared to chloride threshold.

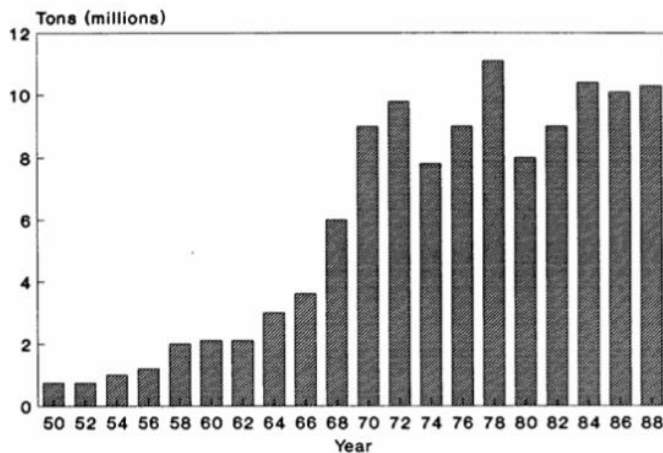
FIGURE 2-1 Trends in highway salt use, 1950–1988 (source: Salt Institute).
