3RD AVENUE BRIDGE

Bridge Inspection and Condition Evaluation Report

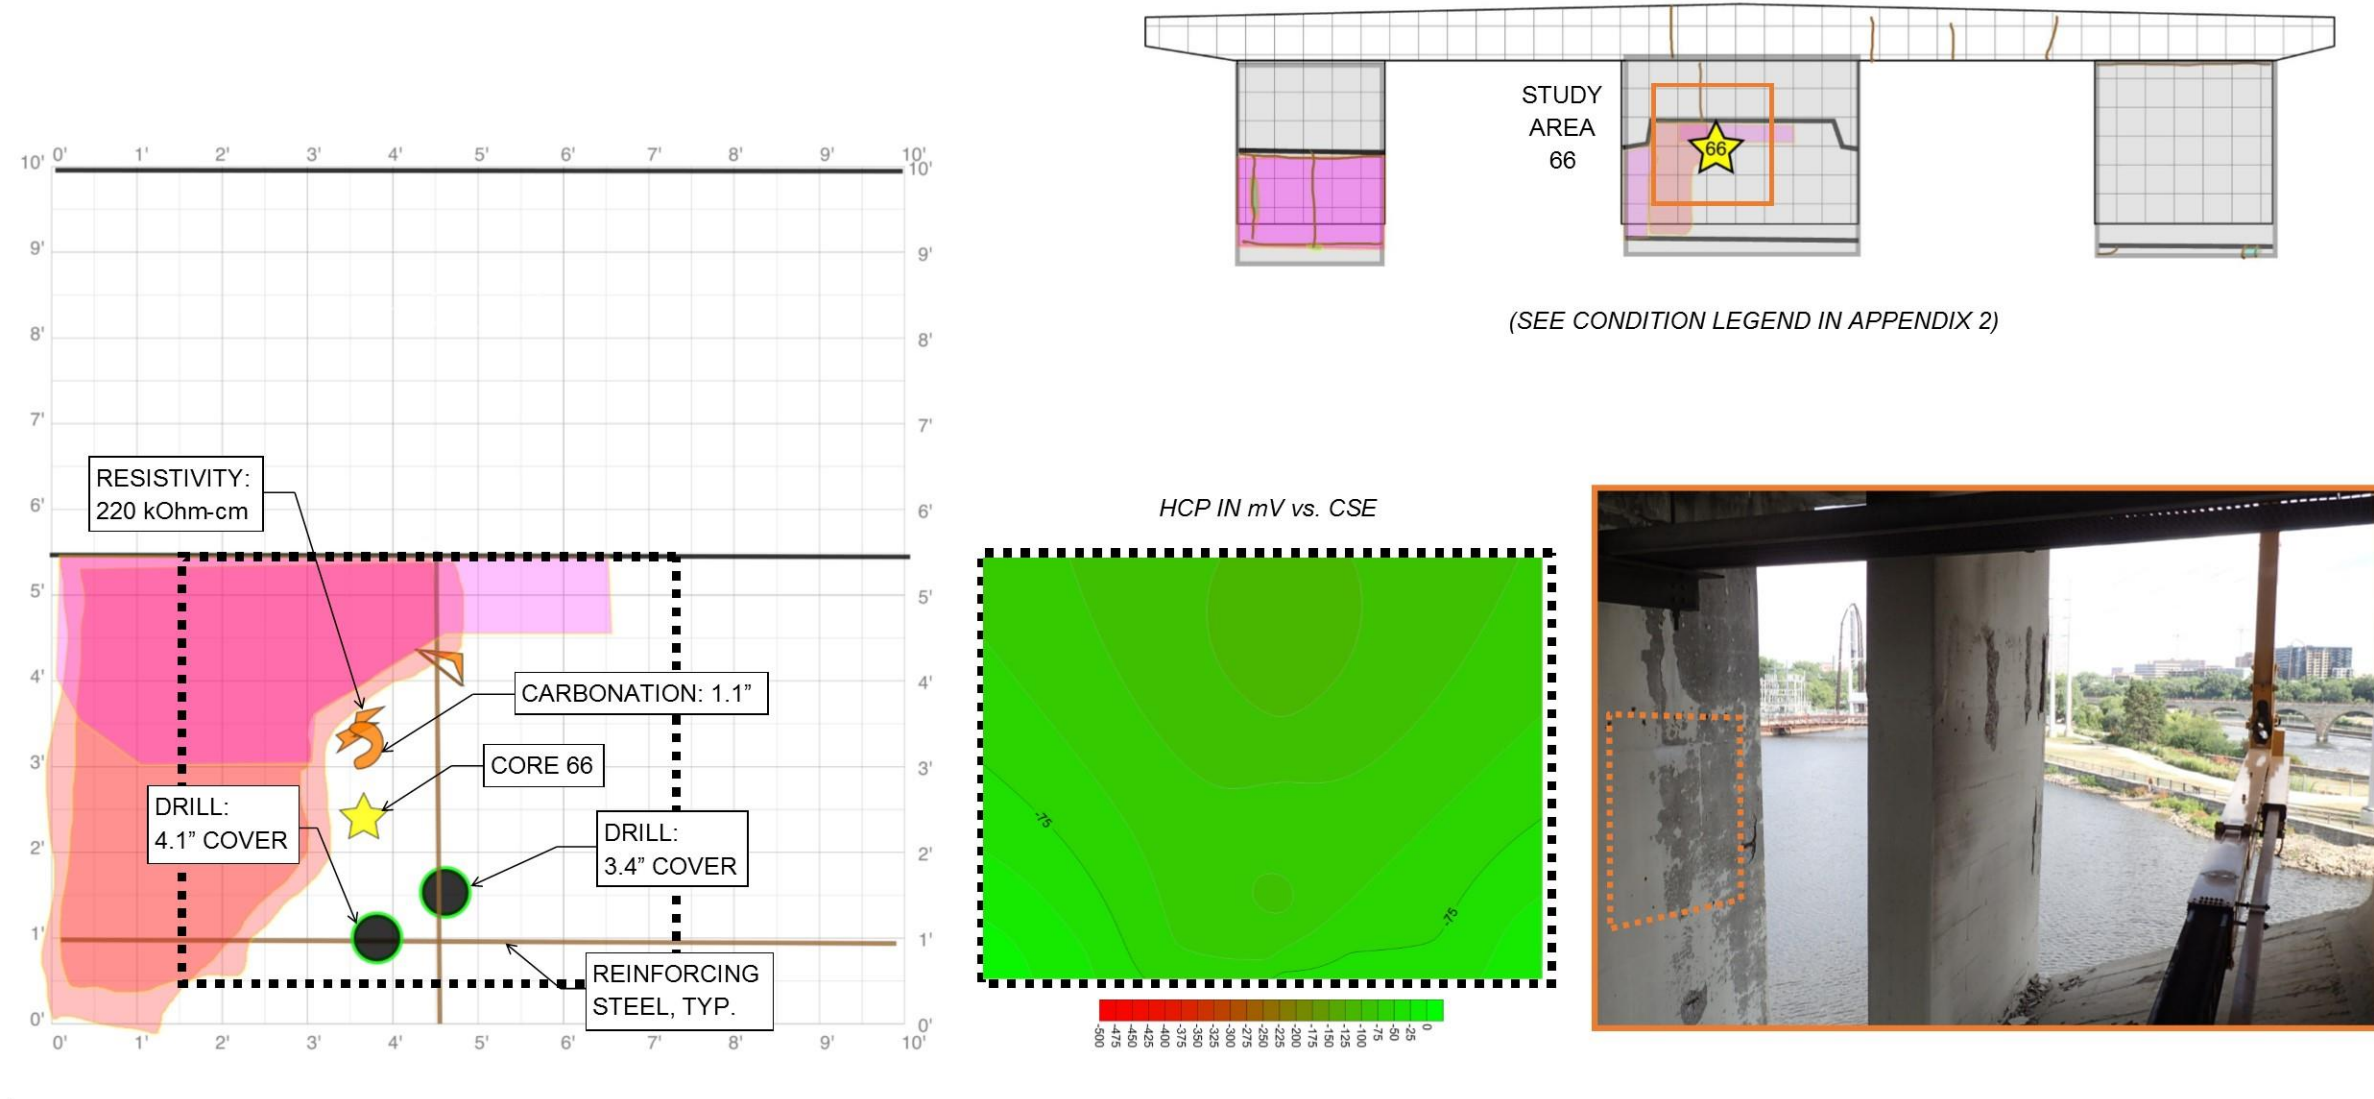
Study Area	Element	Inspection Date	Type	Distress Quantity (%)	Cores Sample(s)	HCP - Avg. (mV vs. CSE)	HCP - Min. (mV vs. CSE)	Resipod - Resistivity Avg. (kOhm-cm)	iCOR - Current Density Avg. (uA/cm ²)	iCOR - Resistivity Avg. (kOhm-cm)	BAC Meter - Current Density Avg. (um/yr)	Cover Vertical Bars - Rep. Minimum (in.)	Cover Horizontal Bars - Rep. Minimum (in.)	Carbonation Avg. (in.)	Deterioration Mechanism(s)
66	Lower Column	7/15/2017	NDE & CORE	10 to 30	66	-92	-165	220	N/A	N/A	1.5	3.4	4.1	1.1	Chloride Exposure; Carbonation

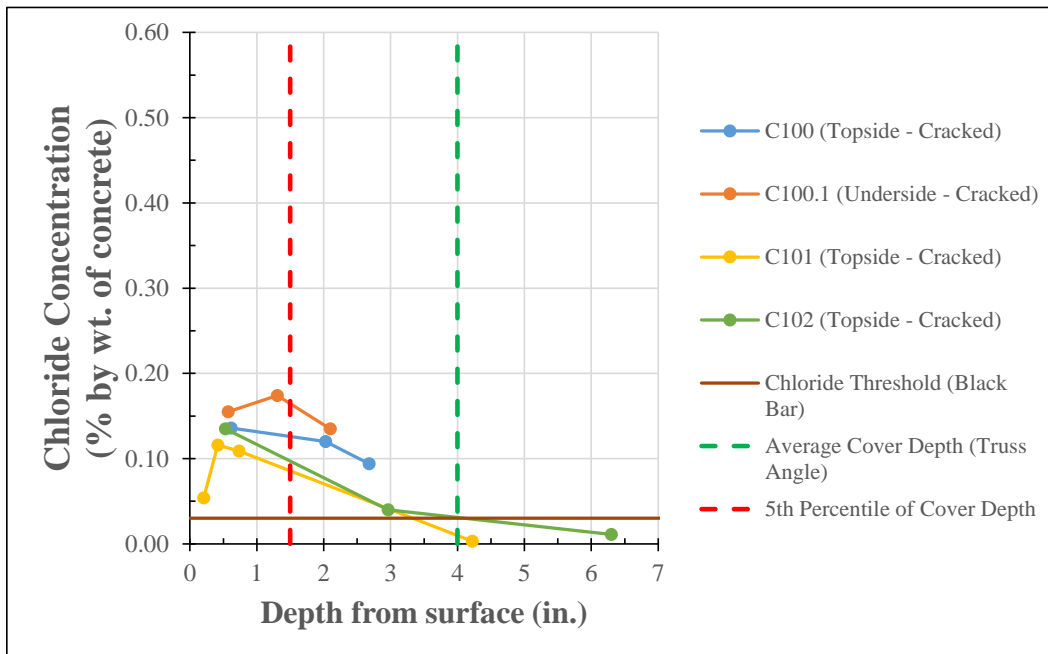
Figure 6.27. Chloride profiles for Arch Rib cores compared to chloride threshold for corrosion initiation and reinforcement cover depth measurements.

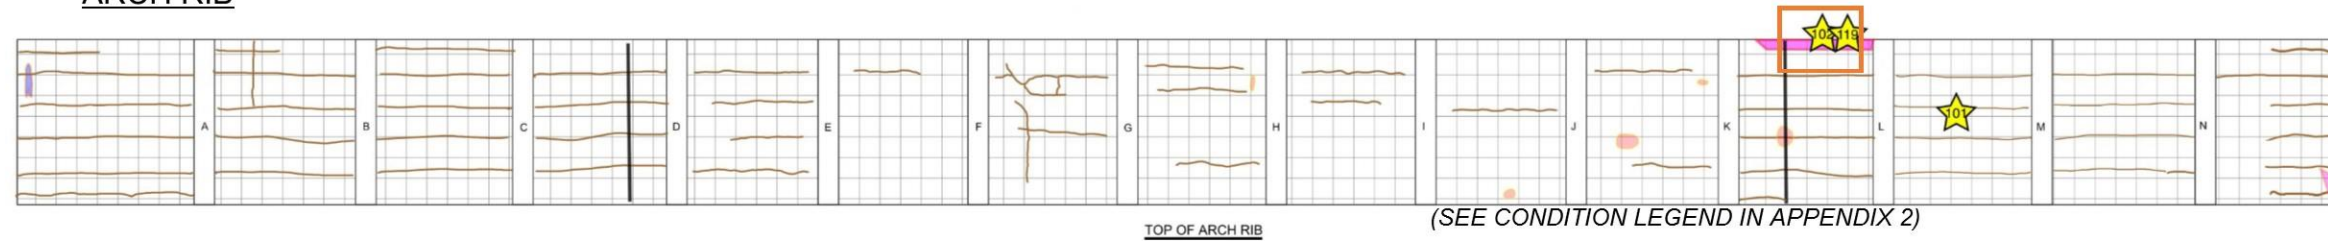
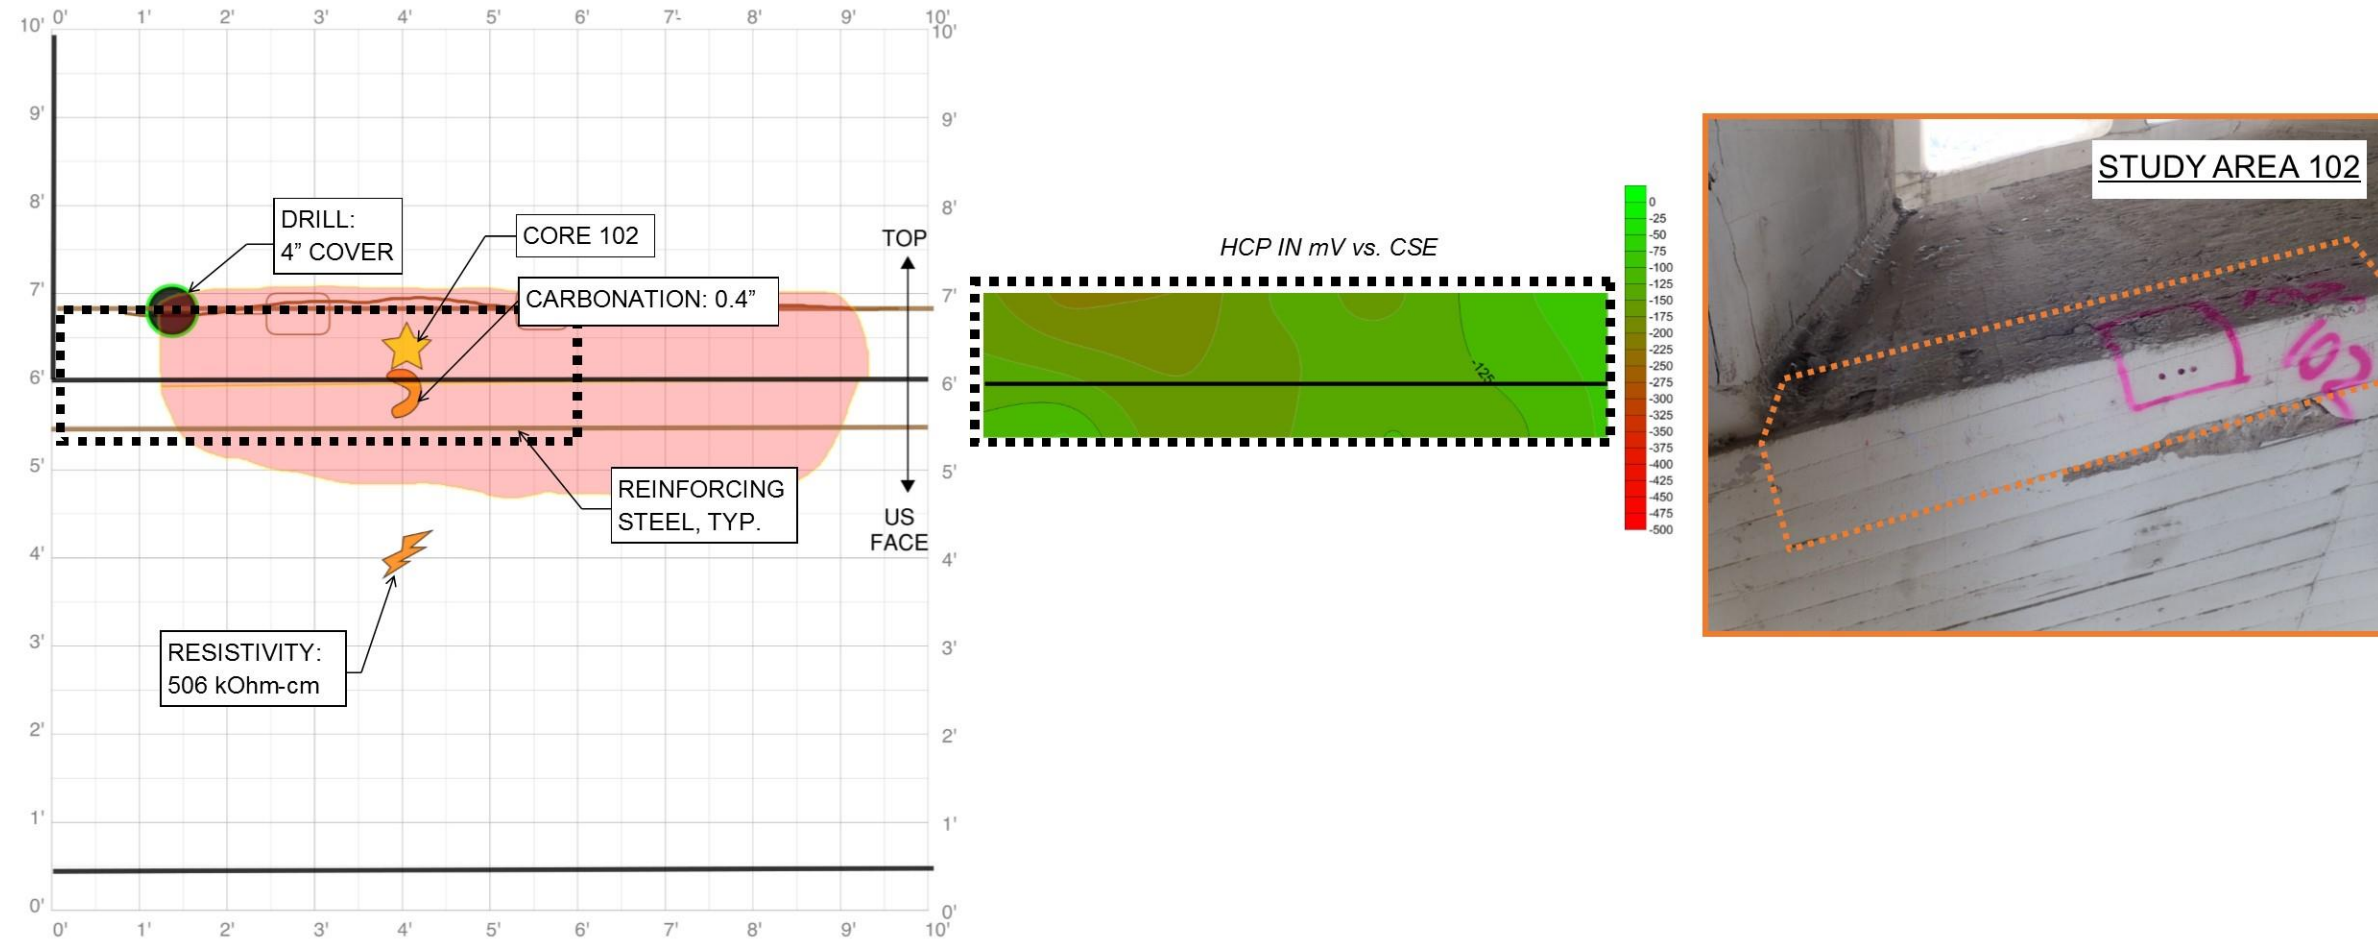
Study Area	Element	Inspection Date	Type	Distress Quantity (%)	Cores Sample(s)	HCP - Avg. (mV vs. CSE)	HCP - Min. (mV vs. CSE)	Resipod - Resistivity Avg. (kOhm-cm)	iCOR - Current Density Avg. (uA/cm ²)	iCOR - Resistivity Avg. (kOhm-cm)	BAC Meter - Current Density Avg. (um/yr)	Cover Truss Topside - Rep. Minimum (in.)	Cover Vertical Face - Rep. Minimum (in.)	Cover Truss Underside - Rep. Minimum (in.)	Carbonation Avg. (in.)	Deterioration Mechanism(s)
102	Arch Rib	7/16/2017	NDE & CORE	> 30	102	-140	-210	506	N/A	N/A	N/A	2.8	N/A	N/A	0.4	Chloride Exposure

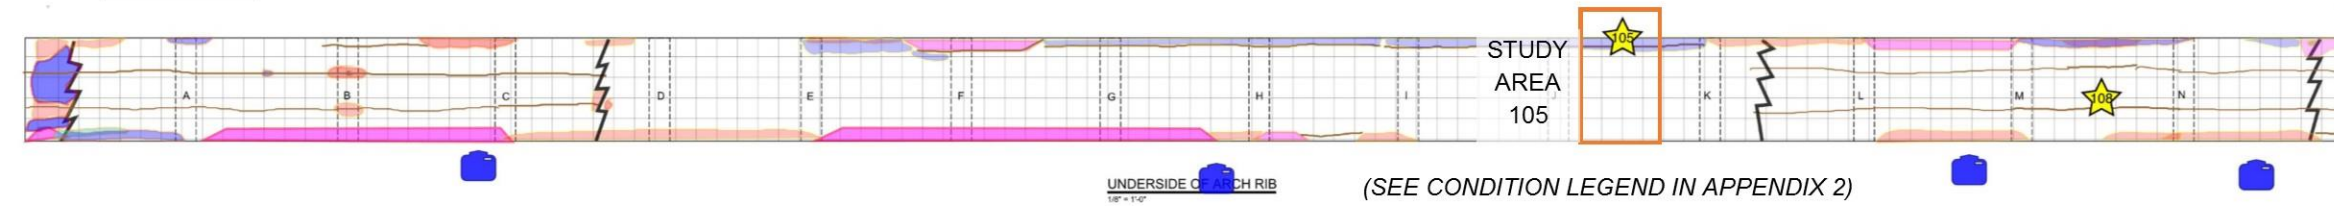
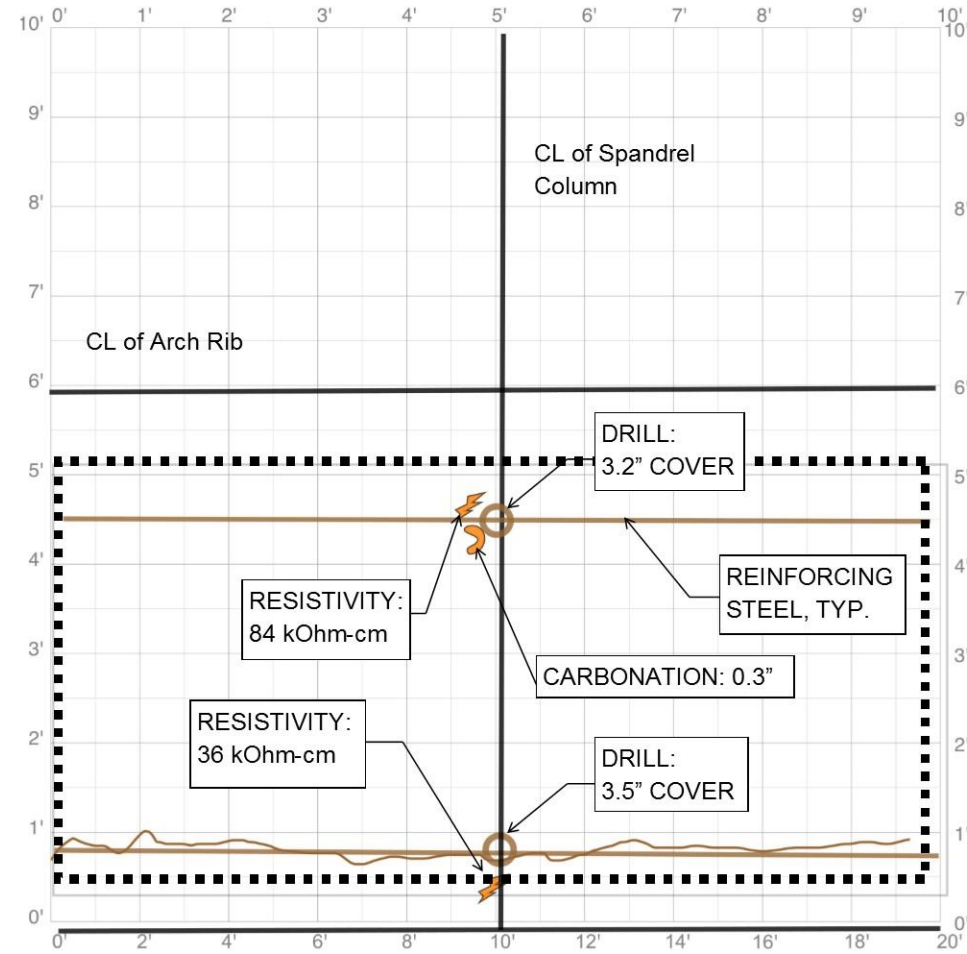
UNDERSIDE OF ARCH RIB (SEE CONDITION LEGEND IN APPENDIX 2)

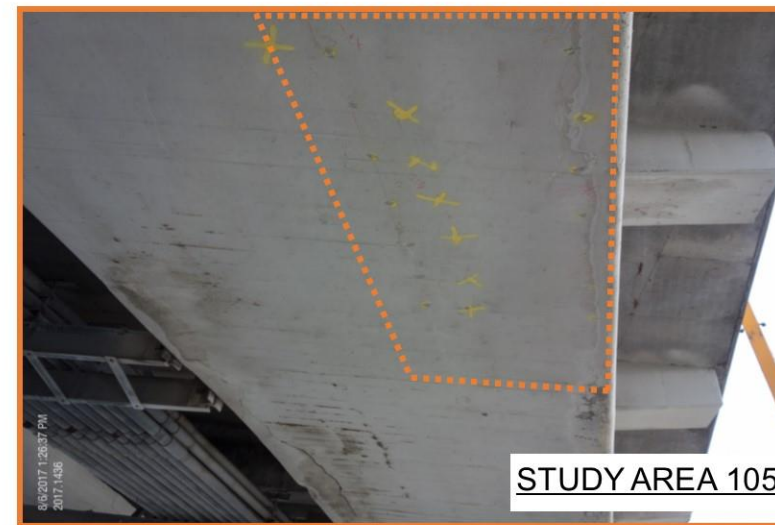
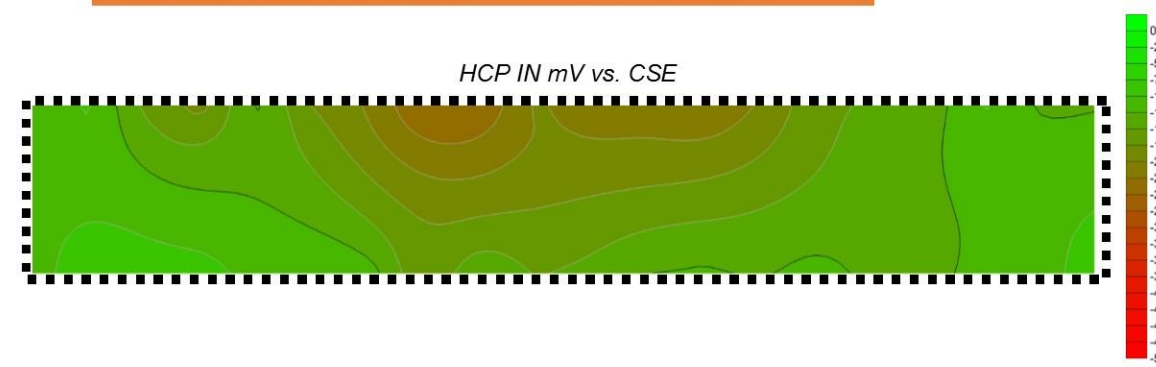
Study Area	Element	Inspection Date	Type	Distress Quantity (%)	Cores Sample(s)	HCP - Avg. (mV vs. CSE)	HCP - Min. (mV vs. CSE)	Resipod - Resistivity Avg. (kOhm-cm)	iCOR - Current Density Avg. (uA/cm ²)	iCOR - Resistivity Avg. (kOhm-cm)	BAC Meter - Current Density Avg. (um/yr)	Cover Truss Topside - Rep. Minimum (in.)	Cover Vertical Face - Rep. Minimum (in.)	Cover Truss Underside - Rep. Minimum (in.)	Carbonation Avg. (in.)	Deterioration Mechanism(s)
105	Arch Rib	8/6/2017	NDE ONLY	< 1	--	-144	-249	61	N/A	N/A	N/A	N/A	N/A	2.6	0.3	Chloride Exposure

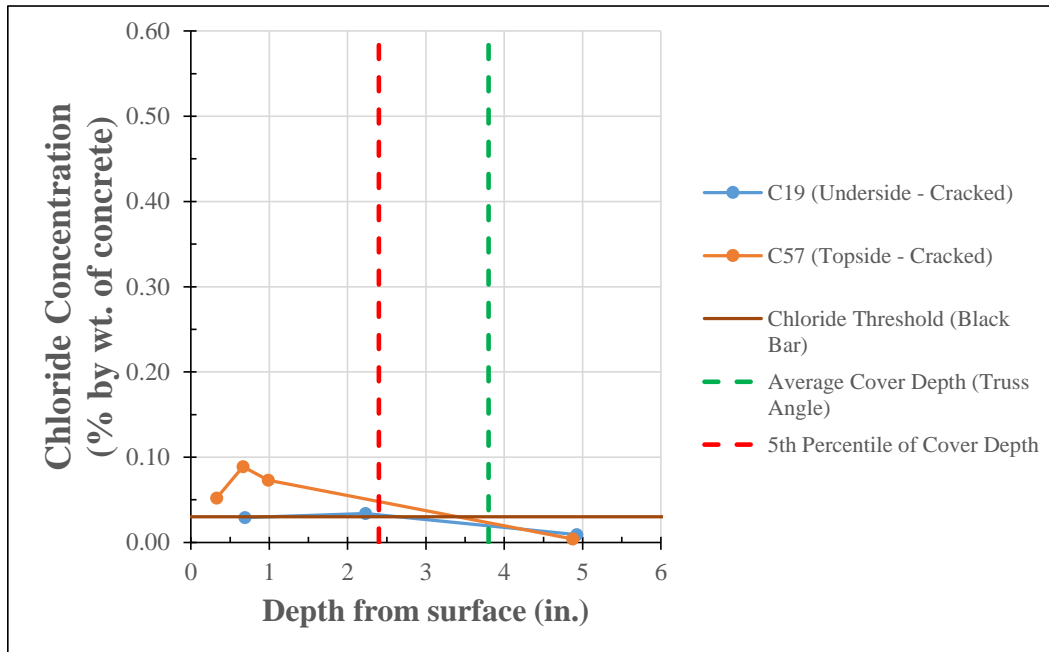
Figure 6.30. Chloride profiles for Barrel Arches cores compared to chloride threshold.

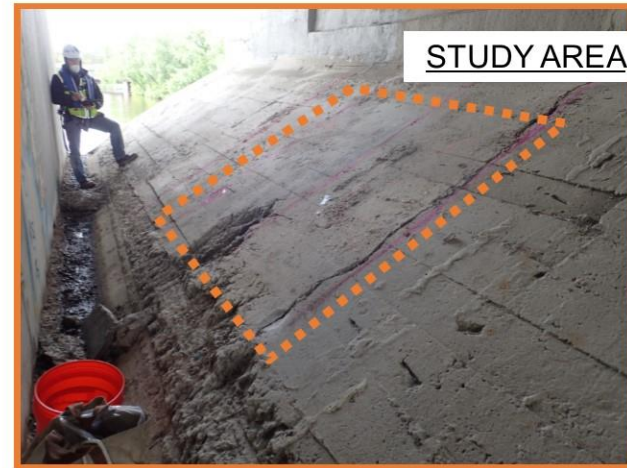
STUDY AREA 57
 BARREL ARCH

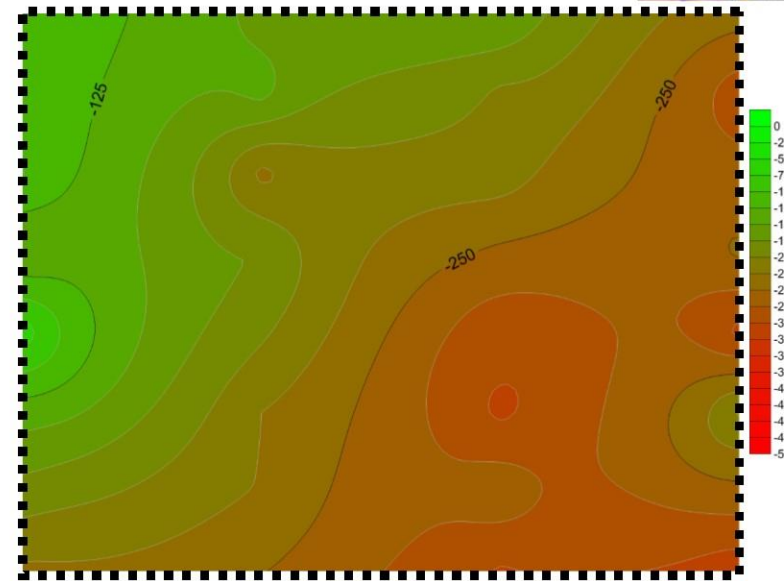
(SEE CONDITION LEGEND IN APPENDIX 2)

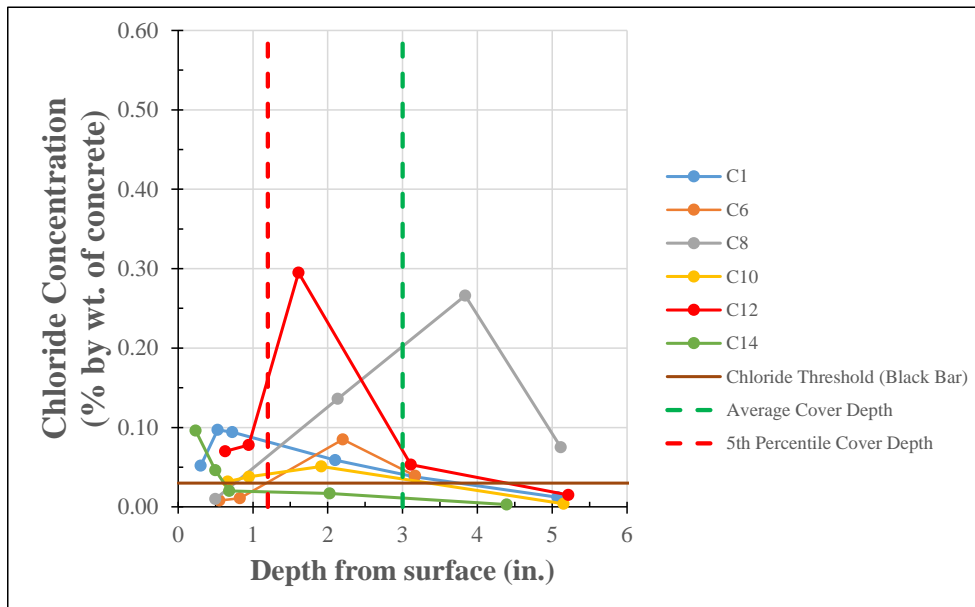
Figure 6.32. Chloride profiles for arch pier cores compared to chloride threshold.

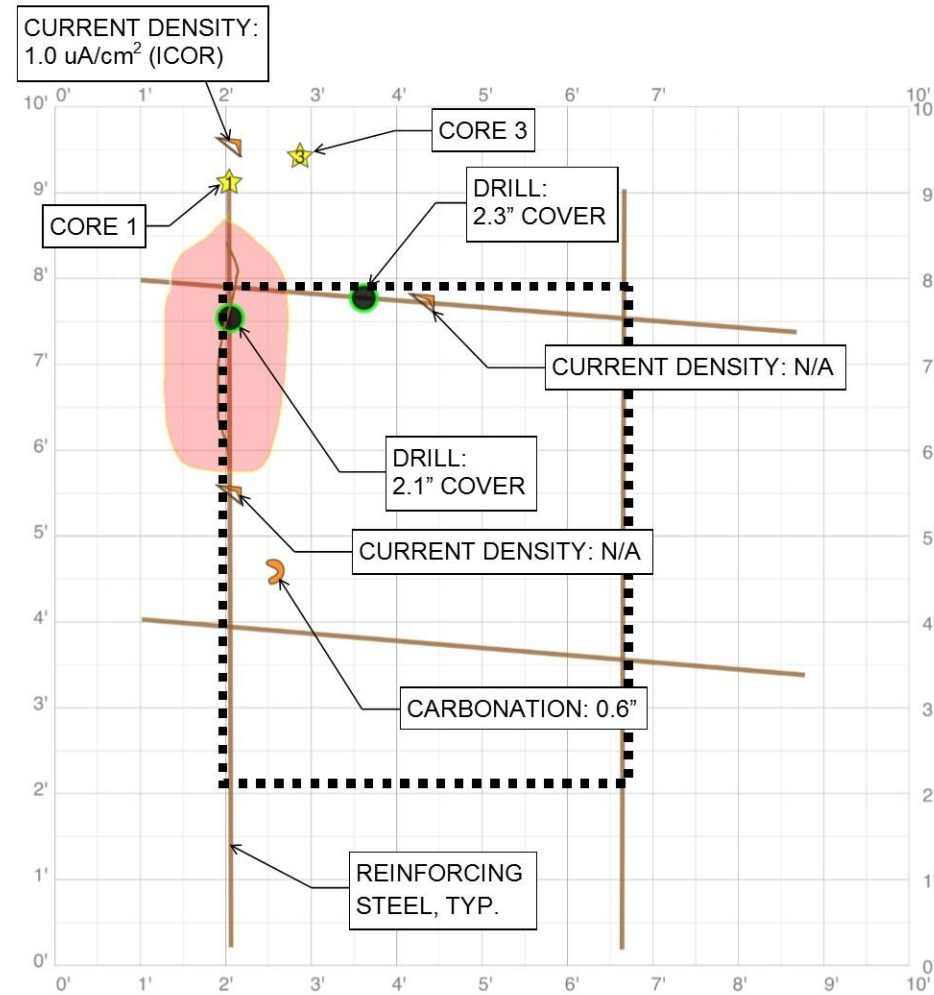
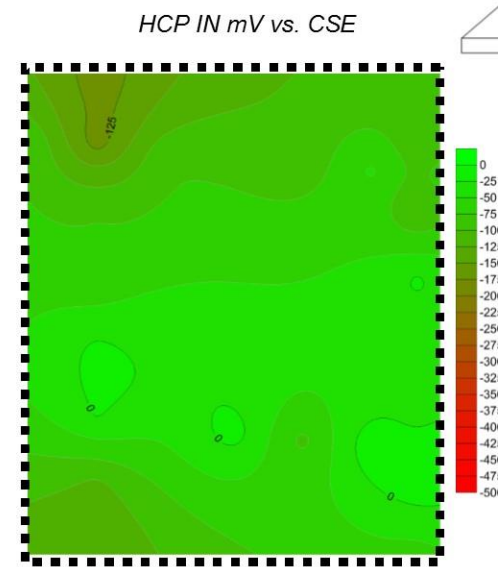
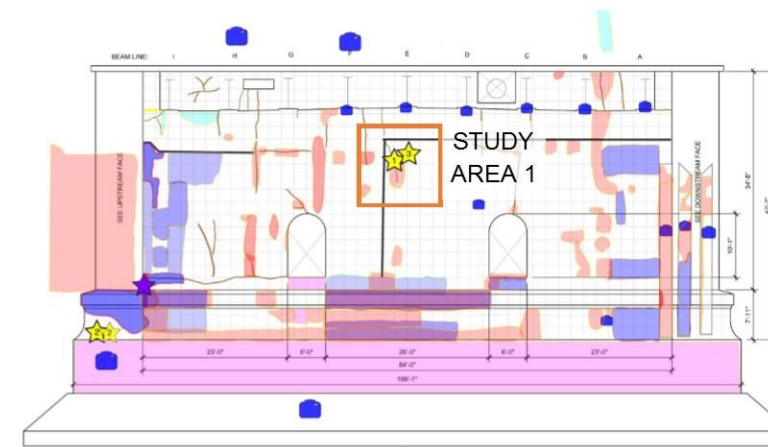
(SEE CONDITION LEGEND IN APPENDIX 2)

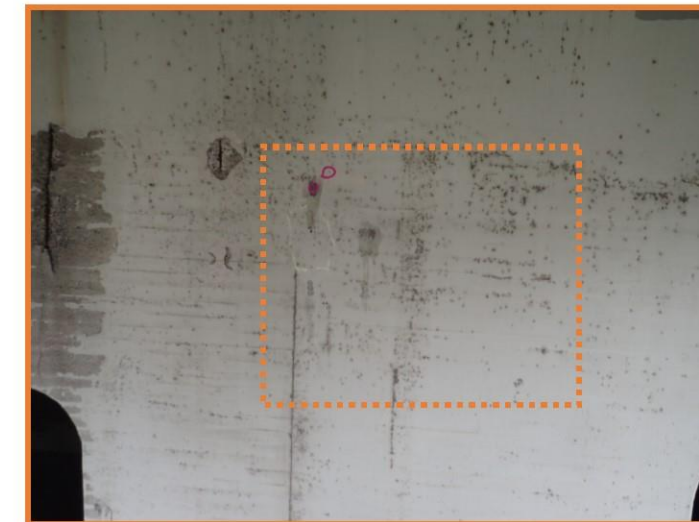
Study Area	Element	Inspection Date	Type	Distress Quantity (%)	Cores Sample (s)	HCP - Avg. (mV vs. CSE)	HCP - Min. (mV vs. CSE)	Resipod - Resistivity Avg. (kOhm-cm)	iCOR - Current Density Avg. (uA/cm ²)	iCOR - Resistivity Avg. (kOhm-cm)	BAC Meter - Current Density Avg. (um/yr)	Cover Vertical Bars - Rep. Minimum (in.)	Cover Horizontal Bars - Rep. Minimum (in.)	Carbonation Avg. (in.)	Deterioration Mechanism(s)
1	Arch Pier - Wall	5/22/2017	NDE & CORE	1 to 10	1 & 3	-41	-136	N/A	1.0	92	N/A	1.2	2.2	0.6	Chloride Exposure; Carbonation

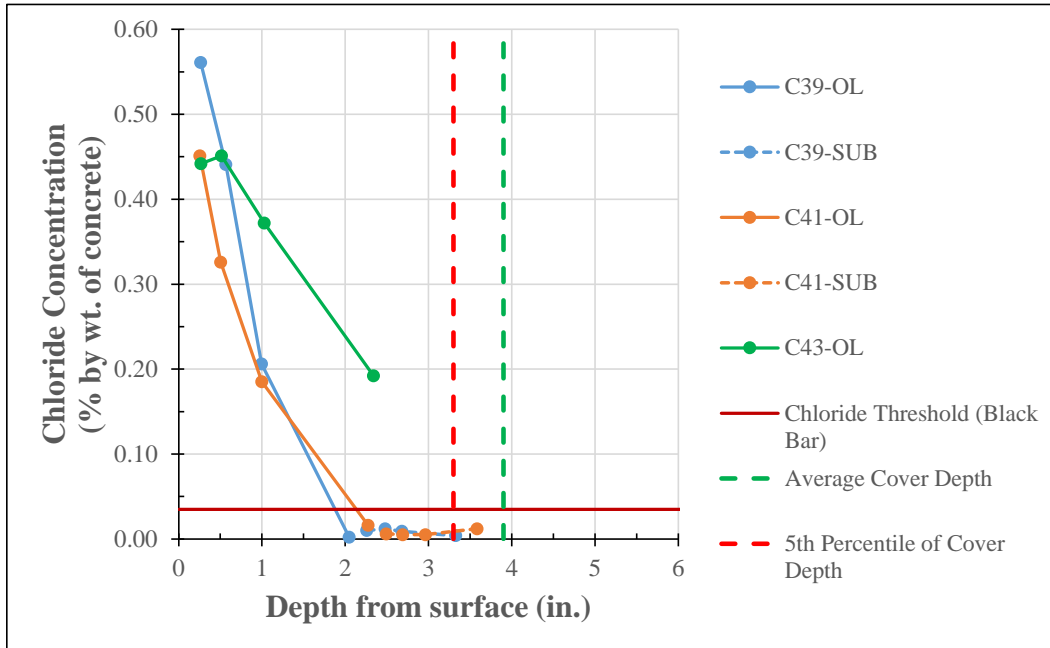
Figure 6.35. Chloride profiles for Deck Roadway - Approach (topside) cores compared to chloride threshold for corrosion initiation for black bar as a reference and reinforcement cover depth measurements. Note top bars are actually epoxy-coated, so threshold is higher - see Section 3.2.1.2.
 (Overlay = OL; Substrate = SUB)

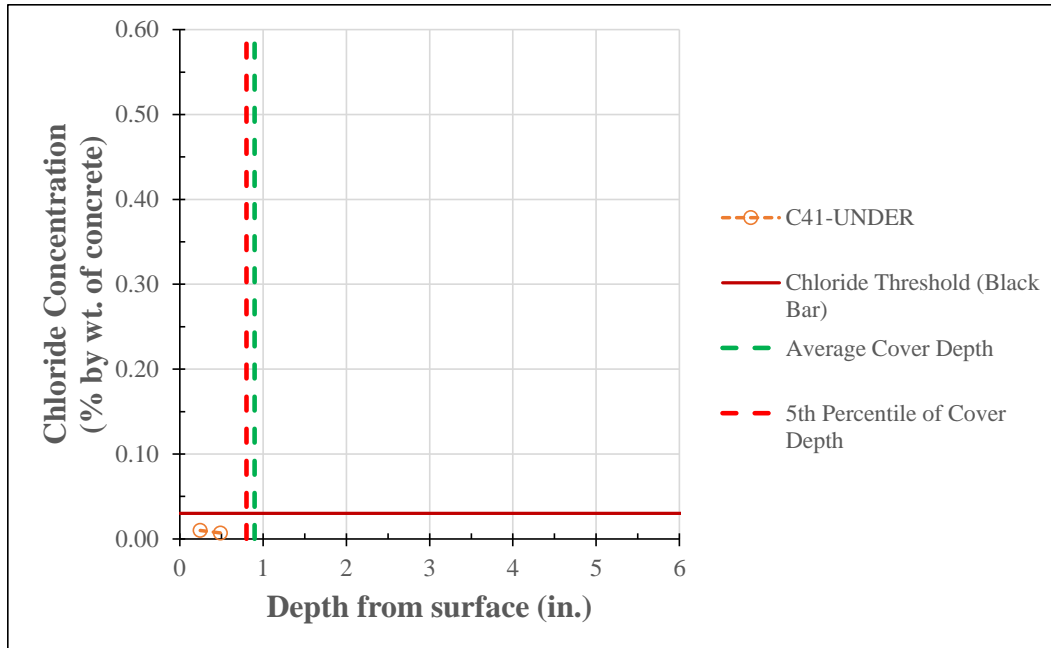
Figure 6.36. Chloride profiles for Deck Roadway - Approach (underside) cores compared to chloride threshold for corrosion initiation and reinforcement cover depth measurements. (Underside = UNDER)

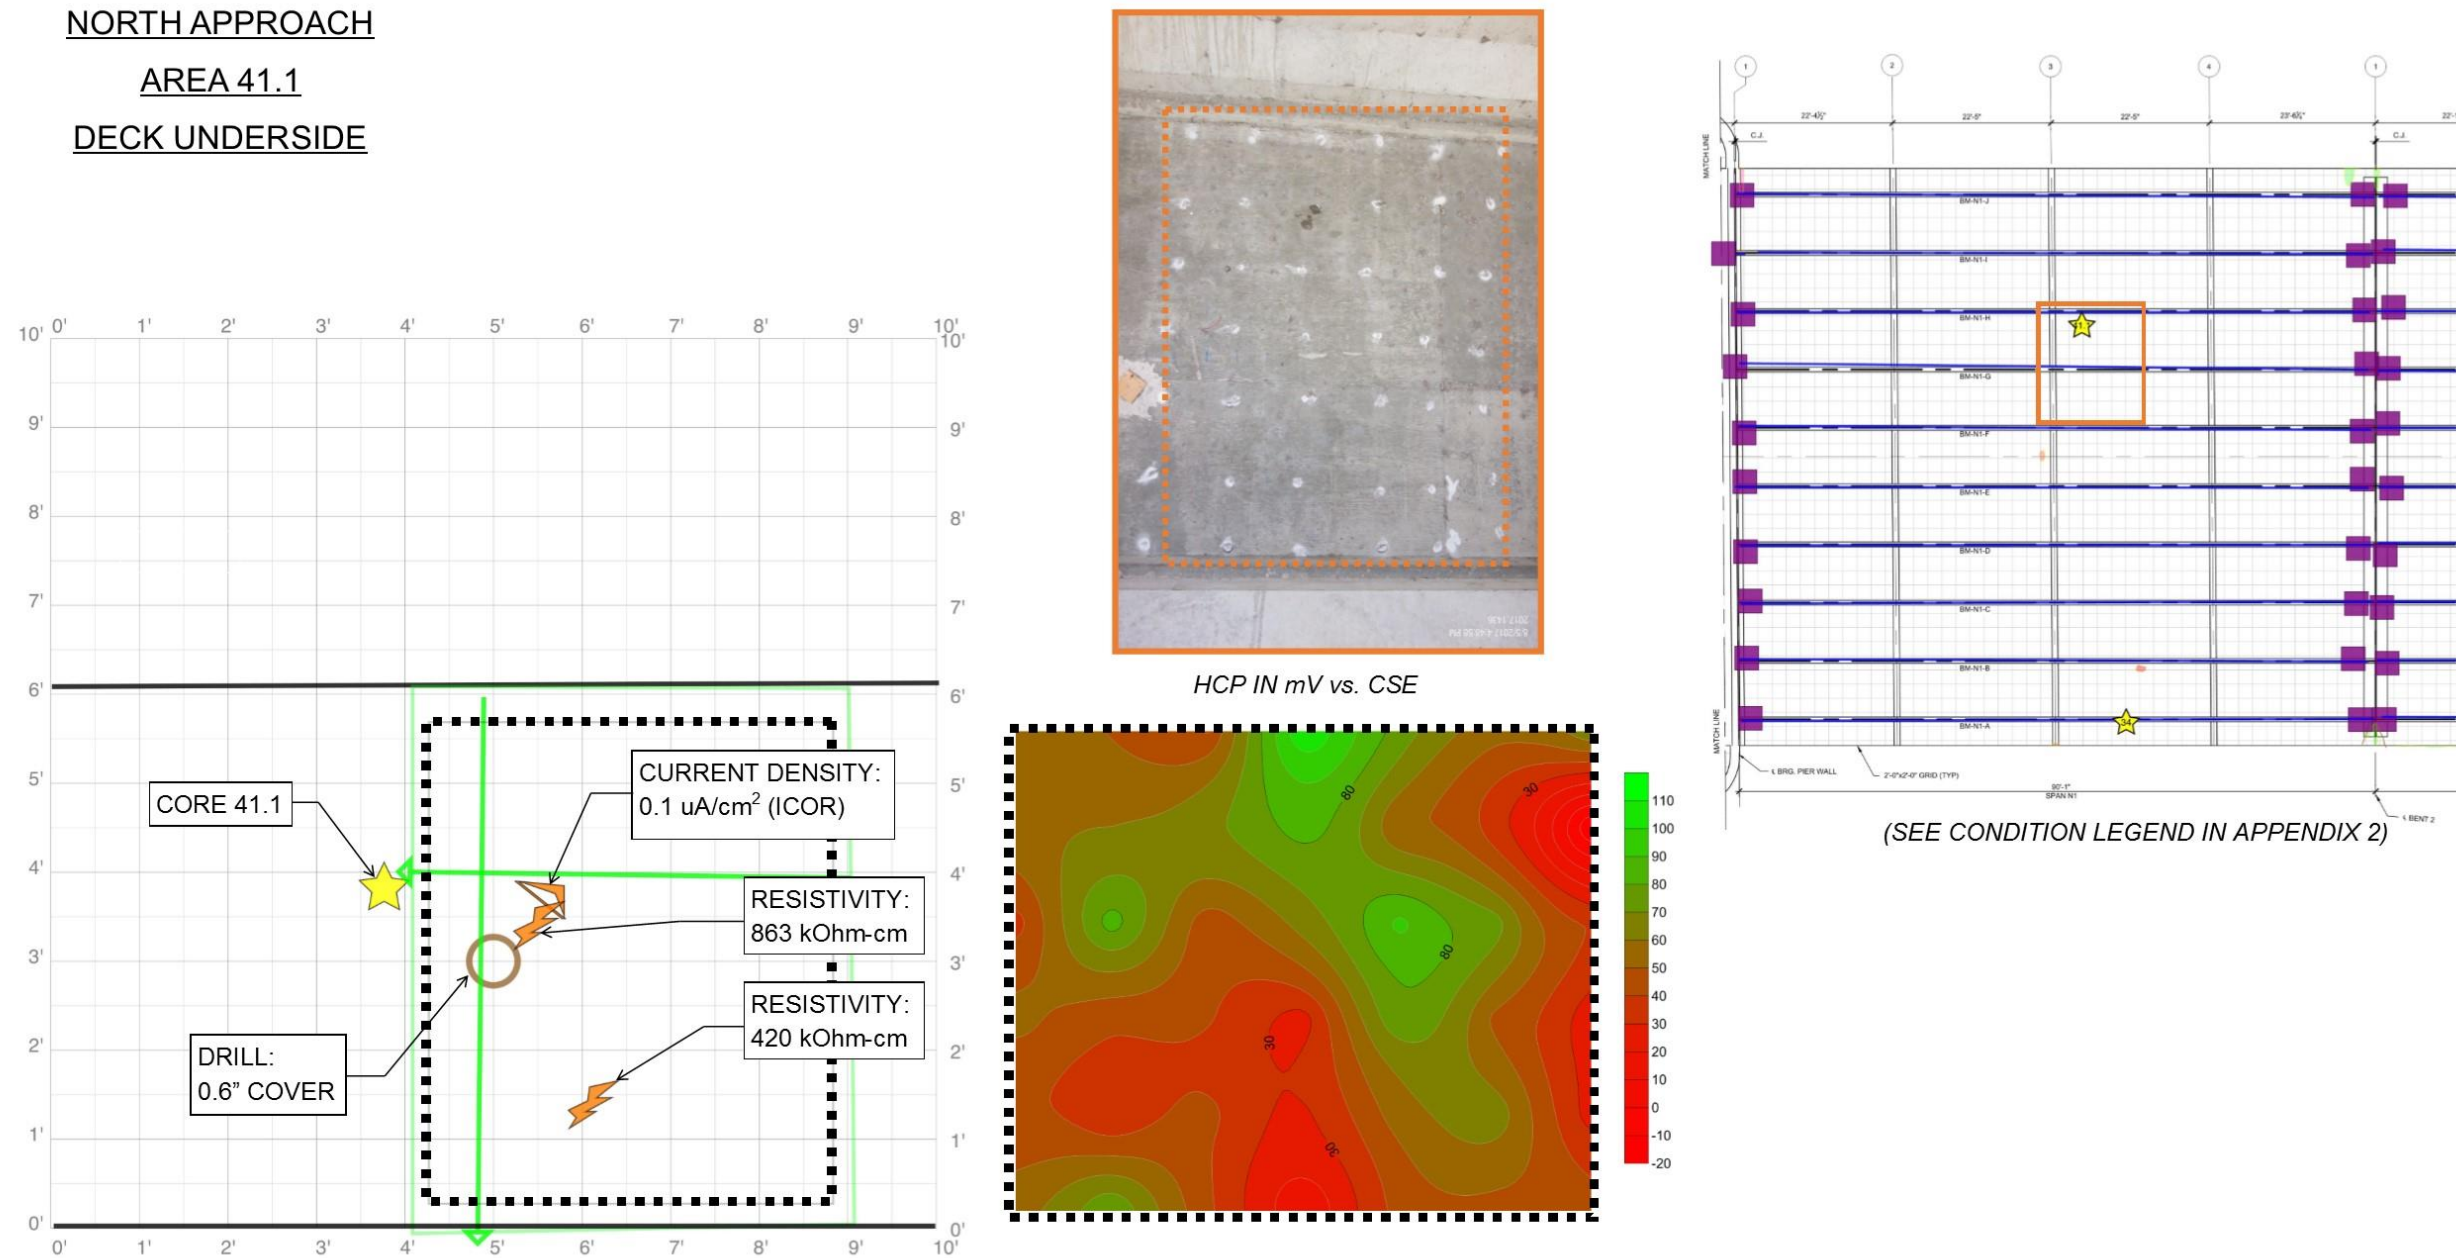
Study Area	Element	Inspection Date	Type	Distress Quantity (%)	Cores Sample(s)	HCP - Avg. (mV vs. CSE)	HCP - Min. (mV vs. CSE)	Resipod - Resistivity Avg. (kOhm-cm)	iCOR - Current Density Avg. (uA/cm ²)	iCOR - Resistivity Avg. (kOhm-cm)	BAC Meter - Current Density Avg. (um/yr)	Cover Vertical Bars - Rep. Minimum (in.)	Cover Horizontal Bars - Rep. Minimum (in.)	Carbonation Avg. (in.)	Deterioration Mechanism(s)
41.1	Deck Underside	8/5/2017	NDE & CORE	< 1	41	51	-20	642	0.1	309	N/A	1.0	0.6	N/A	Chloride Exposure

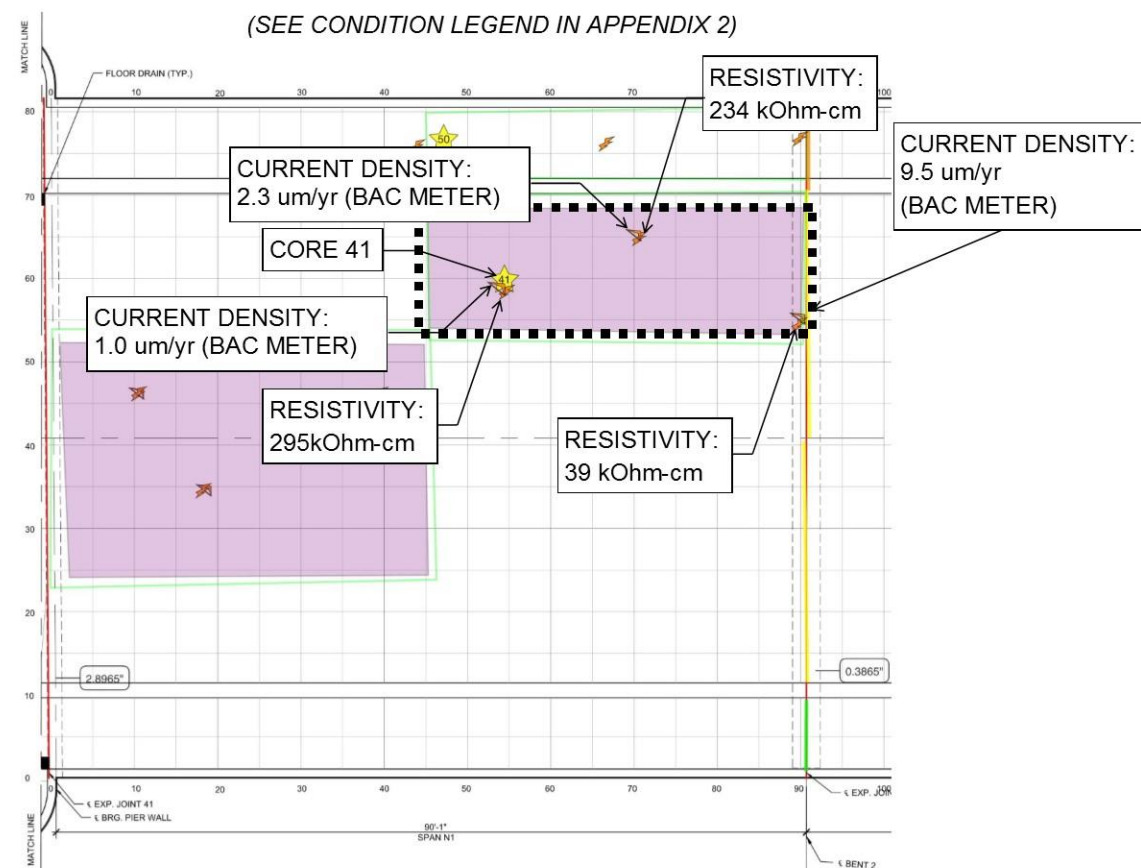
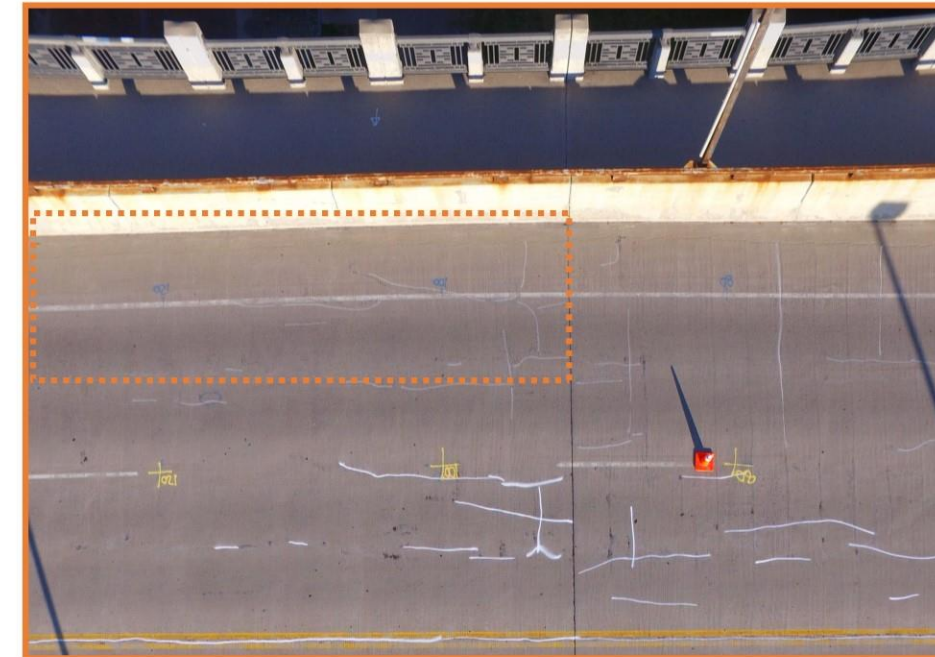
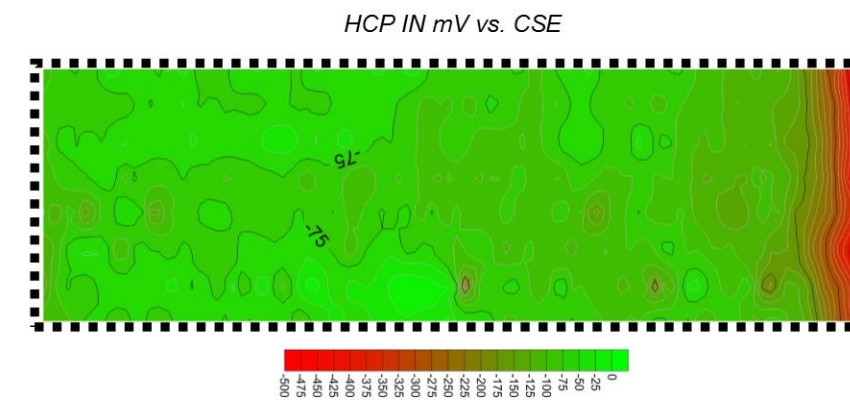
Study Area	Element	Inspection Date	Type	Distress Quantity (%)	Cores Sample(s)	HCP - Avg. (mV vs. CSE)	HCP - Min. (mV vs. CSE)	Resipod - Resistivity Avg. (kOhm-cm)	iCOR - Current Density Avg. (uA/cm ²)	iCOR - Resistivity Avg. (kOhm-cm)	BAC Meter - Current Density Avg. (um/yr)	Cover Vertical Bars - Rep. Minimum (in.)	Cover Horizontal Bars - Rep. Minimum (in.)	Carbonation Avg. (in.)	Deterioration Mechanism(s)
N. App.	Deck Roadway	5/23/2017	NDE & CORE	< 1	41	-109	-553	189	N/A	N/A	4.3	4.3	3.8	N/A	Chloride Exposure

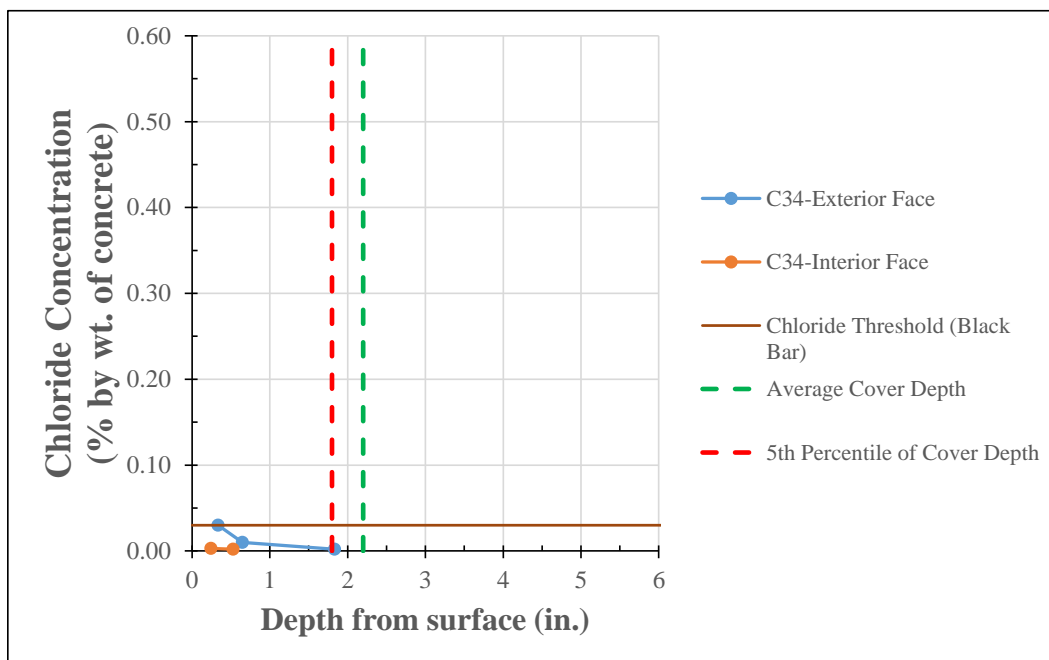
Figure 6.41. Chloride profiles for Prestressed Girder core compared to chloride threshold.

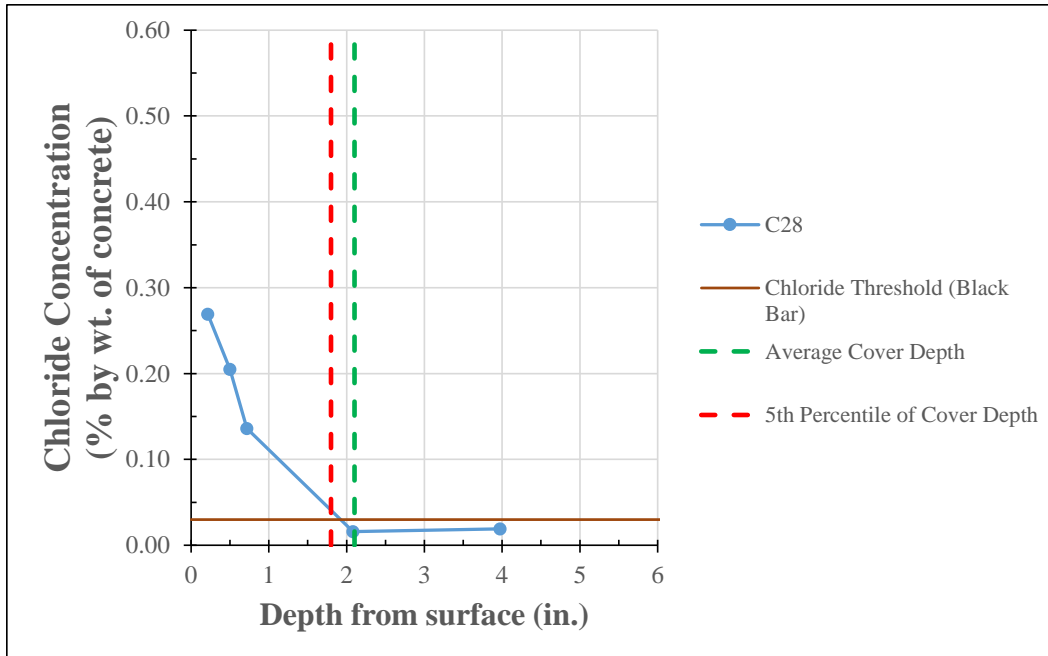
Figure 6.42. Chloride profile for North Abutment core compared to chloride threshold.

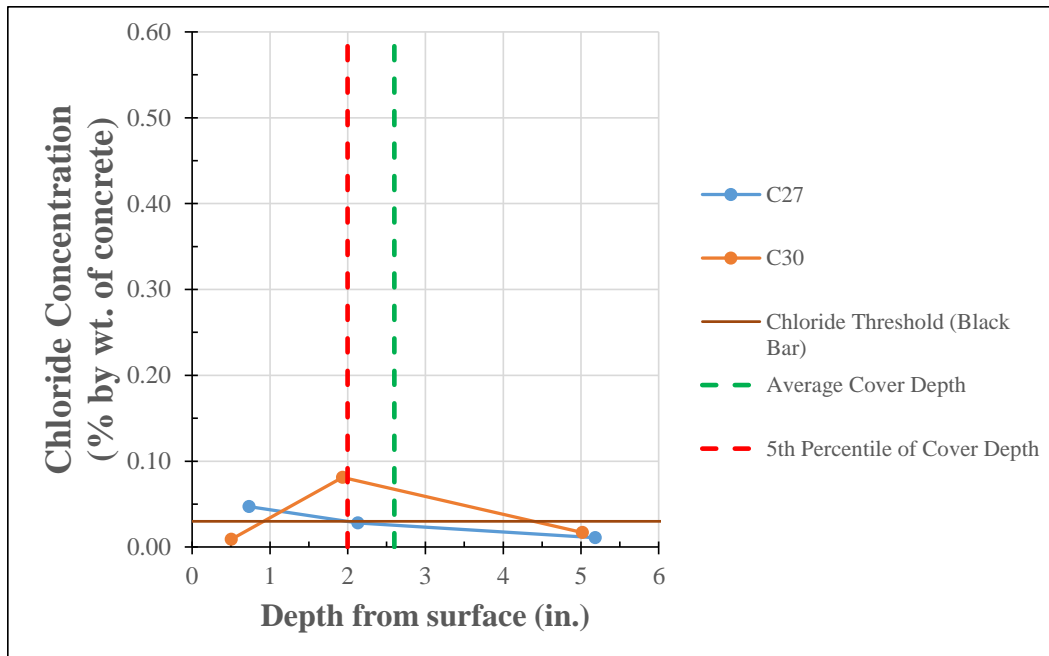
Figure 6.44. Chloride profiles for North Retaining Walls cores compared to chloride threshold.

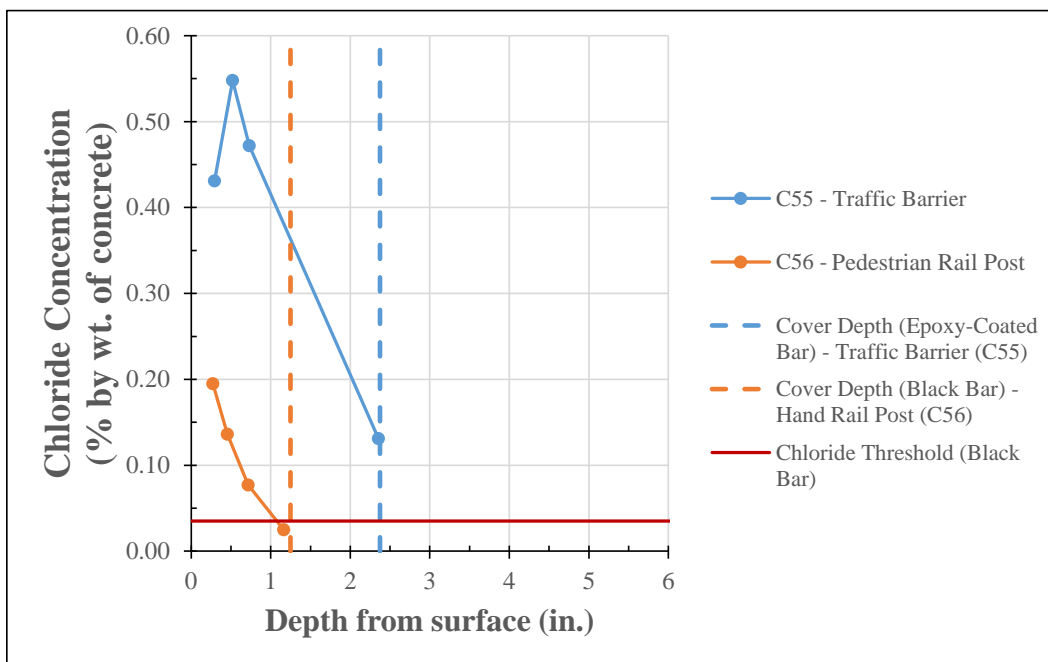
Figure 6.45. Chloride profiles for Deck Rail Elements compared to chloride threshold for black bar as a reference. Note that the bars in the Traffic Barrier are epoxy-coated reinforcing, which has a higher corrosion threshold - see Section 3.2.1.2.

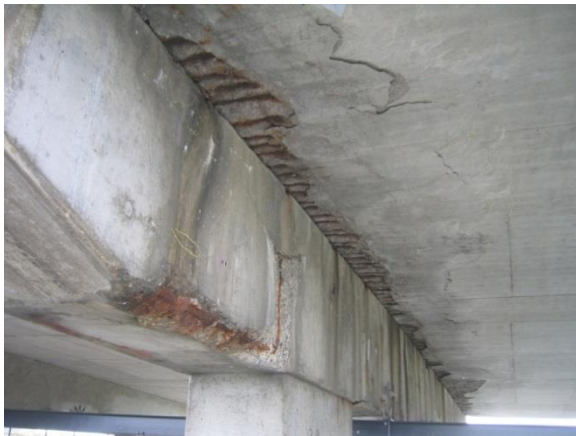
a) Franklin Avenue Bridge (2008)

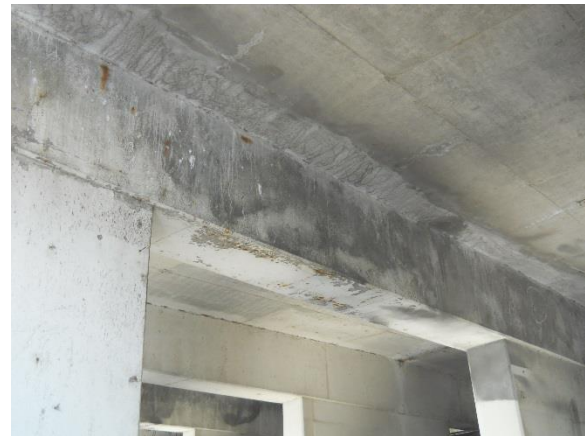
b) 3rd Avenue Bridge (2017)
