3RD AVENUE BRIDGE

Bridge Inspection and Condition Evaluation Report

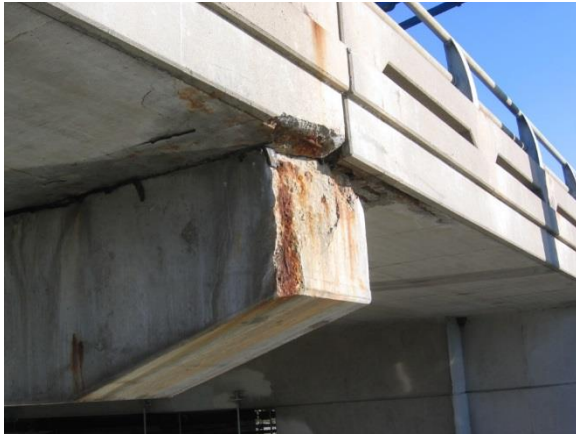
a) Franklin Avenue Bridge (2008)

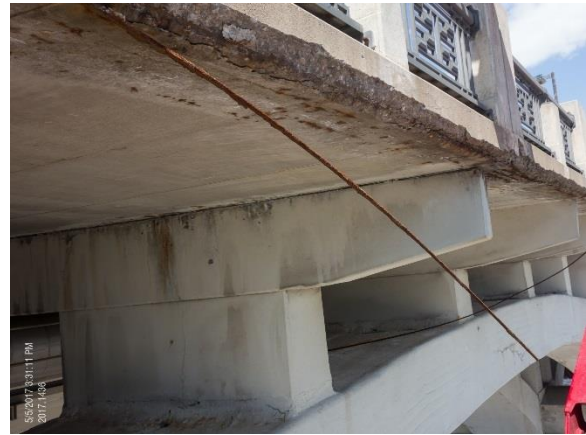
b) 3rd Avenue Bridge (2017)

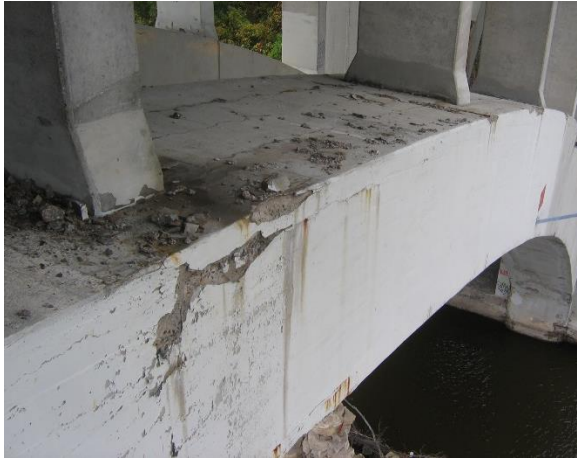
a) Franklin Avenue Bridge (2008).

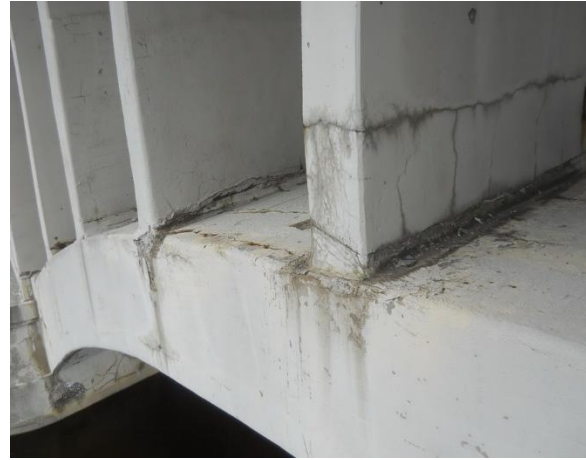
b) 3rd Avenue Bridge (2017).

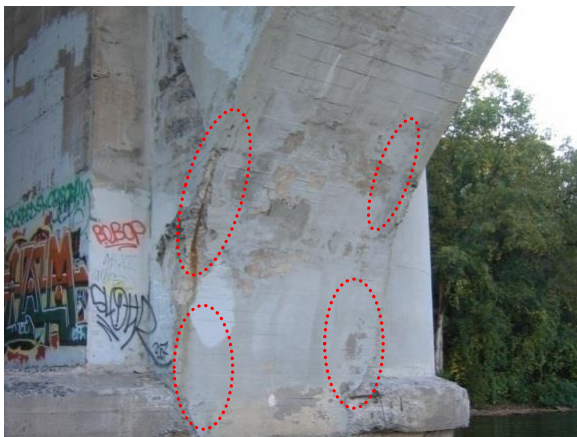
a) Franklin Avenue Bridge (2008) - View of freeze thaw deterioration near base of arch ribs (circled).

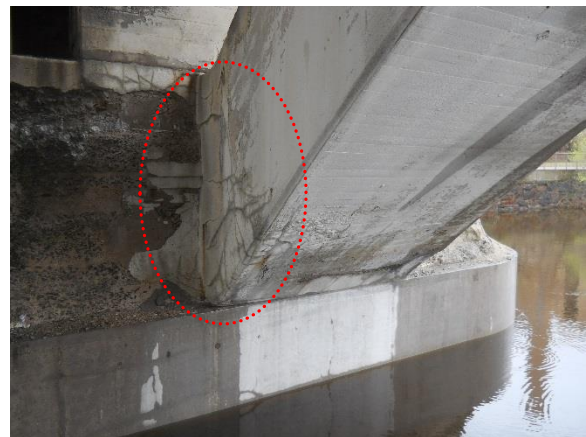
b) 3rd Avenue Bridge (2017) - View of freeze thaw deterioration near base of arch rib.

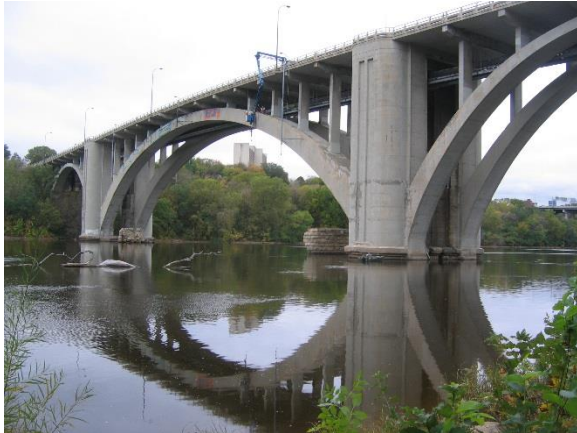
a) Franklin Avenue Bridge (2008) - Overall view of river piers - note calm water conditions.

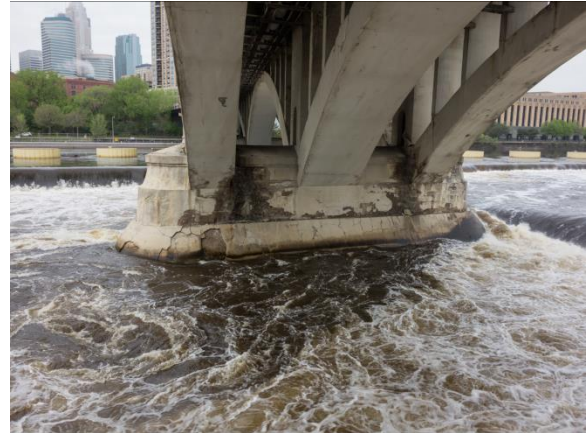
b) 3rd Avenue Bridge (2017) - Pier 3 - Note turbulent water conditions.

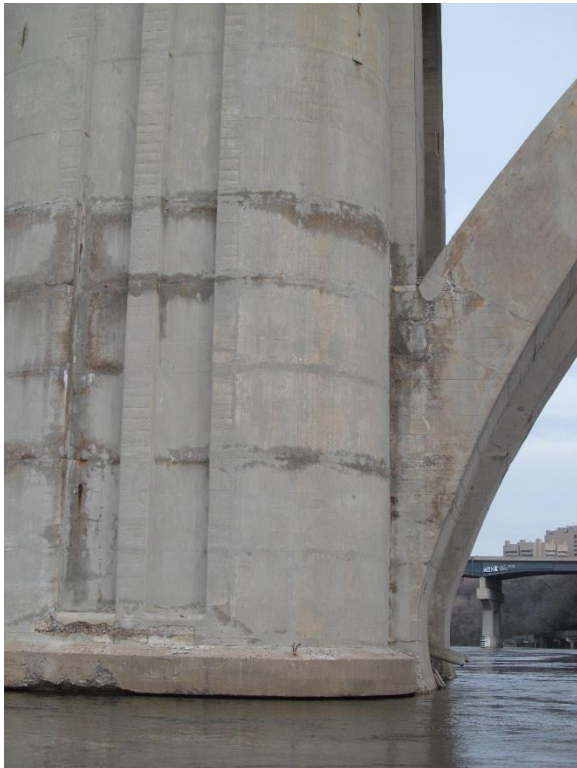
a) Franklin Avenue Bridge (2008) - View at base of Pier 3. Note limited amount of freeze thaw distress above water pool elevation.

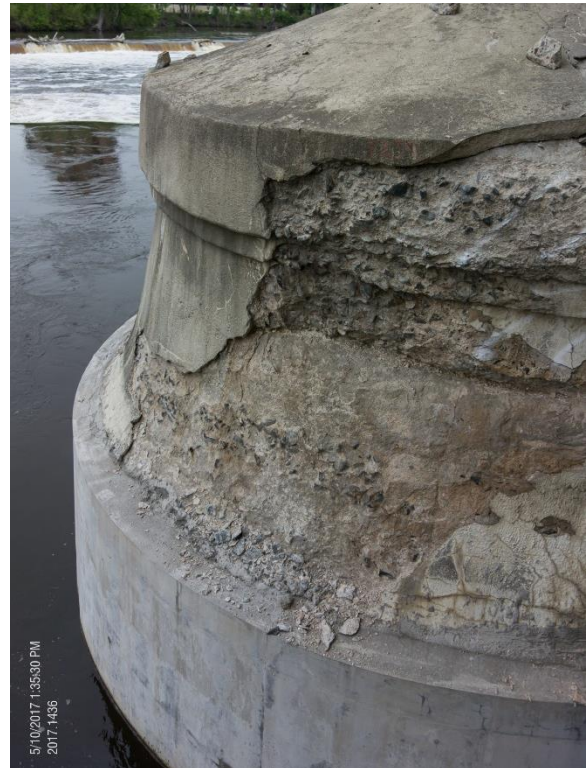
b) 3rd Avenue Bridge (2017) - Freeze thaw distress extending many feet above water level, and a concrete repair jacket was previously installed at this pier.
