February 24, 2015

**Re: Bridge No. 2440 Rehabilitation Dive Inspection Summary for 2014**

AMI Project # 141122

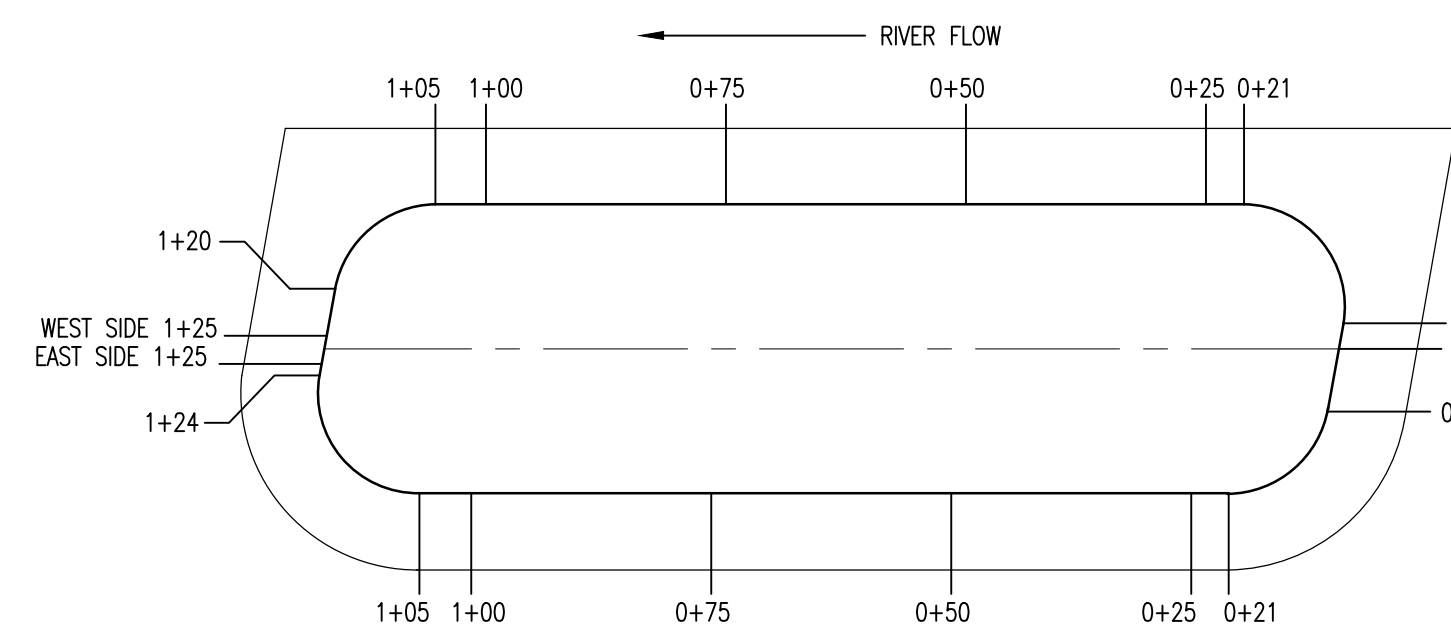
**2**  
S1.0  
PIER 1 SECTION  
SCALE: 1" = 20'-0"

For the deteriorated concrete near the waterline, the construction documents required a horizontal saw cut at the base of the rehabilitation area that penetrated the concrete pier 3" to 5". The face of the concrete at the saw cut location was heavily deteriorated with areas of spalling concrete. Due to the spalling concrete and the resulting uneven surfaces, the saw cut did not penetrate the concrete pier the specified minimum of 3" on approximately 15% on the concrete pier. As a result of the smaller saw cut, the distance from the vertical dowel to the inside face of the concrete forms was also less than the specified minimum distance of 3".

The distance between the vertical rebar also exceeded the specified spacing of 12". The ACI code allows a placement tolerance of ¼ times the specified spacing but not to exceed 1". This results in a maximum allowable spacing of 13". Approximately 50% of the vertical rebar were spaced greater than 12" and 25% to 30% of the vertical rebar were spaced greater than 13". The maximum spacing between the vertical rebar was 14".

After each concrete pour, AMI re-inspected the new concrete to document any areas of washout or deficiencies. On the east and west side of the pier, the new concrete had migrated below the saw cut. The forms were slightly out from the original vertical concrete face of the pier which allowed the concrete to migrate below the saw cut due to the spalling concrete. The location of the forms did allow for additional concrete cover on the rebar. The concrete below the saw cut had areas of honeycombing that were about 5" to 6" in height. On the west side of the pier, a large area of concrete was missing presumably due to a failure of the concrete forms. The area of missing concrete was approximately 18.5" tall with a maximum penetration 4" which exposed one vertical bar and one vertical dowel of the new rebar. To remedy this area, the contractor installed a 3'-0" tall by 4'-0" wide concrete form that protruded from the new concrete face 1-<sup>7</sup>/<sub>8</sub>". The missing area of concrete was located approximately at station 0+35 on the west side of the pier. AMI was unable to re-inspect this repair after the concrete had been placed due to early freeze up.

In one area where the new concrete had not migrated below the saw cut, the bottom edge of the new concrete protruded out from the existing concrete face. The maximum protrusion or lip was approximately <sup>3</sup>/<sub>4</sub>" over an 8'-0" long horizontal area and was located near the upstream tip of the pier. Because of this lip, the bottom edge of the new concrete is susceptible to damage from ice impacts and abrasion.

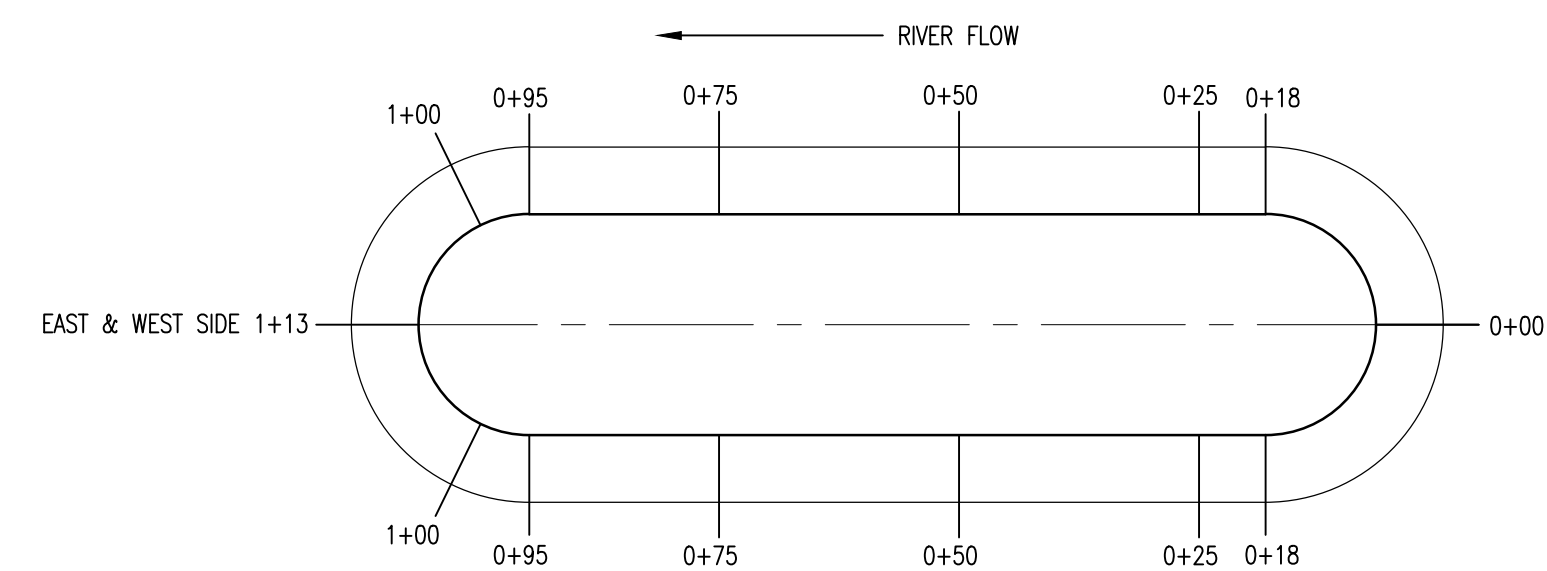
**3**  
S1.0  
PIER 2 SECTION  
SCALE: 1" = 20'-0"

The condition of the horizontal saw cut and spacing of the vertical rebar were very similar to the conditions described for pier #1. However, the spacing of the bottom horizontal rebar was also outside the specified spacing of 12". The bottom horizontal rebar was not set at a consistent elevation and had a wave profile to it. This caused a maximum distance to the adjacent bar to range greatly with a maximum distance of 13 3/8".

The condition of the new concrete on the upstream half also had areas of honeycombing concrete below the saw cut which were similar to pier #1. No areas of missing concrete were documented but the concrete forms were still present on the downstream half of the pier during AMI's last inspection. Two vertical bulges in the new concrete were documented near the upstream tip of the pier. The bulges have occurred at the location where two concrete forms butt up to each other. The bulge appears to be ground smooth above the waterline but a very apparent edge was still present below the waterline. The maximum difference between the two concrete faces was approximately 2" over a distance of 2'-0".

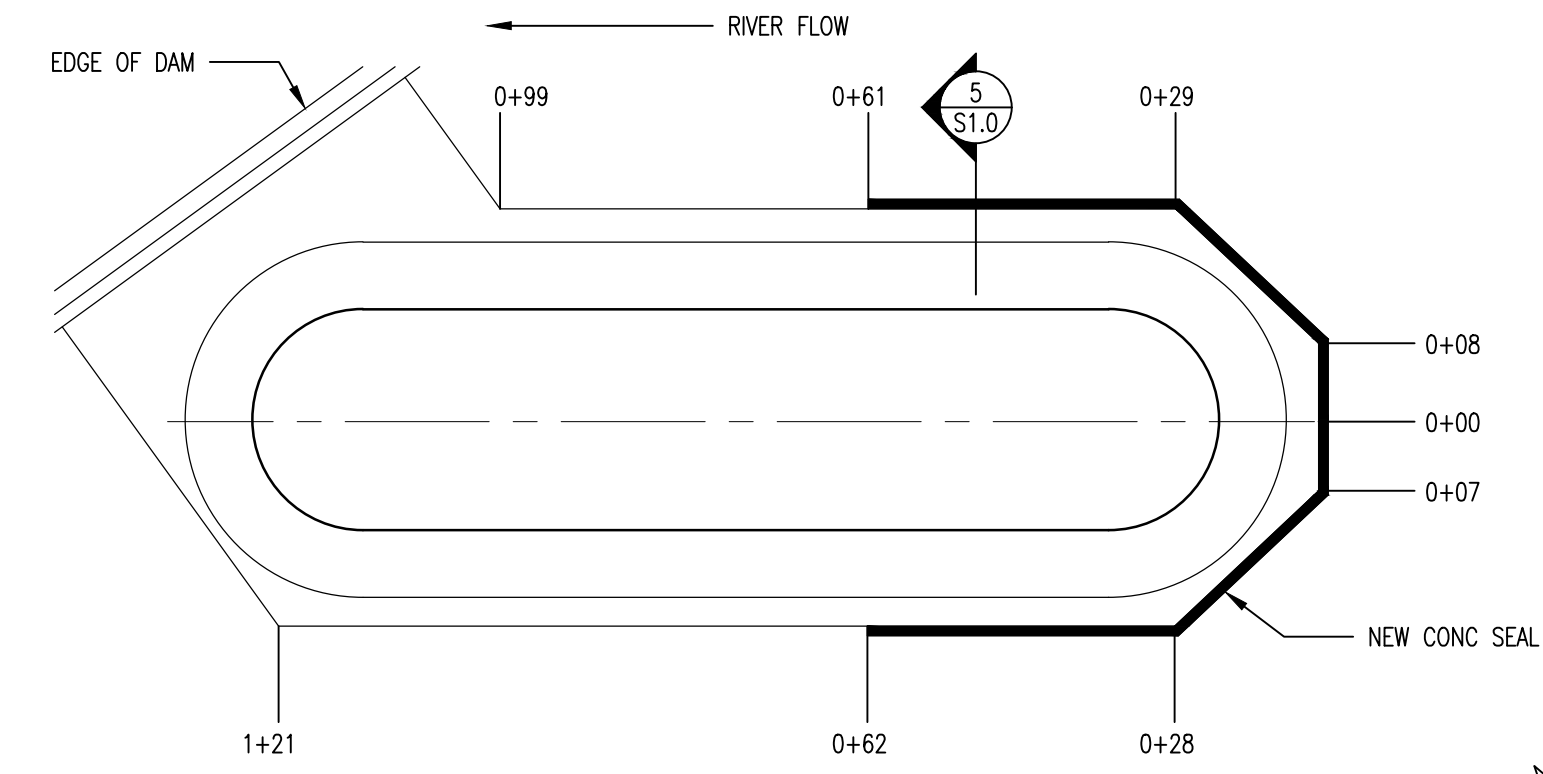
**4**  
S1.0  
PIER 5 SECTION  
SCALE: 1" = 20'-0"

Bridge pier #5 was located just to the east of the horseshoe dam. The required rehabilitation work for pier #5 included filling the scour hole below the pier with concrete and rehabilitating an area of deteriorated concrete on the east side of the pier. See attached MnDot Construction Plans for additional information on the require pier rehabilitation.

The construction documents call out an area of deteriorated concrete on the east side of the pier. The area was approximately 5'-0" wide by 3'-0" tall with a penetration that ranged from 2'-0" to 3'-0". This area was located on the construction documents at 3'-0" below the normal river elevation on the tapered face of the concrete pier. However, a spall of that size was not documented by the contractor or AMI. An area of honeycombed concrete with a similar area was documented near the specified area but the penetration was only 2" instead of 2'-0" to 3'-0". This area will need to be addressed during the 2015 construction.

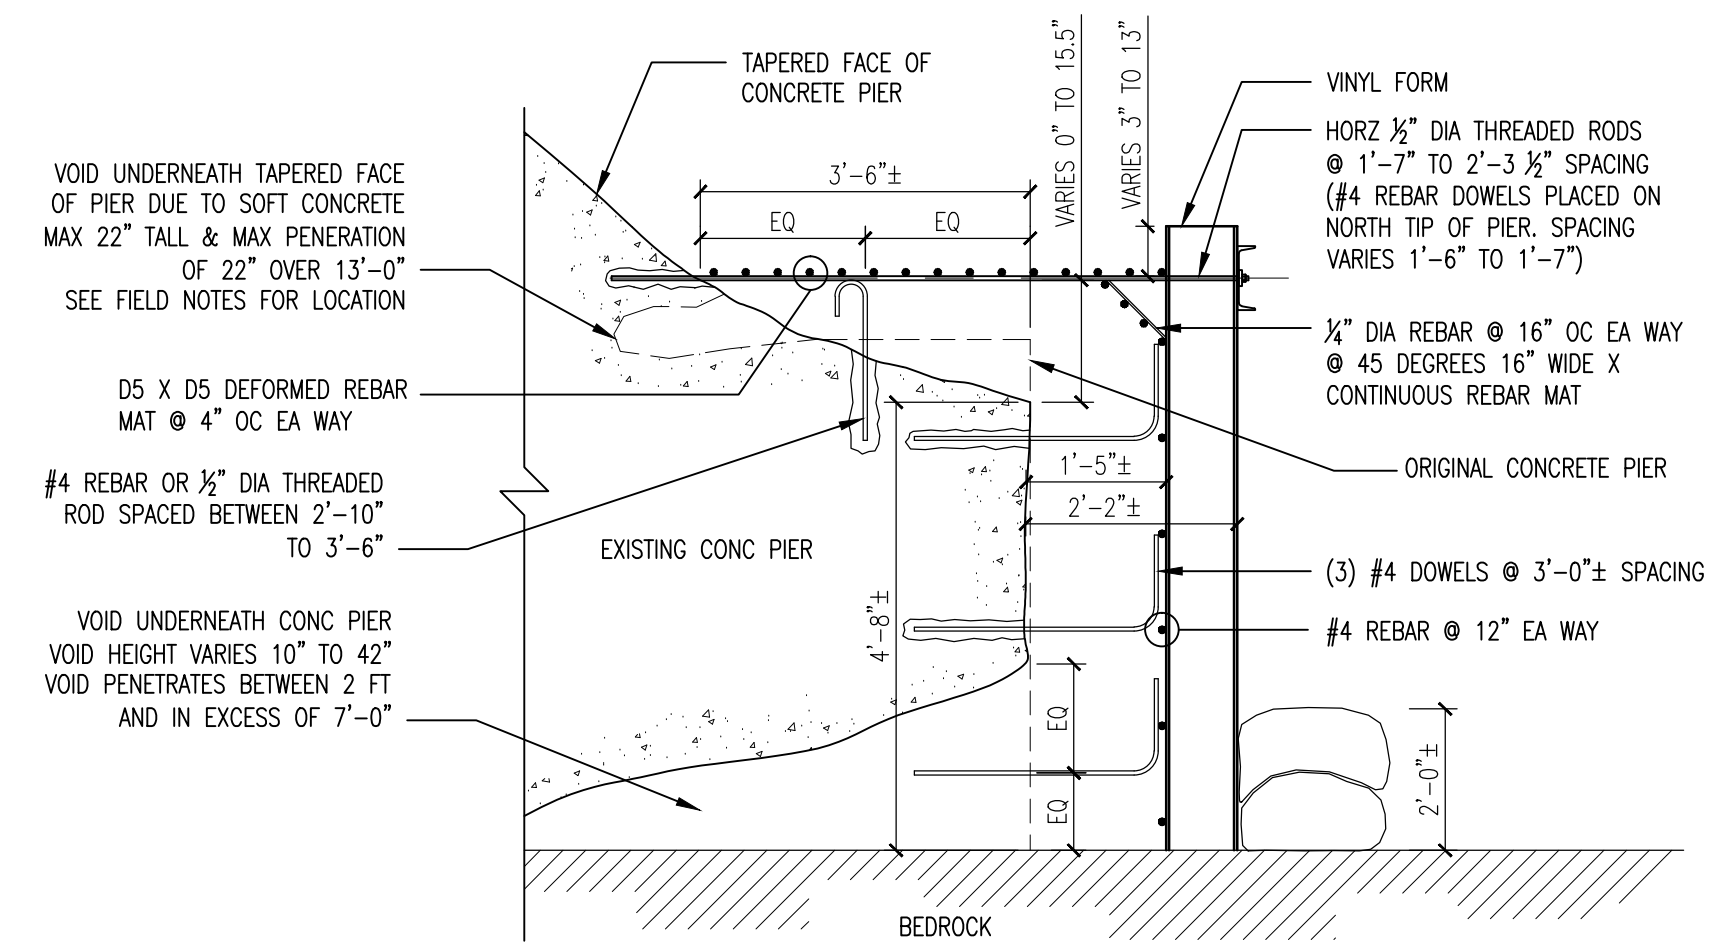
**5**  
S1.0  
PIER 5 DETAIL  
SCALE: 1" = 2'-0"

To rehabilitate the scour hole below the pier, the contractor had to remove any loose sediment and debris from below the pier and then place 6'-0" to 7'-0" tall forms around the scour areas. The new concrete would extend up from the bedrock to the horizontal face of the concrete pier. During the process of removing loose sediment and debris below the pier, the contractor discovered very low strength concrete or grout located along the vertical face of the existing concrete footing. The thickness of the low strength concrete or grout varied from 6" to the entire height of the vertical face of the pier footing. The low strength concrete or grout also appeared to extend underneath the tapered face of the concrete pier. Due to the large volume of the low strength concrete or grout, the areas were not removed but encased in additional concrete that extended above the horizontal face of the pier. A general cut section of the new repairs can be seen in detail 5/S1.0 of the attached AMI drawings.

The new repairs consisted of an additional D5xD5 deformed rebar mat with 4" spacing above the horizontal face of the existing concrete pier. The mat was attached to the existing concrete pier with horizontal and vertical dowels. The vertical dowels were a mixture of #4 rebar and 1/2" diameter threaded rod while the horizontal dowels were primarily 1/2" diameter threaded rods. However, some #4 horizontal rebar dowels were documented near the upstream tip of the concrete pier. MnDot onsite personnel verbally approved the change from rebar to threaded rods.
