# Full-Depth Recycling Study: Test Track Construction and First- Level Analysis of Phase 1 and Phase 2 HVS Testing, Forensic Investigation, and Phase 1 Laboratory Testing

**Authors:**  
D. Jones, S. Louw, and R. Wu

Partnered Pavement Research Center (PPRC) Contract Strategic Plan Element 4.59 (DRISI Task 2707):  
Guidelines for Full-Depth Reclamation of Pavements

<b>DOCUMENT RETRIEVAL PAGE</b>		<b>Research Report: UCPRC-RR-2015-02</b>			
<b>Title:</b> Full-Depth Recycling Study: Test Track Construction and First-Level Analysis of Phase 1 and Phase 2 HVS Testing, Forensic Investigation, and Phase 1 Laboratory Testing					
<b>Authors:</b> D. Jones, S. Louw, and R. Wu					
<b>Caltrans Technical Lead:</b> D. Maskey					
<b>Prepared for:</b> Caltrans	<b>FHWA No.:</b> CA172707A	<b>Report Submitted:</b> 04/21/2016	<b>Final Publication Date</b> 07/11/2016		
<b>Strategic Plan Element No:</b> 4.59	<b>DRISI Task No.:</b> 2707	<b>Status:</b> Final	<b>Version No.:</b> 1		
<b>Abstract:</b> <p>This first-level report describes the first two phases of a study comparing the performance of four different full-depth pavement reclamation strategies, namely pulverization with no stabilization (FDR-N

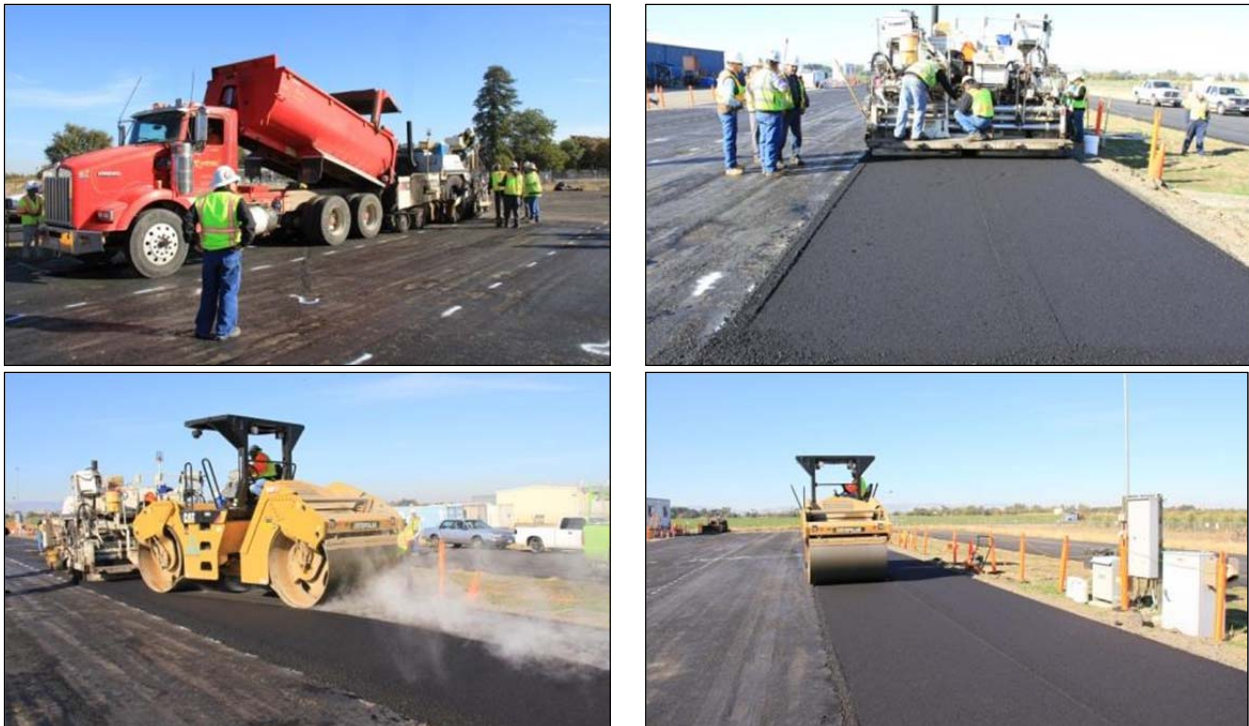
**Figure 3.37: Asphalt concrete placement.**

Mix was transported using end-dump trucks. Paving was carried out in a west-east direction and followed conventional procedures (Figure 3.37). Work started in Lane #1, followed by Lanes #2, #3, and #4. The second lift on Lane #1 (Cell #2) was placed after completion of the first lift on the other lanes. A breakdown roller closely followed the paver, applying about four passes. A single pass was made with an intermediate rubber-tired roller, followed by another four passes with a finish roller. Compaction of the lower lift appeared to be consistent and no problems were noted (Figure 3.38). On the second lift placed in Cell #2, the mix appeared tender and some shearing was noted (Figure 3.39) in the vicinity of the instrumentation cables (discussed in Section 4.4).

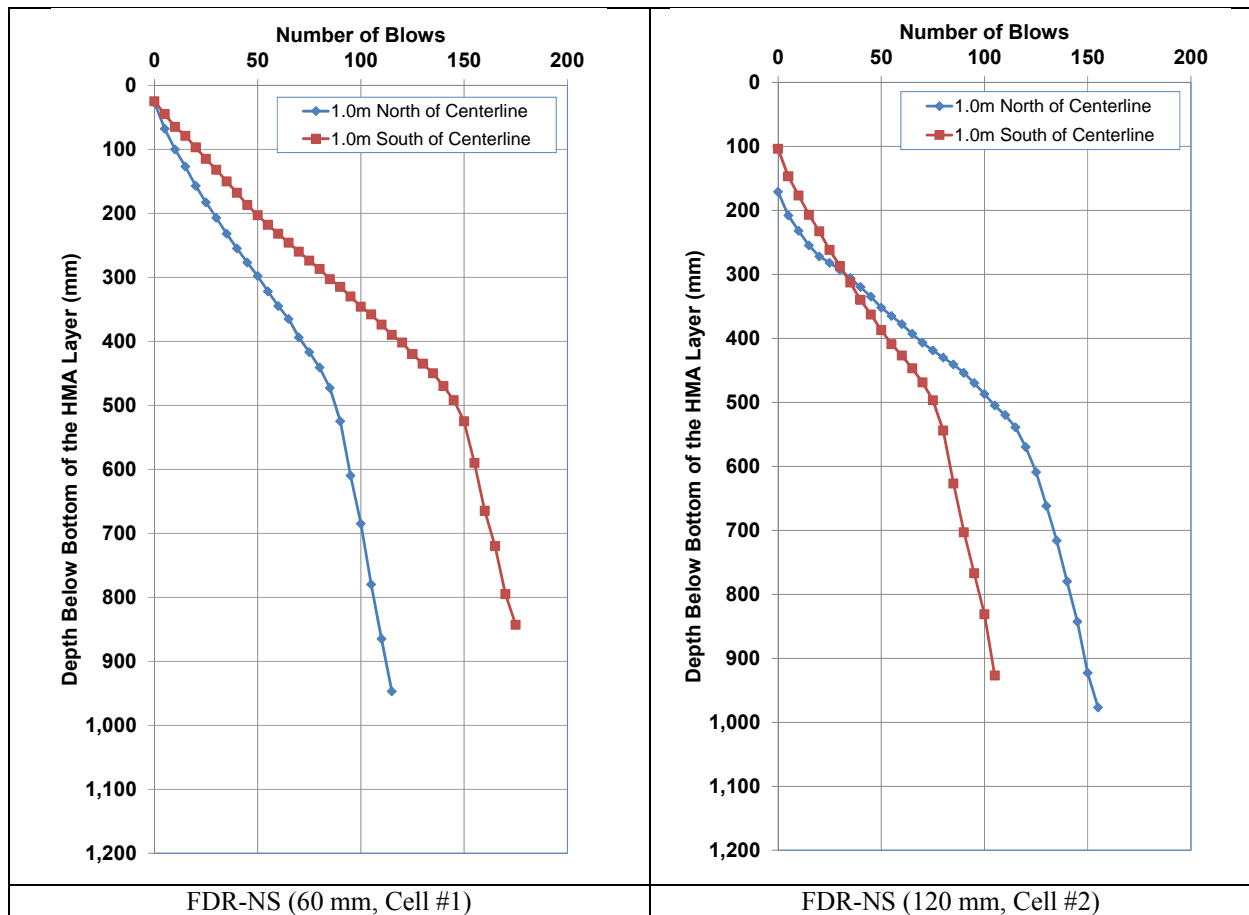
- FDR-NS: Tests were done on both the 60 mm and 120 mm thick asphalt concrete sections. Only one distinct change was noted in the penetration rate. This was at approximately 20 in. (500 mm) below the bottom of the asphalt concrete layer, corresponding to the interface between the original base and the subgrade. This indicates that the recycled base and old aggregate base layer had similar mechanical properties. The combined as-built thickness was comparable to the 22.5 in. (570 mm) design thickness.
- FDR-EE, FDR-FA, and FDR-PC: Measurements were consistent with those taken on the FDR-NS sections, with a distinct change between the base and subgrade at approximately 20 in. (500 mm) below the bottom of the asphalt concrete layer.

**Figure 3.41: Unbound layer DCP penetration curves for unstabilized sections.**

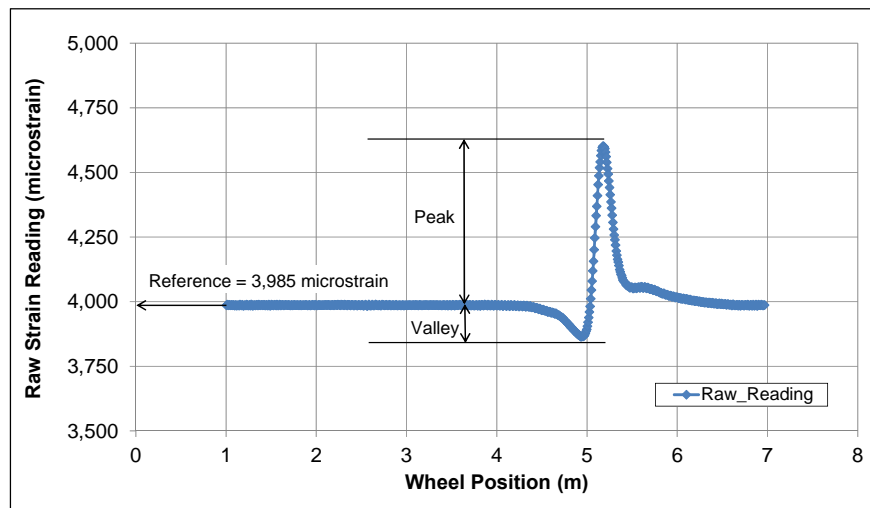
**Figure 4.7: Example strain reading and definition of summary quantities.**

Strain readings were recorded and loaded into a database where the actual calibration coefficients for each specific strain gauge are stored. When data is extracted from the database, the necessary minor rescaling is built into the query to ensure that the individual gauge factors are used in place of the average value of 0.830. Example strain data recorded from one of the strain gauges is presented in Figure 4.7, which shows the variation of the strain gauge reading versus wheel position as the wheel travels from one end of the test section to the other. Several quantities are summarized based on the raw readings. Specifically, the reference value is the reading when the wheel is at the far end of the test section. The peak and valley are maximum and minimum values deviating from the reference value, respectively.

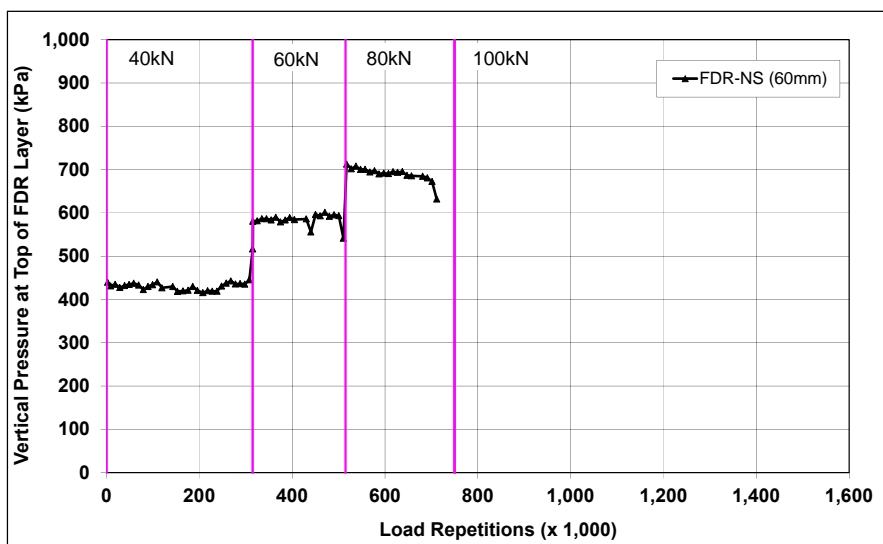
Figure 5.11 shows the traffic-induced vertical pressure at the top of the recycled base layer. Pressure readings were stable, but sensitive to load change, for the duration of the test. Increases in recorded pressures occurred after the load changes, as expected. The reason for the decrease in pressure at the end of the test is unclear, but it is assumed that either the instrumentation was damaged or support conditions under the pressure cell changed.

Figure 5.11: 672HB: Vertical pressure at the top of the recycled layer.

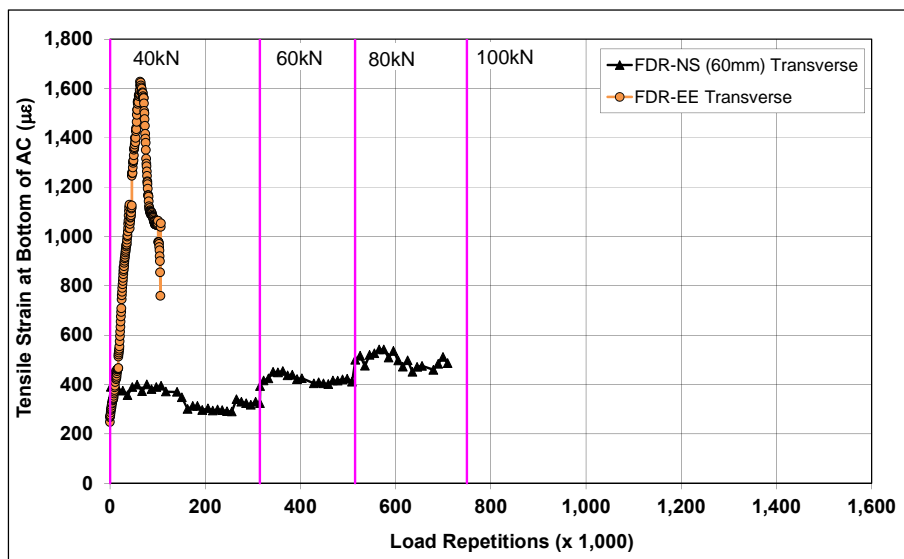
Figure 5.89 shows the peak traffic-induced transverse tensile strain at the bottom of the asphalt concrete layer. The strain gauge installed to measure longitudinal strain was damaged during placement of the asphalt concrete surfacing and no data was recorded from this instrument.

**Figure 5.89: 676HC: Tensile strain at the bottom of the asphalt concrete layer.**

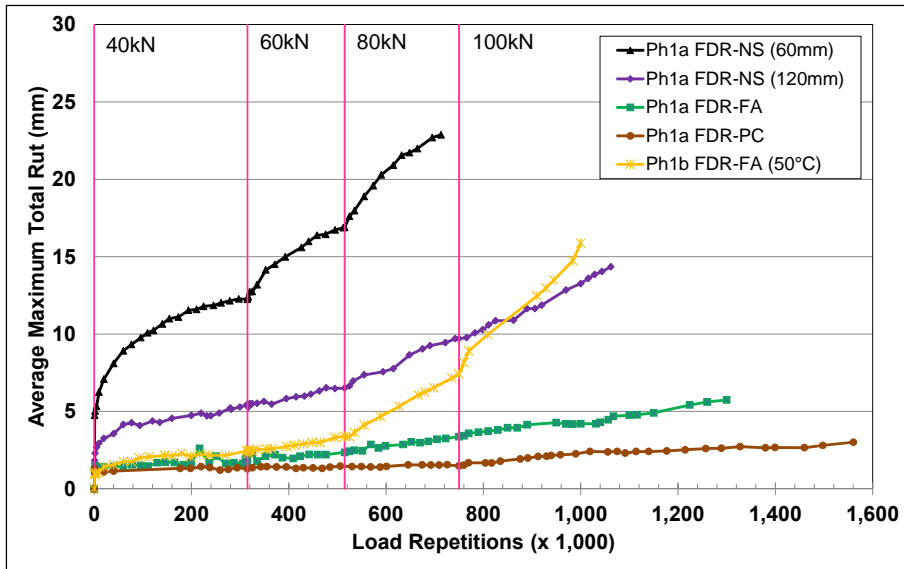
Figure 6.15: Comparison of Phase 1a and Phase 1b average maximum rut.

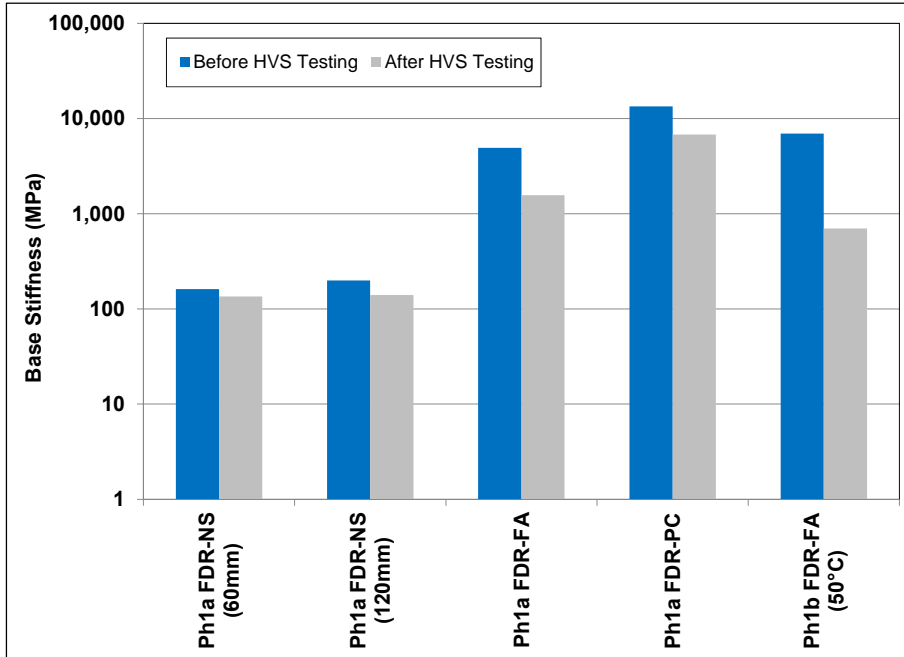
Figure 6.16: Comparison of Phase 1a and Phase 1b backcalculated stiffness.

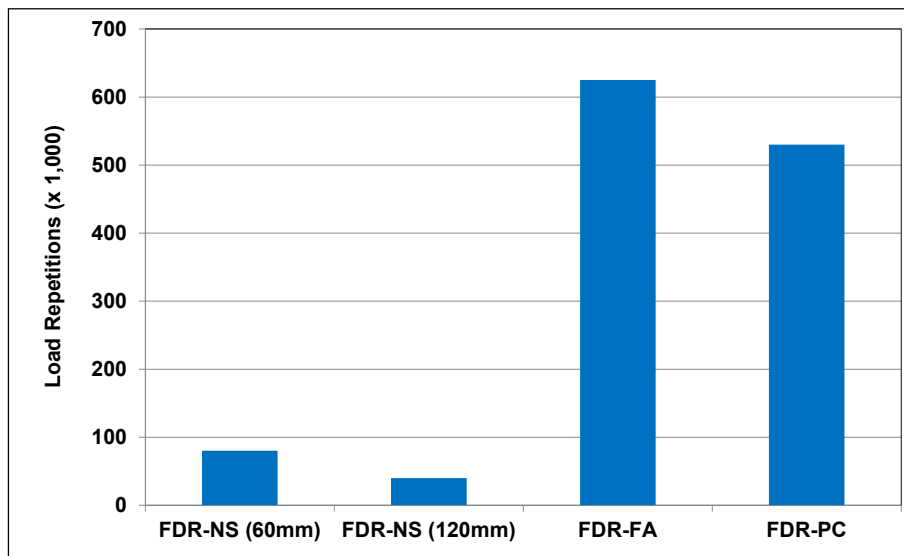
**Figure 7.56: Number of load repetitions to reach terminal cracking under wet conditions.**
