# Pavement Condition Report

## Mahnomen County Airport (3N8)

**December 2016**

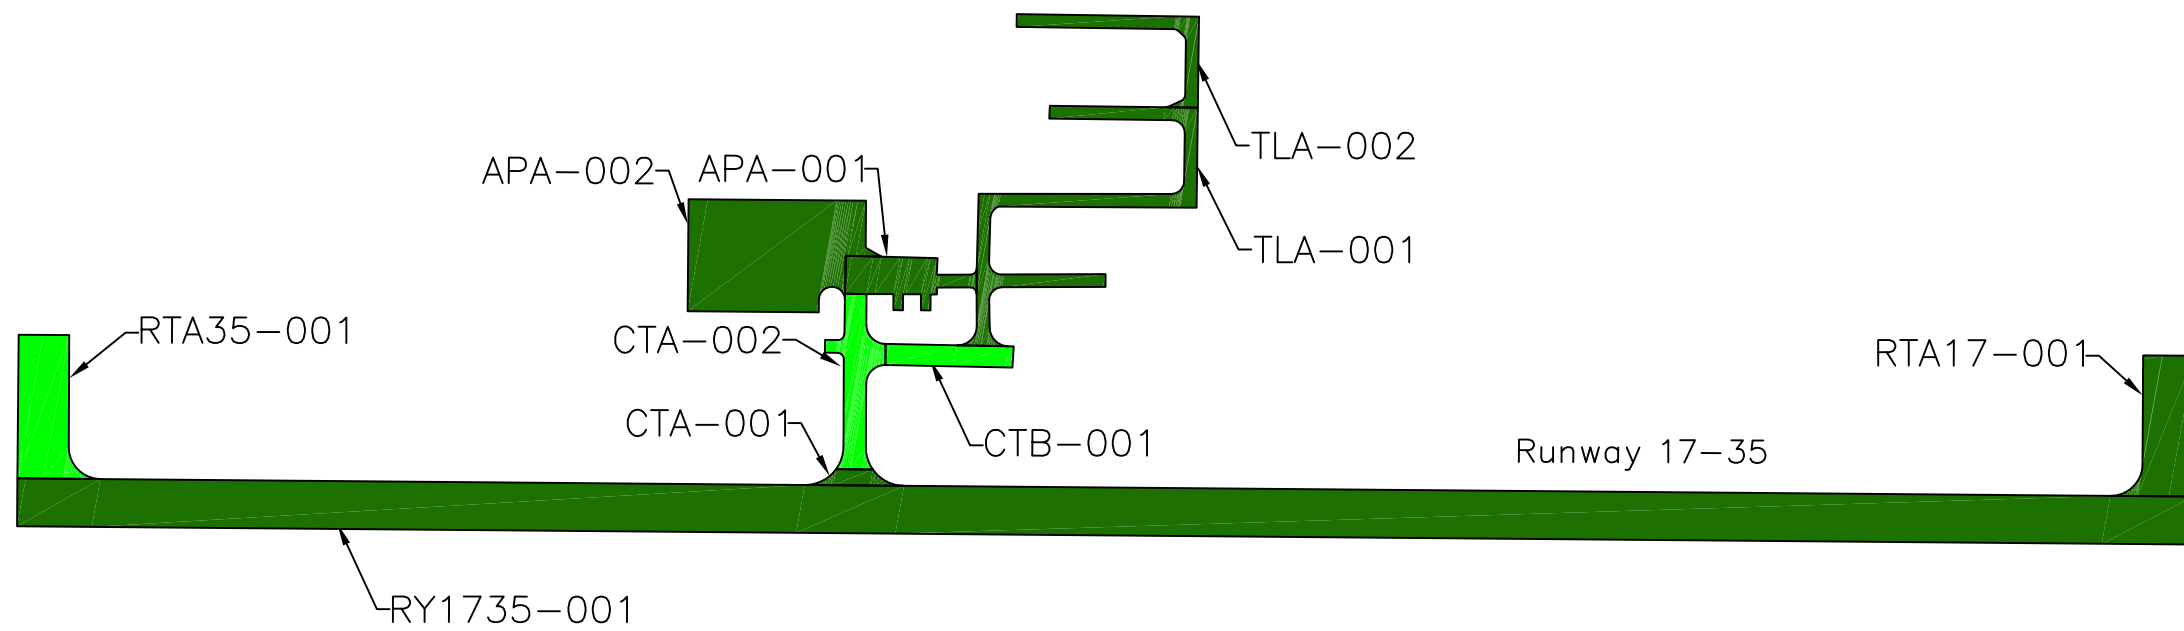
Figure 4. 2016 Pavement Condition Index Rating at Mahanomen County Airport (3N8).

The results of the 2016 PCI inspection are presented in figure 4. The overall area-weighted, inspected PCI for 3N8 is 92. When summarizing PCI values, an area-weighted calculation is used instead of a straight mathematical average because the area-weighted calculations eliminate the skewing of the PCI due to the disparity of the section sizes.

Note: Overlay(2014) on CTA-002 exhibits reflective cracking leading to higher than normal deterioration of PCI.
