Pavement Condition Report

Hutchinson Municipal Airport (HCD)

December 2016

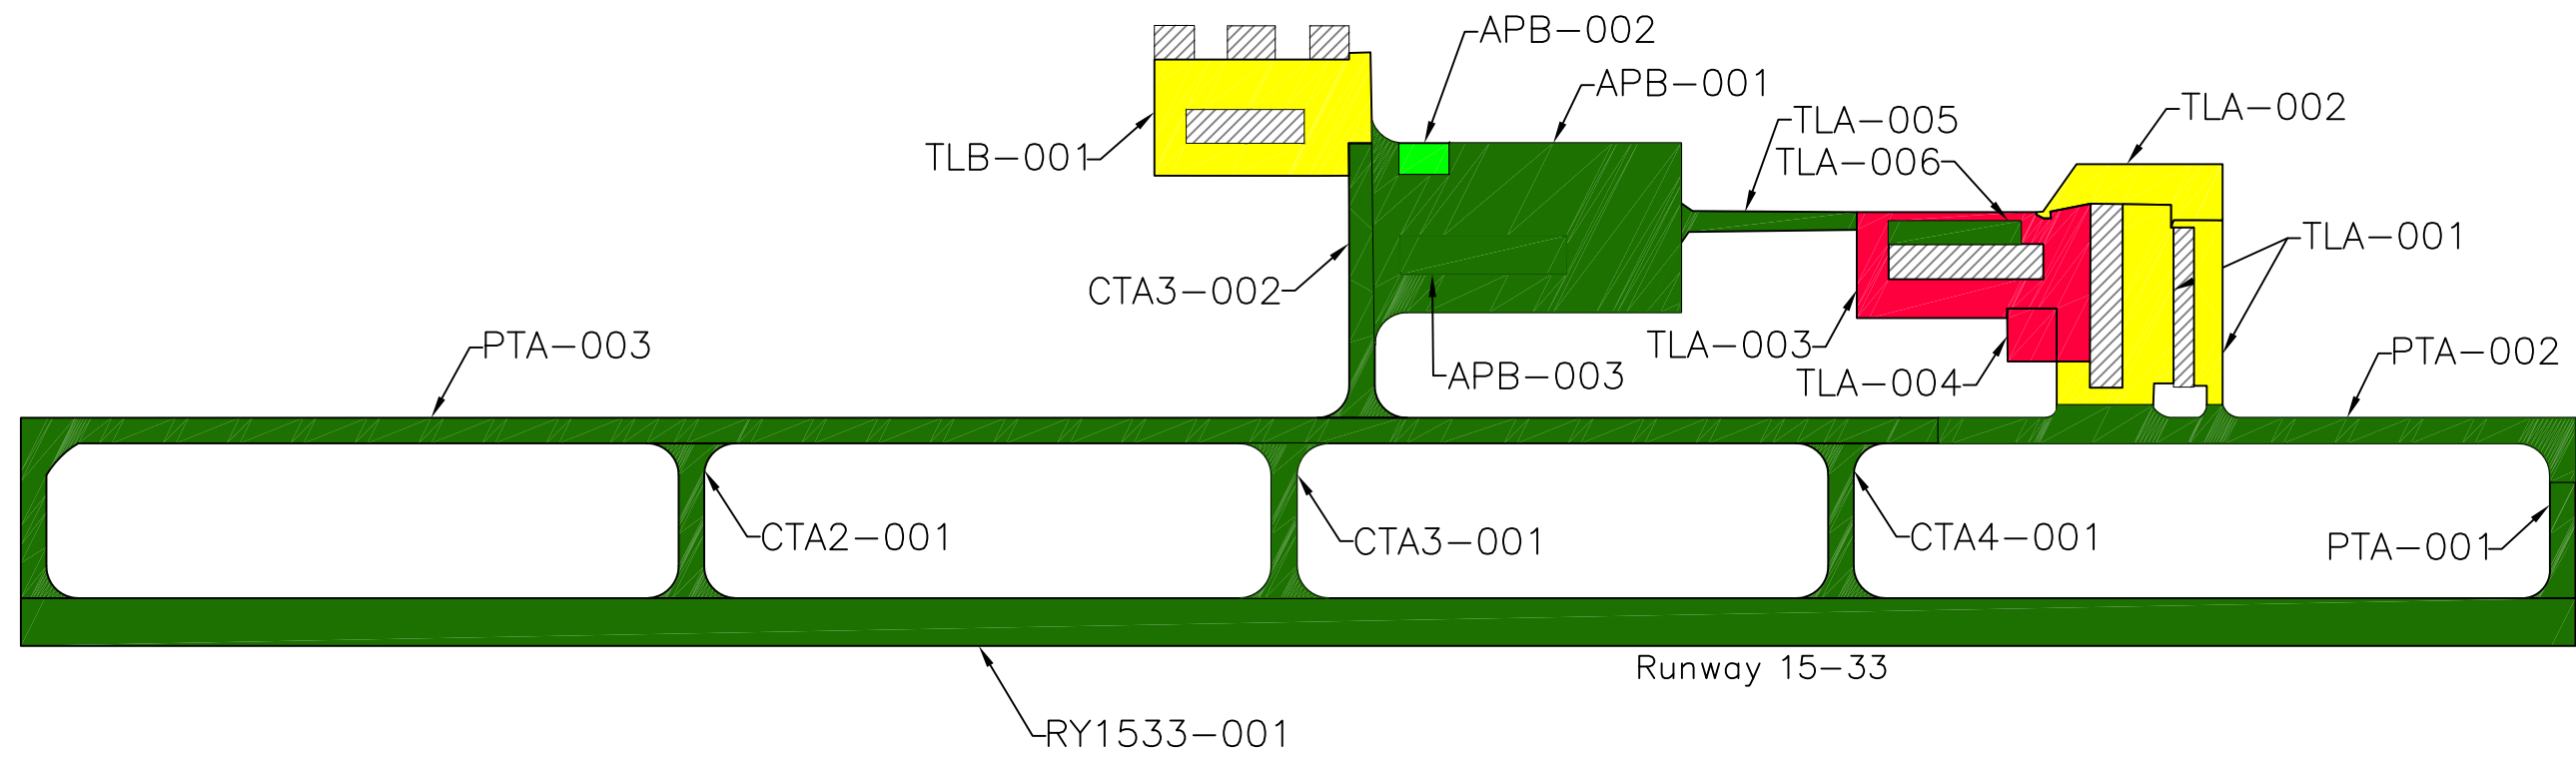
Figure 4. 2016 Pavement Condition Index Rating at Hutchinson Municipal Airport–Butler Field (HCD).

The results of the 2016 PCI inspection are presented in figure 4. The overall area-weighted, inspected PCI for HCD is 91. When summarizing PCI values, an area-weighted calculation is used instead of a straight mathematical average because the area-weighted calculations eliminate the skewing of the PCI due to the disparity of the section sizes.
