Pavement Condition Report

Winona Municipal Airport (ONA)

December 2018

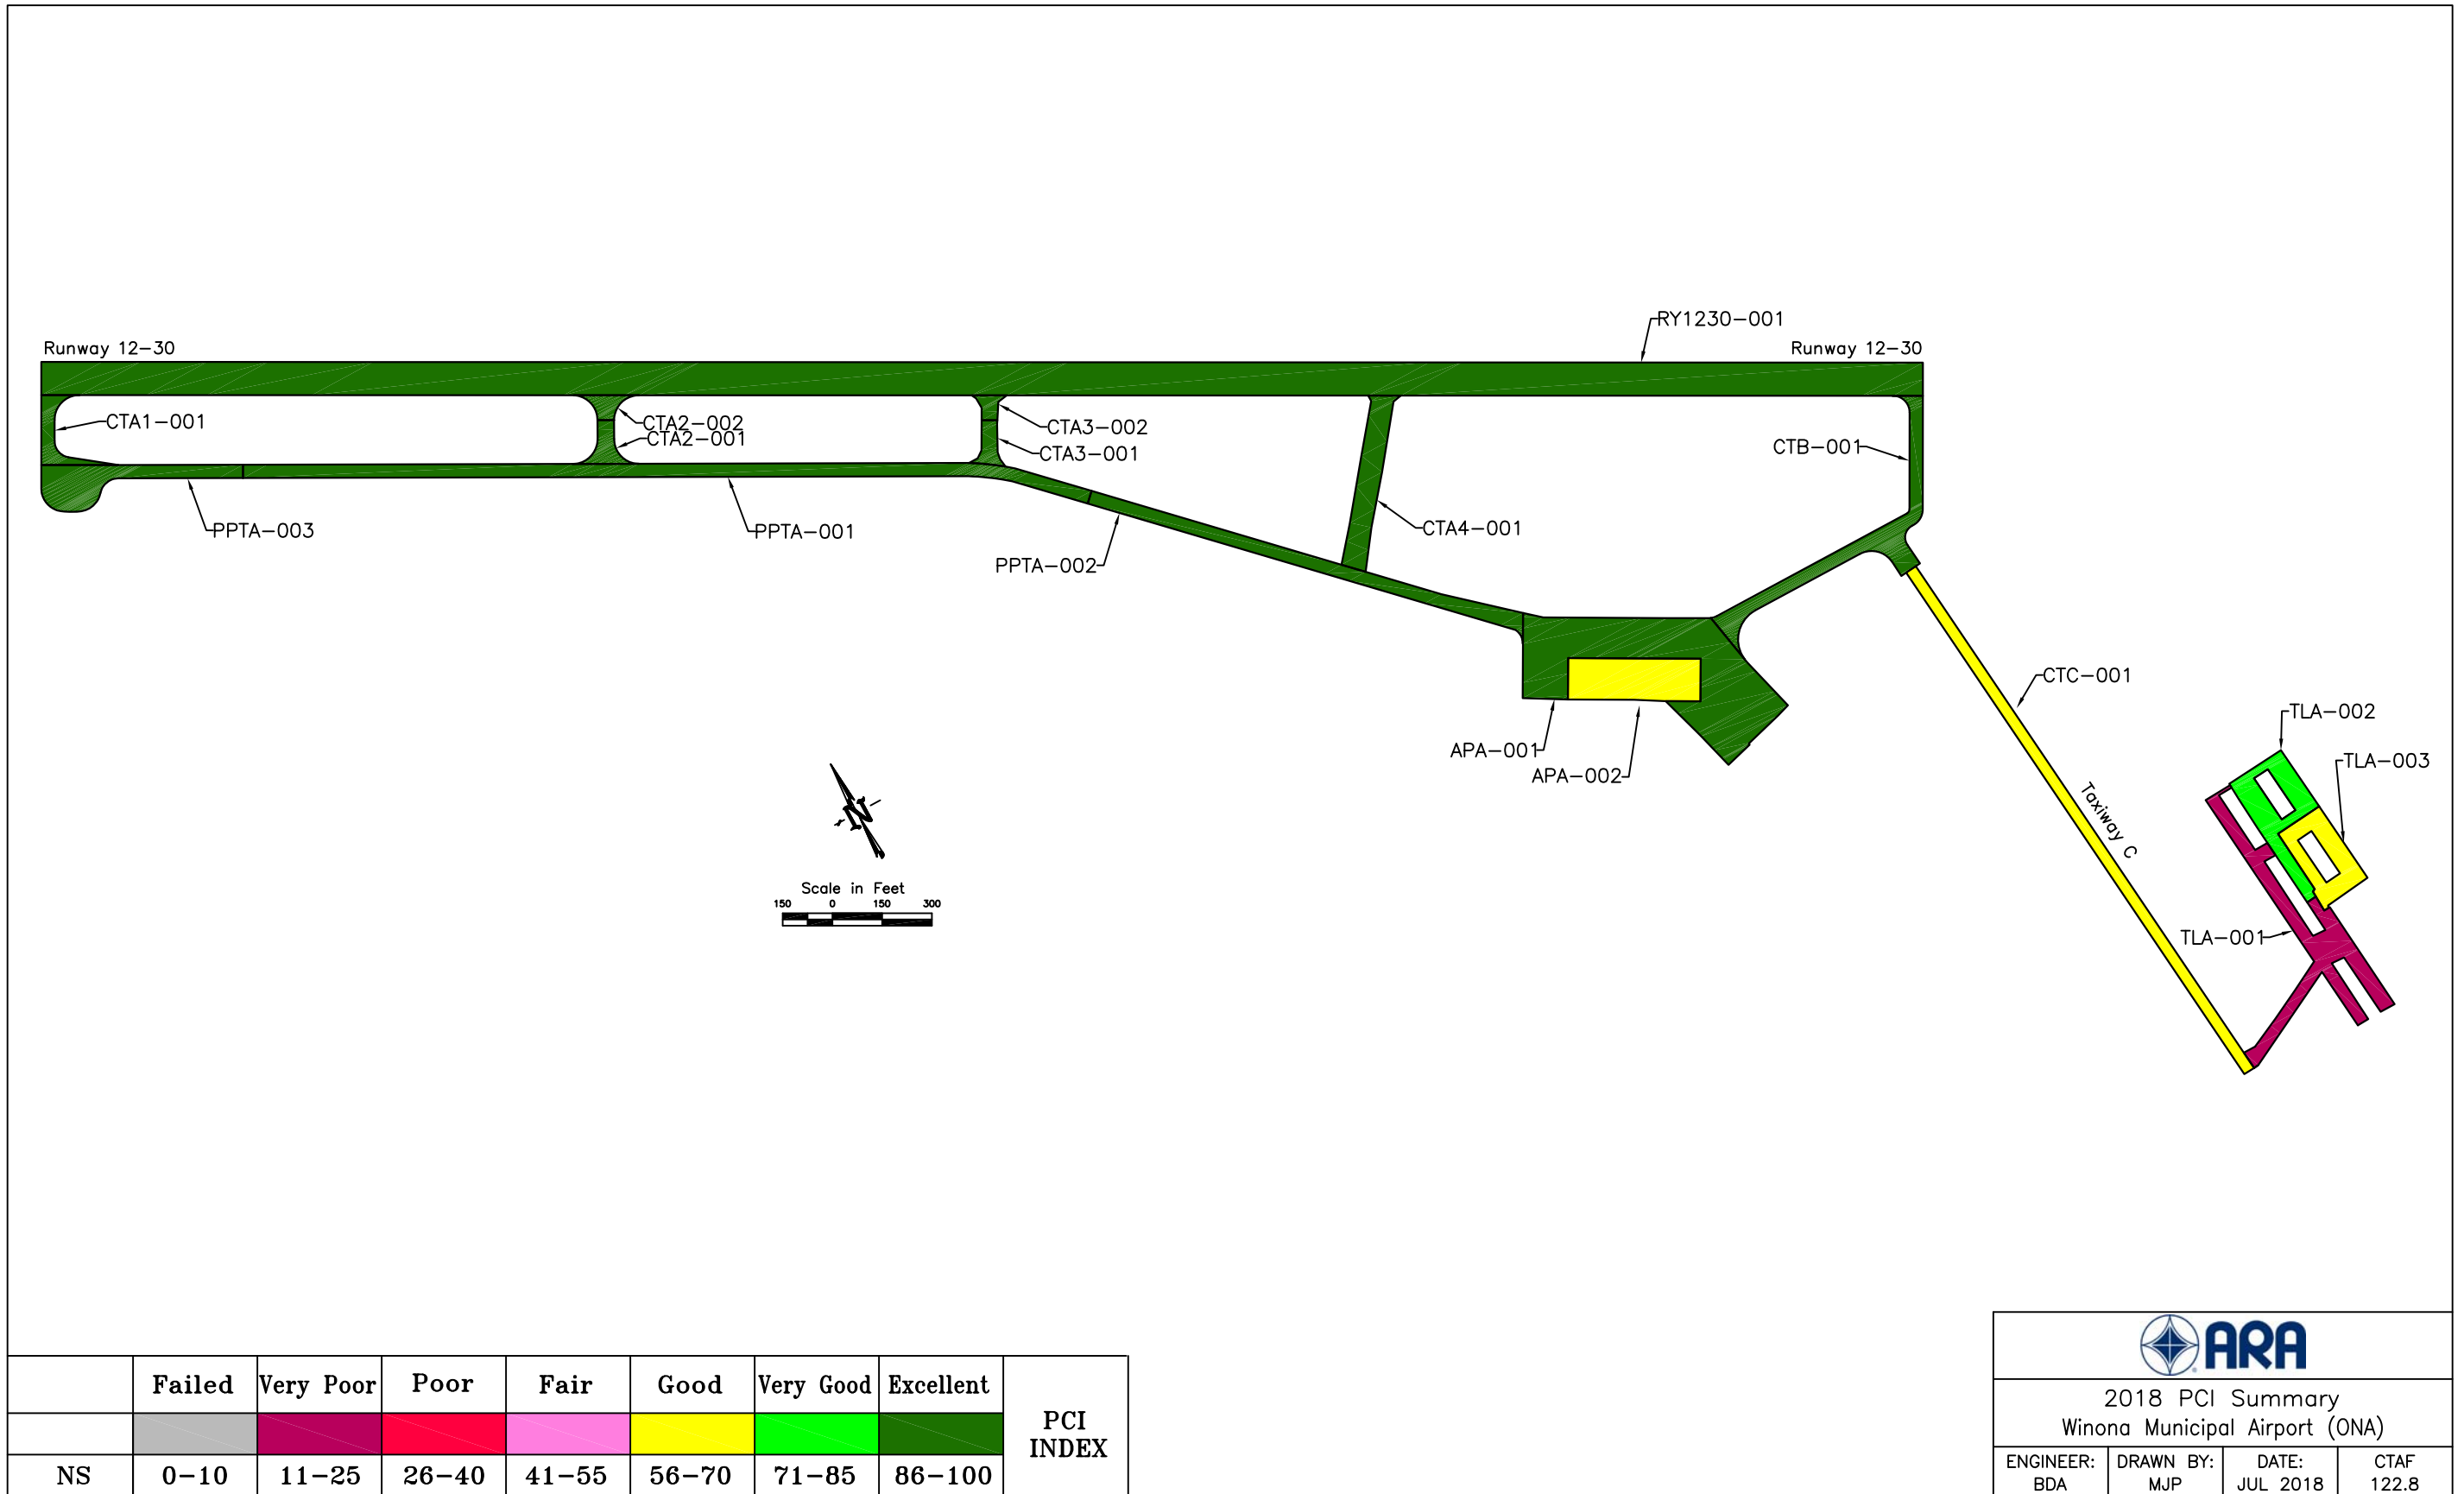
Figure 4. 2018 Pavement Condition Index Rating at Winona Municipal Airport (ONA).

The results of the 2018 PCI inspection are presented in figure 4. The overall area-weighted, inspected PCI for ONA is 90. When summarizing PCI values, an area-weighted calculation is used instead of a straight mathematical average because the area-weighted calculations eliminate the skewing of the PCI due to the disparity of the section sizes.

⁷Higher than expected deterioration rate of 4.8 PCI/year due to the development of medium-severity L&T cracking and medium-severity weathering.
