# Pavement Condition Report

## Aitkin Airport (AIT)

**December 2019**

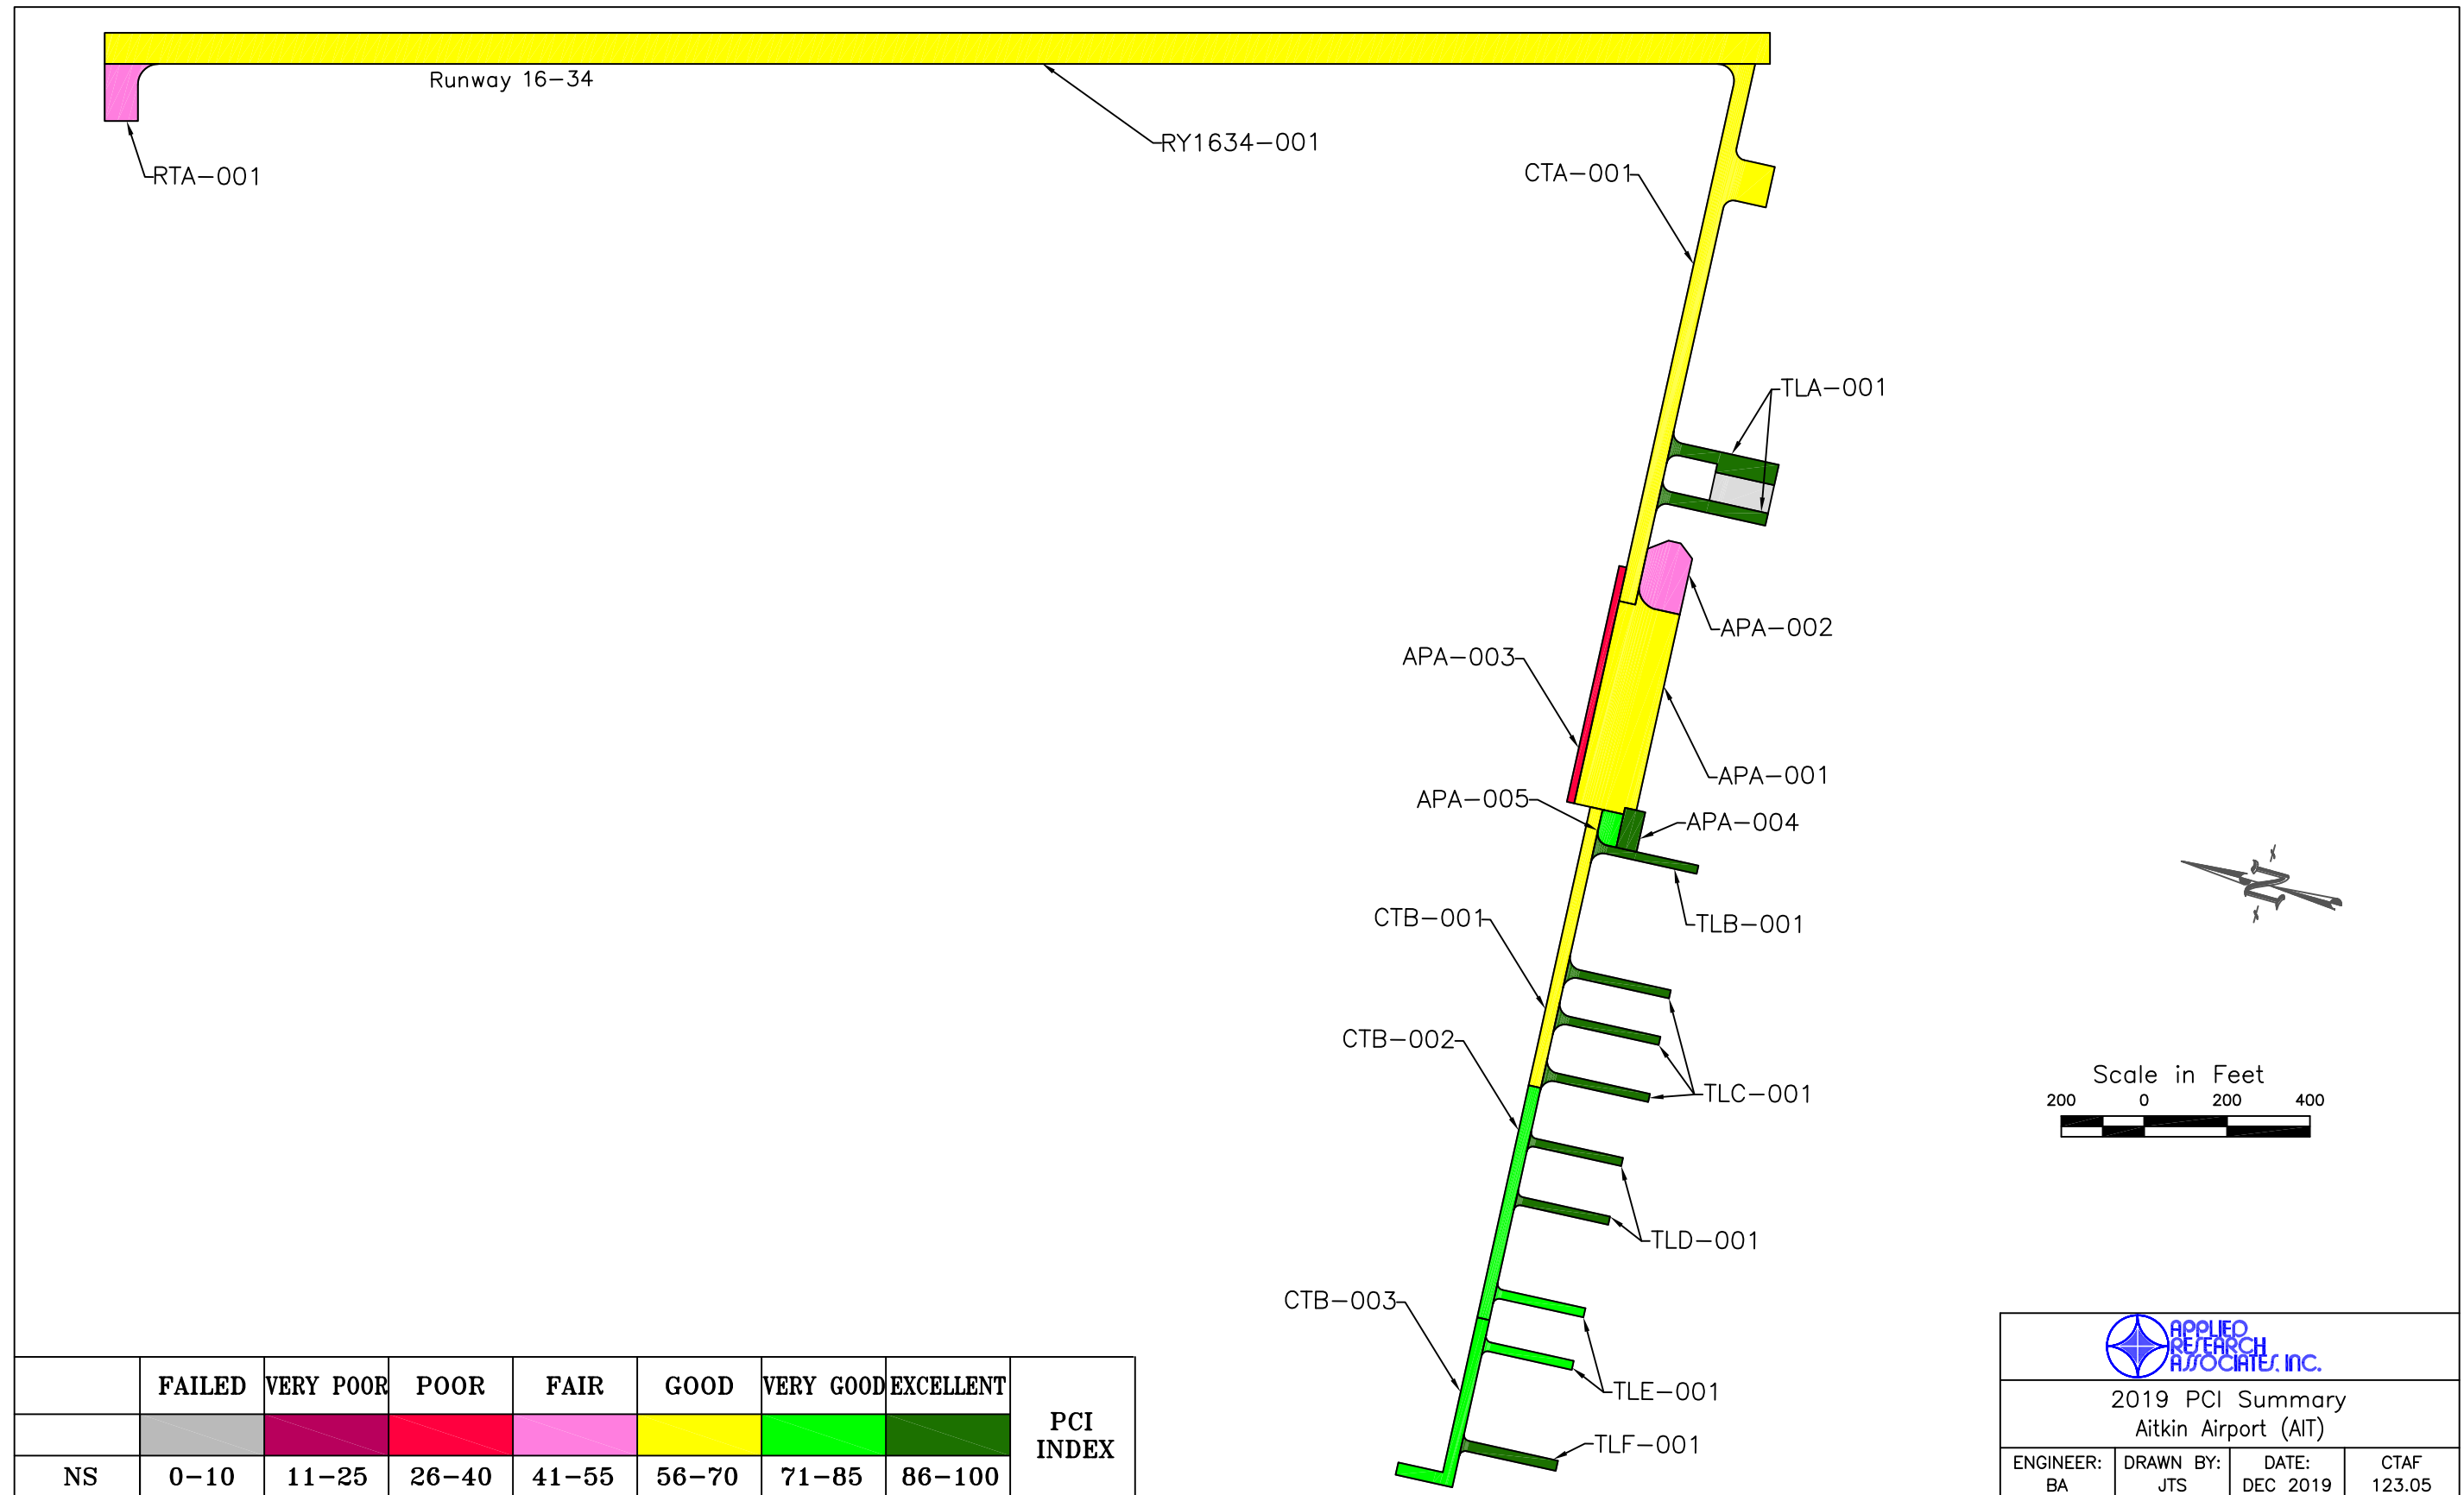
Figure 4. 2019 Pavement Condition Index Rating at Aitkin Airport (AIT).

The results of the 2019 PCI inspection are presented in figure 4. The overall area-weighted, inspected PCI for AIT is 66. When summarizing PCI values, an area-weighted calculation is used instead of a straight mathematical average because the area-weighted calculations eliminate the skewing of the PCI due to the disparity of the section sizes.

<sup>6</sup>Higher than expected deterioration rate of 5.0 PCI/year due to the development of medium Alligator cracking and L&T cracking in significant quantities.

<sup>7</sup>Higher than expected deterioration rate of 6.2 PCI/year due to the development rutting in significant quantities caused by winter snow operations and excess water.

<sup>8</sup>Increase in PCI due to quality maintenance being completed since last inspection showing losses of high and medium cracking.

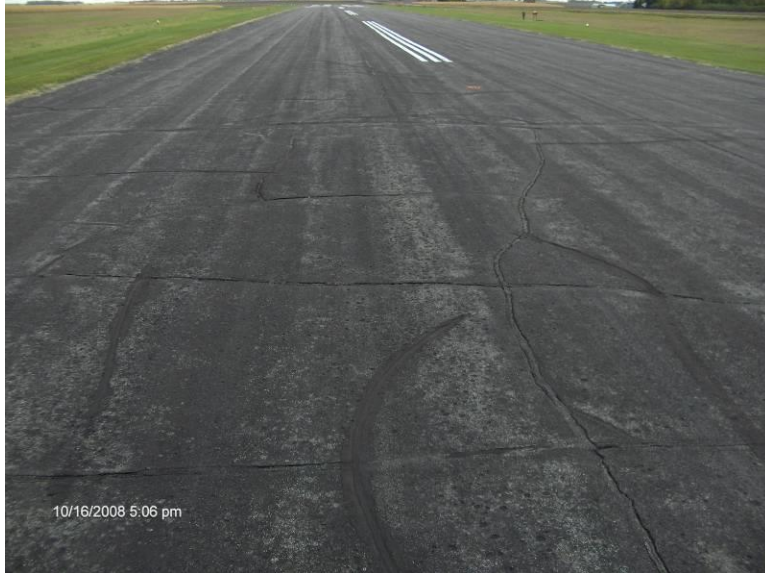
### *Example of Block Cracking*

Block cracking is longitudinal and transverse cracking that has established a pattern of blocks ranging in size from 1ft x 1ft to 10ft x 10ft. This distress typically happens in older asphalt pavements and is an indication that the bituminous binder has lost most of its flexibility. The severity determination is basically determined by the crack width criteria defined for longitudinal and transverse cracking. Crack sealing typically is used to repair block cracking; however, the amount of required sealant can be extensive due to the high density of cracks.
