Pavement Condition Report

Chandler Field Airport – Alexandria (AXN)

December 2019

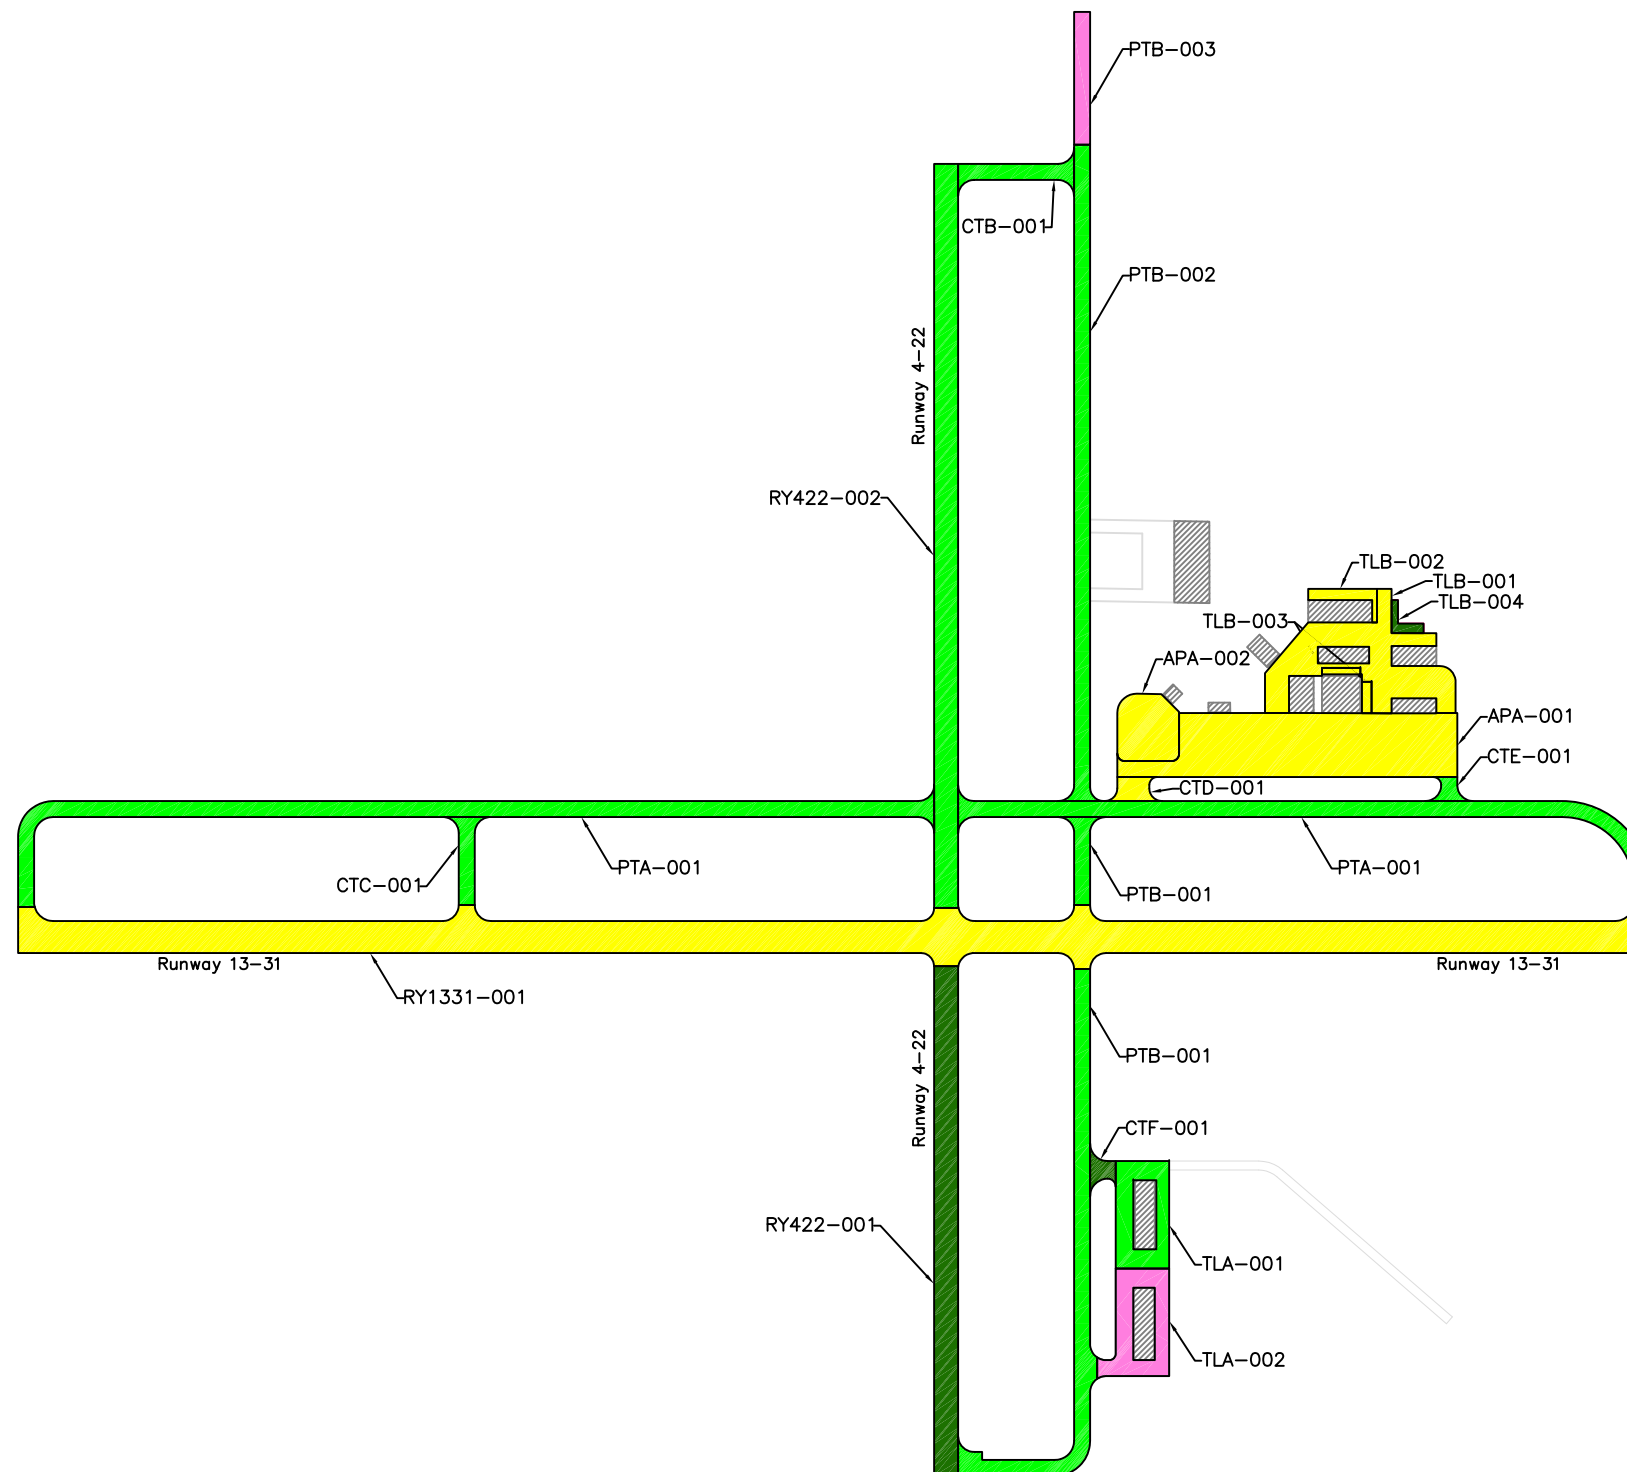
Figure 4. 2019 Pavement Condition Index Rating at Chandler Field Airport – Alexandria (AXN).

The results of the 2019 PCI inspection are presented in figure 4. The overall area-weighted, inspected PCI for AXN is 71. When summarizing PCI values, an area-weighted calculation is used instead of a straight mathematical average because the area-weighted calculations eliminate the skewing of the PCI due to the disparity of the section sizes.

⁸Higher than expected deterioration rate of 5.9 PCI/year due to the development of low Block cracking and low L&T cracking in significant quantities.

⁹Higher than expected deterioration rate due to reflective cracking through the asphalt overlay.

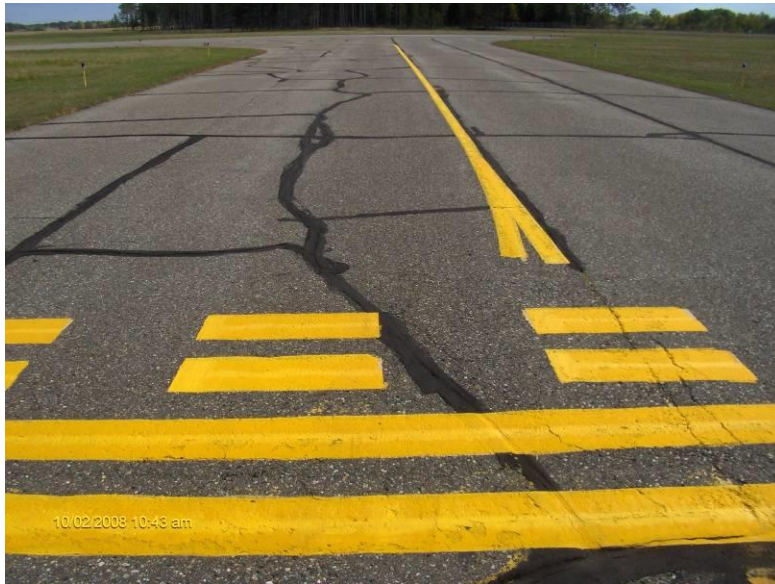
Example of Longitudinal and Transverse Cracking (L&T cracking)

Longitudinal and transverse cracks are caused by pavement aging, by construction, and by subsurface movement. Aging occurs as pavement loses some of its components to the atmosphere and becomes more brittle. Consistent application of pavement sealcoats can help to prevent the occurrence of age related cracks. Cracks will also develop along poorly constructed paving lane joints. Ensuring that joints are made when both sides are still hot, and near the same temperature, is one of the best ways to mitigate this potential problem. Seasonal movement caused by changes in moisture content or temperature differences can also cause pavement cracks. Asphalt pavement placed over a PCC pavement or cement stabilized base course may evidence reflective cracking from the underlying material. Longitudinal and transverse cracks are not caused by wheel loads, although traffic may worsen their condition.

Low severity longitudinal and transverse cracks are less than $\frac{1}{4}$ inch wide, or if sealed with suitable filler material in satisfactory condition can be any width, less than 3 inches, if they are not spalled. Maintenance usually is not indicated for low-severity cracking. Moderately spalled cracks and cracks wider than $\frac{1}{4}$ inch which are not satisfactorily sealed are at medium severity. Medium-severity cracks should be sealed with a high-quality crack filling material. Severely spalled cracks and cracks wider than 3 inches are at high severity. High-severity L&T cracks normally require patching.

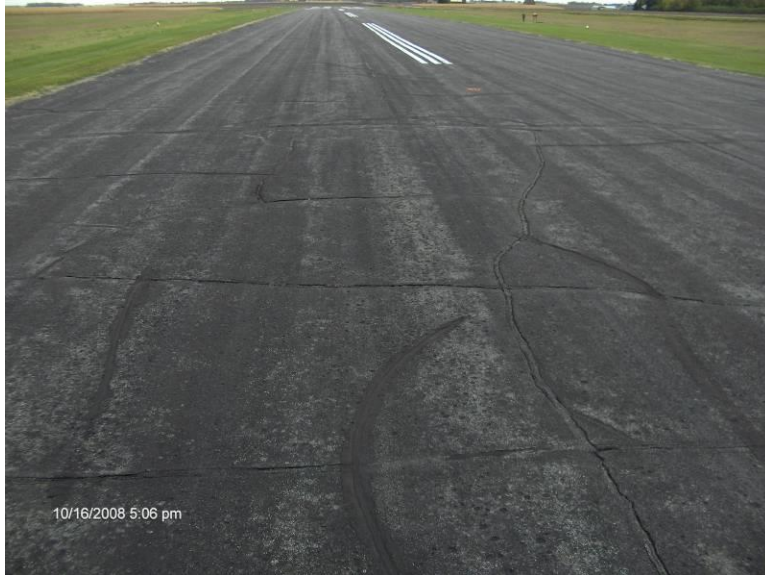
Example of Block Cracking

Block cracking is longitudinal and transverse cracking that has established a pattern of blocks ranging in size from 1ft x 1ft to 10ft x 10ft. This distress typically happens in older asphalt pavements and is an indication that the bituminous binder has lost most of its flexibility. The severity determination is basically determined by the crack width criteria defined for longitudinal and transverse cracking. Crack sealing typically is used to repair block cracking; however, the amount of required sealant can be extensive due to the high density of cracks.

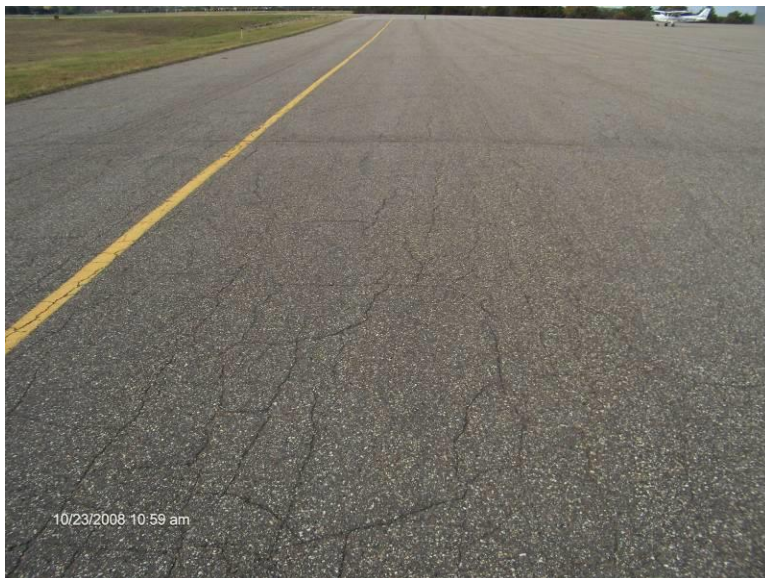
Example of Alligator Cracking

Alligator (or fatigue) cracks are a series of interconnected load-related cracks caused by fatigue of the asphalt surface. Alligator cracking is a significant structural distress and develops only in places subject to traffic loads. These cracks typically initiate at the bottom of the asphalt layer (where tensile strains

are highest) and propagate upward - so once a fatigue crack is visible, significant damage has already occurred.

At low severity, alligator cracks are evidenced by a series of parallel hairline cracks (usually in a wheel path). Further traffic and deterioration leads to the interconnection of these cracks. Medium severity alligator cracking is a well-defined pattern of interconnected cracks, some spalling may be present. High severity alligator cracks have lost aggregate interlock between adjacent pieces, the cracks may be severely spalled with FOD potential, and most likely the pieces will move freely under traffic. Alligator cracking is a structural failure and cannot be repaired with sealant, the proper repair is full-depth patching.

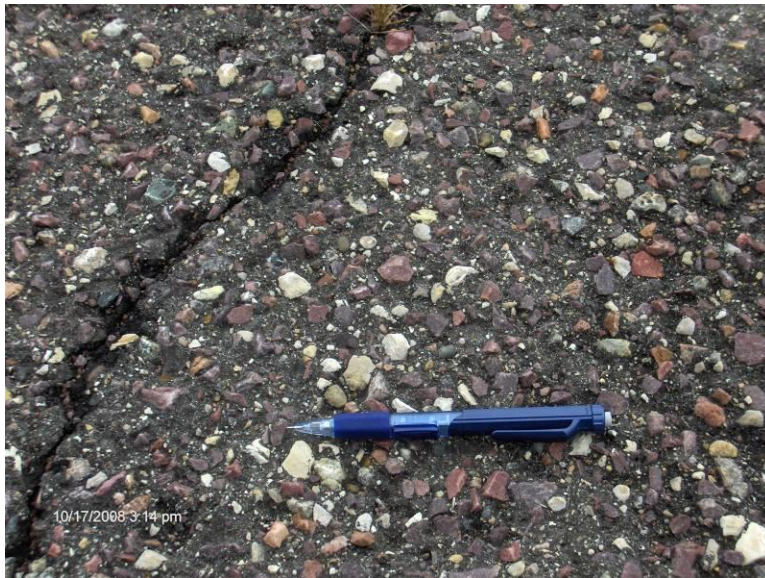
Example of Raveling/Weathering

Raveling and weathering are the wearing away of the pavement surface. Raveling is the condition where the mid- to large size aggregates are becoming dislodged; weathering is when the fine aggregate wears away exposing the edges of the larger aggregate. These distresses are usually evident over large areas and may occur together (pictured above) or separately. Raveling and weathering may indicate that the asphalt binder has hardened significantly.

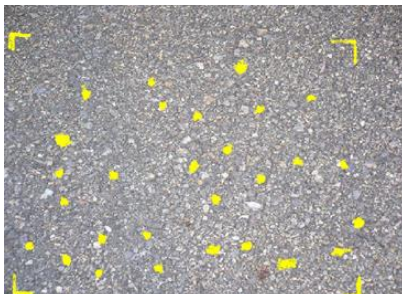
Raveling – At low severity, the number of missing coarse aggregates (> 3/8 inch) is between 5-20 missing/yd², medium severity (pictured below where the missing coarse aggregates have been dotted with yellow paint) is 21-40 missing/yd², and high severity is > 40 missing/yd².

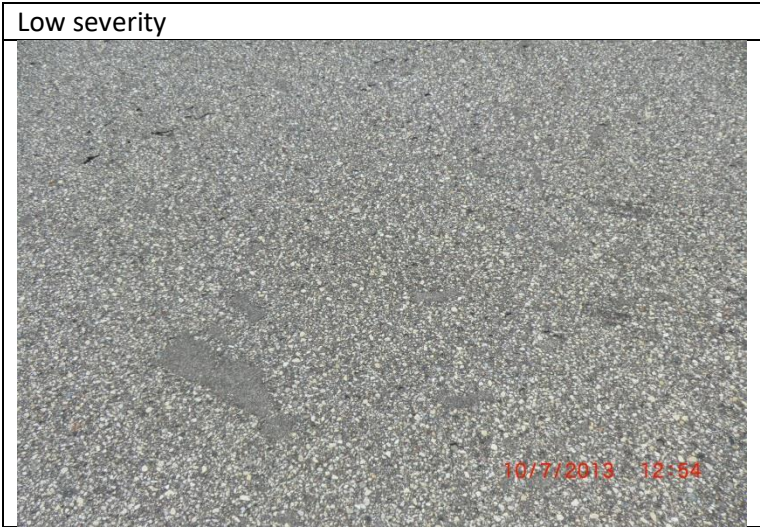
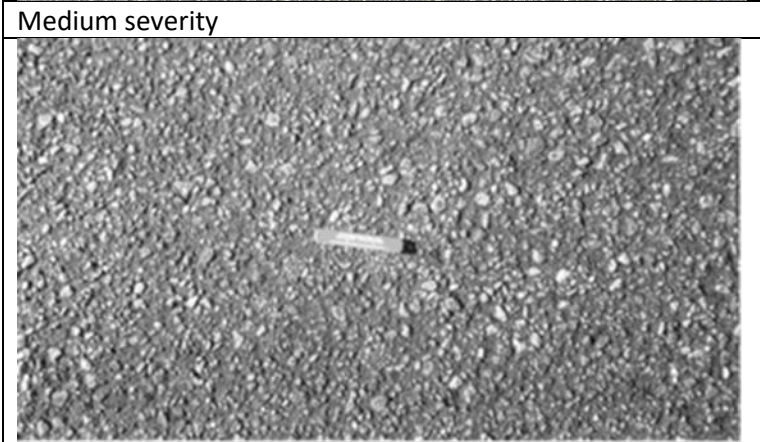
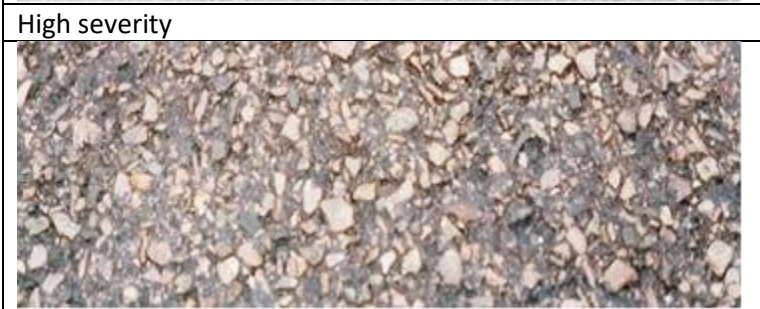
Weathering – At low severity, the coarse aggregate is slightly exposed due to the wearing away of the fine aggregate. At medium severity, the coarse aggregate is exposed up to ¼ the width of the longest side. At high severity, the coarse is exposed greater than ¼ the width of the longest side.

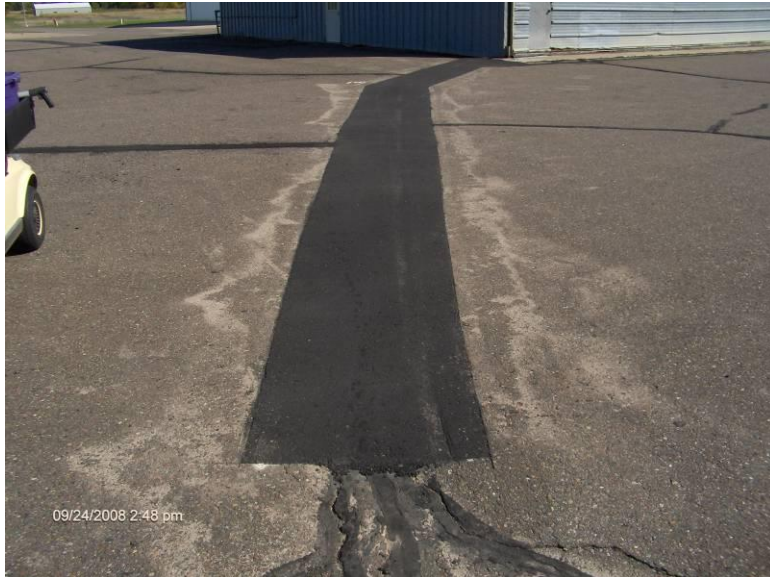
Example of Patching

Patched areas are defined when a portion of the original pavement is replaced with a material intended as a semi-permanent repair. A patch is documented as a defect because it is considered a break in the integrity of the pavement structure. Patches are constructed for a variety of reasons including utility repairs, correcting grade issues, and addressing a defect in the original pavement. The severity level of patches is determined by the amount of distress (i.e. cracking, depression, weathering/raveling, etc.) occurring within the limits of the patched area.

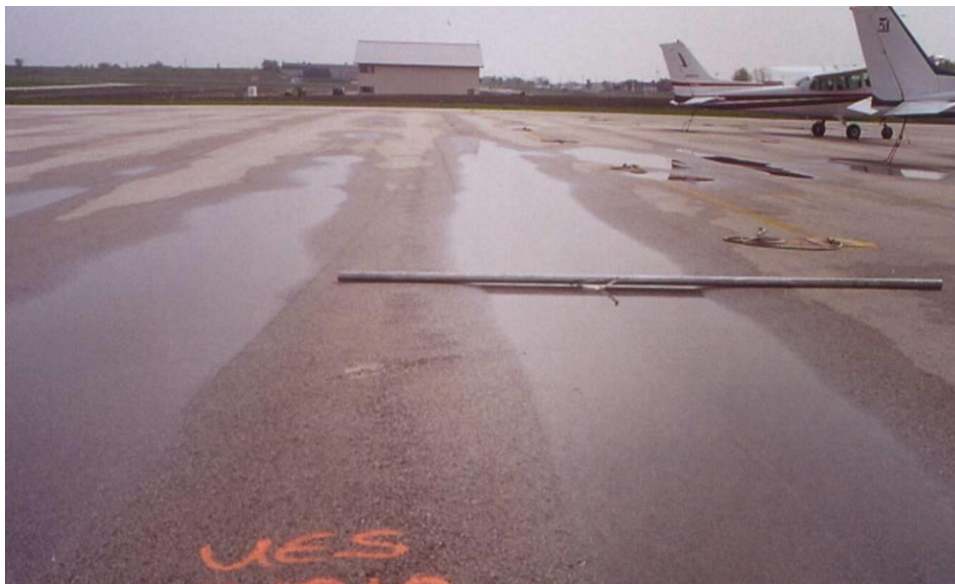
Example of Rutting

Ruts are localized, load related, areas of pavement having elevations lower than the surrounding sections. Rutting is due to base and subgrade consolidation, caused by excessive wheel loads or poor compaction. Ruts indicate structural failure, and can cause hydroplaning. At low severity, ruts have an

average depth of ¼ to ½ inches. At medium severity, ruts have an average depth of ½ to 1 inch. High severity, ruts have an average depth greater than 1 inch. Full-depth patching is the appropriate repair for ruts.

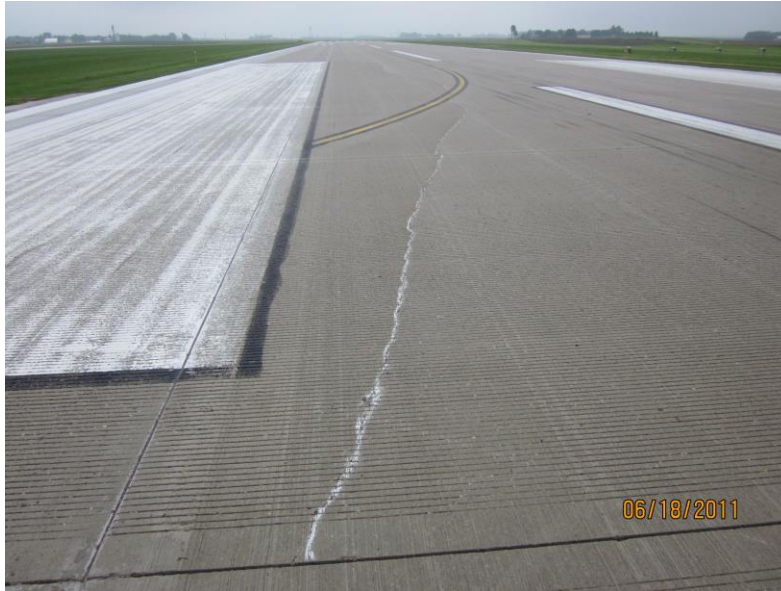
Example of Longitudinal, Transverse, and Diagonal Cracking

LTD cracking is most often a result of externally applied loads and/or constrained temperature deformations. External loads cause LTD cracking through flexure. Temperature changes on restrained slabs will result in stresses due to friction or curling. When any of these stresses exceed the strength of the slab, cracking will occur. LTD cracking is recorded at low, medium, or high severity, depending on the width of crack opening and degree of deterioration. At low severity, the crack is less than 1/8th inch wide with little spalling and no corrective action is indicated. At medium severity, LTD cracks can be up to 1 inch wide with moderate spalling, and should be repaired and sealed using procedures similar to joint sealing. At high severity, cracks exceed 1 inch in width and may be severely spalled. High-severity LTD cracking is evidence of serious load failure of the slab, and correction may require patching or slab replacement. If the distress occurs in several adjacent slabs at medium or high severity, major rehabilitation of that pavement area is indicated.

When a slab is divided by LTD cracks into four or more pieces, the slab is said to be "divided" or "shattered." Shattered slab is a separate distress category and is indicative of significant structural failure as the slab loses its ability to distribute loads to subgrade and further slab deterioration can be expected. Shattered slabs are rated in three severities, with slab replacement recommended for medium and high severities.

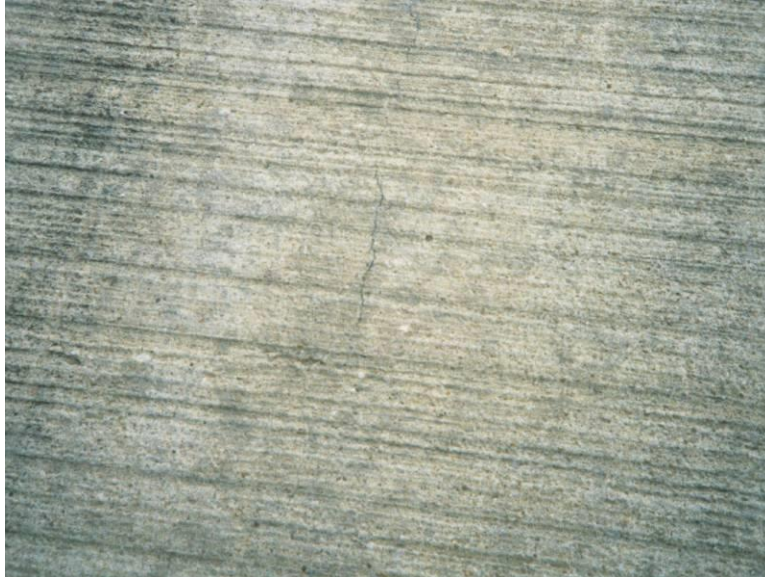
Example of Shrinkage Cracking

Shrinkage cracks are small, nonworking (no spalling along edge) cracks that are visible at the surface but do not penetrate through the full depth of concrete. Shrinkage cracks most commonly occur shortly after construction due to concrete shrinkage during the curing process. Shrinkage cracks are usually so small that they are not visible until staining or material loss at crack edges begins to take place. Shrinkage cracks do not represent a structural weakness, and no corrective action is prescribed.

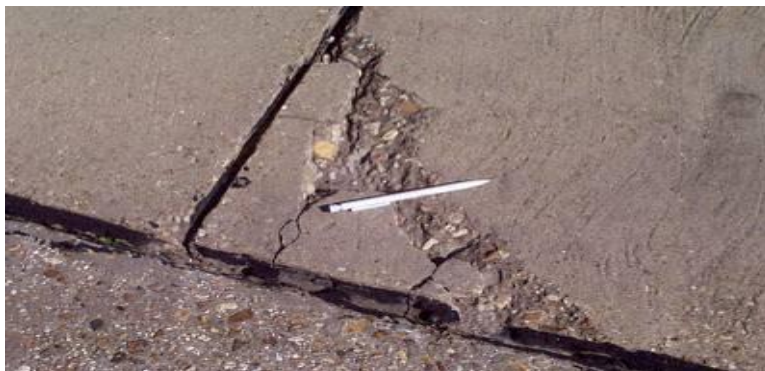
Example of Joint and Corner Spalling

Spalls at slab joints and corners are caused by excessive internal stress in the pavement. Spalls occur when these stresses exceed the shear strength of the concrete. Spalling usually results from thermal expansion during warm or hot weather. As slabs expand, they push against one another at joints. If the joints are filled with incompressibles, such as sand, or if adjacent slabs offset slightly, stresses can become severe, causing spalls. Spalling can be reduced significantly by conscientious maintenance of joint sealant.

Spall repair requires patching. The extent and severity of spalling on a pavement surface suggests appropriate action. For example, at low severity, spalled concrete remains securely in place in the slab. A low-severity spall should be monitored closely for further deterioration and should be patched when

spalled particles become loose in place, or at the next scheduled patching activity in the section. Medium- and high-severity spalls should be repaired immediately to prevent the incidence of FOD. If the pavement can be restored to serviceable condition, spalls should be carefully patched for long-term service. If the pavement is beyond repair, temporary patching should be considered to control FOD.

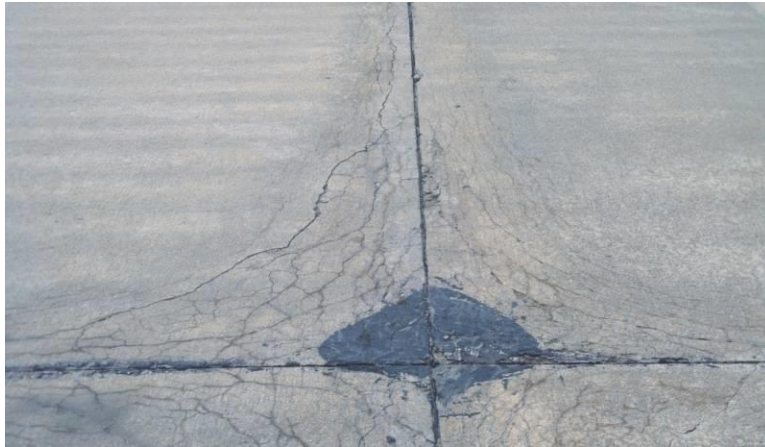
Example of Durability Cracking

Durability cracking (D-cracking) is caused by environmental factors, the most common of which is freezing/thawing. It usually appears as a pattern of hairline cracks running parallel to a joint or crack, or in a corner, where water tends to collect. This type of cracking eventually leads to disintegration of the pavement, creating FOD potential. At low severity, D-cracking is evident, but no disintegration has occurred. As the distress advances to medium severity, the distress pattern is evident over a significant area of the slab, and some disintegration and FOD potential exists. High severity durability cracking is evidenced by extensive cracking with loose and missing pieces and significant FOD potential.

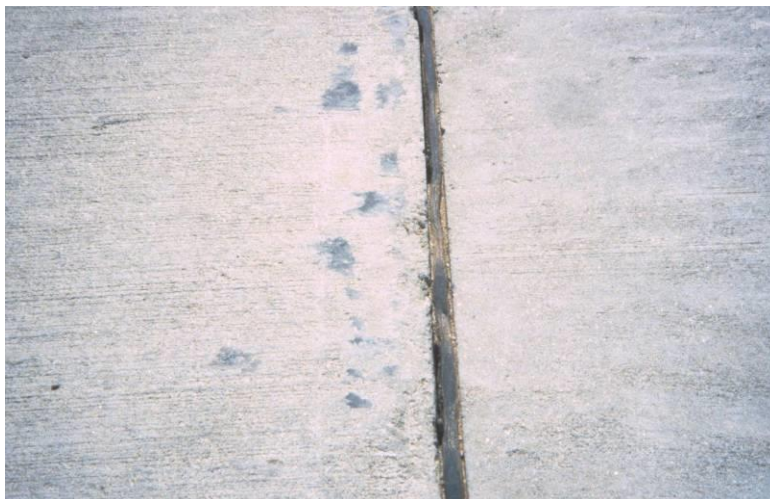
Example of Joint Seal Damage

Joint seal damage is recorded at three severities: low, medium, and high. When joint sealant is in perfect condition (no damage), it is not a distress. At low severity, at least 10 percent of the sealant is debonded but still in contact with the joint edges (i.e., joint sealant is in serviceable condition but should

be monitored for evidence of more serious failure). Medium-severity joint seal damage is recorded when at least 10 percent of the sealant has visible gaps smaller than 1/8th inch and is an indicator that replacement should be programmed as soon as is practicable. In the meantime, aggressive inspection and sustaining maintenance is recommended to minimize subsurface damage from moisture penetration. At high severity, visible gaps exceed 1/8th inch and the amount and degree of joint seal damage is such that repair is no longer feasible. The only appropriate corrective action is sealant replacement.

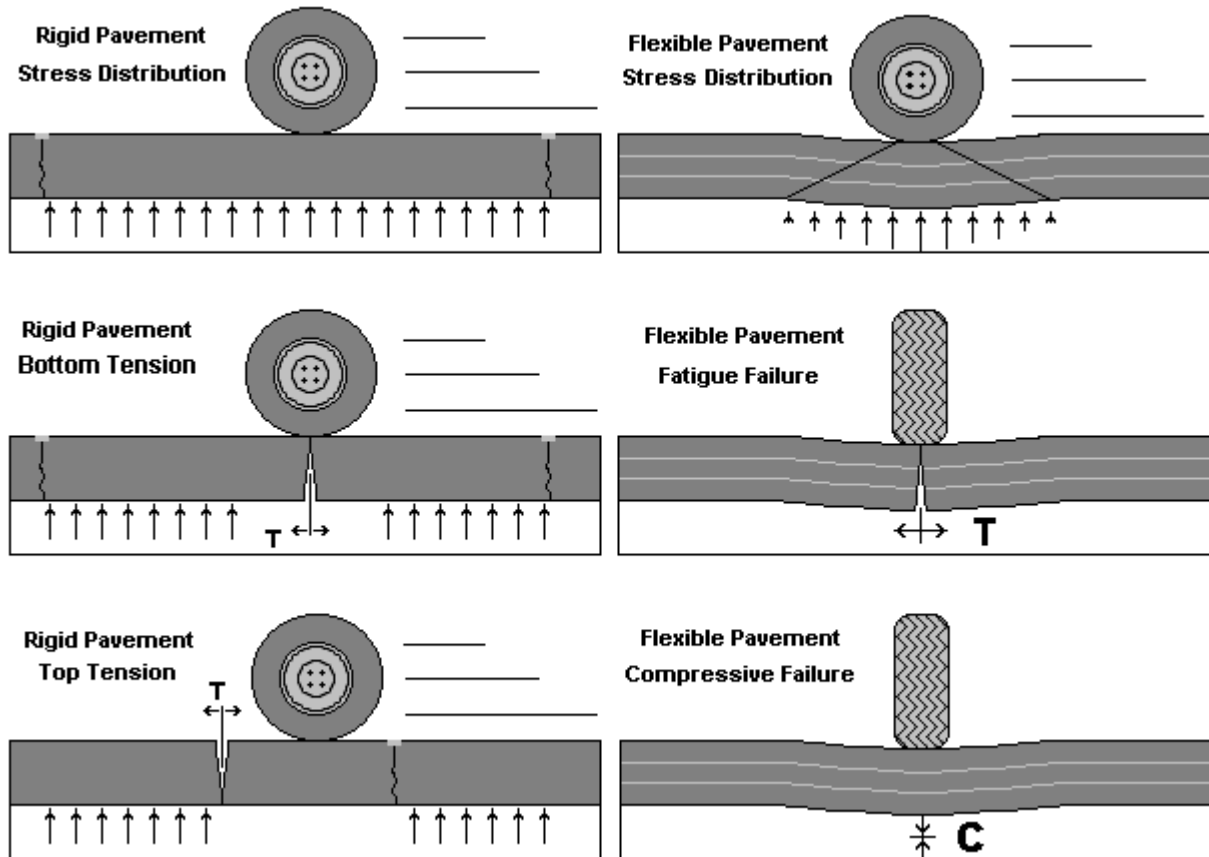
Figure G.1. Pavement failure.

Load-related cracks can start at the top or bottom of a pavement section. In asphalt sections, load-related (fatigue) cracks start at the bottom. If a load-related crack reaches the surface, it usually indicates significant structural deficiency. In PCC pavement, corner breaks are caused by top tension, and the crack propagates downward. Mid-slab LTD cracks are examples of bottom tension.

Spalls can be caused by either wheel loads or environmental factors, anytime there is movement between adjacent slabs. If a small rock is allowed into a joint, a differential movement between adjacent slabs can cause a spall. Spalling can be minimized by keeping joint and crack sealant intact.
