Pavement Condition Report

Detroit Lakes Airport-Wething Field (DTL)

December 2017

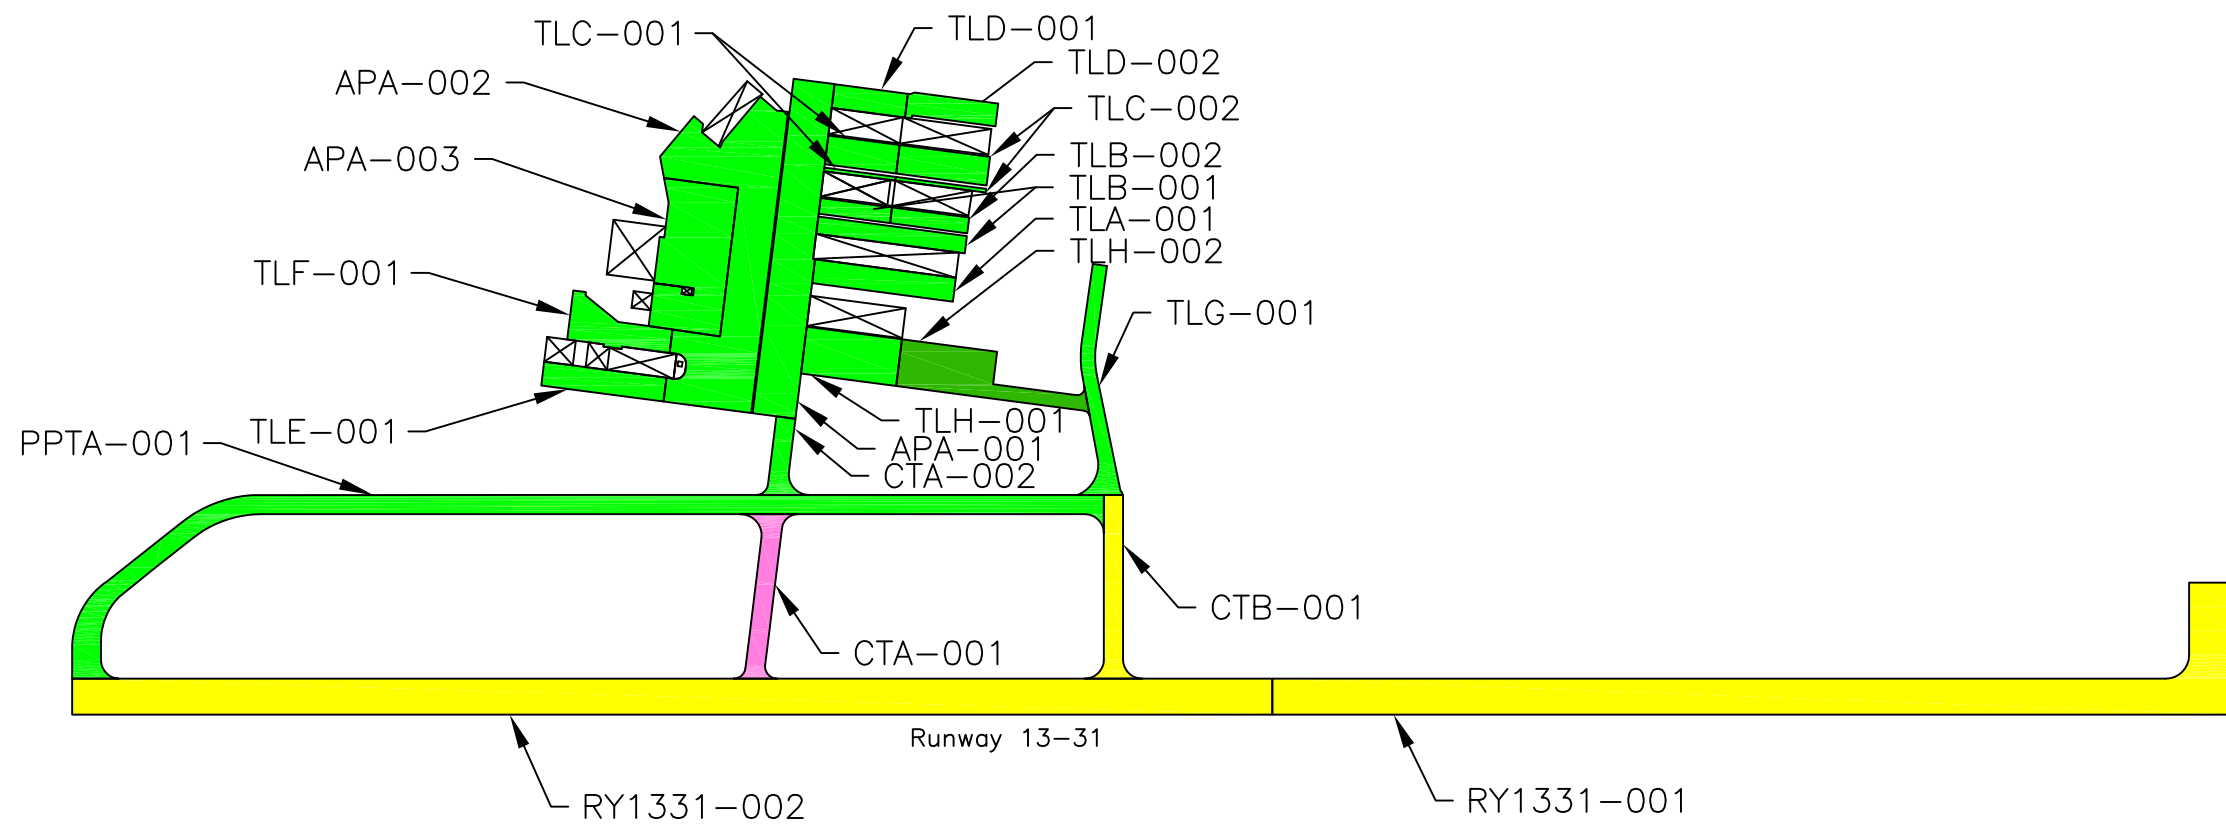
Figure 4. 2017 Pavement Condition Index Rating at Detroit Lakes Airport (DTL).

The results of the 2017 PCI inspection are presented in figure 4. The overall area-weighted, inspected PCI for DTL is 69. When summarizing PCI values, an area-weighted calculation is used instead of a straight mathematical average because the area-weighted calculations eliminate the skewing of the PCI due to the disparity of the section sizes.
