Pavement Condition Report

Elbow Lake Municipal - Pride of the Prairie Airport (Y63)

December 2017

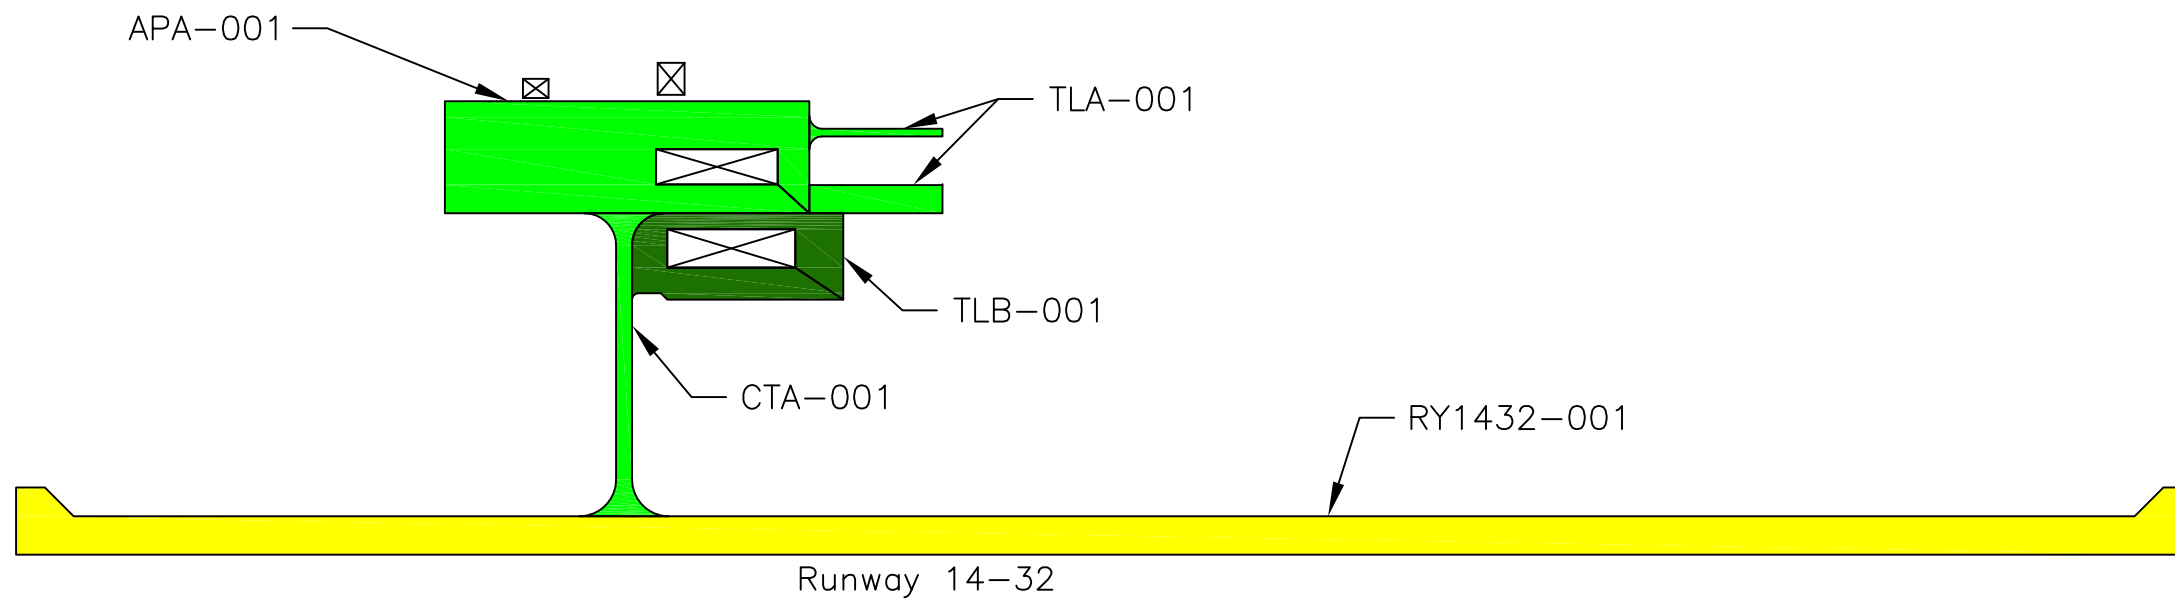
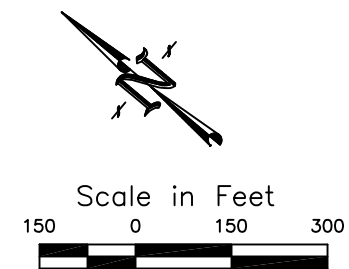
Figure 4. 2017 Pavement Condition Index Rating at Elbow Lake Municipal Airport (Y63).

The results of the 2017 PCI inspection are presented in figure 4. The overall area-weighted, inspected PCI for Y63 is 73. When summarizing PCI values, an area-weighted calculation is used instead of a straight mathematical average because the area-weighted calculations eliminate the skewing of the PCI due to the disparity of the section sizes.

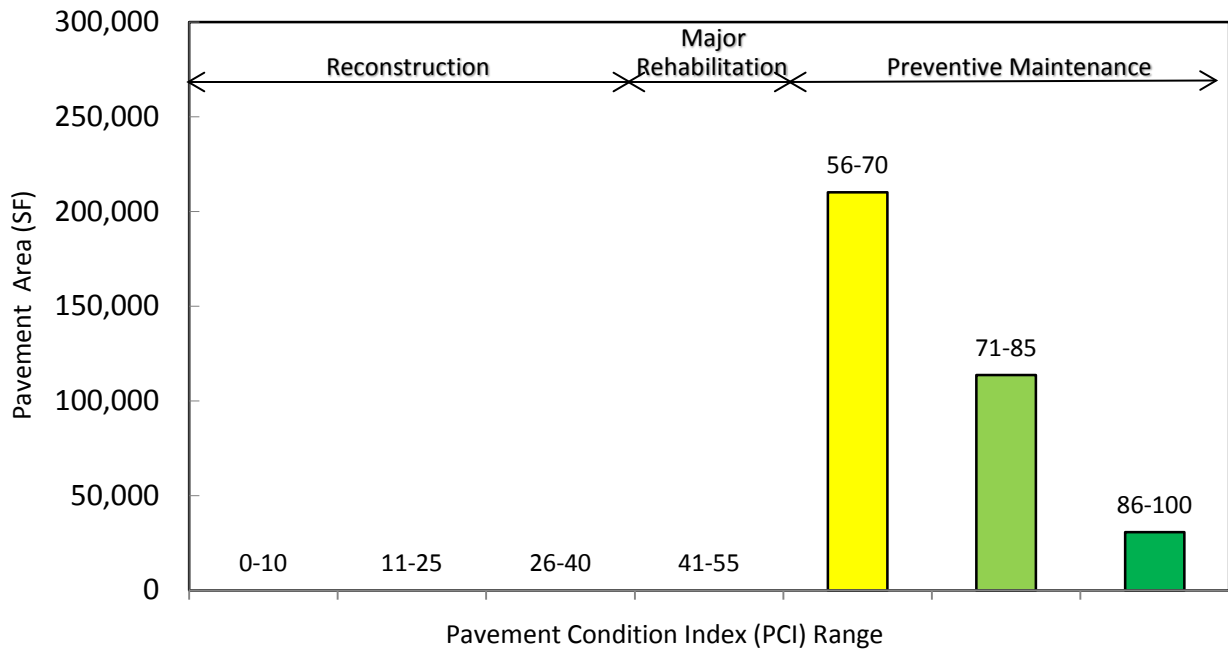
Figure 5. Condition distribution.

Figures 5 and 6 present the overall PCI for Y63 by area distribution and pavement use, respectively. Table 3 presents the PCI summary for each section at Y63, including the drop in PCI per year. Generally, pavement sections will deteriorate between 1 and 3 PCI points per year. Sections deteriorating at higher rates may need maintenance above the normal application rates and should be closely monitored in case major repairs become necessary earlier than expected.

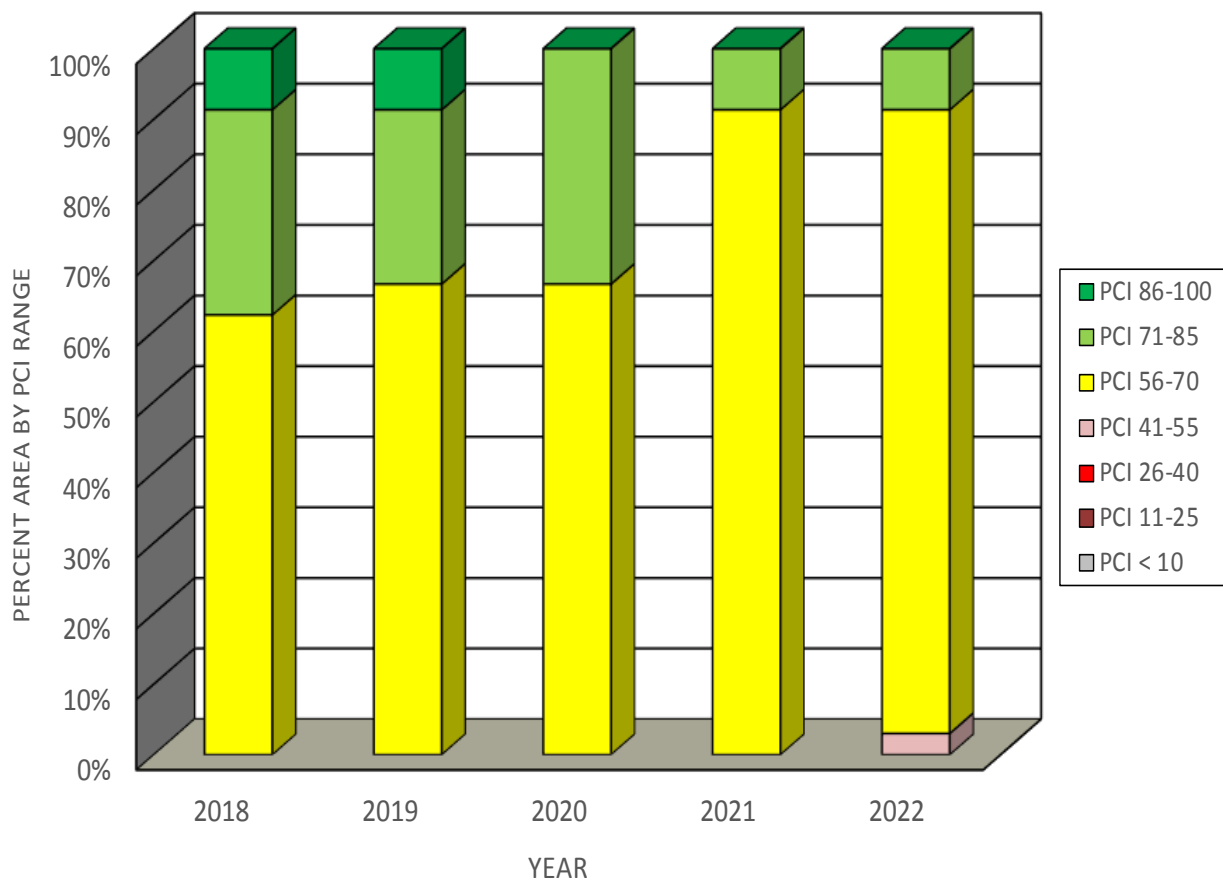
Figure 7. Projected PCI by percent area.

Figure 7 shows the projected PCI at Y63 by percent area for the next 5 years assuming no major repairs (overlays, reconstruction, etc.) are performed during that period. It shows how quickly a pavement network can deteriorate when no capital improvements are made.
