Pavement Condition Report

Bagley Municipal Airport (7Y4)

December 2019

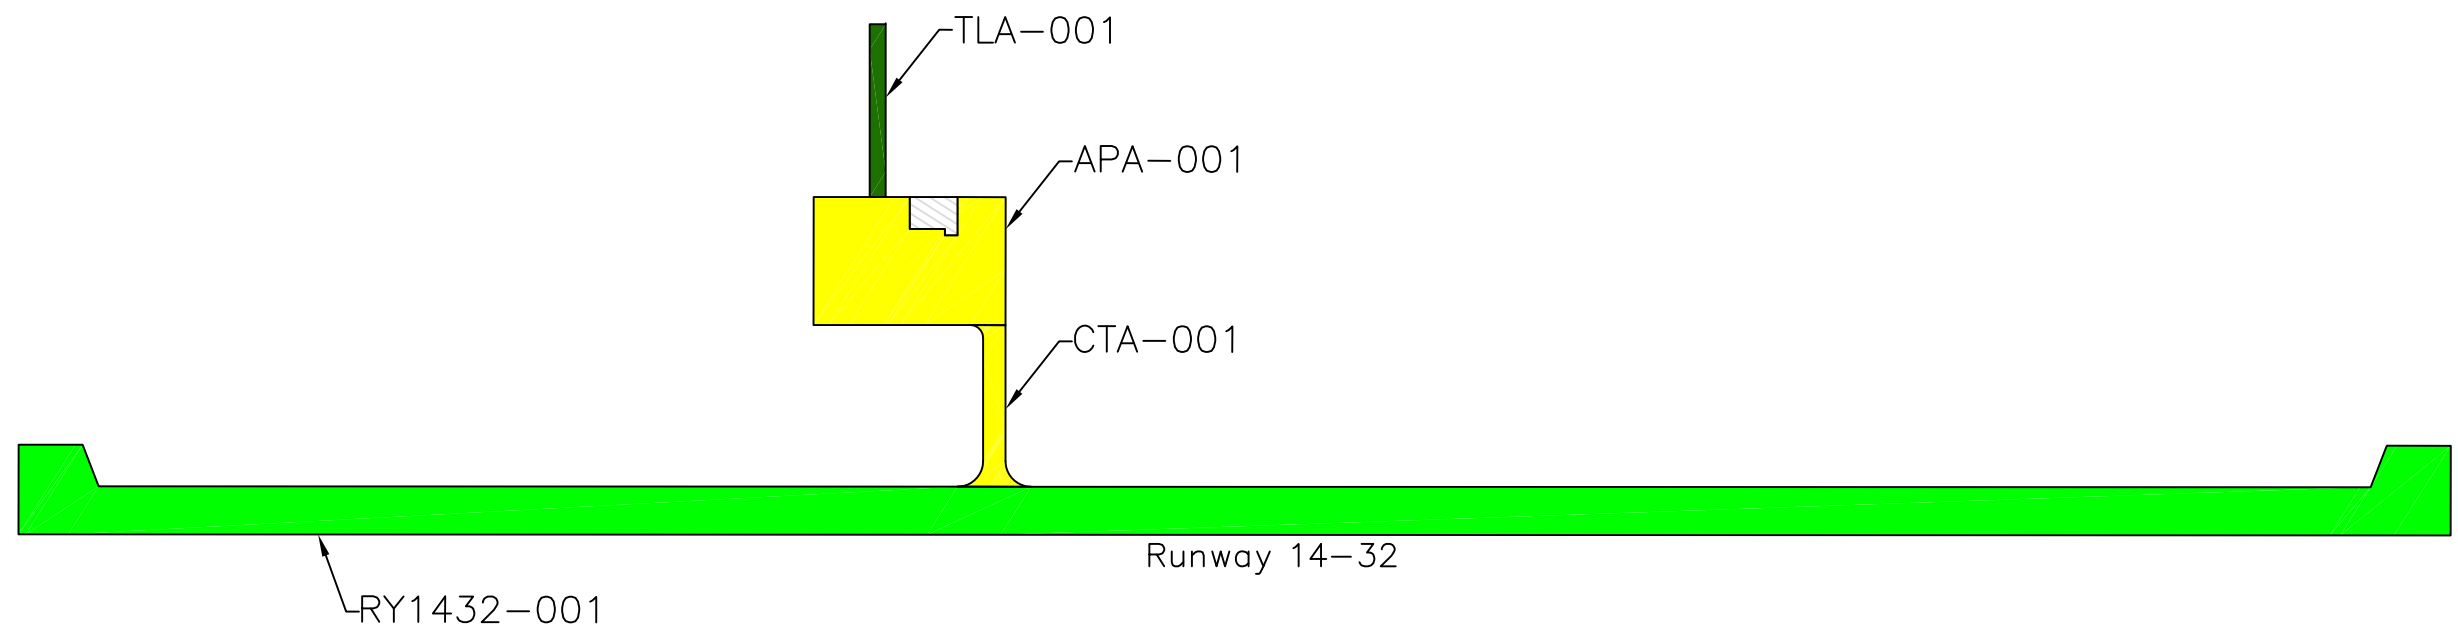
Figure 4. 2019 Pavement Condition Index Rating at Bagley Municipal Airport (7Y4).

The results of the 2019 PCI inspection are presented in figure 4. The overall area-weighted, inspected PCI for 7Y4 is 71. When summarizing PCI values, an area-weighted calculation is used instead of a straight mathematical average because the area-weighted calculations eliminate the skewing of the PCI due to the disparity of the section sizes.

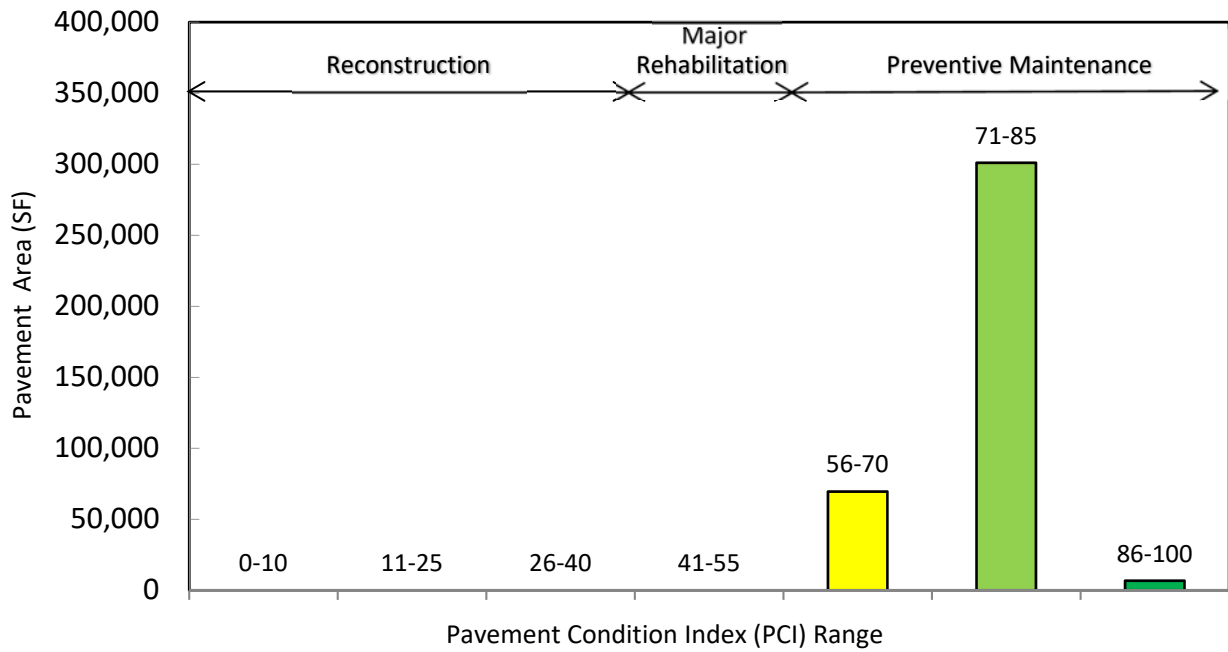
Figure 5. Condition distribution.

Figures 5 and 6 present the overall PCI for 7Y4 by area distribution and pavement use, respectively. Table 3 presents the PCI summary for each section at 7Y4, including the drop in PCI per year. Generally, pavement sections will deteriorate between 1 and 3 PCI points per year. Sections deteriorating at higher rates may need maintenance above the normal application rates and should be closely monitored in case major repairs become necessary earlier than expected.

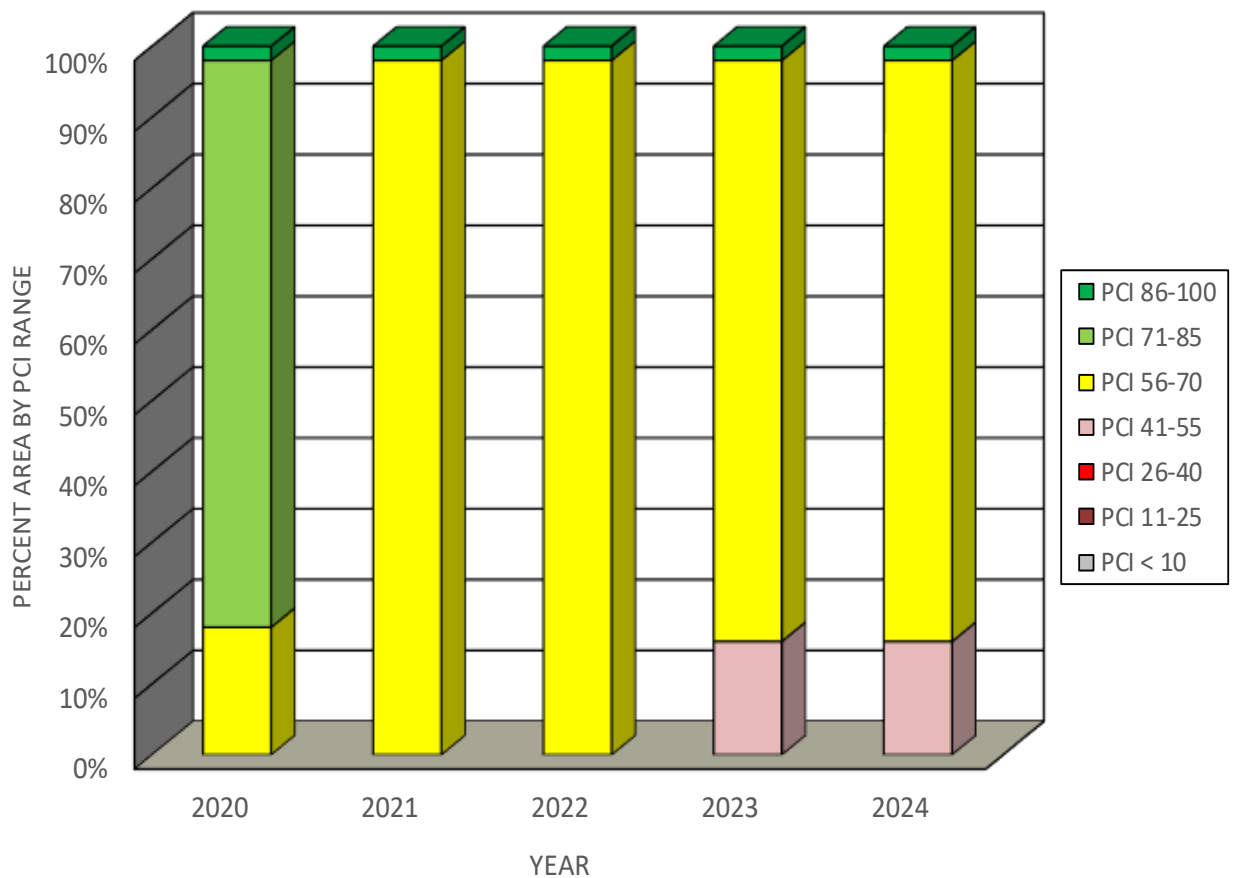
Figure 7. Projected PCI by percent area.

Figure 7 shows the projected PCI at 7Y4 by percent area for the next 5 years assuming no major repairs (overlays, reconstruction, etc.) are performed during that period. It shows how quickly a pavement network can deteriorate when no capital improvements are made.
