Pavement Condition Report

Granite Falls Municipal Airport (GDB)

December 2019

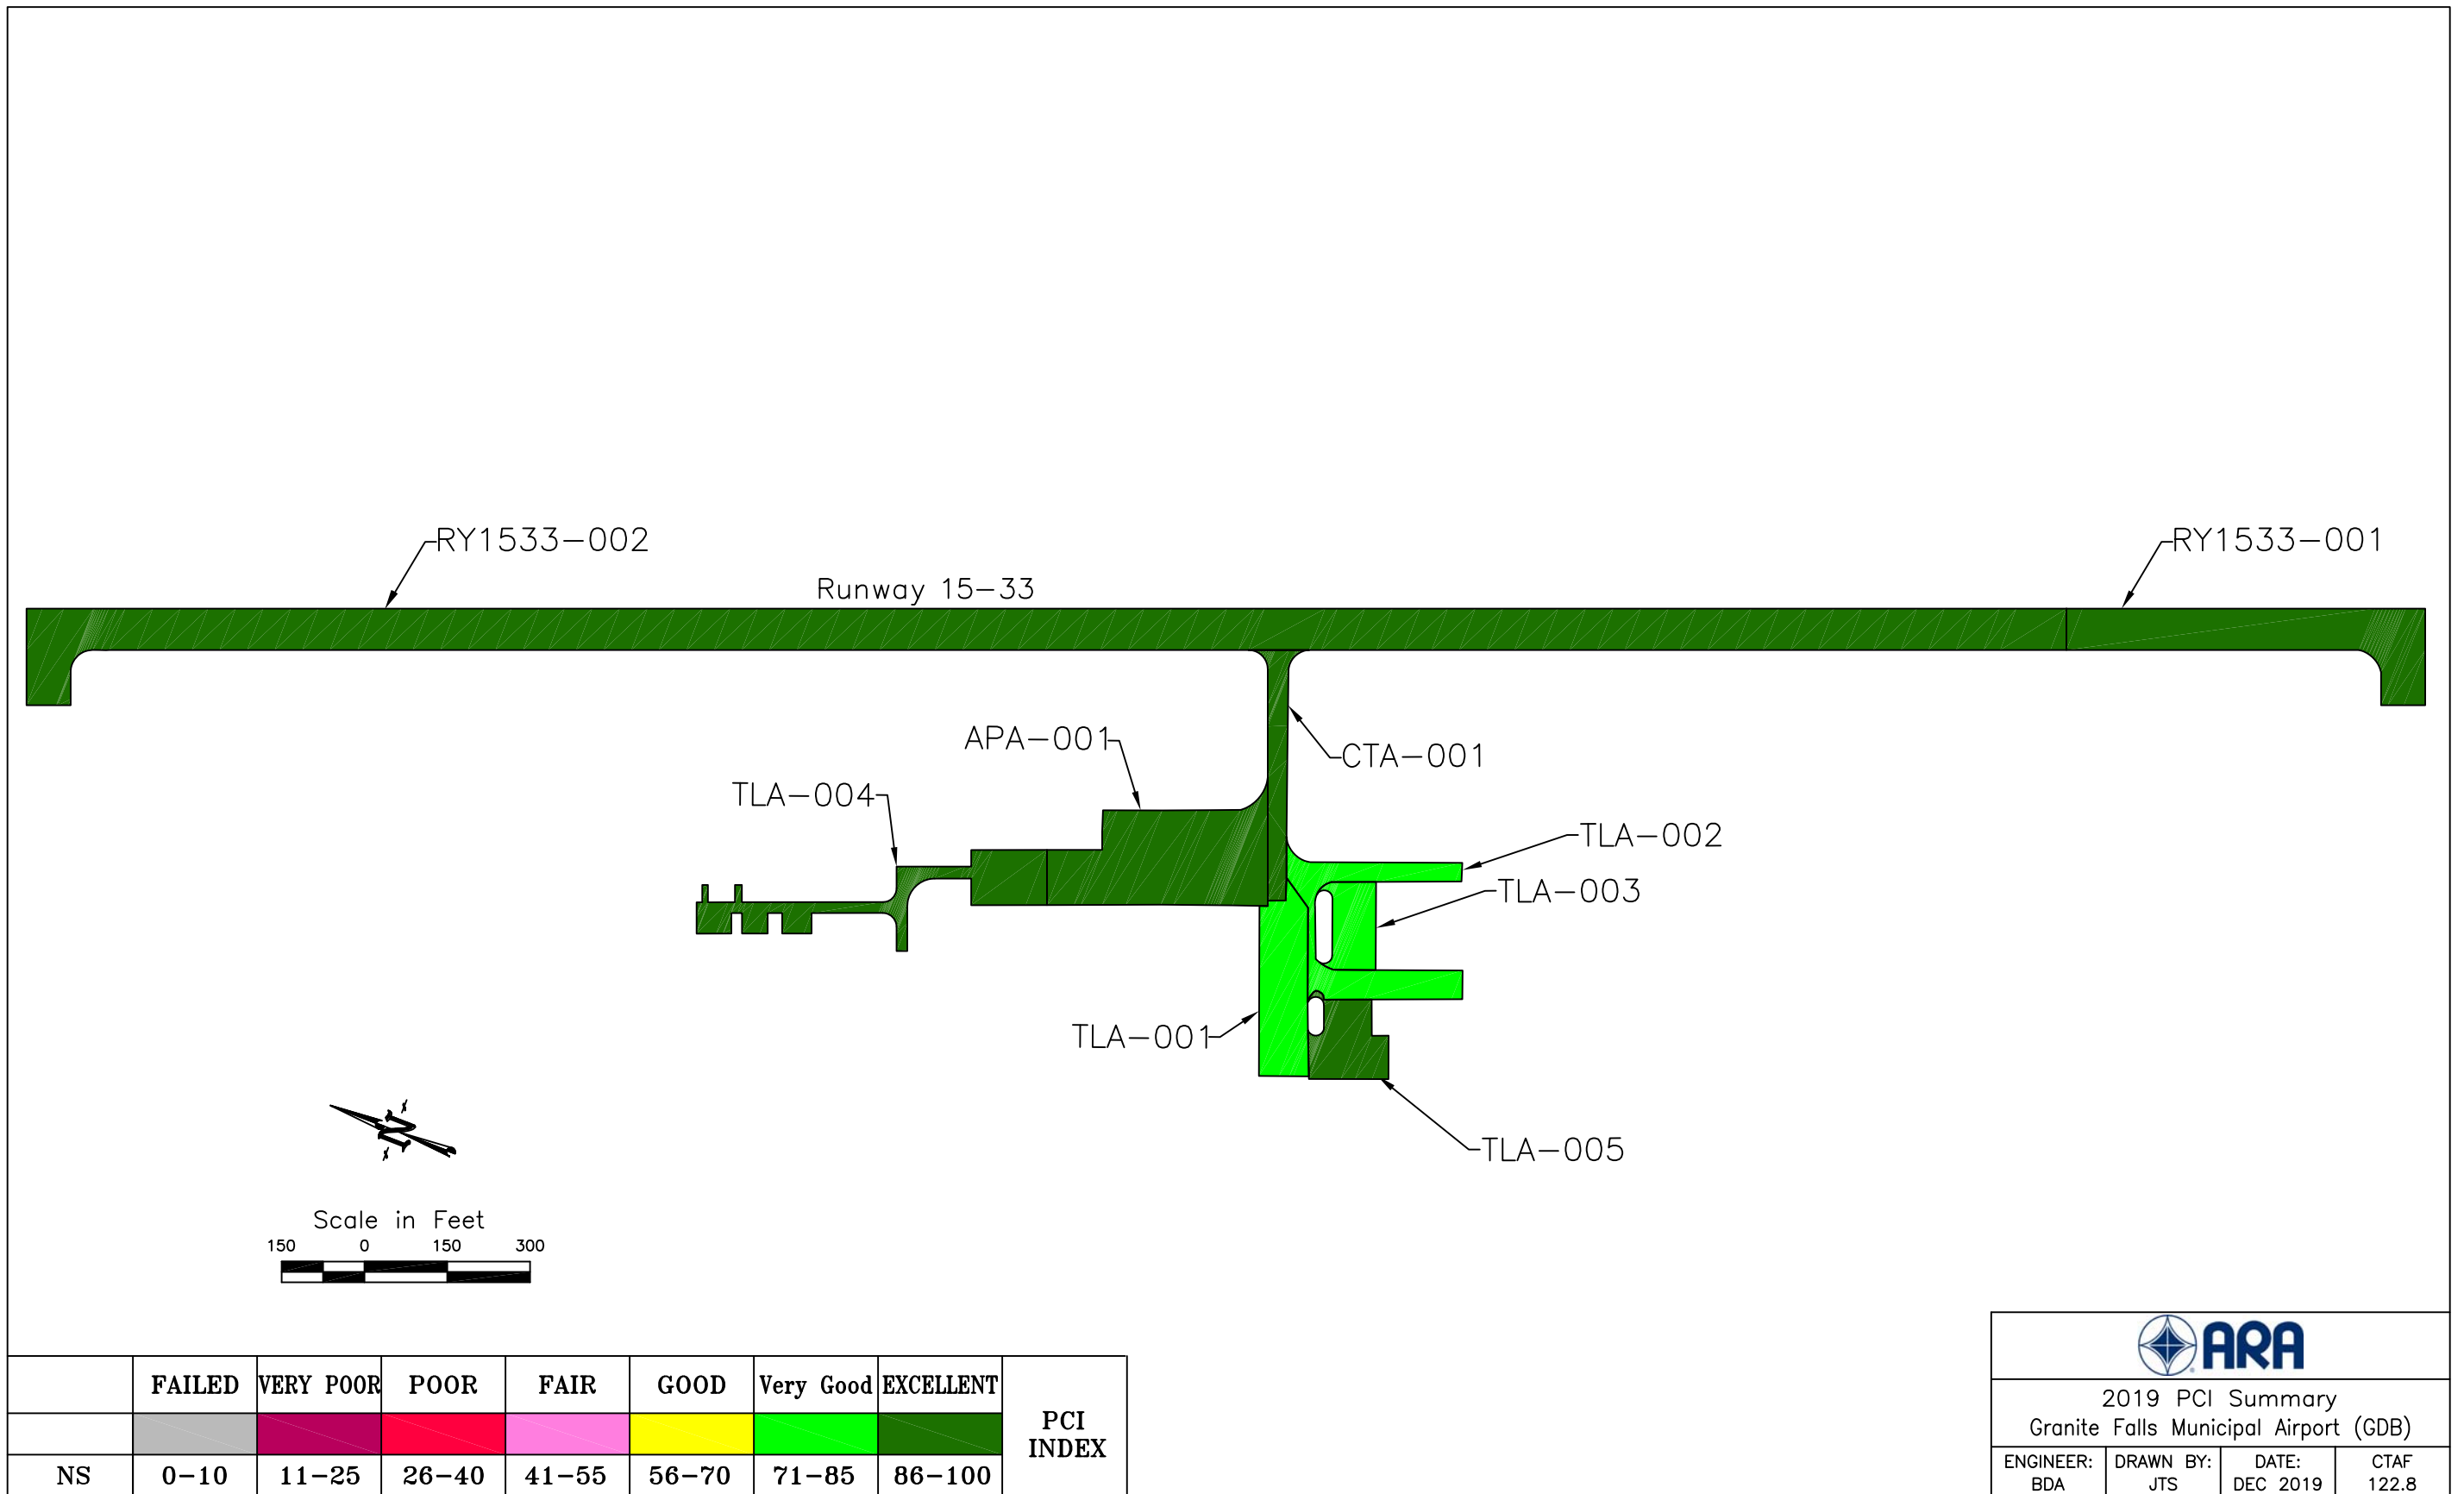
Figure 4. 2019 Pavement Condition Index Rating at Granite Falls Municipal Airport (GDB).

The results of the 2019 PCI inspection are presented in figure 4. The overall area-weighted, inspected PCI for GDB is 94. When summarizing PCI values, an area-weighted calculation is used instead of a straight mathematical average because the area-weighted calculations eliminate the skewing of the PCI due to the disparity of the section sizes.

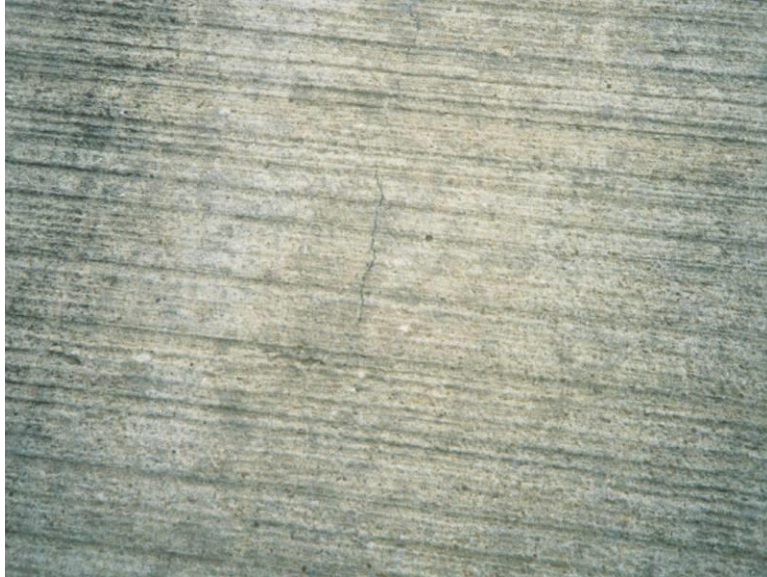
Example of Shrinkage Cracking

Shrinkage cracks are small, nonworking (no spalling along edge) cracks that are visible at the surface but do not penetrate through the full depth of concrete. Shrinkage cracks most commonly occur shortly after construction due to concrete shrinkage during the curing process. Shrinkage cracks are usually so small that they are not visible until staining or material loss at crack edges begins to take place. Shrinkage cracks do not represent a structural weakness, and no corrective action is prescribed.

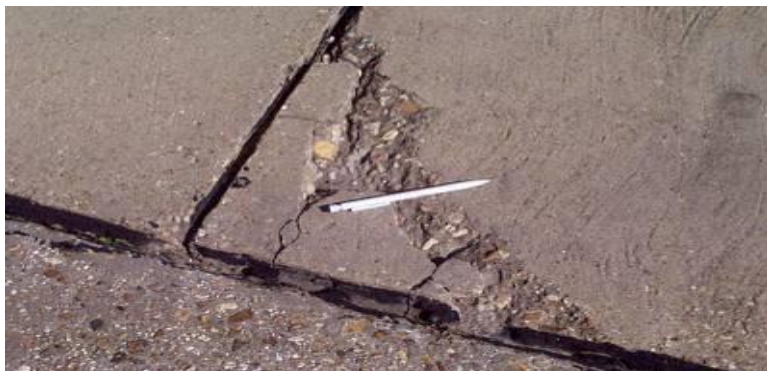
Example of Joint and Corner Spalling

Spalls at slab joints and corners are caused by excessive internal stress in the pavement. Spalls occur when these stresses exceed the shear strength of the concrete. Spalling usually results from thermal expansion during warm or hot weather. As slabs expand, they push against one another at joints. If the joints are filled with incompressibles, such as sand, or if adjacent slabs offset slightly, stresses can become severe, causing spalls. Spalling can be reduced significantly by conscientious maintenance of joint sealant.

Spall repair requires patching. The extent and severity of spalling on a pavement surface suggests appropriate action. For example, at low severity, spalled concrete remains securely in place in the slab. A low-severity spall should be monitored closely for further deterioration and should be patched when

spalled particles become loose in place, or at the next scheduled patching activity in the section. Medium- and high-severity spalls should be repaired immediately to prevent the incidence of FOD. If the pavement can be restored to serviceable condition, spalls should be carefully patched for long-term service. If the pavement is beyond repair, temporary patching should be considered to control FOD.
