February 24, 2015

**Re: Bridge No. 2440 Rehabilitation Dive Inspection Summary for 2014**

AMI Project # 141122

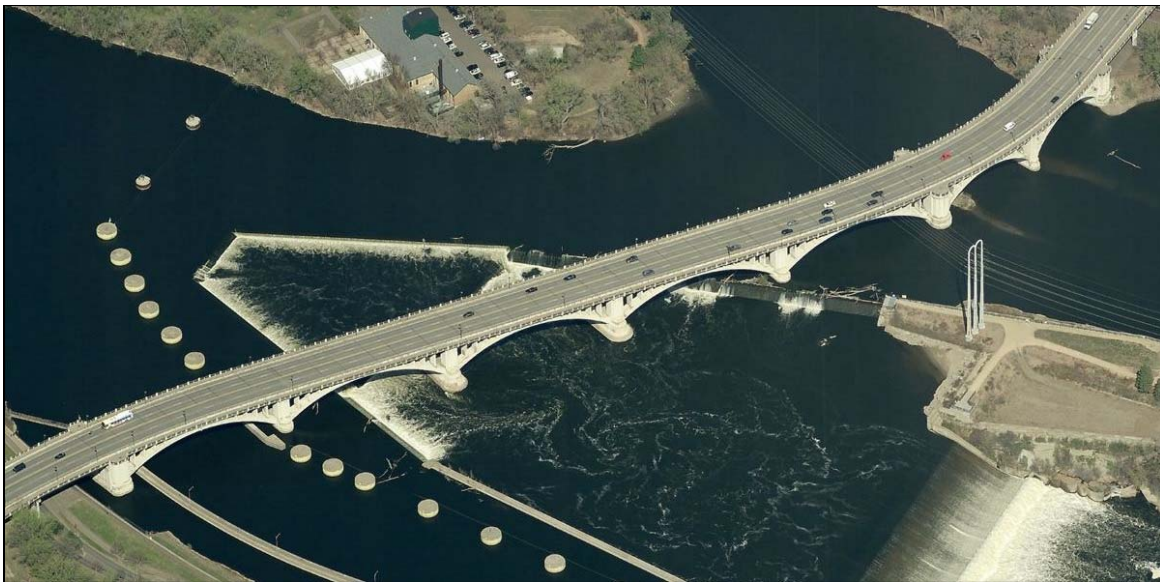
Picture 1: Aerial view of bridge no. 2440

This letter is written in regards to the rehabilitation of bridge number 2440 which crosses the Mississippi River in Minneapolis, MN. Three of the eight concrete bridge piers were to be rehabilitated above and below the waterline. This letter will summarize the work completed and the construction changes which occurred below the waterline on bridge piers #1, 2, & 5. A detailed description of the defects documented during the inspection process can be viewed in the Field Notes of the attached documents. This letter is a summary of the inspection and should be used in conjunction with the attached documents. An aerial view of the bridge can be seen in Picture #1 below and the location of the piers can be seen on S1.0 in the attached drawings.

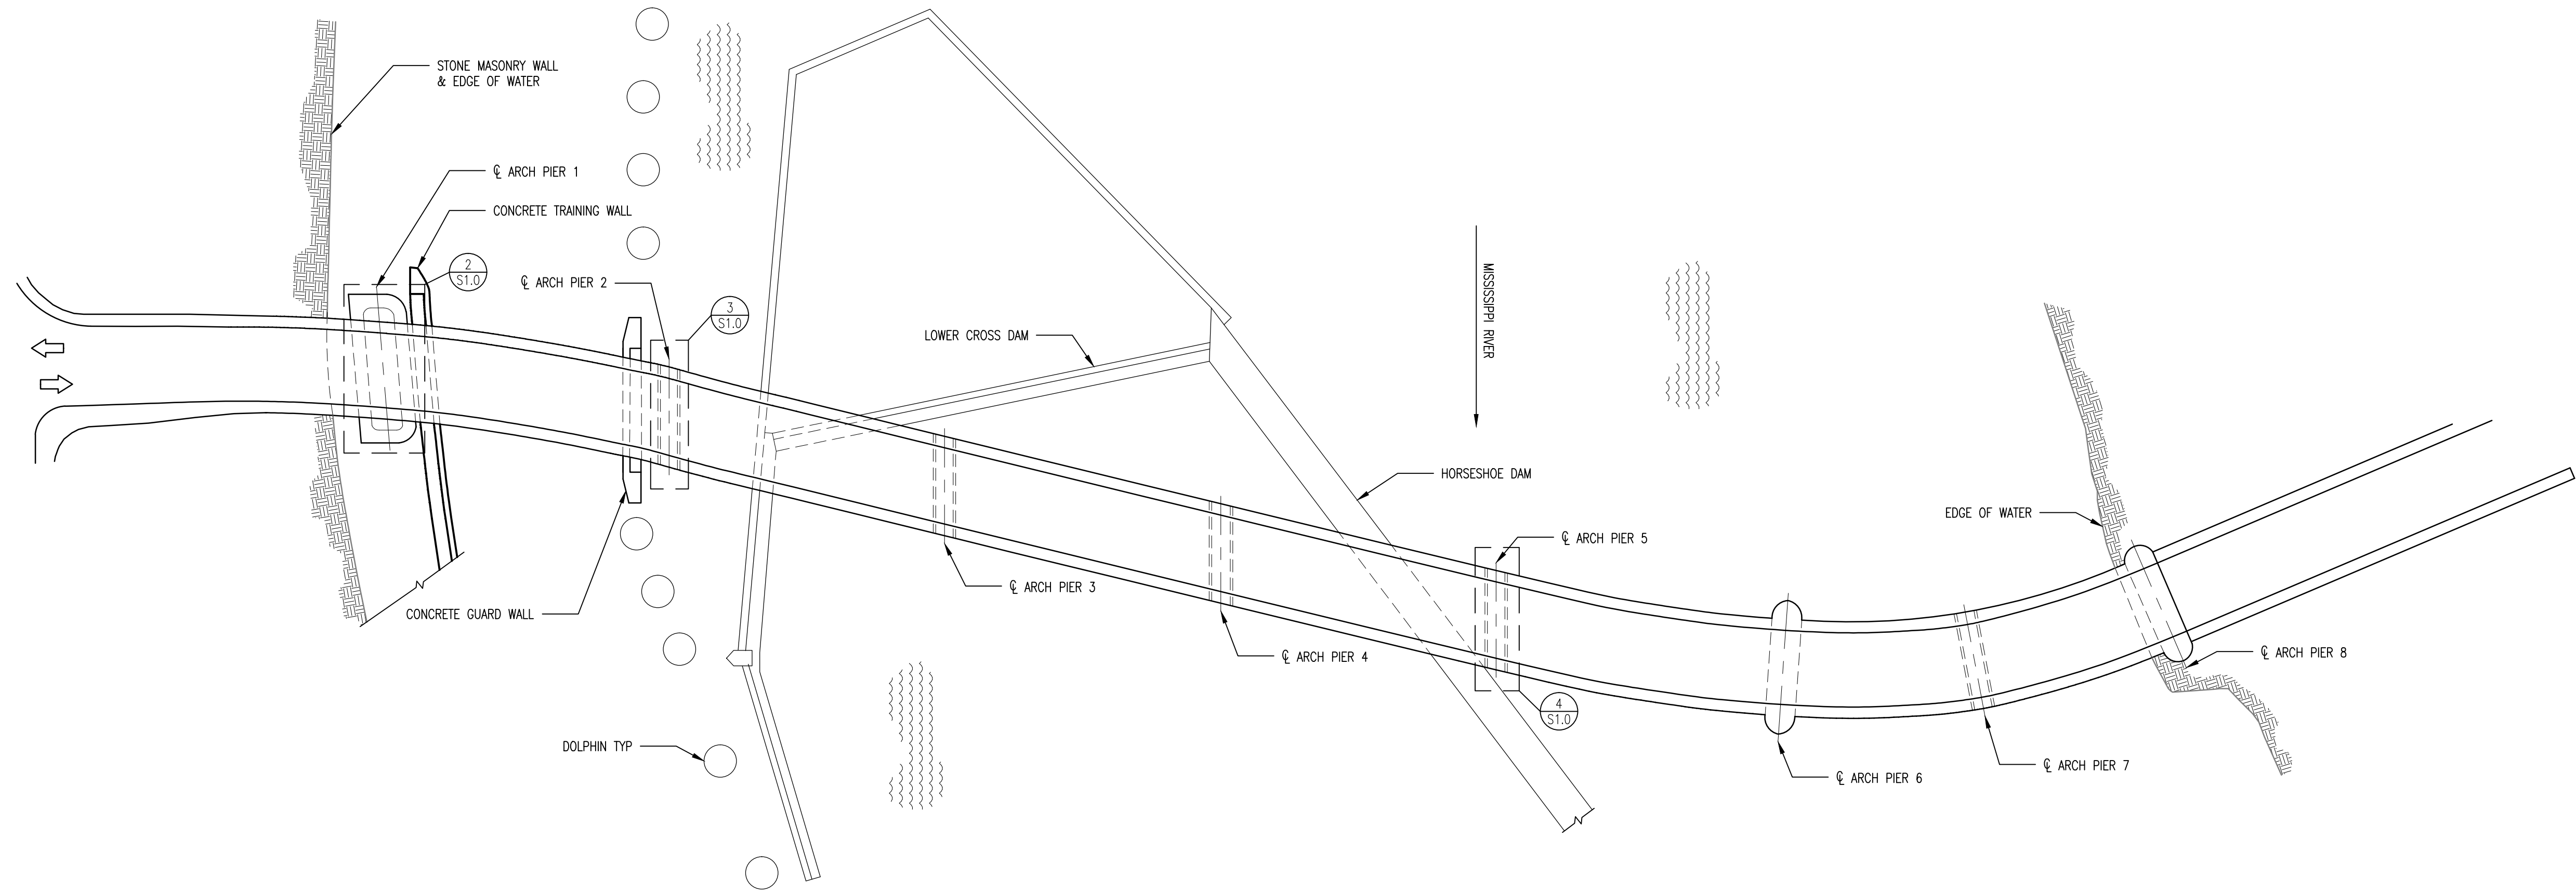
**1**  
S1.0  
GENERAL PLAN  
SCALE: 1" = 40'-0"

To rehabilitate the scour hole below the pier, the contractor had to remove any loose sediment and debris from below the pier and then place 6'-0" to 7'-0" tall forms around the scour areas. The new concrete would extend up from the bedrock to the horizontal face of the concrete pier. During the process of removing loose sediment and debris below the pier, the contractor discovered very low strength concrete or grout located along the vertical face of the existing concrete footing. The thickness of the low strength concrete or grout varied from 6" to the entire height of the vertical face of the pier footing. The low strength concrete or grout also appeared to extend underneath the tapered face of the concrete pier. Due to the large volume of the low strength concrete or grout, the areas were not removed but encased in additional concrete that extended above the horizontal face of the pier. A general cut section of the new repairs can be seen in detail 5/S1.0 of the attached AMI drawings.

The new repairs consisted of an additional D5xD5 deformed rebar mat with 4" spacing above the horizontal face of the existing concrete pier. The mat was attached to the existing concrete pier with horizontal and vertical dowels. The vertical dowels were a mixture of #4 rebar and 1/2" diameter threaded rod while the horizontal dowels were primarily 1/2" diameter threaded rods. However, some #4 horizontal rebar dowels were documented near the upstream tip of the concrete pier. MnDot onsite personnel verbally approved the change from rebar to threaded rods.

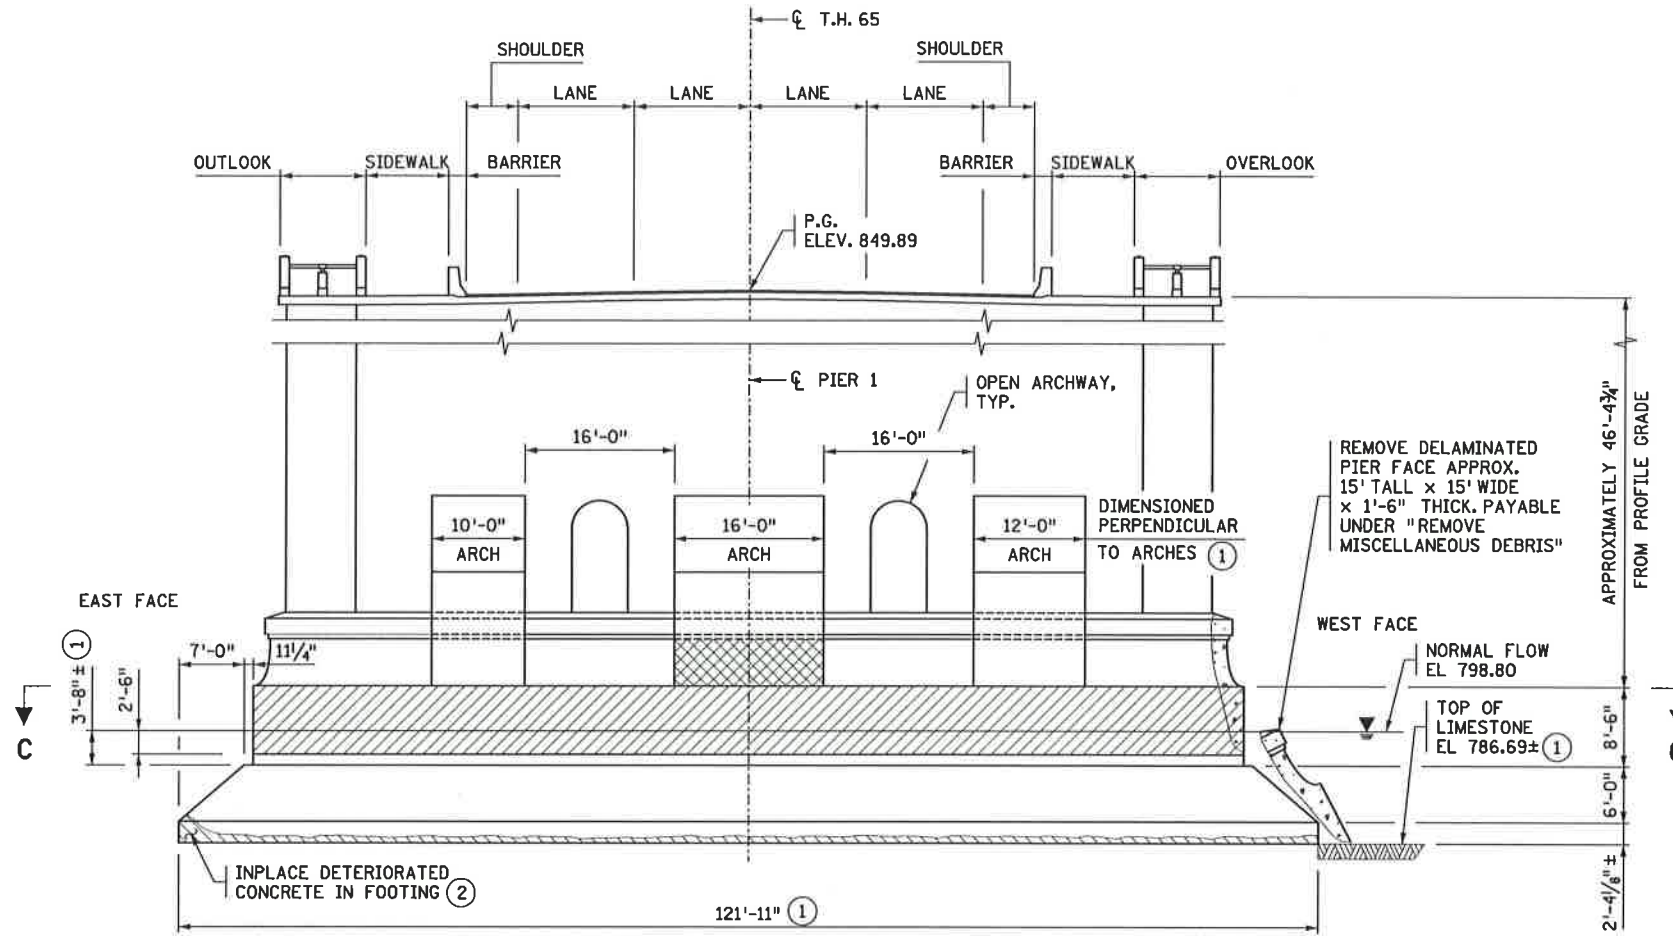
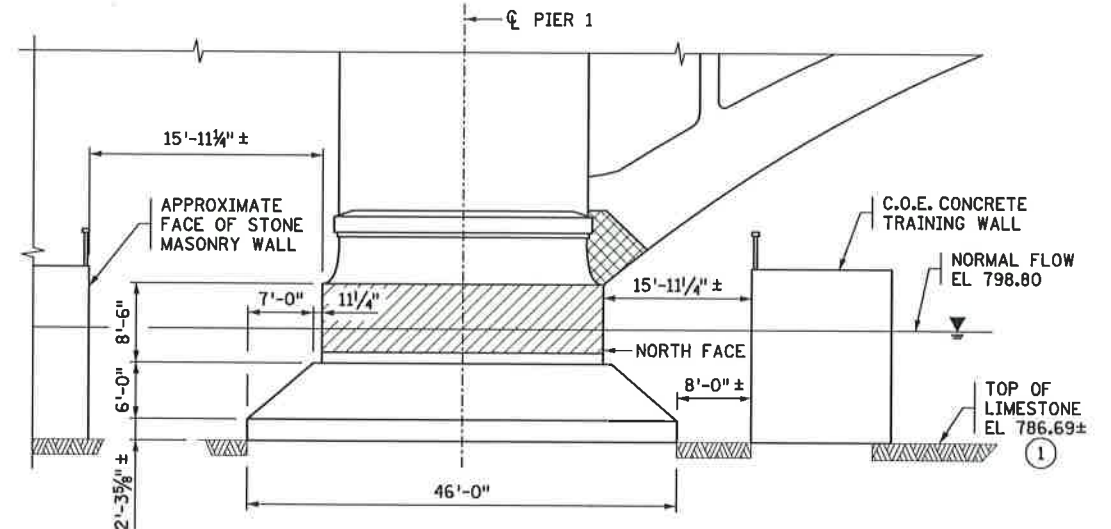
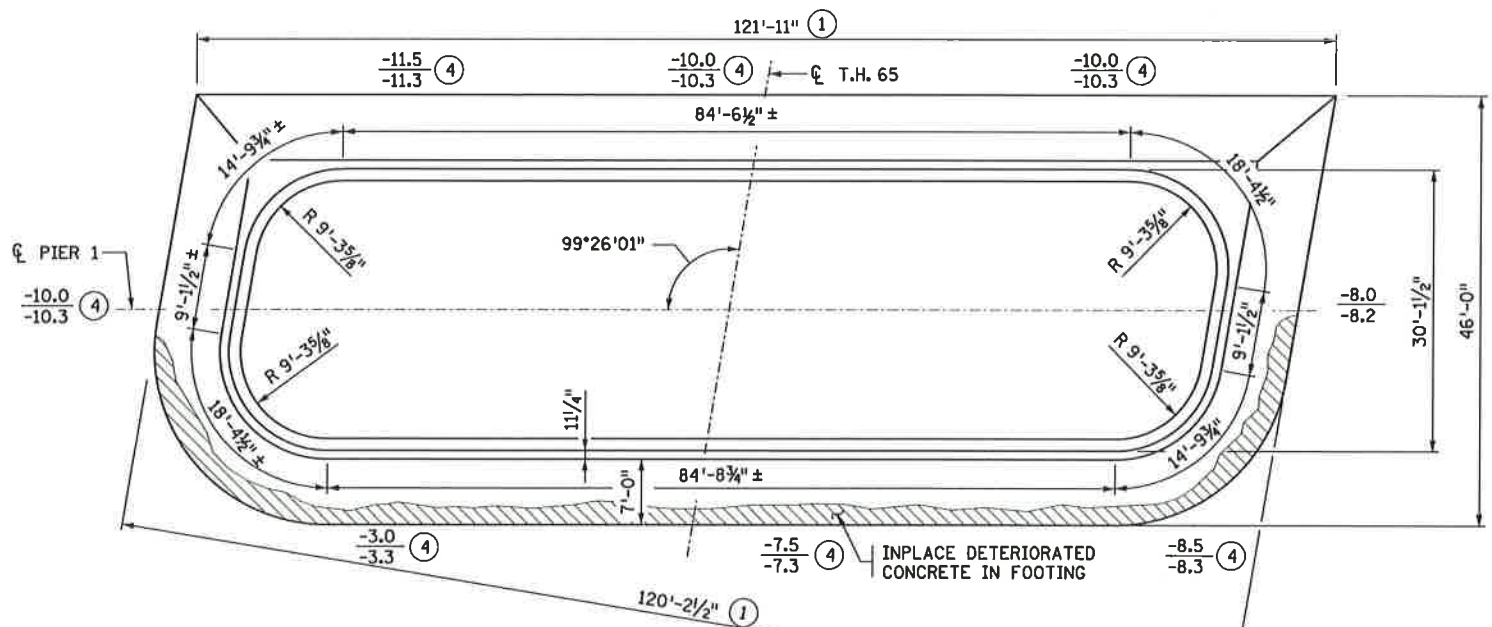
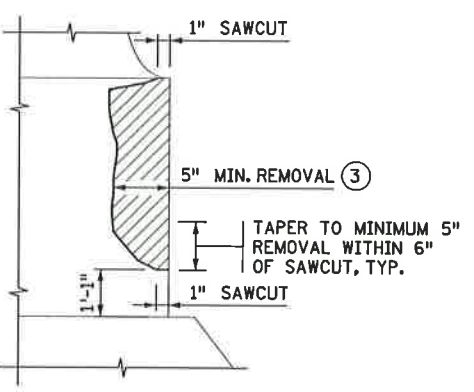
PIER 1 REMOVAL

Bridge pier #1 was located on the far west side of the river. Deteriorated concrete was to be removed and rehabilitated with new concrete and stainless steel rebar on two different areas of the pier below the waterline. However, only one area of deteriorated concrete near the waterline

had been rehabilitated during the 2014 construction season, due to the delays in the construction schedule. The rehabilitation of the second area of deteriorated concrete near the mud line will be completed in 2015. See attached MnDot Construction Plans for additional information on the require pier rehabilitation.

For the deteriorated concrete near the waterline, the construction documents required a horizontal saw cut at the base of the rehabilitation area that penetrated the concrete pier 3" to 5". The face of the concrete at the saw cut location was heavily deteriorated with areas of spalling concrete. Due to the spalling concrete and the resulting uneven surfaces, the saw cut did not penetrate the concrete pier the specified minimum of 3" on approximately 15% on the concrete pier. As a result of the smaller saw cut, the distance from the vertical dowel to the inside face of the concrete forms was also less than the specified minimum distance of 3".

The distance between the vertical rebar also exceeded the specified spacing of 12". The ACI code allows a placement tolerance of ¼ times the specified spacing but not to exceed 1". This results in a maximum allowable spacing of 13". Approximately 50% of the vertical rebar were spaced greater than 12" and 25% to 30% of the vertical rebar were spaced greater than 13". The maximum spacing between the vertical rebar was 14".

After each concrete pour, AMI re-inspected the new concrete to document any areas of washout or deficiencies. On the east and west side of the pier, the new concrete had migrated below the saw cut. The forms were slightly out from the original vertical concrete face of the pier which allowed the concrete to migrate below the saw cut due to the spalling concrete. The location of the forms did allow for additional concrete cover on the rebar. The concrete below the saw cut had areas of honeycombing that were about 5" to 6" in height. On the west side of the pier, a large area of concrete was missing presumably due to a failure of the concrete forms. The area of missing concrete was approximately 18.5" tall with a maximum penetration 4" which exposed one vertical bar and one vertical dowel of the new rebar. To remedy this area, the contractor installed a 3'-0" tall by 4'-0" wide concrete form that protruded from the new concrete face 1-<sup>7</sup>/<sub>8</sub>". The missing area of concrete was located approximately at station 0+35 on the west side of the pier. AMI was unable to re-inspect this repair after the concrete had been placed due to early freeze up.

In one area where the new concrete had not migrated below the saw cut, the bottom edge of the new concrete protruded out from the existing concrete face. The maximum protrusion or lip was approximately <sup>3</sup>/<sub>4</sub>" over an 8'-0" long horizontal area and was located near the upstream tip of the pier. Because of this lip, the bottom edge of the new concrete is susceptible to damage from ice impacts and abrasion.

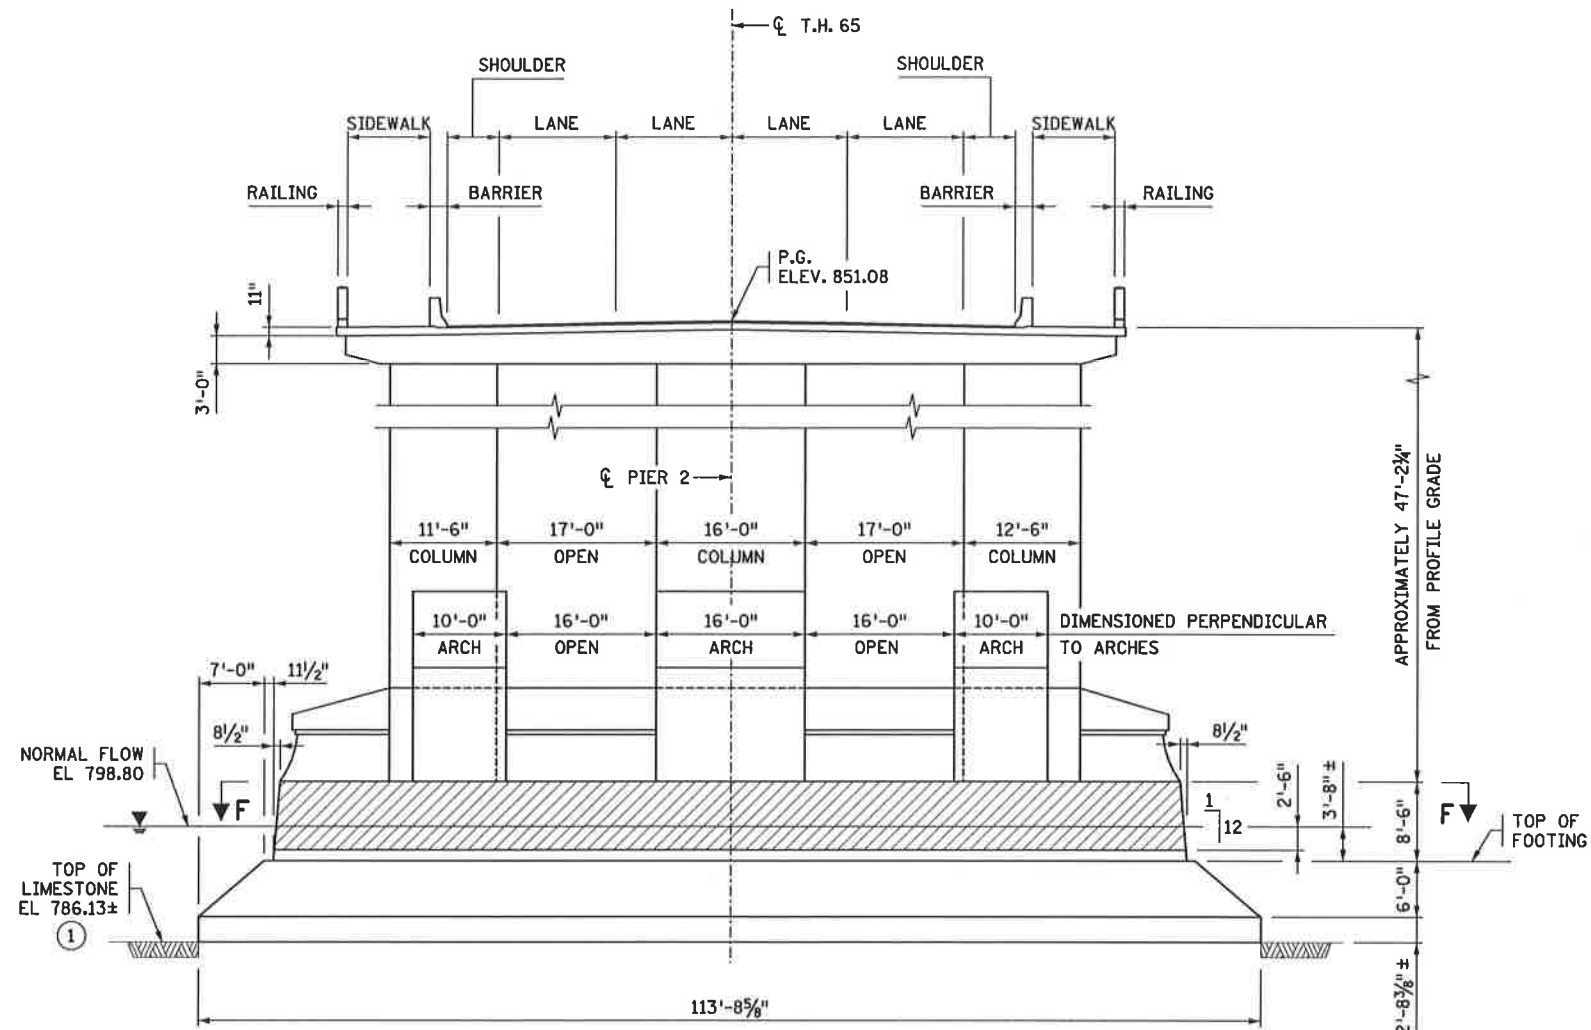
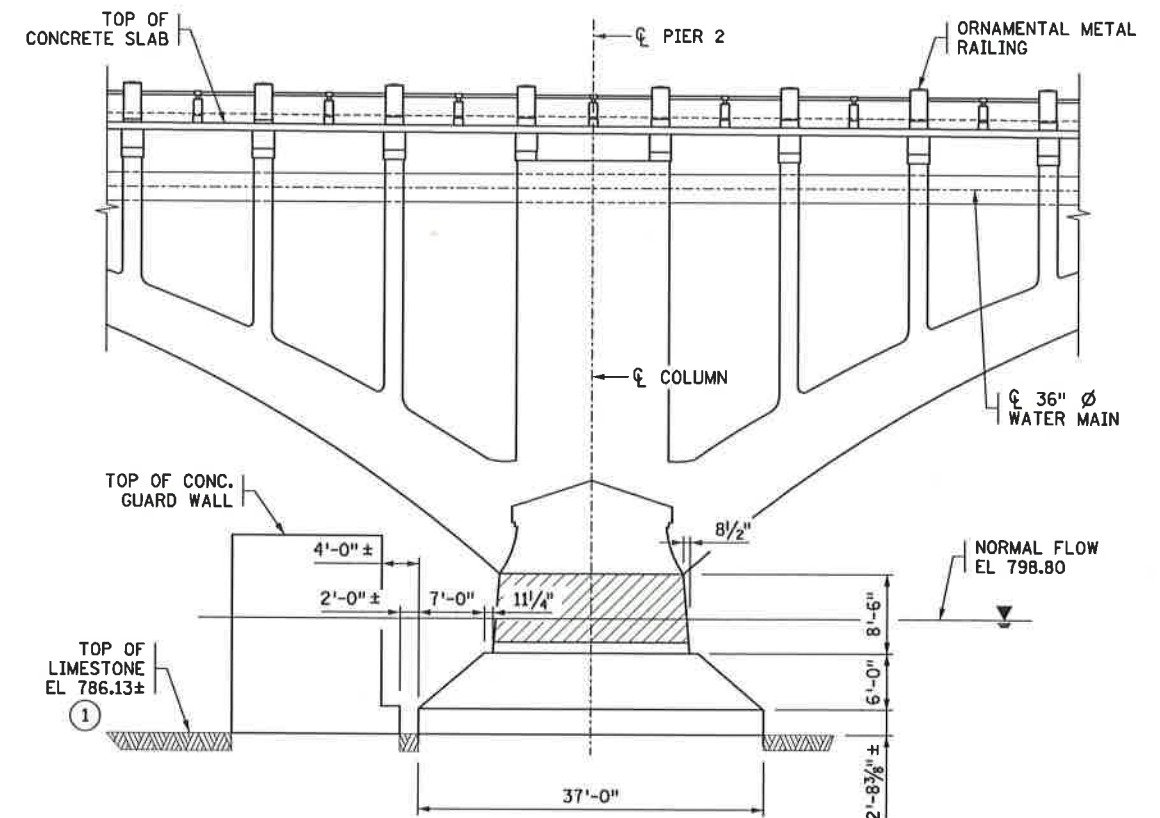
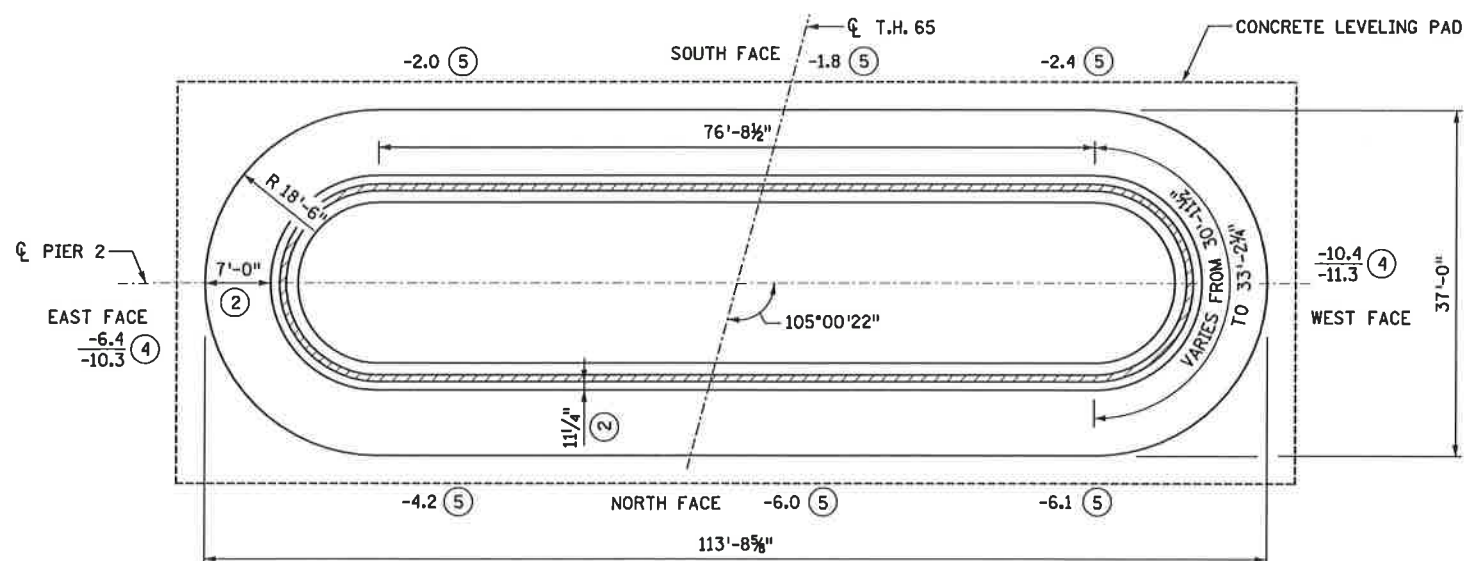
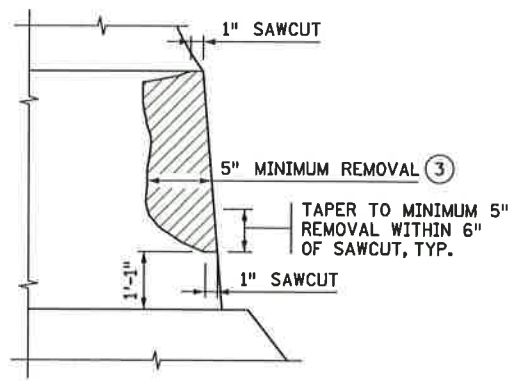
PIER 2 REMOVAL SECTION

The condition of the horizontal saw cut and spacing of the vertical rebar were very similar to the conditions described for pier #1. However, the spacing of the bottom horizontal rebar was also outside the specified spacing of 12". The bottom horizontal rebar was not set at a consistent elevation and had a wave profile to it. This caused a maximum distance to the adjacent bar to range greatly with a maximum distance of 13 3/8".

The condition of the new concrete on the upstream half also had areas of honeycombing concrete below the saw cut which were similar to pier #1. No areas of missing concrete were documented but the concrete forms were still present on the downstream half of the pier during AMI's last inspection. Two vertical bulges in the new concrete were documented near the upstream tip of the pier. The bulges have occurred at the location where two concrete forms butt up to each other. The bulge appears to be ground smooth above the waterline but a very apparent edge was still present below the waterline. The maximum difference between the two concrete faces was approximately 2" over a distance of 2'-0".

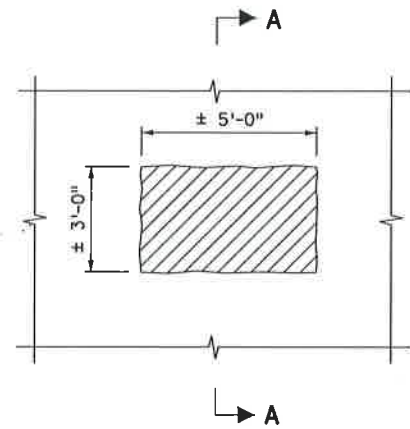
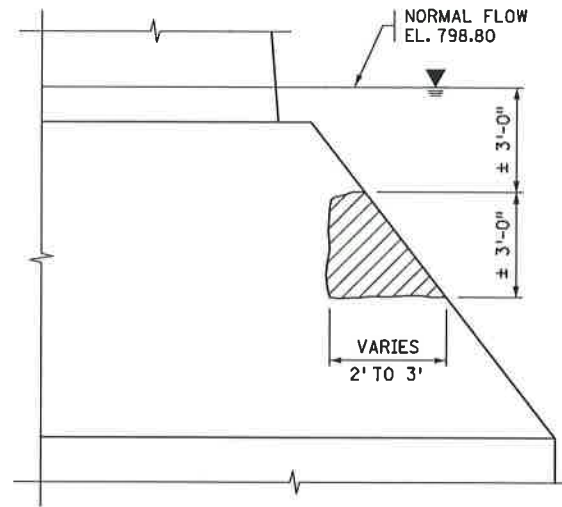
**PIER 5 SURFACE REMOVALS**  
(FIELD VERIFY DIMENSIONS)

The construction documents call out an area of deteriorated concrete on the east side of the pier. The area was approximately 5'-0" wide by 3'-0" tall with a penetration that ranged from 2'-0" to 3'-0". This area was located on the construction documents at 3'-0" below the normal river elevation on the tapered face of the concrete pier. However, a spall of that size was not documented by the contractor or AMI. An area of honeycombed concrete with a similar area was documented near the specified area but the penetration was only 2" instead of 2'-0" to 3'-0". This area will need to be addressed during the 2015 construction.
